## Utvrđivanje uzroka nastanka havarije motora SUS na osnovu retrospektivne funkcije dijagnostike

# Determining the Cause of Engine Failure Based on the Retrospective Diagnostic Function

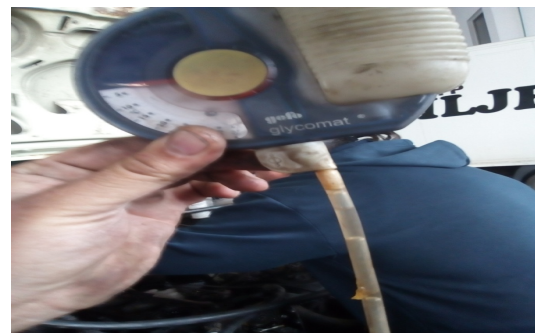
3. In the cooling system, instead of the prescribed coolant, ordinary water is poured, which is technically unacceptable (Figure 4). The use of ordinary water instead of coolant, which is recommended by the vehicle manufacturer, and which must be used during the operation of the vehicle, has a catastrophic negative effect on engine performance:

Figure 4: By controlling the type and quality of the coolant in the engine, it was concluded that there is ordinary water in it

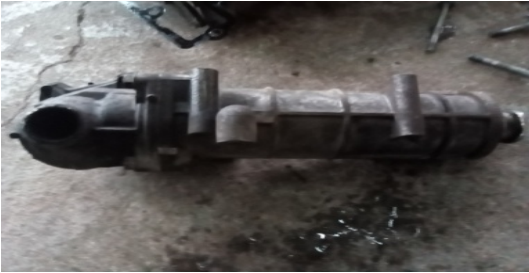
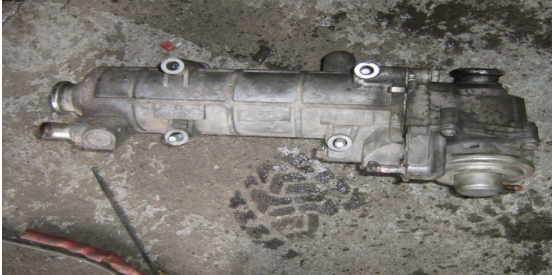
4. The EGR valve does not work (Figures 5 and 6). In the case of the EGR valve on the motor in question, there was a disturbance in its operation, primarily due to inadequate maintenance, which leads to its negative effect on the operation of the motor. The cause is the appearance of clogging, primarily due to the deposition of soot particles. EGR valves are used to regulate the combustion of the mixture, in order to increase economy and reduce the amount of nitrogen oxides and hydrocarbons.

Figure 5: EGR valve of engine IVECO FICE0481HC003 is non-functional - extremely dirty-view 1

Figure 6: EGR valve of engine FICE0481HC003 is non-functional - extremely dirty-view 2

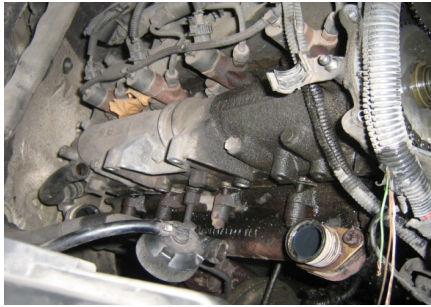
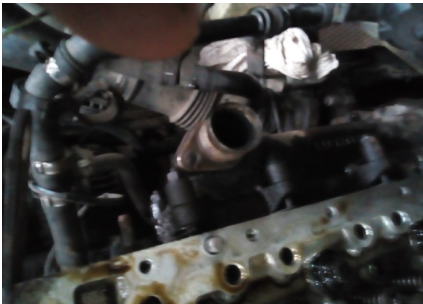
5. Does not work-there is no physical DPF-FAP filter (Figures 7 and 8). The engine in question was manufactured with a DPF-FAP filter and then met Euro 4 standards. This engine, at the time of determining its technical condition, does not meet the Euro 4 norm, but works at the level of the Euro 3 norm, and even lower, primarily because the DPF-FAP filter has been removed (Figures 7 and 8), and the EGR valve is dirty and non-functional (Figures 5 and 6). Since there is no DPF-FAP filter on the subject motor (means that the motor does not work with the PDF filter), the following negative effects occur:

- Turbo engine group, pistons, nozzles, EGR valve, piston rings and other engine parts are damaged because high temperature and pressure are created.
- Larger drop in performance, limits engine operation to 3000 rpm.

Figure 7: Motor engine- does not have PDF valve-view 1

Figure 8: Motor engine - does not have PDF valve-view 2

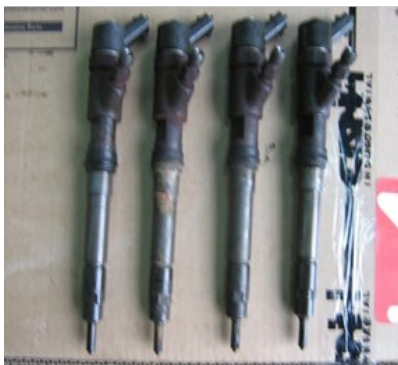
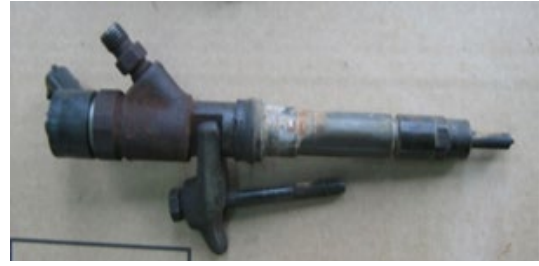
6. The injector on the fourth cylinder of the subject engine has an extremely large amount of scale and corrosion (Figure 9 and 10). Under the action of the coolant (water), on the propulsion engine produced by Iveco FICE0481H C03, large deposits of lime scale and corrosion appeared on the injector of the fourth cylinder. There is also a large presence of scale on the injector. This indicates that there is a penetration of the liquid, which is used to cool the engine, to the injector on the fourth cylinder. That is technically unacceptable. Since the fluid used to cool the engine reached the injector on the fourth cylinder (this cannot happen with technically correct engines), that same fluid damaged other parts of the engine and caused it to malfunction.

Figure 9: Engine injectors of engine IVECO FICE0481HC003

Figure 10: Fourth cylinder engine injectors of engine IVECO FICE0481HC003

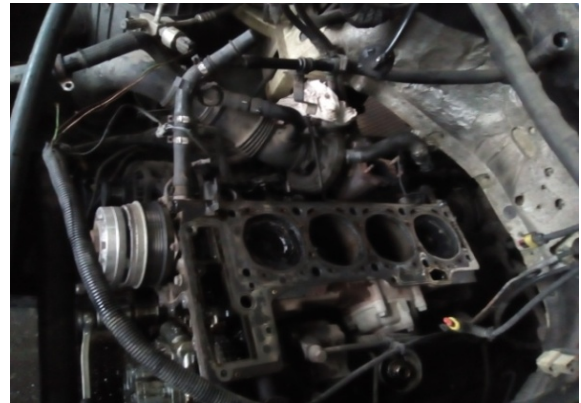
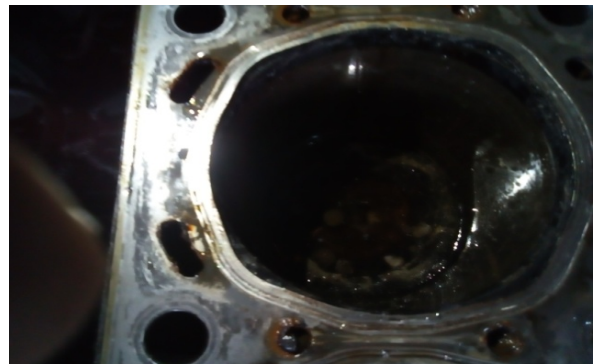
7. The condition of the piston group (piston-piston rings-cylinder) is extremely poor. Large deposits of resin, corrosion and scorching are present (Figure 11,12). This shows that exploitation of the vehicle in question, but also its maintenance, was not carried out in the manner prescribed by the manufacturer. The piston group of the engine (piston-piston rings-cylinder) is in extremely poor technical condition (Figures 11,12), among other things, due to frequent overheating during vehicle operation.

Figure 11: Motor engine IVECO FICE0481HC003 - view of the complete engine block from top, after disassembling the cylinder head

Figure 12: Fourth cylinder engine -view of the engine block part - the fourth cylinder and the piston in it, after dismantling the engine head

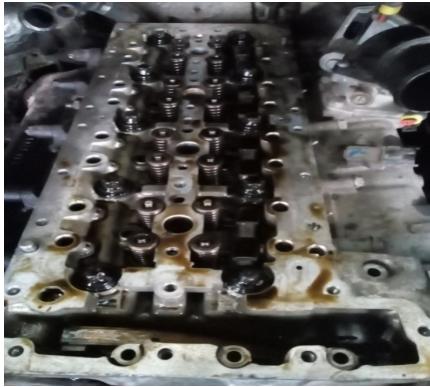
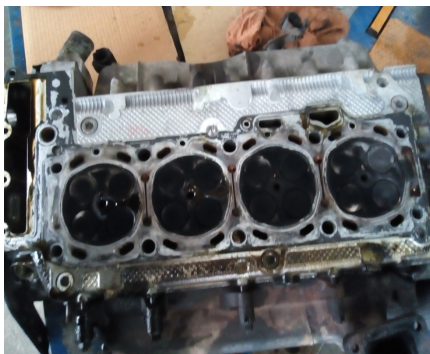
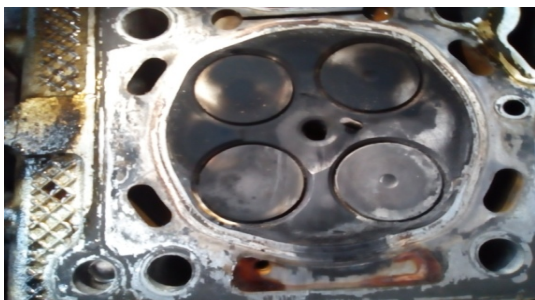
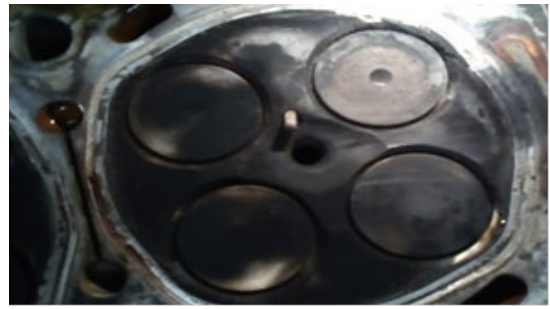
8. Due to the use of ordinary water as a means of cooling the engine, lime scale builds up inside the cylinder head (Figures: 13,14,15,16), but also in the entire cooling system of the engine in question. This has led to reduced flow channels, where the coolant is to move, and thus the cooling capacity (heat dissipation capacity) is reduced.

Lime scale deposits are an insulator, so that this fact points to the conclusion that the heat released in the working space of the subject engine could not be removed properly, as predicted and realized by the manufacturer of the subject engine. By using ordinary water as a means of cooling the engine, limescale builds up on the injector of the fourth cylinder of the engine in question.

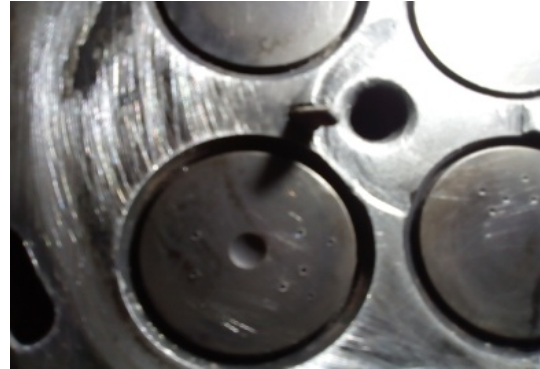
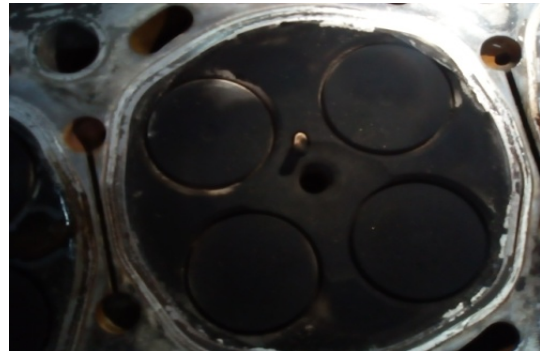
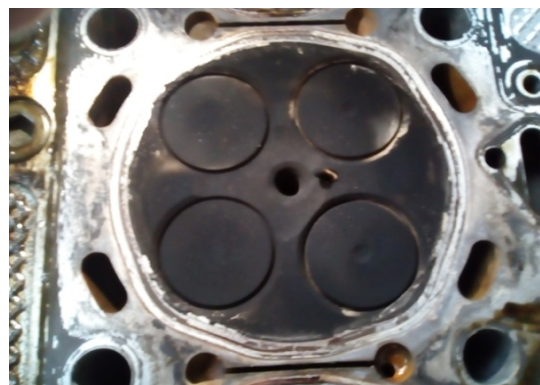
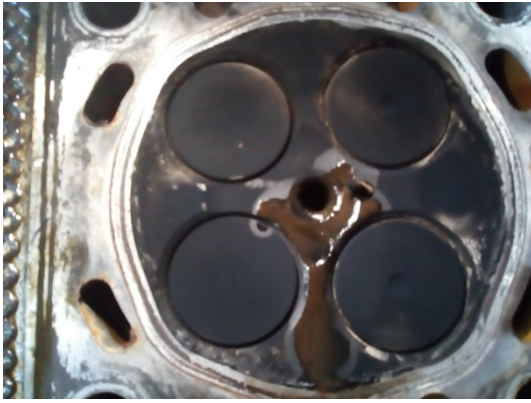
- EGR valve condition (Figures 5,6);
- Lack of DPF valve (Figures 7,8);
- Coolant quality (Figures 3,4);
- Sealing condition between cylinder head and engine block, as well as valve condition (Figures 13,15,17,18,19, 20);

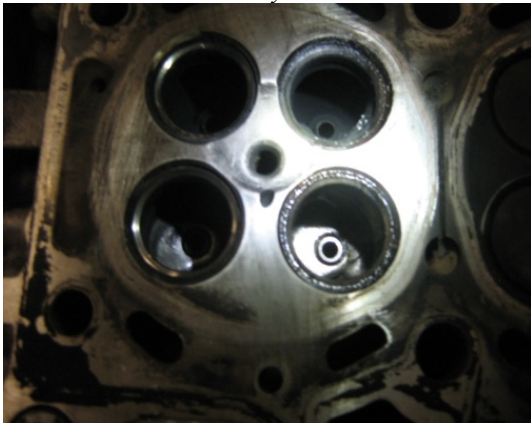
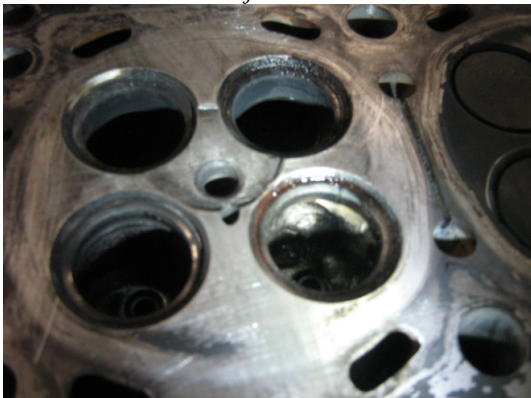
Figure 21: Motor engine IVECO F1CE0481HC003 - view 3 on the lower part of the cylinder head (above the fourth cylinder) where there was a crack on the side of the injector

Figure 22: Motor engine IVECO F1CE0481HC003- view 2 on the lower part of the cylinder head (above the fourth cylinder) where a crack appeared on the side of the injector. The picture shows a view of the welded part on the side of the valve.

9. Welded cylinder head on the fourth cylinder on the valve side (Figure 21,22), where the cylinder head in question had a crack on the injector side.
