Failure Analysis on Tube Arm Cylinder Hydraulic Excavator

Abstract— The Failure on tube rod arm cylinder hydraulic excavator caused to lose production and processing time on mining site. Investigation included visual inspection, chemical analysis, metallography analyze, and microhardness test. Tube material used high silicon material type while the standard used ST52 carbon steel type. The tube was broken and crack to several pieces. The chemical composition of the tube has different in sulfur and silicon content. From hardness test with micro hardness method, sample tube broken has lower hardness compared to standard hardness. Metallography analysis obtained the phase of tube has same phase with standard which is ferrite and pearlite phase but has different grain size. Based on this study, it can be resumed failure on tube is because impurities and different specification on raw material.

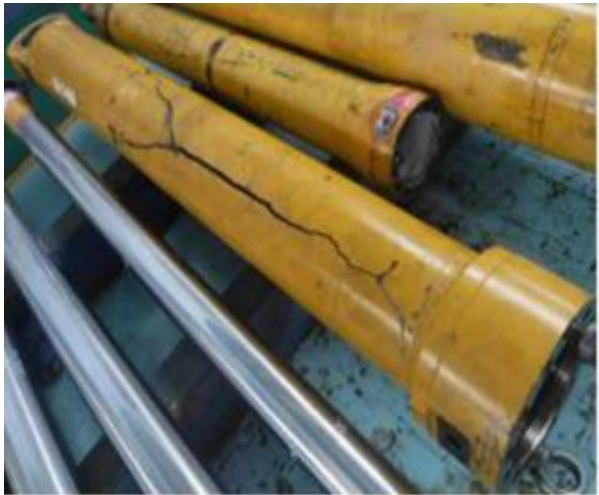
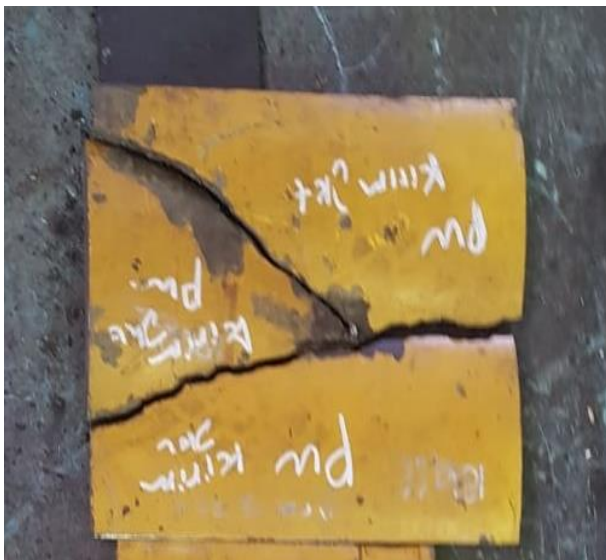
Figure. 3 Broken Tube Sample

Figure below show broken part from the tube and it divided into several pieces. We did some test and analyze, to obtained data from piece of crack on surface and inner diameter tube.

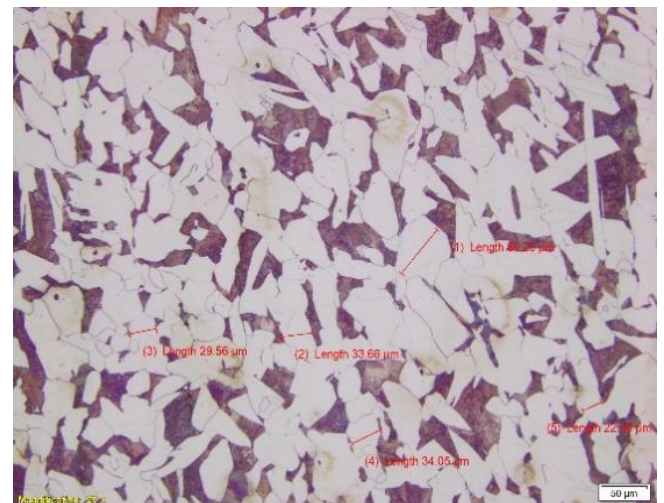
Figure. 4 Broken Tube Sample Microstructure

Using an optical microscope. In this tube arm cylinder broken analysis, the thing that is of concern is the phase contained in the arm cylinder broken part. Based on the results of the microstructural analysis, the broken tube arm cylinder sample consists of

ferrite and pearlite phases which have ductile and tough properties. Whereas the reference ST52 also consists of ferrite and pearlite phases which have ductile and tough properties. Based on the analysis of ferrite grain size, it can be seen that the grain size of ferrite up to the arm cylinder sample looks larger (34-60 μm) than the grain size of Reference ST 52 ferrite, which is (26-28 μm) (Zhou et al., 2020). The larger the grain, the lower the hardness and tensile strength, but the better the ductility (Khodabakhshi & Gerlich, 2020). As explained in the graph below

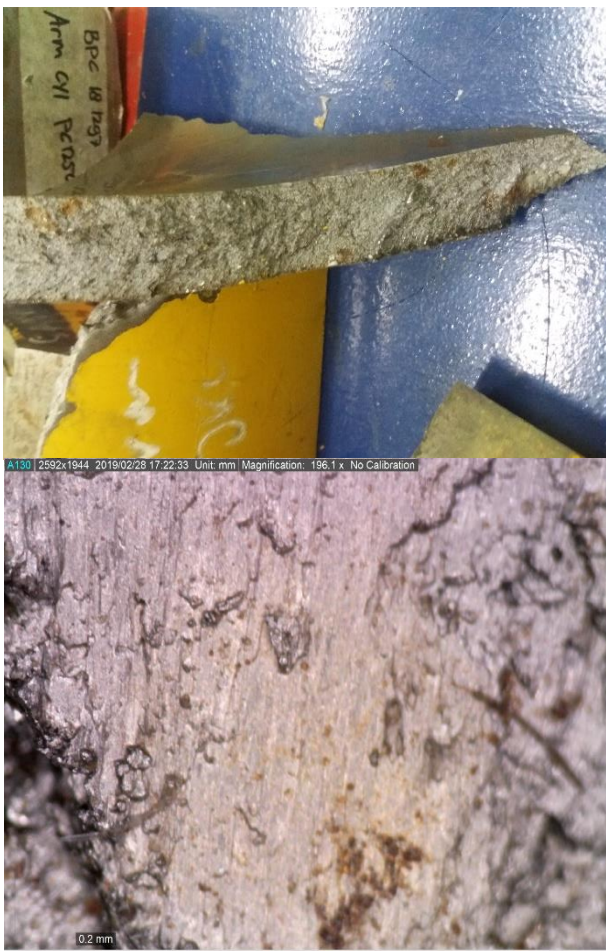
Figure. 8 Surface Sample Fracture

With dino-lite portable microscope we examined the surface broken area, the surface has rough and smooth fracture area which indicated is spontaneous fracture. No beachmarks or striation seen, which indicated fatigue failure not the main fracture for this failure
