ASSESSMENT OF THE ST. GIUSTA CHURCH IN BAZZANO AFTER THE L'AQUILA EARTHQUAKE ON APRIL 6, 2009

One of the first surveyed historical buildings was the church St. Giusta in Bazzano, about 7 km from L'Aquila city, one of the most beautiful churches of the area.

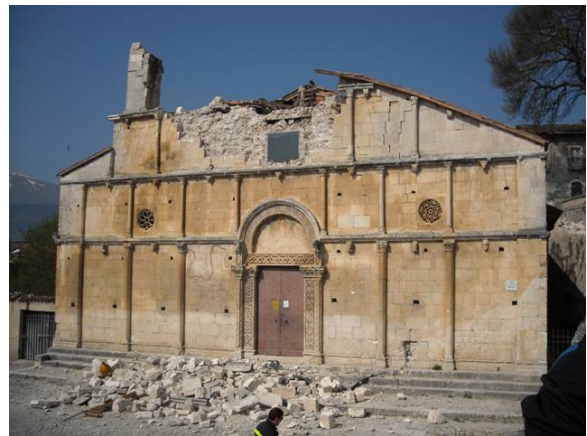
Serious damages were caused by the April 2009 earthquake to the facade (Fig. 2), with the collapse of the bell tower and of the top of the facade, the out of plane rotation of the facade and the in plane damage of the facade and of the lateral walls. Heavy damages also were caused to the columns and to the pillars under flexural actions.

Figure 2: The façade of St. Giusta church after the earthquake of 06.04.2009.

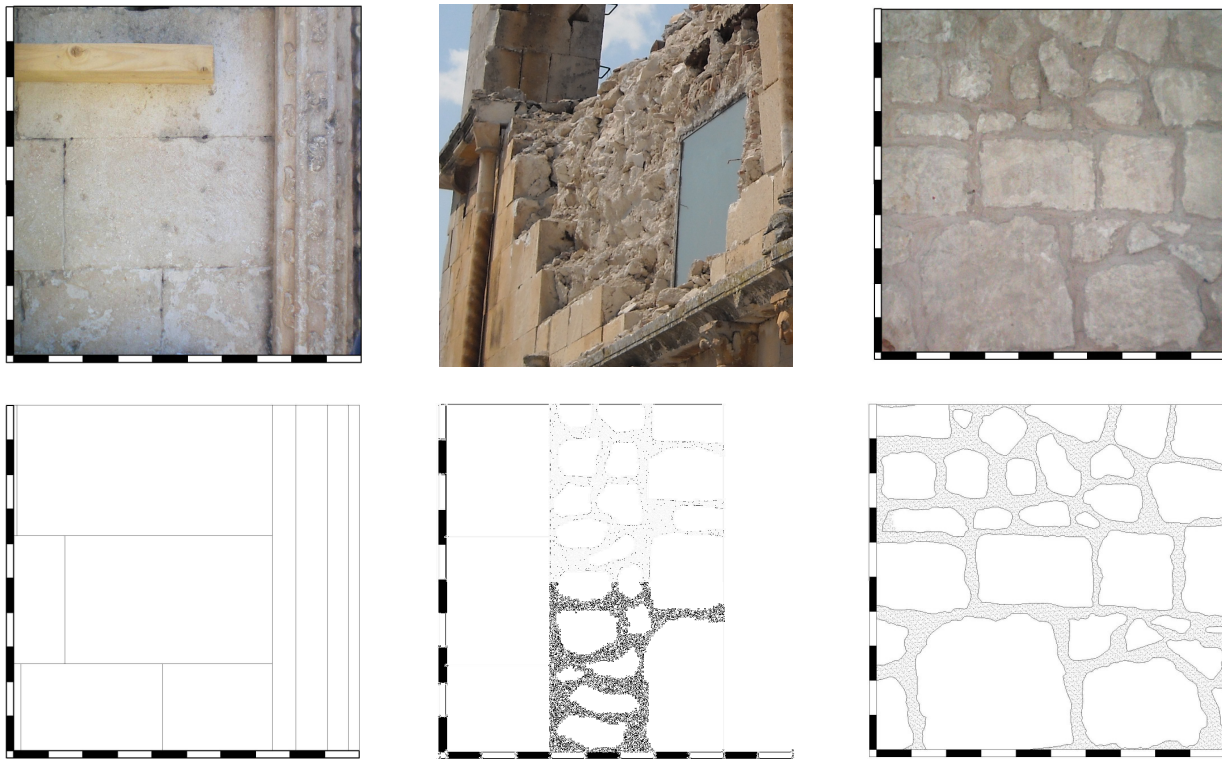
As shown in figure 6, the external leaf of the facade wall is made of calcareous regular stone blocks and, as in many other cases in the region, the internal leaf is less regular, while in the middle a third leaf is made in small irregular stones. Connections among the leaves are not visible; this explains both the high vulnerability of the top of the facade. In the other selected point the masonry has irregular texture and irregular calcareous stones.

Figure 6: Masonry (prospect and cross section) of the facade.

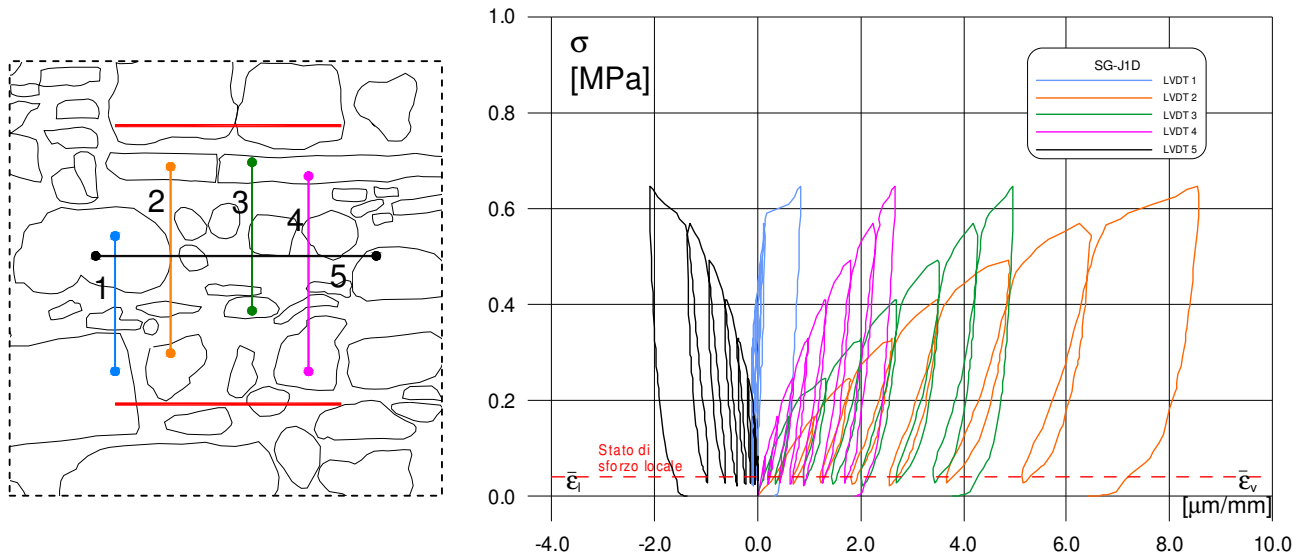
The local state of stress, measured with the single flat-jack test, was difficult to evaluate due to the irregularity of the masonry and the movement of some stones during the wall cut, but it was estimated about 0,04 MPa. The mechanical behaviour due to compression measured with the double flat-jack test, show a high non-homogeneous deformable masonry without a linear behaviour (Fig.7), due to the irregular not cut stones and high presence of mortar. With the double flat-jack test the modulus of elasticity results lower than 200 MPa.

Figure 7: Double flat jack test on the masonry wall dividing the nave from the left aisle.

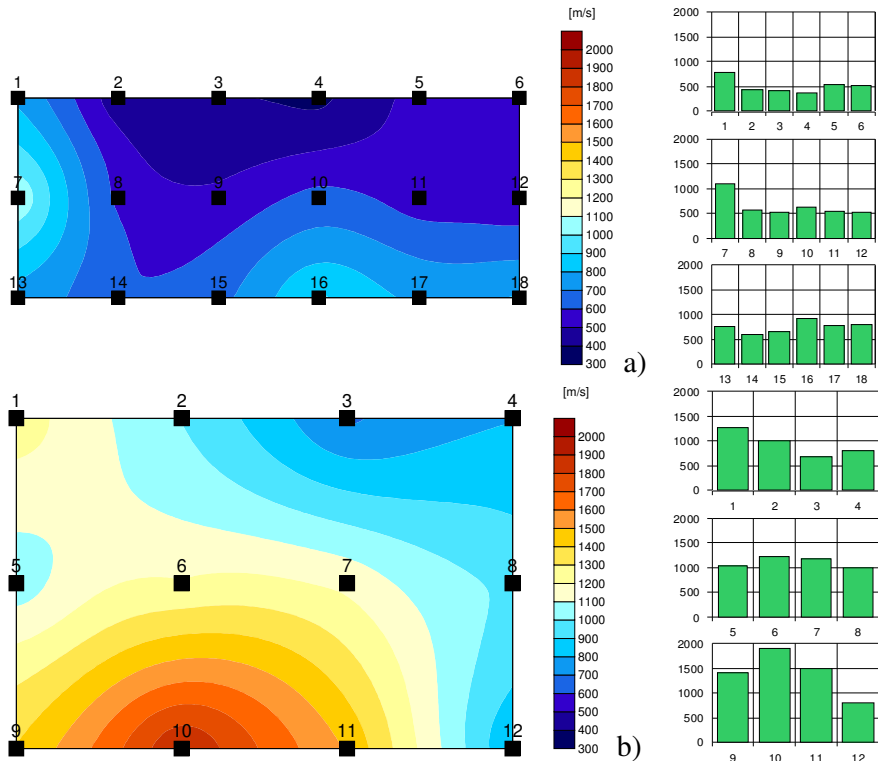
Also sonic pulse velocity test by transparency measured on the same area of the wall shows a masonry with low values of velocity, 637 m/s, while on façade wall the measured values are the double (Fig.8),

Figure 8: Sonic pulse velocity tests on: a) the masonry wall dividing the nave from the left aisle and b) façade masonry.

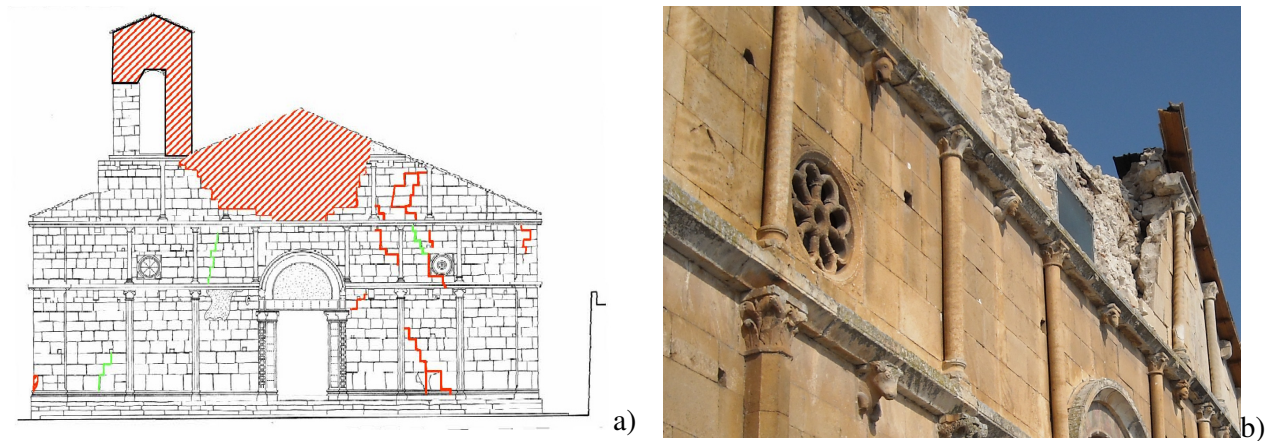
the greatest damage (Fig.9a): the façade has indeed lost the gable at the ridge beam and in front of the central nave, with detachment of the external leaf around the central window to the second cornice. The outer leaf and its decoration have a clear out of plumb and are in unsafe conditions (Fig.9b).

Figure 9: a) Crack pattern of the façade and b) out of plumb of external leaf of the masonry wall.

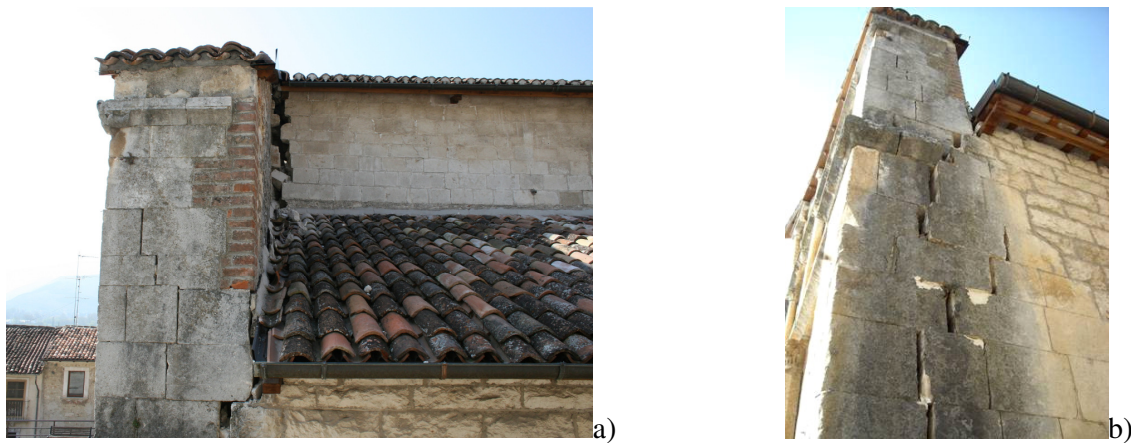
Looking at the side elevations of the church it is clearly visible how the entire facade is overturning, with maximum opening at the top, at the corner front-nave, with major emphasis on the right side to the east, at the aisle (Fig. 10).

Even in the lower part the damage is larger on the right side (East) than on the left (west) and this could be due to differences in planimetric shape of the two aisles, with or without transverse bracing walls. The detachment of the masonry façade from transversal walls is visible from inside the church.

Figure 10: Detachment of the longitudinal masonry walls from the façade: a) higher part and b) lower part.

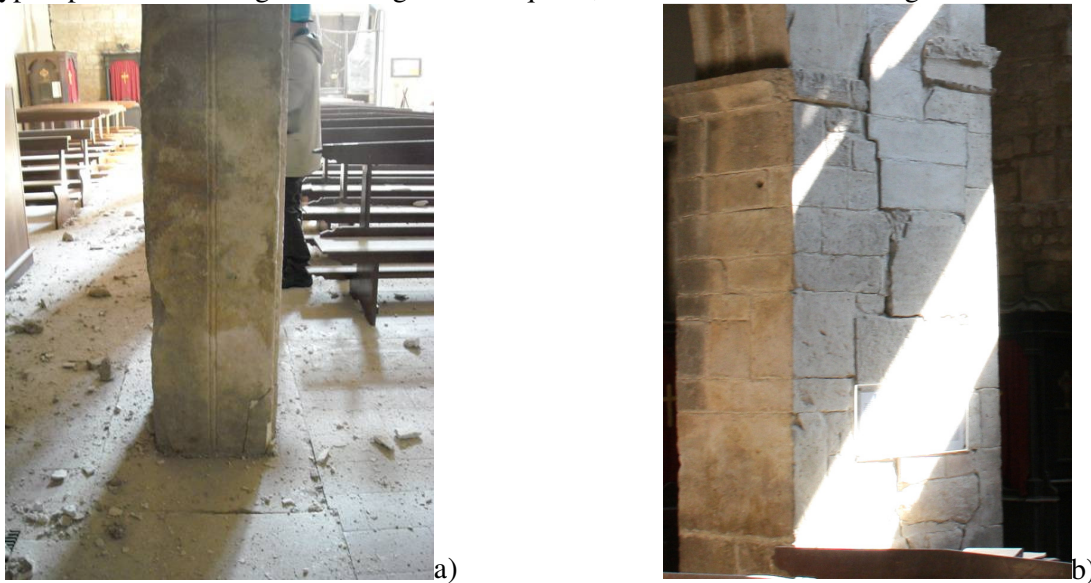
Therefore, the most damaged wall is the one on the right, with arches, columns and pillars. All columns and pillars present an overturning with cracks due to compression to the foot toward the center of the church and with loss of material (Fig.11a).

The larger pillar to the façade presents crushing cracks in all his full height (Fig.11b).

Figure 11: The damage of the pillars: a) a stone lintel used as a pillar due to overturning and b) the largest pillar damage by crushing.

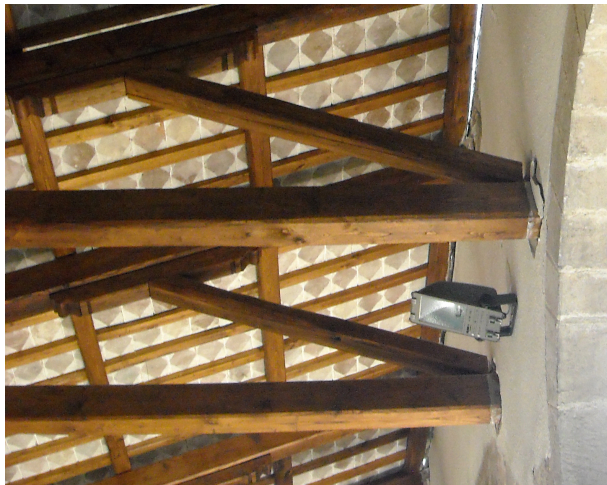
In addition, the dividing walls between the nave and the aisles presents wood trusses elements that moved out from the wall (Fig.12).

Figure 12: Wood trusses went out from the wall.

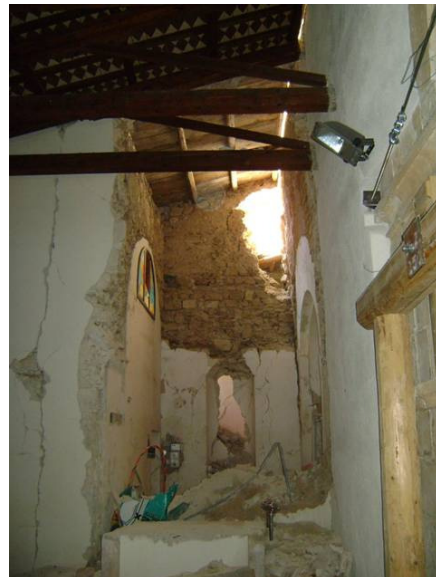
Figure 13: the collapse of the masonry wall behind the lateral chapel.

The transversal walls of the left aisle, in the pastor's house and in correspondence of the chapel, are badly damaged due to shear actions (Fig.13). Some vaults in bricks partially collapsed.

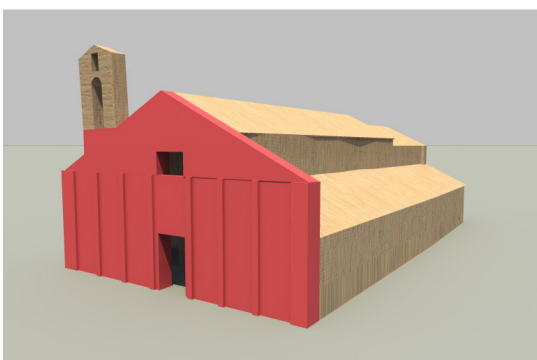
The safety in St. Giusta church results as verified, in case of earthquake, for the facade of the church and of the right side of the facade (assuming the seismic acceleration direction perpendicular to the facade) (Fig.14a,c).

Resistant Acceleration
 $SLD = \frac{\text{Resistant Acceleration}}{\text{Stressing Acceleration}} = 1,1 > 1$ verified

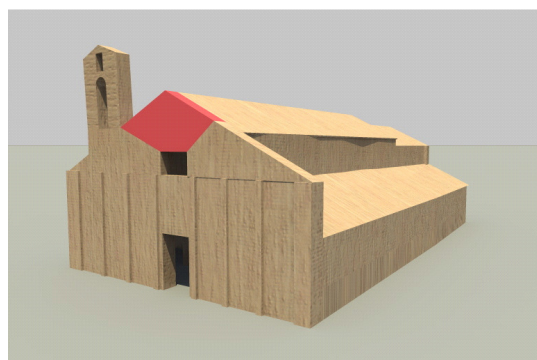
While the safety results as not verified, in case of earthquake, for the top of the facade, with horizontal crack on the tympanum with an opening and for the wall between the central nave and the right aisle, isolated or with lateral constraint, (assuming the seismic acceleration direction perpendicular to the facade) (Fig.14b,d).

Resistant Acceleration
 $SLD = \frac{\text{Resistant Acceleration}}{\text{Stressing Acceleration}} = 0,85 < 1$ **not verified**

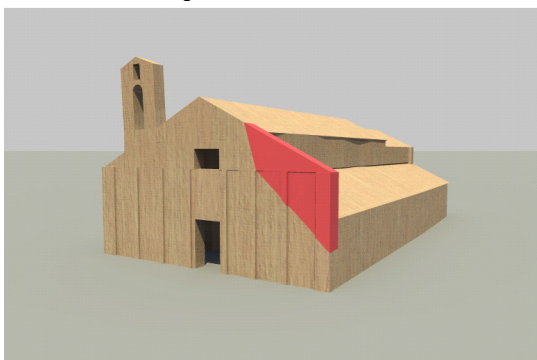
Resistant Acceleration
 $SLD = \frac{\text{Resistant Acceleration}}{\text{Stressing Acceleration}} = 1,05 > 1$ verified

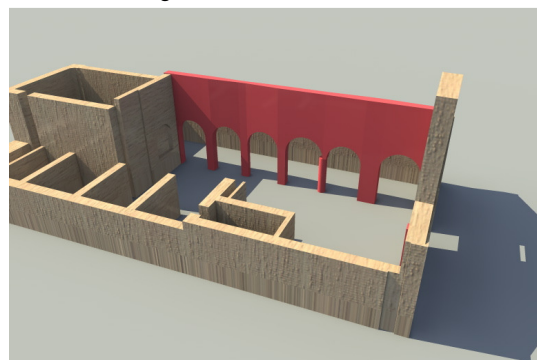
Resistant Acceleration
 $SLD = \frac{\text{Resistant Acceleration}}{\text{Stressing Acceleration}} = 0,22 < 1$ **not verified**

Unlike the continuous full wall dividing the left aisle (now the pastor's house), the wall between the nave and the right aisle has a high vulnerability due to the absence of transverse bracing walls. Furthermore, the macro-elements consists of pillars and stone elements of different sizes and geometry. These pillars

support a masonry wall with an important mass. This macro-element clearly presents a very high instability out of its plane.

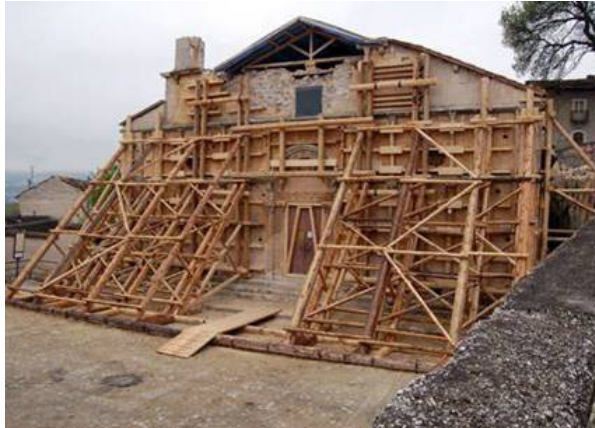
Figure 15: Propping of the buildings facades

Propping of the building facade made with contrasting elements was immediately realised (Fig.15), braced and anchored to the ground by steel rod. This intervention was possible thanks to the free space in front of the church. A double level of tie-rods on the facade anchored to the openings was realised. The most damaged pillar was encircled with flat steel bars (Fig.16) and the internal arches near the façade were bended.

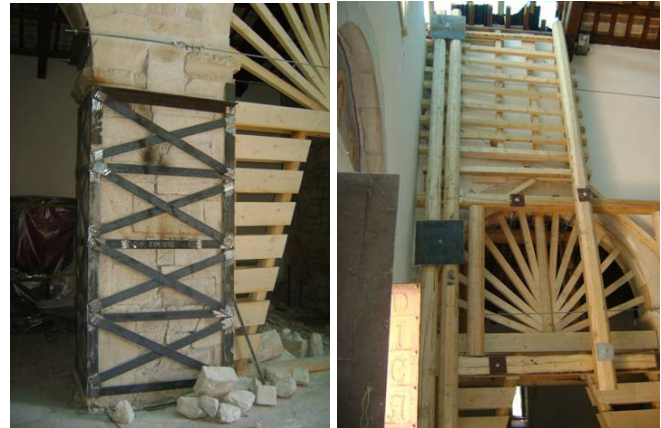
Figure 16: the encircled main pillar and bending of the aches.
