# Development of Guidelines for Inspection, Repair, and Use of Portable Concrete Barriers—Volume 1: Technical Report

Technical Report 0-7059-R1-Vol1

TEXAS A&M TRANSPORTATION INSTITUTE  
COLLEGE STATION, TEXAS

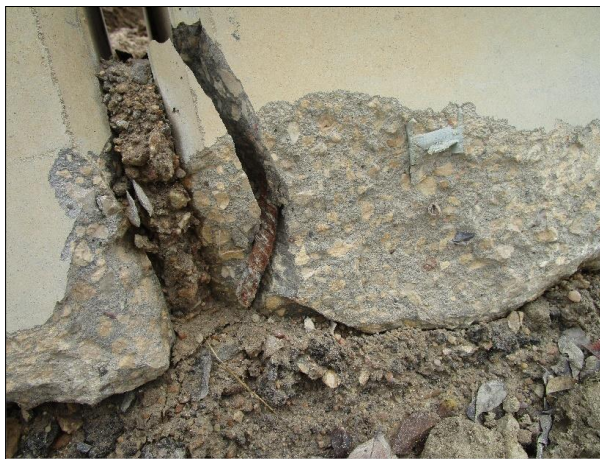
When the rebar is exposed to moisture and water, possibly because of inadequate cover or surface irregularity, a chemical reaction takes place, resulting in the formation of iron oxide (rust) on the rebar surface. Due to the production of iron oxide, the rebar volumetrically expands by up to six times its original volume. This increase in volume imposes significant expansive forces on the surrounding concrete, which can cause a chunk of the concrete to spall and break off. Spalling increases access of air and water to the rebar embedded within the barrier and creates a cycle of corrosion, exacerbating the process with each subsequent cycle (2). Figure 2.2 shows an example of a barrier with a corroded rebar and spalled concrete.

**Figure 2.2. Corrosion of Reinforcing Bar Embedded in the Toe of the Concrete Barrier.**

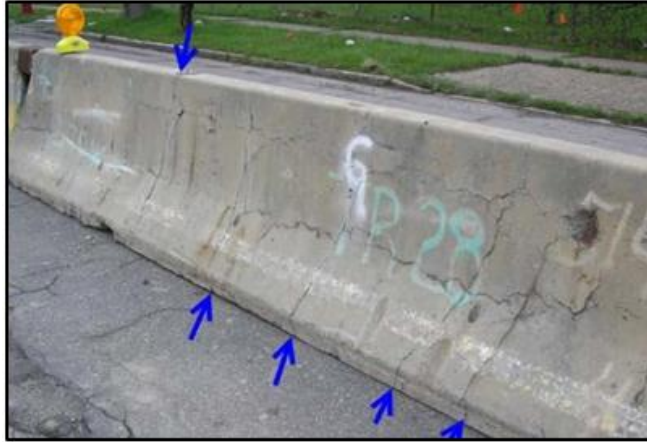
Cracks in concrete are complete or incomplete separation of the material into two or more parts through breaking or fracturing. Figure 2.4 shows cracks of varying extent at different locations of PCBs.

**Figure 2.4. Cracking in Portable Concrete Barriers (8).**

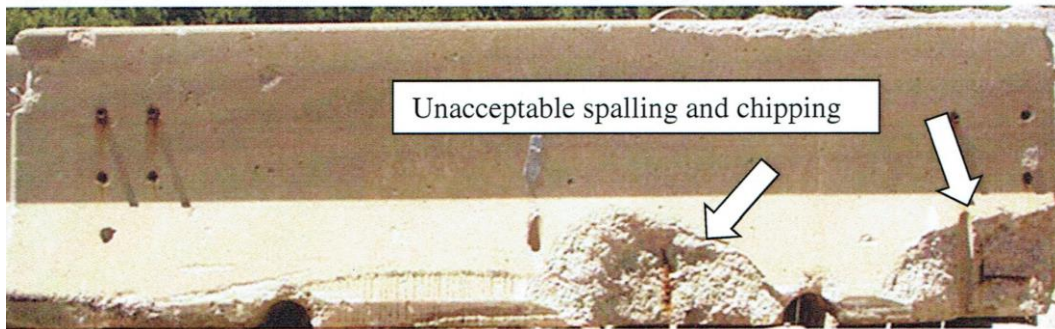
**Figure 2.17. Example of Unacceptable Barrier—Illinois (28).**

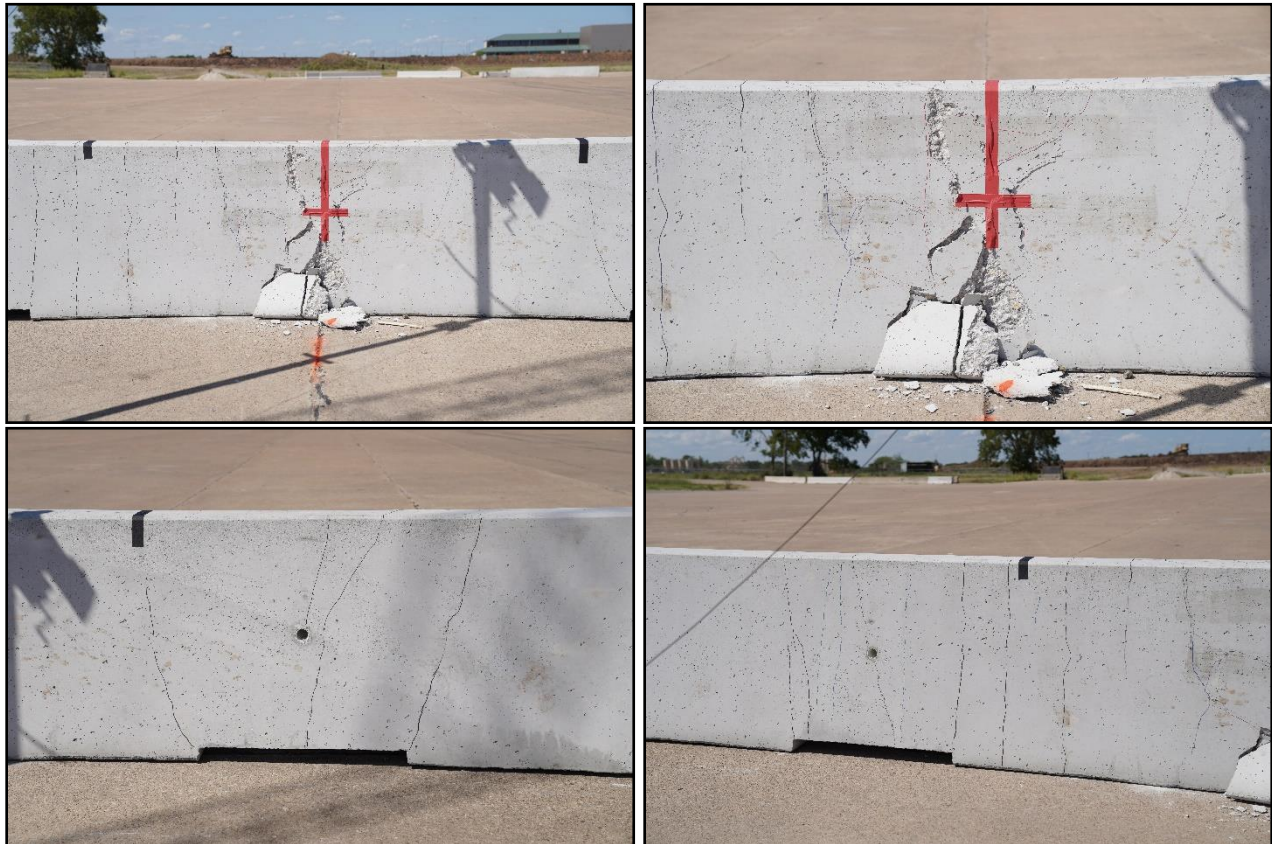
and 2 inches at the back. Barrier C had multiple cracks on both the front and the back, with one being a very large crack on the back of the barrier at impact, with rebar both exposed and broken in several places. There was some additional spalling of the concrete at the joint of barriers C and D and also at impact. Barrier B also had some cracking on both the front and the back. Maximum dynamic deflection during the test was 19.8 inches, and maximum permanent deformation was 19.0 inches. Data from the accelerometers were digitized for evaluation of occupant risk, and the results are shown in Table 5.4. Figure 5.9 summarizes pertinent test impact frames.

**Figure 5.8. Single-Slope Barrier after Test No. 440590-01-B8.**

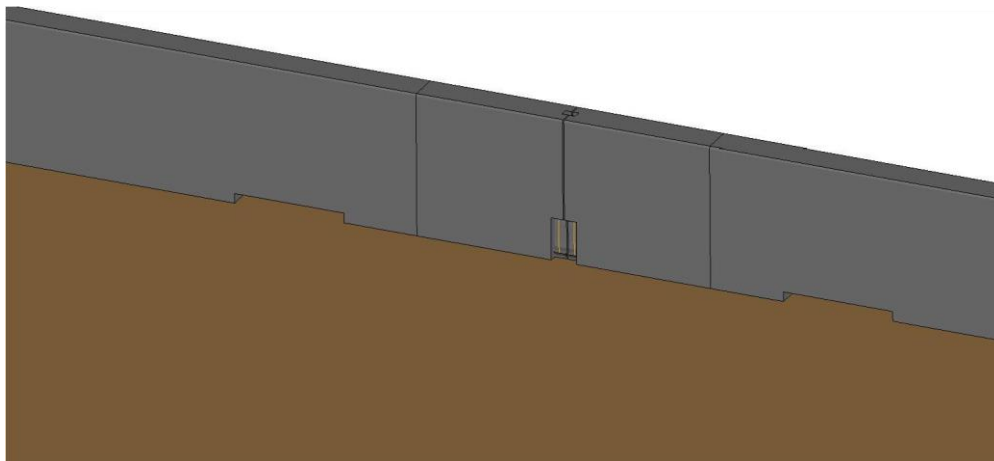
Preexisting damage in the form of a 13-inch (length) by 4-inch (width) by 2-inch (depth) spall was created on adjacent toes of the barriers. Figure 7.9 illustrates the damage created in the barrier.

**Figure 7.9. Pre-damaged Barrier with Adjacent Toes Having Spall of Length = 13 inches, Width = 4 inches, Depth = 2 inches.**

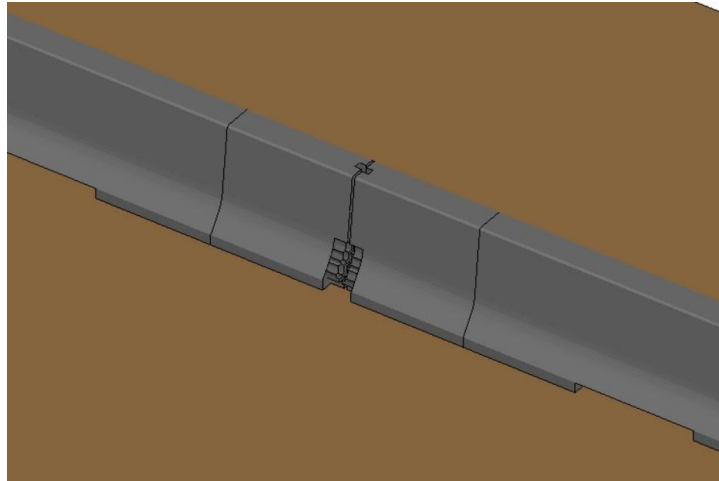
Preexisting damage in the form of a 13-inch (length) by 4-inch (width) by 2-inch (depth) spall was created on adjacent toes of the barrier. Figure 7.12 illustrates the damage created in the barrier.

**Figure 7.12. Pre-damaged F-Shape Barrier with Adjacent Toes Having Spall of Length = 13 inches, Width = 4 inches, Depth = 2 inches.**

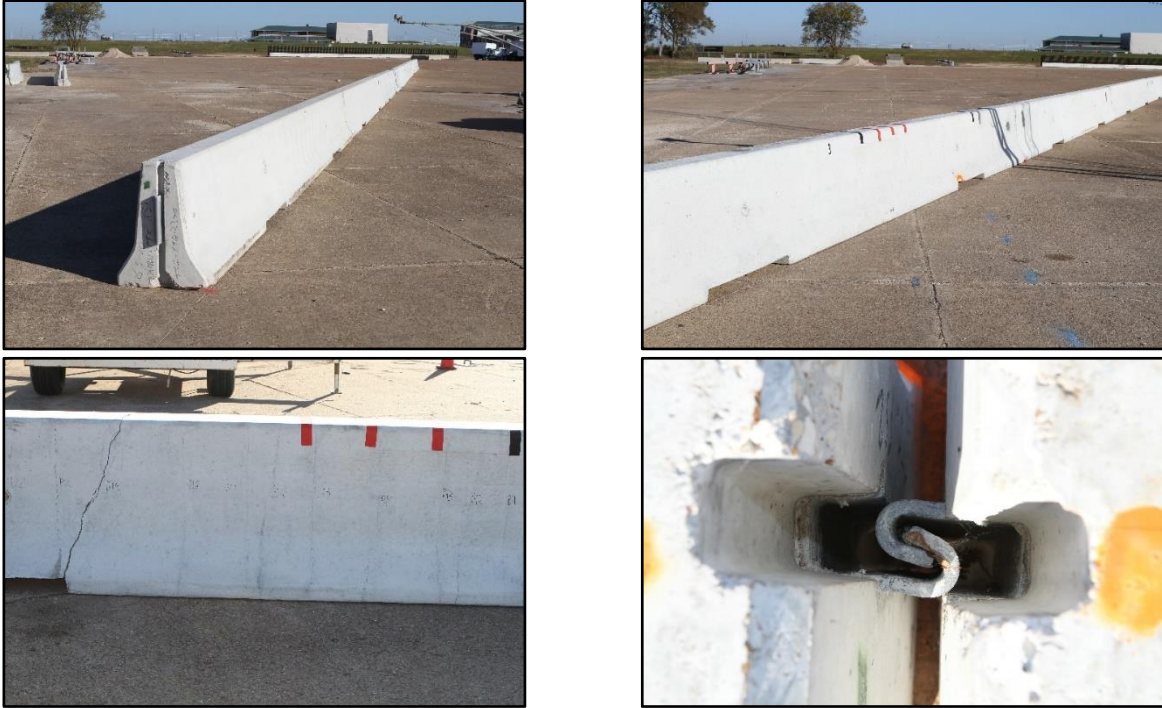
**Figure 8.1. Damaged Portable Concrete Barrier before Test No. 440592-1.**

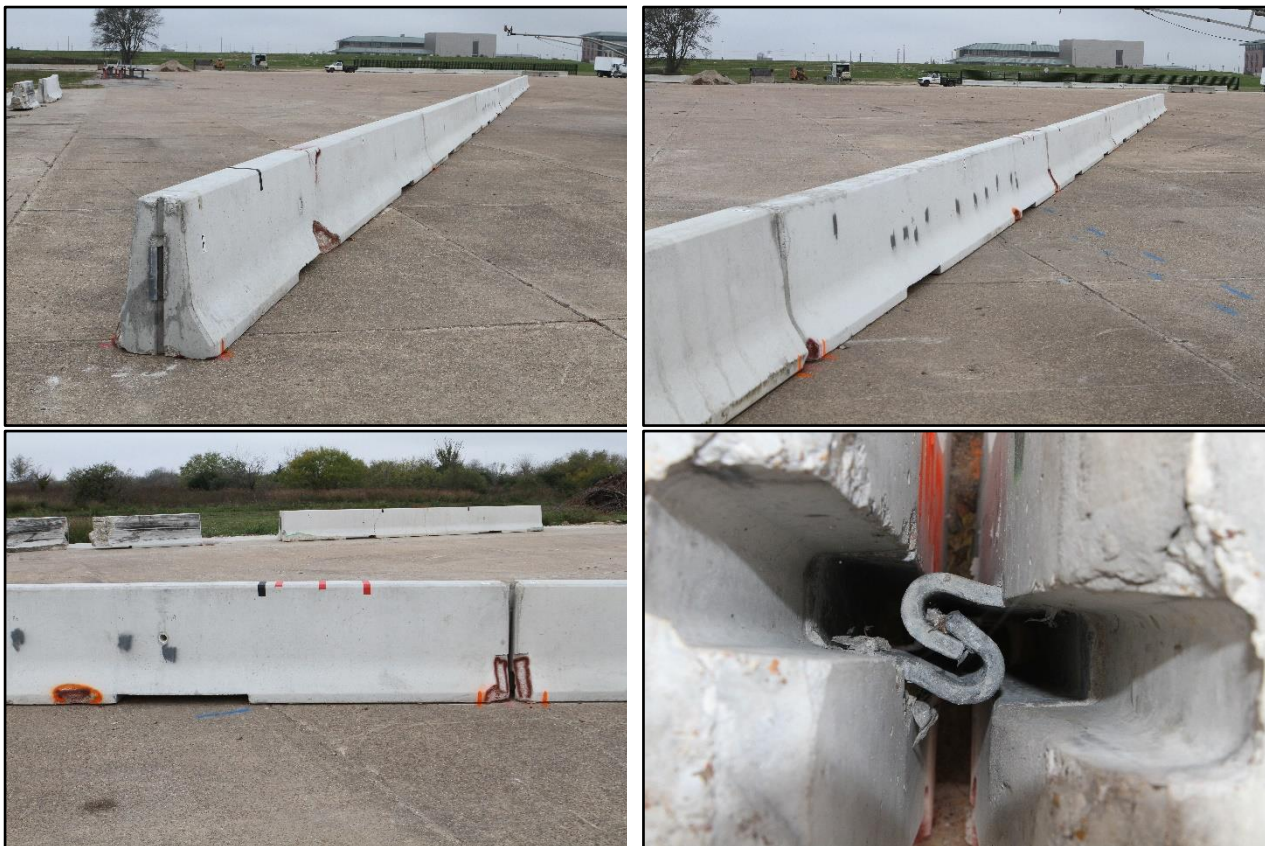
**Figure 8.2. Damaged Portable Concrete Barrier before Test No. 440592-2.**

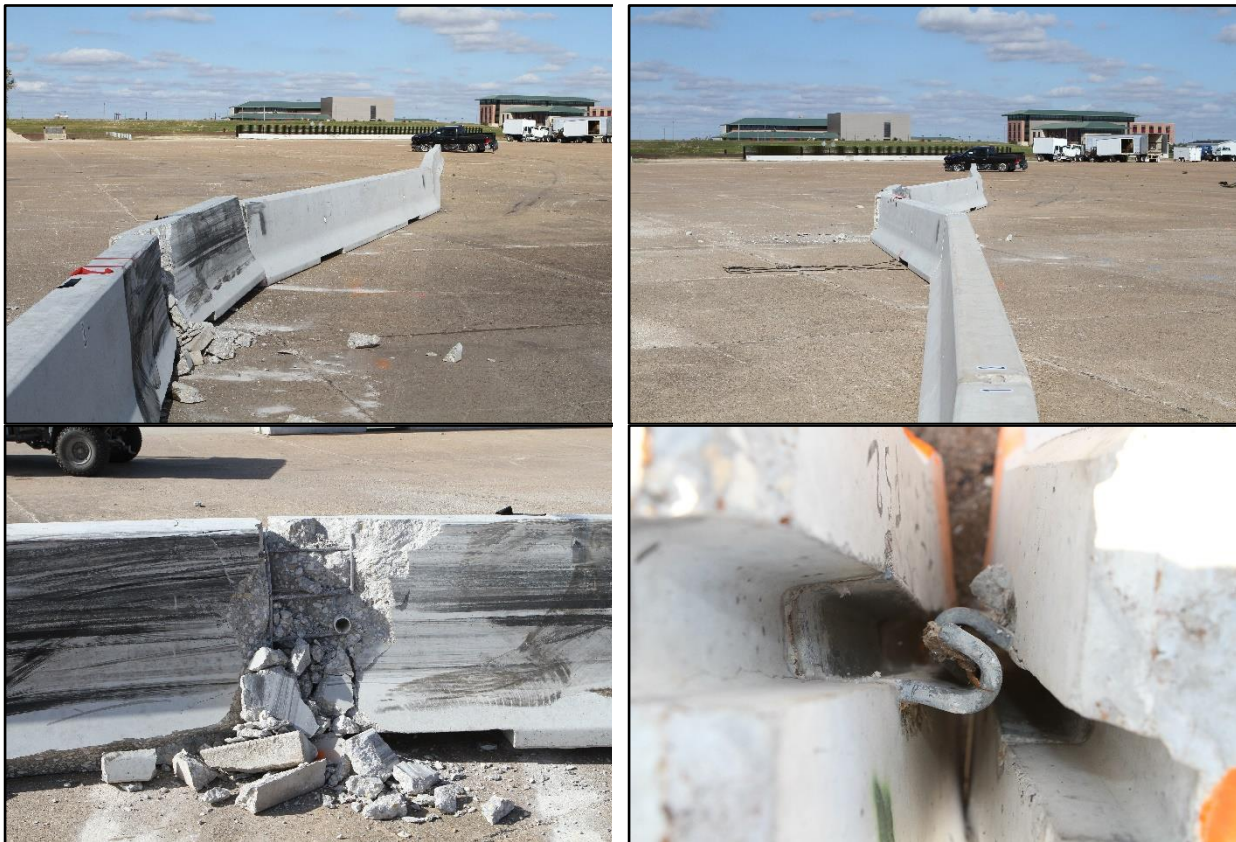
**Figure 8.7. Damaged Portable Concrete Barrier after Test No. 440592-1.**

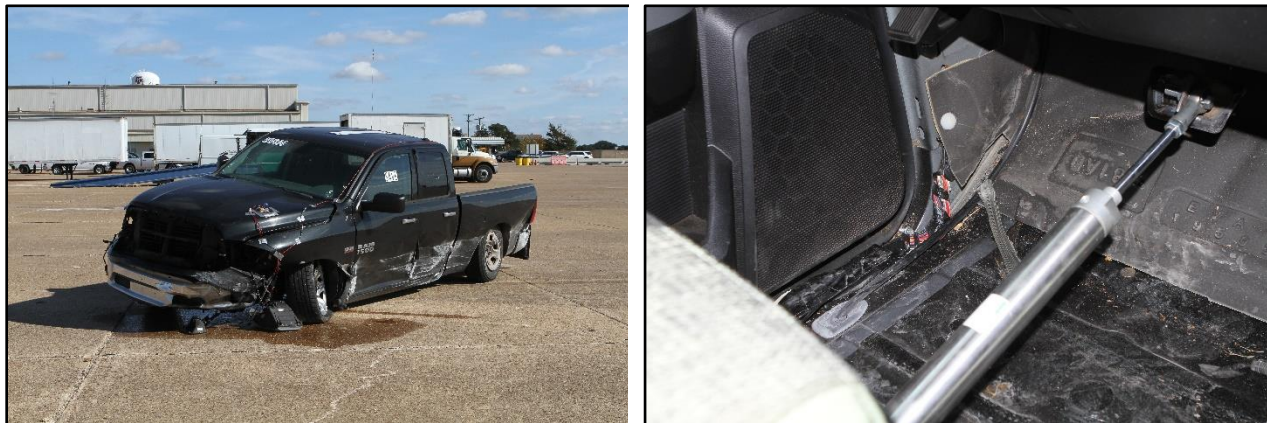
| <b>Description of Damage to Vehicle:</b> | The front bumper, hood, grill, left headlight, left front fender, left front tire and rim, left front door, left rear door, left cab corner, left rear quarter fender, left rear tire and rim, left taillight, tailgate, and rear bumper were damaged. |

**Figure 8.8. Vehicle after Test No. 440592-1.**

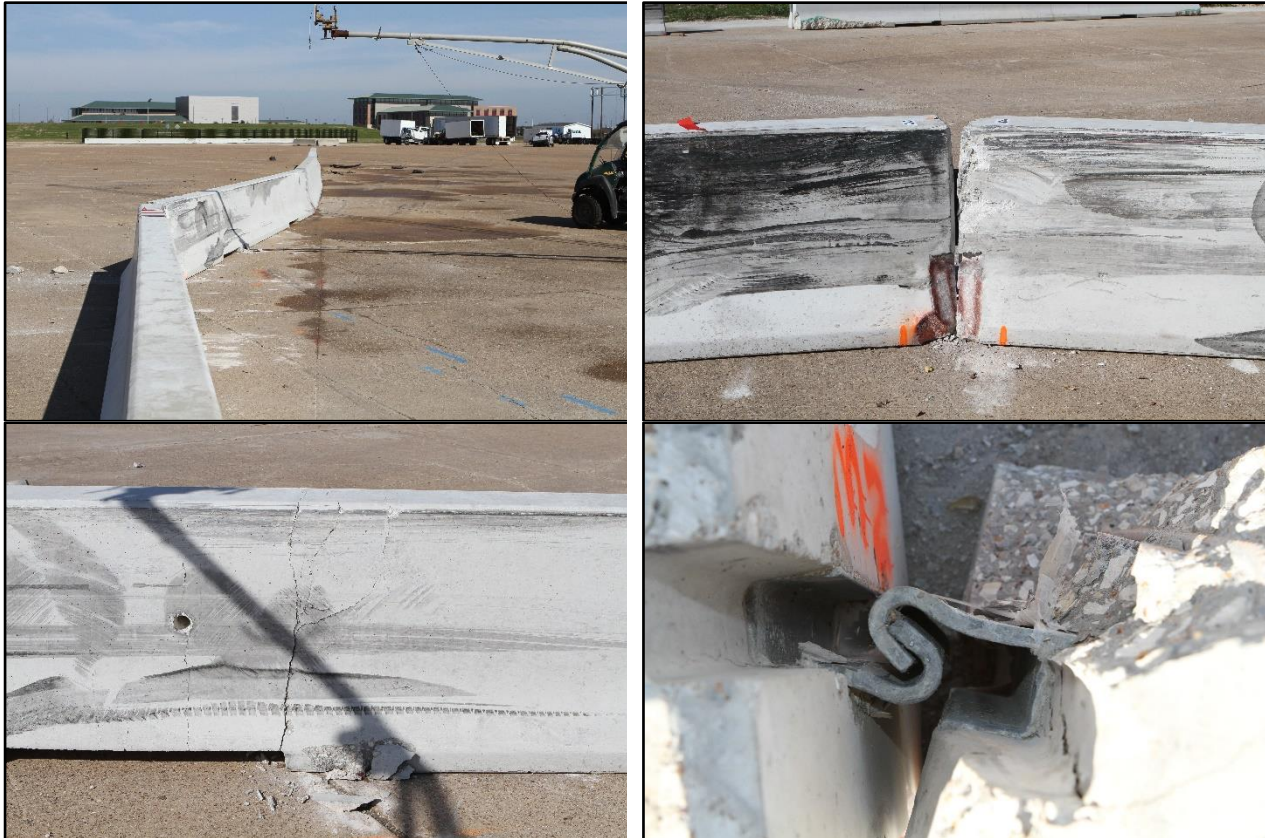
**Figure 8.11. Damaged Portable Concrete Barrier after Test No. 440592-2.**

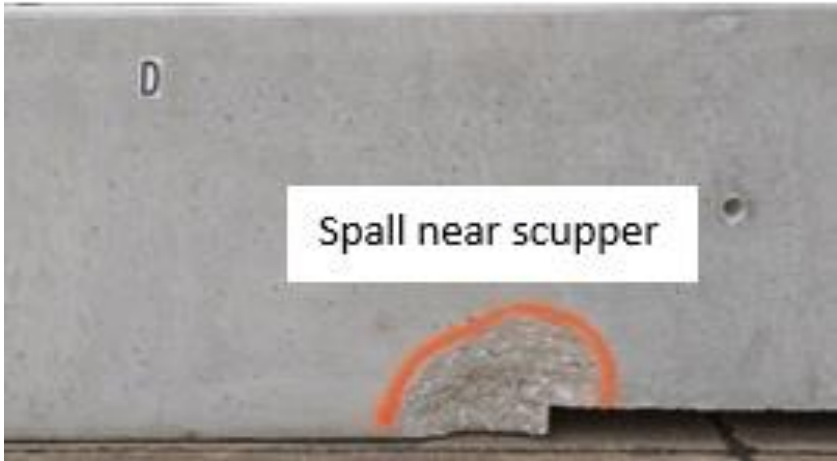
| <b>Example</b> | <b>Image and Description</b> |
|---|---|
| A-1 | <p data-bbox="639 831 1325 898">Spall at drainage scupper. No exposed reinforcement.<br/>Barrier is acceptable.</p> |

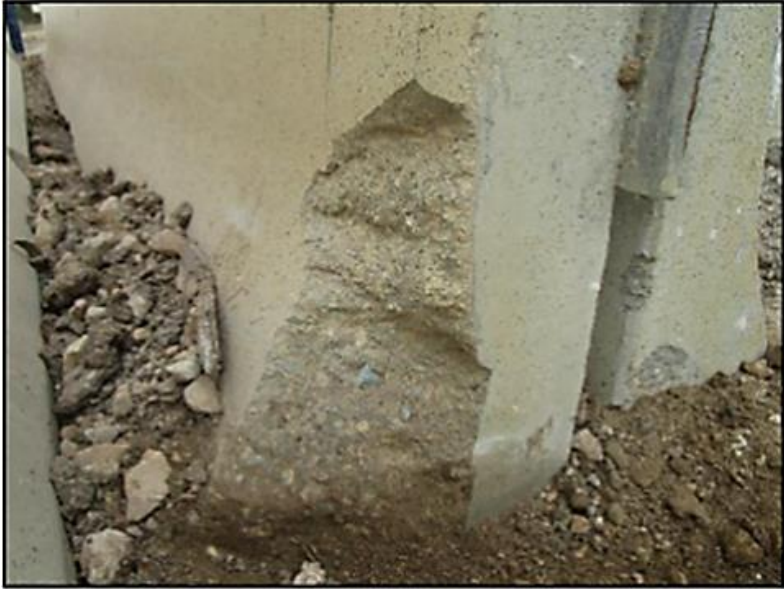
| <b>Example</b> | <b>Image and Description</b> |
|---|---|
| A-2 | <p data-bbox="570 1541 1395 1608">Spall at bottom corner at barrier end. No exposed reinforcement.<br/>Barrier is acceptable.</p> |

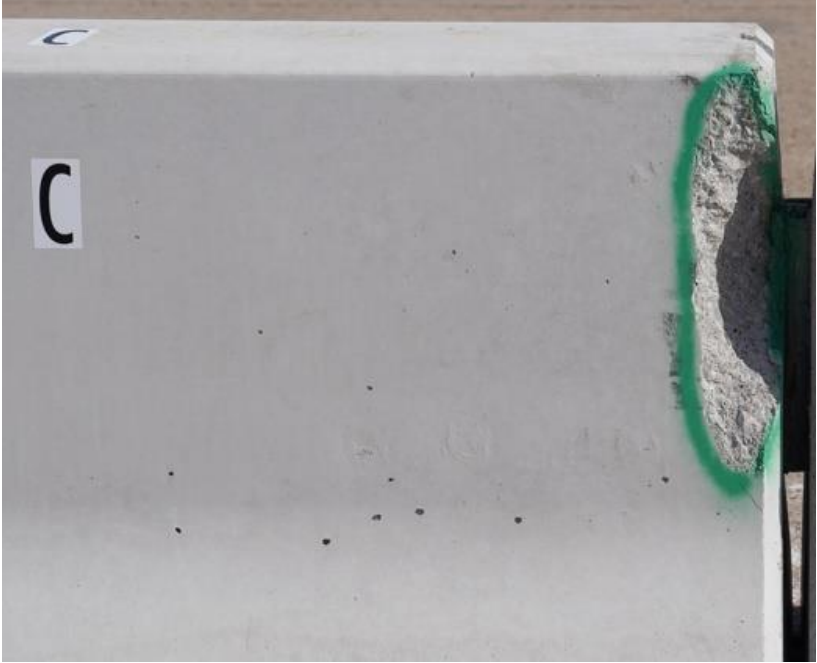
| Example | Image and Description |
|---|--|
| A-3 | <p data-bbox="578 919 1390 993">Spall at upper corner at barrier end. No exposed reinforcement.<br/>Barrier is acceptable.</p> |

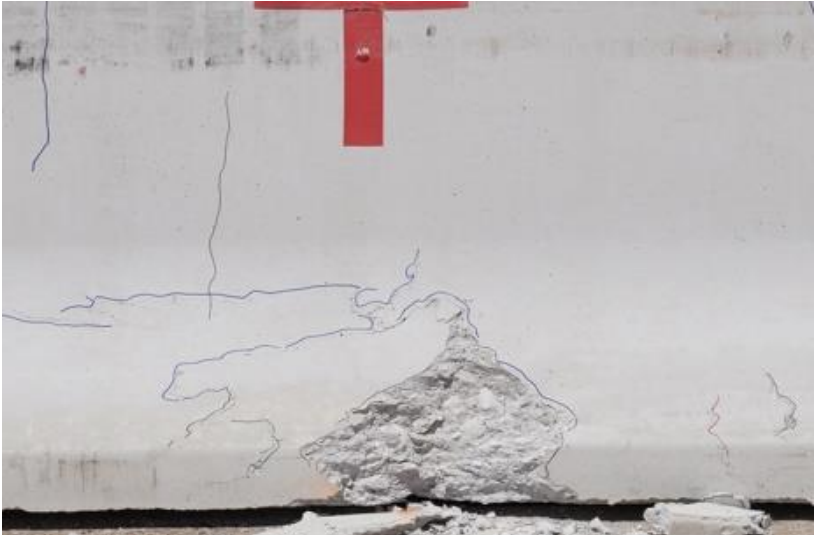
| Example | Image and Description |
|---|--|
| A-4 | <p data-bbox="578 1556 1390 1633">Spall at middle of barrier at toe. No exposed reinforcement.<br/>Barrier is acceptable.</p> |

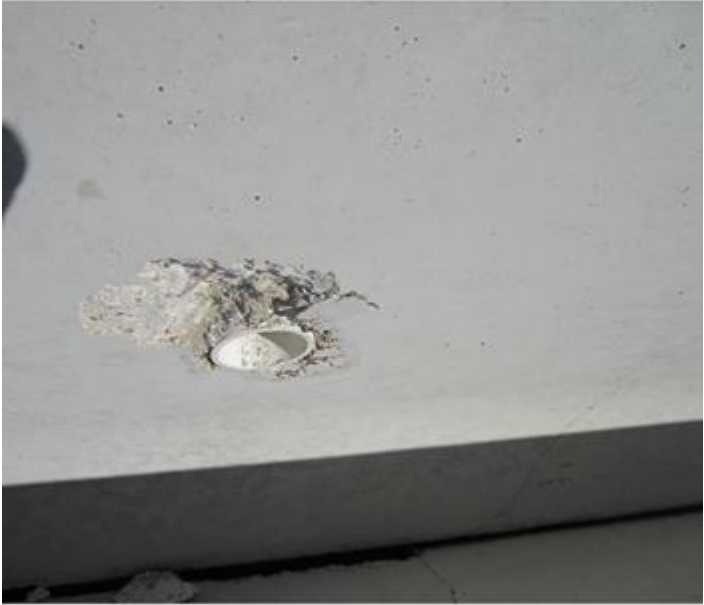
| Example | Image and Description |
|---|--|
| A-5 | <p data-bbox="678 869 1289 940">Spall at lifting pipe. No exposed reinforcement.<br/>Barrier is acceptable.</p> |

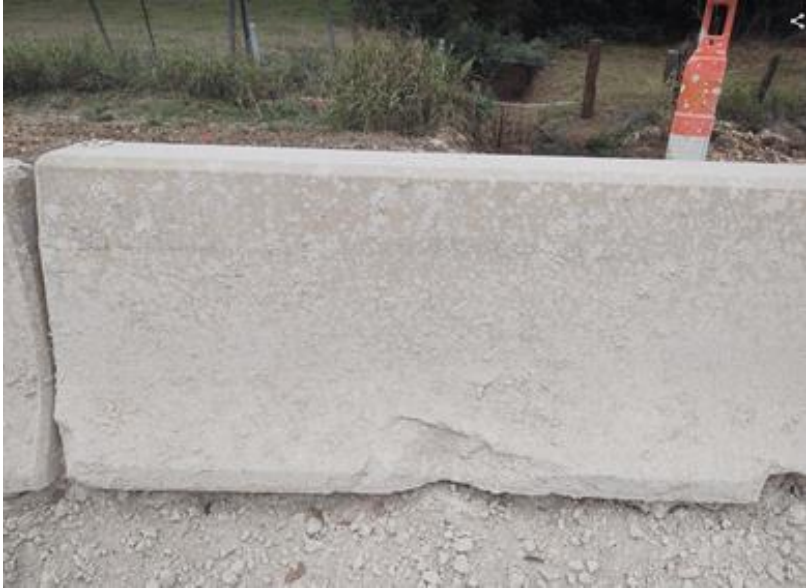
| Example | Image and Description |
|---|--|
| A-6 | <p data-bbox="607 1562 1360 1631">Multiple spalls in same barrier. No exposed reinforcement.<br/>Barrier is acceptable</p> |

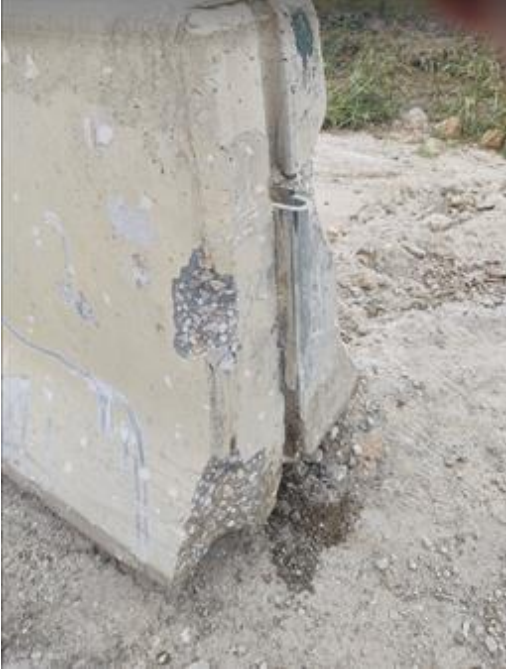
| Example | Image and Description |
|---|--|
| A-7 | <p data-bbox="605 932 1360 999">Multiple spalls in same barrier. No exposed reinforcement.<br/>Barrier is acceptable.</p> |

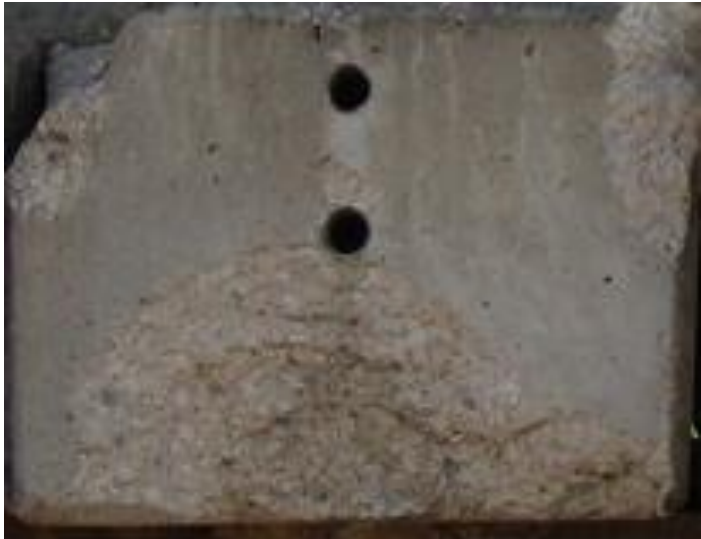
| Example | Image and Description |
|---|--|
| A-8 | <p data-bbox="605 1572 1360 1640">Multiple spalls in same barrier. No exposed reinforcement.<br/>Barrier is acceptable.</p> |

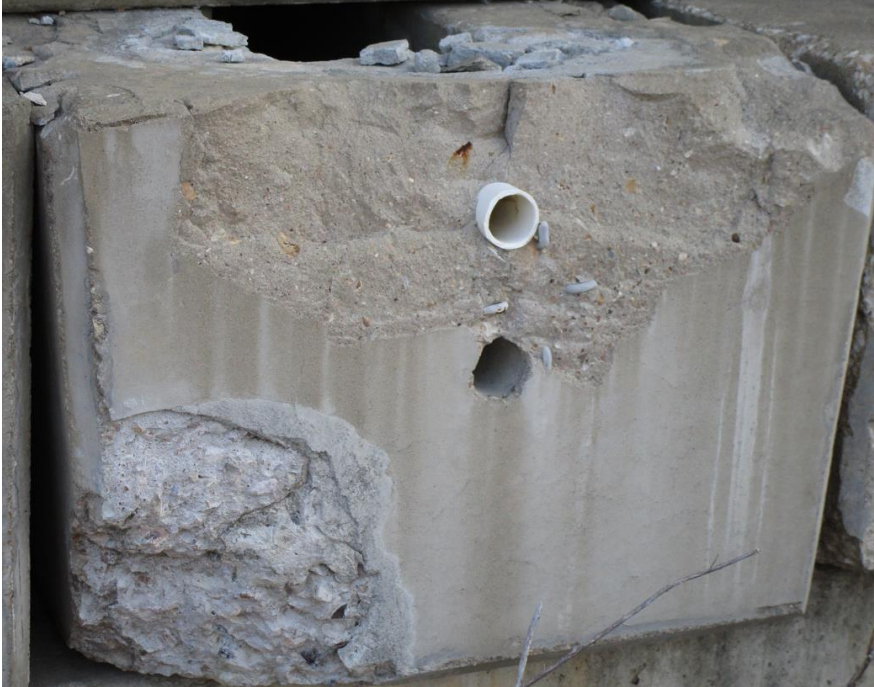
| Example | Image and Description |
|---|---|
| A-9 | <p data-bbox="548 951 1417 1020">Multiple spalls at top and bottom barrier, near segment connections. No exposed reinforcement. Barrier is acceptable.</p> |

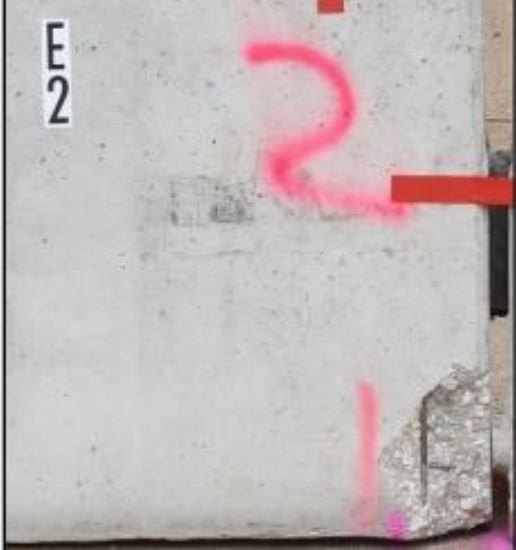
| Example | Image and Description |
|---|--|
| B-3 | <p data-bbox="602 814 1365 884">Spall at barrier end exposing reinforcement with superficial corrosion. Barrier acceptable with repair.</p> |

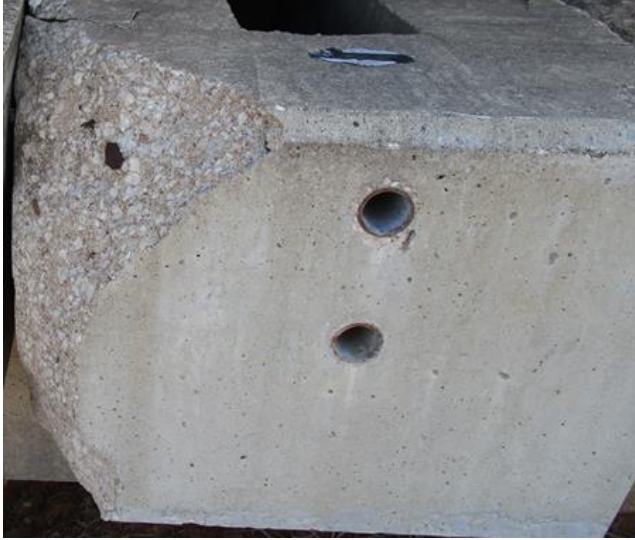
| Example | Image and Description |
|--|---|
| <p data-bbox="337 537 386 569">B-5</p> | <p data-bbox="558 804 1406 873">Spall at barrier top corner exposing reinforcement with superficial corrosion. Barrier acceptable with repair.</p> |

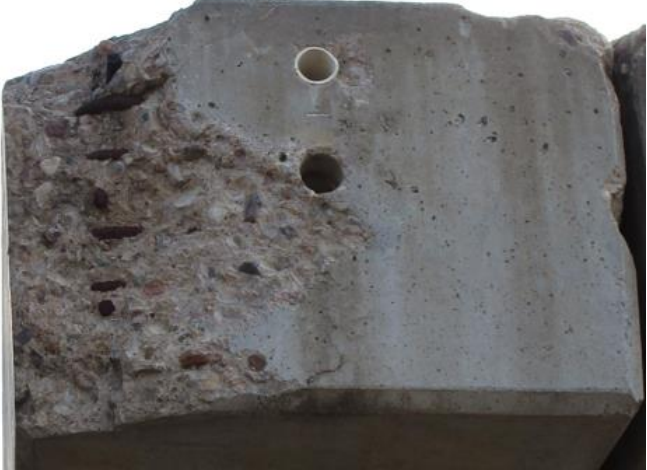
| Example | Image and Description |
|--|---|
| <p data-bbox="337 1157 386 1188">B-6</p> | <p data-bbox="602 1392 1365 1461">Spall at barrier end exposing reinforcement with superficial corrosion. Barrier acceptable with repair.</p> |

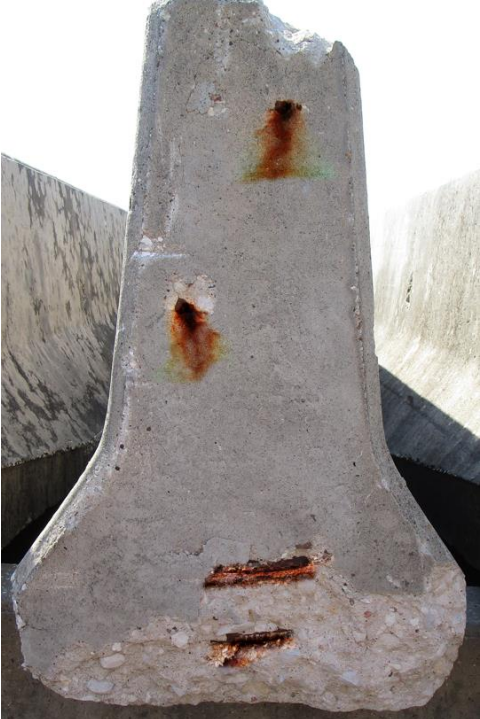
| <b>Example</b> | <b>Image and Description</b> |
|---|---|
| C-1 | <p data-bbox="542 1087 1409 1157">Spalling exposing reinforcement. Evidence of significant corrosion. Barrier is unacceptable and should be removed from service.</p> |

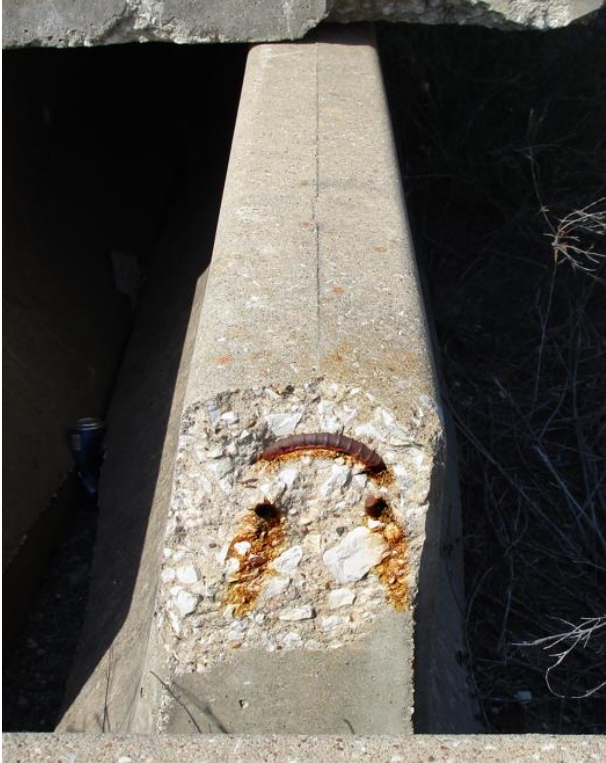
| Example | Image and Description |
|---|---|
| C-2 | <p data-bbox="548 1077 1403 1150">Significant corrosion of exposed rebar. Barrier is unacceptable and should be removed from service.</p> |

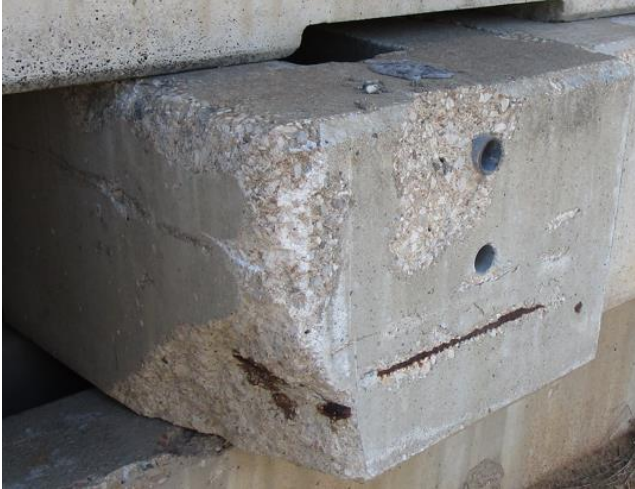
| Example | Image and Description |
|---|---|
| C-3 | <p data-bbox="537 1686 1414 1793">Spall at barrier bottom exposing reinforcement. Evidence of significant corrosion. Barrier is unacceptable and should be removed from service.</p> |

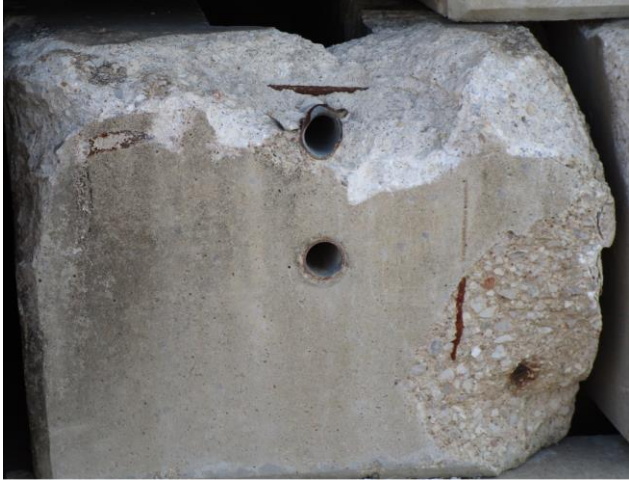
| Example | Image and Description |
|---|--|
| C-4 | <p data-bbox="565 758 1383 865">Multiple spalls exposing reinforcement. Evidence of significant corrosion at barrier bottom, with corrosion staining nearby area. Barrier is unacceptable and should be removed from service.</p> |

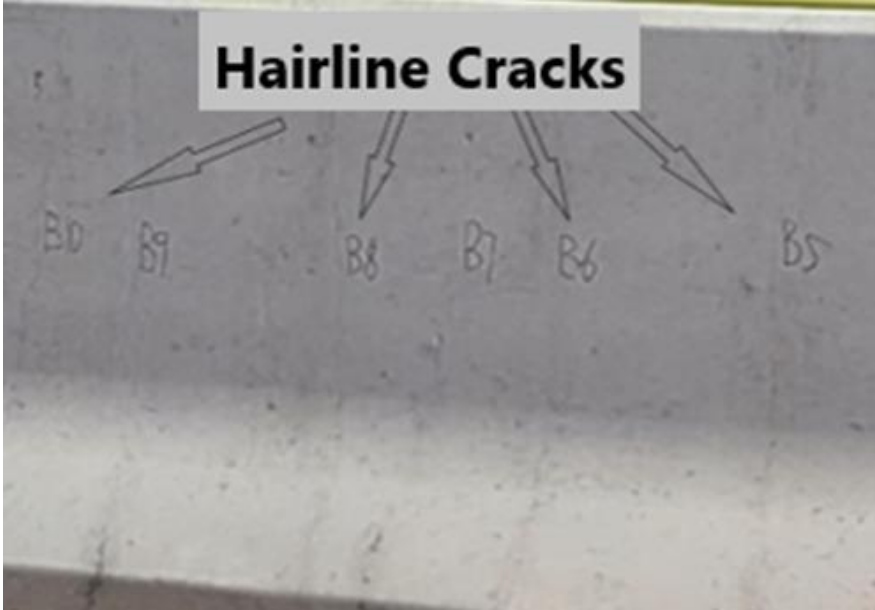
| <b>Example</b> | <b>Image and Description</b> |
|---|---|
| D-1 | <p data-bbox="669 953 1263 989">Multiple hairline cracks. Barrier is acceptable.</p> |

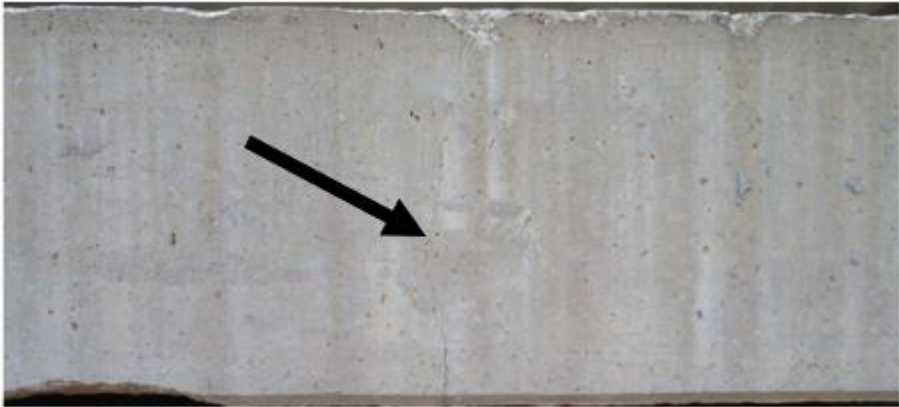
| <b>Example</b> | <b>Image and Description</b> |
|---|---|
| D-2 | <p data-bbox="732 1451 1203 1486">Hairline crack. Barrier is acceptable.</p> |

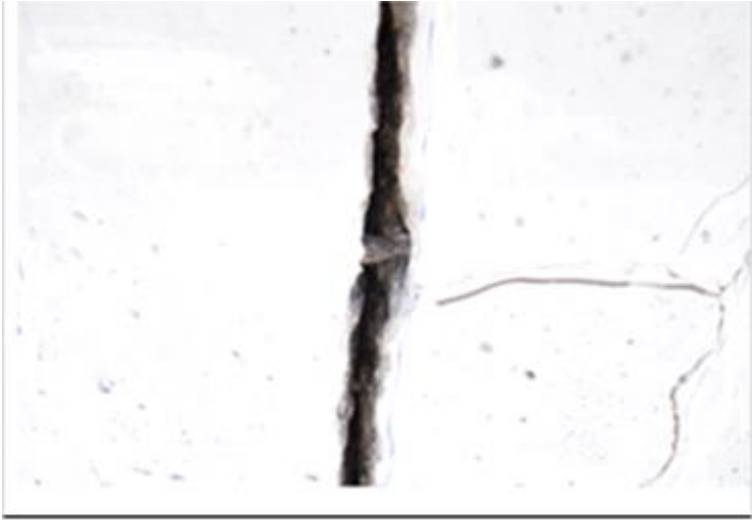
| Example | Image and Description |
|---|---|
| E-1 | <p data-bbox="483 835 1409 940">Crack width measuring less than 0.25 inches. Although reinforcement is exposed due to the crack presence, there is no evidence of corrosion. Barrier acceptable with repair.</p> |

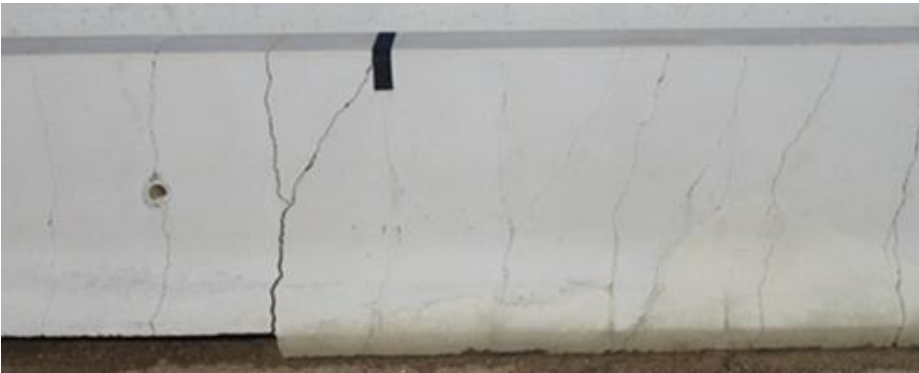
| Example | Image and Description |
|---|---|
| E-2 | <p data-bbox="477 1348 1419 1453">Crack measuring less than 0.25 inches (lower half of the barrier) branching into two cracks whose widths are less than 0.1 inches each. No reinforcement exposure through cracks. Barrier acceptable with repair.</p> |

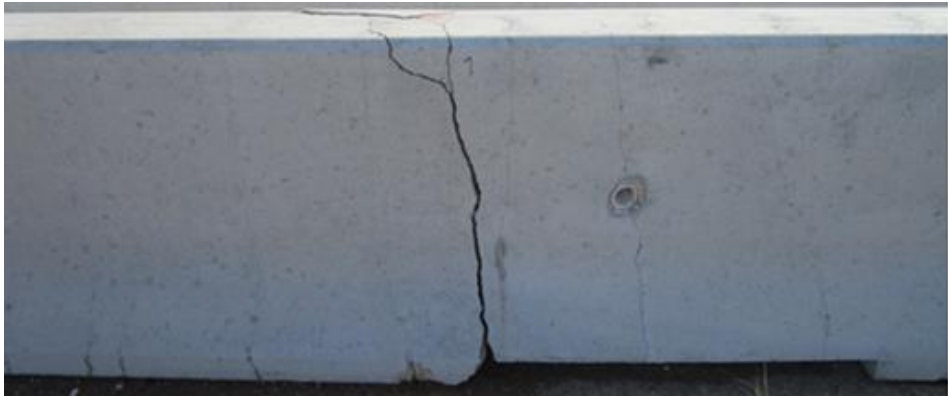
| Example | Image and Description |
|---|--|
| E-3 | <p data-bbox="483 674 1409 779">Crack measuring less than 0.25 inches, branching into two cracks whose combined widths are less than 0.25 inches. No reinforcement exposure through cracks. Barrier acceptable with repair.</p> |

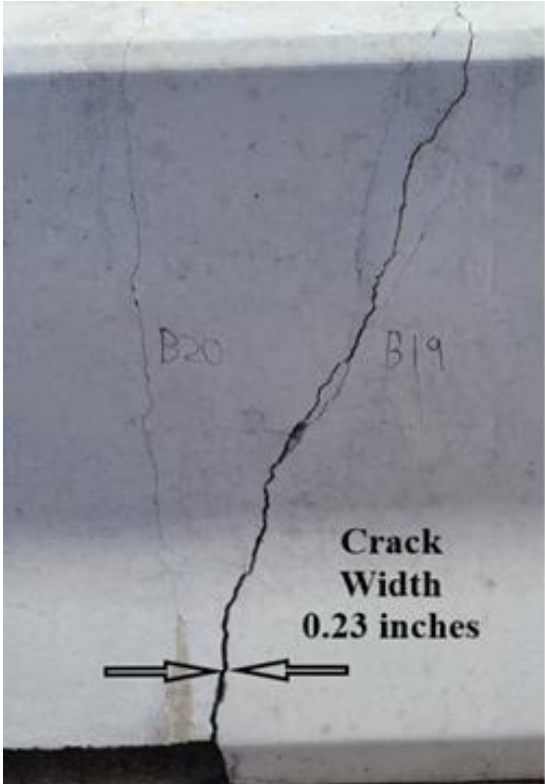
| Example | Image and Description |
|---|--|
| E-4 | <p data-bbox="477 1614 1416 1686">Crack width measuring less than 0.25 inches. No reinforcement exposure through crack. Barrier acceptable with repair.</p> |

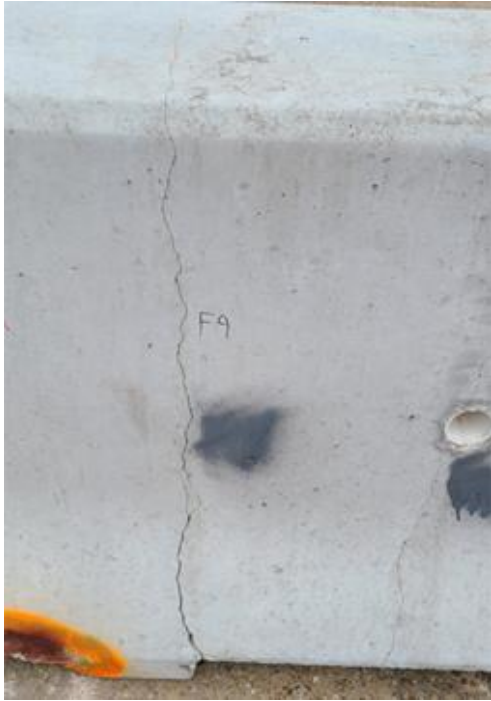
| Example | Image and Description |
|---|--|
| E-5 | <p data-bbox="479 974 1414 1045">Crack width measuring less than 0.25 inches. No reinforcement exposure through crack. Barrier acceptable with repair.</p> |

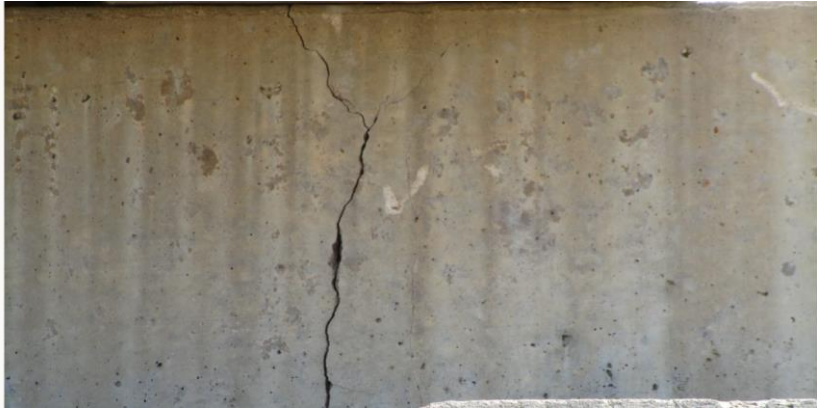
| Example | Image and Description |
|---|--|
| E-6 | <p data-bbox="479 1501 1414 1572">Crack width measuring less than 0.25 inches. No reinforcement exposure through crack. Barrier acceptable with repair.</p> |

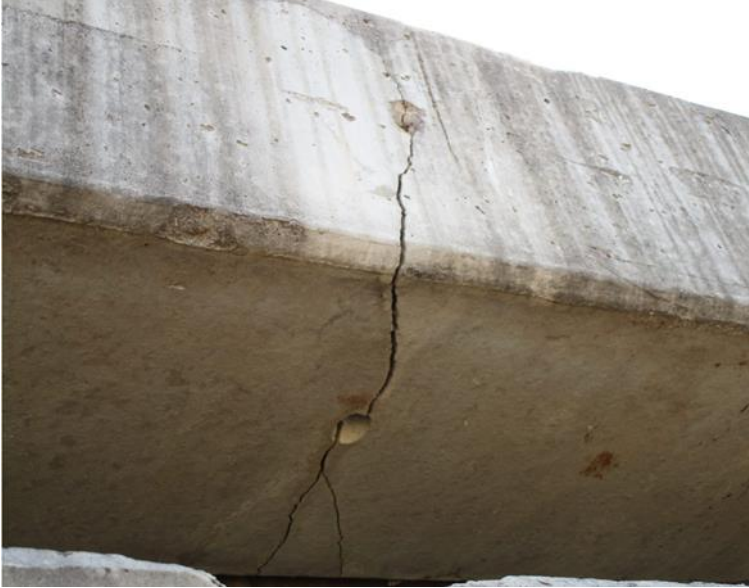
| Example | Image and Description |
|---|--|
| E-7 | <p data-bbox="479 850 1416 919">Crack width measuring less than 0.25 inches. No reinforcement exposure through crack. Barrier acceptable with repair.</p> |

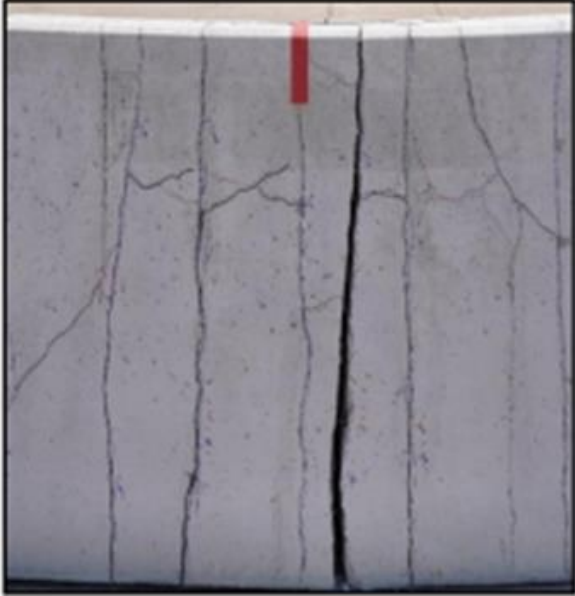
| <b>Example</b> | <b>Image and Description</b> |
|---|--|
| F-1 | <p data-bbox="529 919 1365 989">One crack with measured width exceeding 0.25 inches. Barrier is unacceptable and needs to be discarded.</p> |

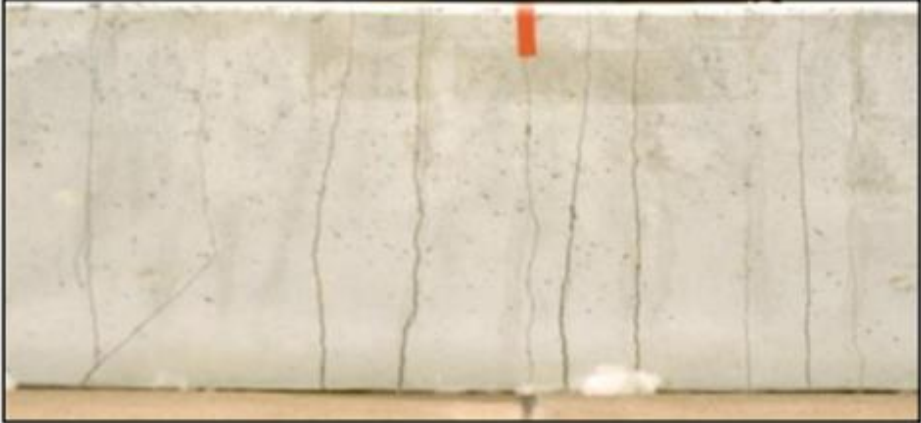
| <b>Example</b> | <b>Image and Description</b> |
|---|--|
| F-2 | <p data-bbox="488 1465 1403 1566">Multiple cracks with measured summed widths greater than 0.25 inches within 1 ft of longitudinal barrier length. Barrier is unacceptable and needs to be discarded.</p> |

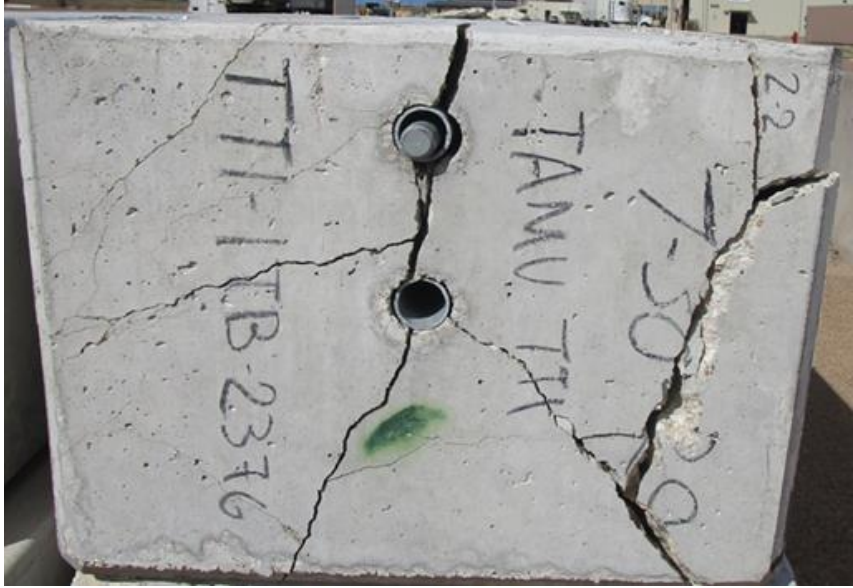
| Example | Image and Description |
|--|--|
| <p data-bbox="300 562 349 594">F-3</p> | <p data-bbox="488 850 1403 919">Multiple cracks with measured widths exceeding 0.25 inches. Barrier is unacceptable and needs to be discarded.</p> |

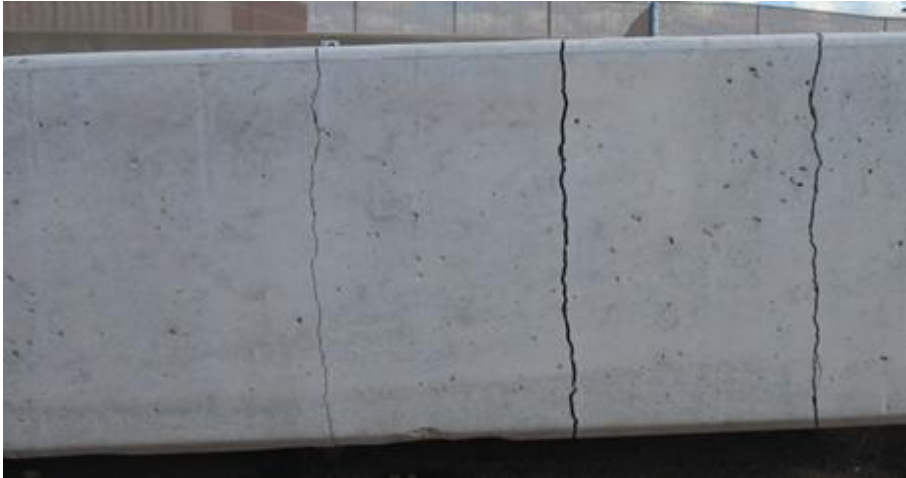
| Example | Image and Description |
|--|--|
| <p data-bbox="300 1199 349 1230">F-4</p> | <p data-bbox="488 1430 1403 1499">Multiple cracks with measured widths exceeding 0.25 inches. Barrier is unacceptable and needs to be discarded.</p> |

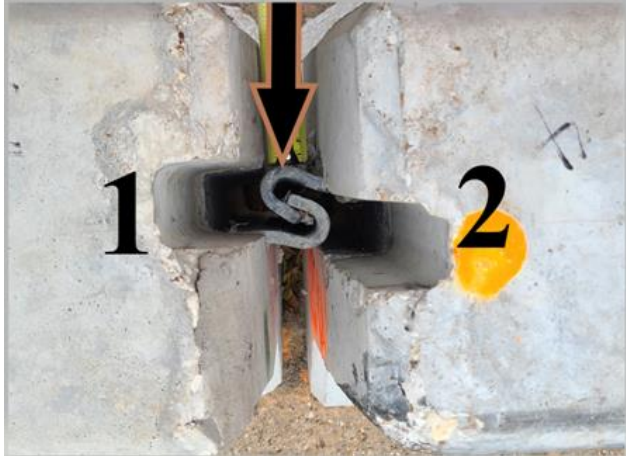
| Example | Image and Description |
|---|--|
| <p>G-1</p> | <p>JJ hooks are not corroded or cracked. Each JJ hook's angular rotation measures less than 20 degrees, and each opening measures less than 1 inch. Both barrier segments with these JJ hooks are acceptable.</p> |

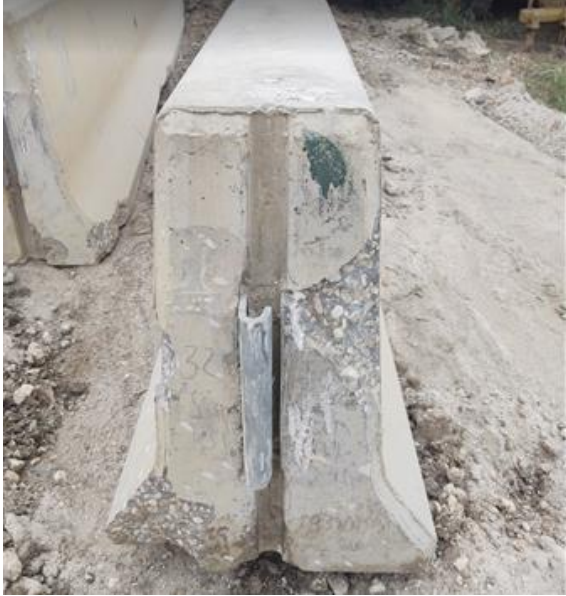
| Example | Image and Description |
|---|--|
| <p>G-2</p> | <p>JJ hook is not corroded or cracked. JJ hook's angular rotation measures less than 20 degrees, and the opening measures less than 1 inch. JJ hook is acceptable.</p> |

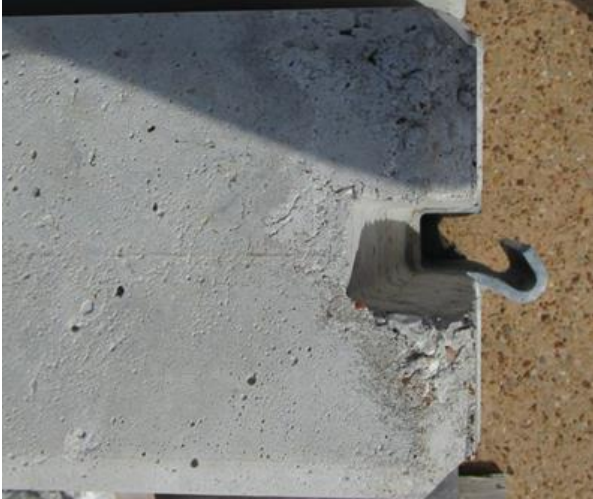
| Example | Image and Description |
|---|---|
| H-1 | <p data-bbox="521 816 1373 884">JJ hook angular rotation measures more than 20 degrees. Barrier is unacceptable and needs to be discarded.</p> |
