# Development of Guidelines for Inspection, Repair, and Use of Portable Concrete Barriers—Volume 1: Technical Report

Technical Report 0-7059-R1-Vol1

TEXAS A&M TRANSPORTATION INSTITUTE  
COLLEGE STATION, TEXAS

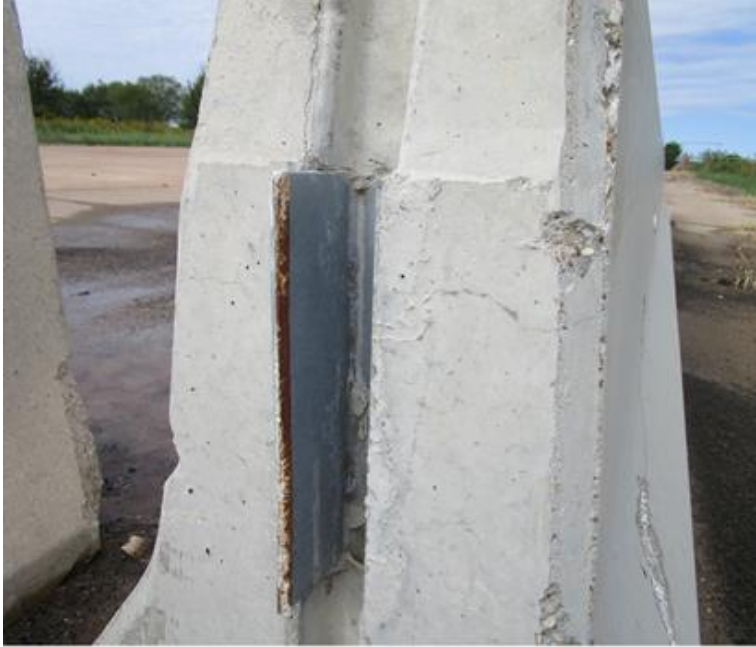
| Example | Image and Description |
|---|--|
| H-3 | <p data-bbox="505 909 1386 945">JJ hook is broken. Barrier is unacceptable and needs to be discarded.</p> |
