20th European Conference on Fracture (ECF20)

## Material characterization of the main steam gate valve made of X20CrMoV 12.1 steel after long term service

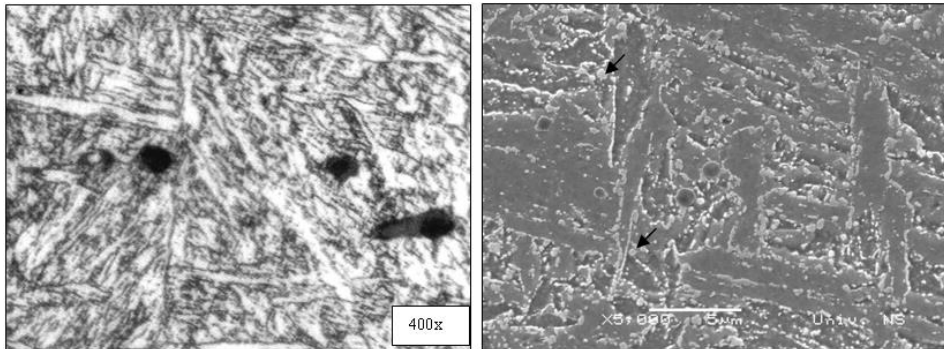
Fig. 2. Microstructure of base material: a) acetate replica optical microscopy; (b) SEM of the middle cross section.

Results of the microstructure examinations carried out on the SEM revealed that material microstructure is composed of the lath martensite and carbide precipitated on the former austenite grain boundaries and on the boundaries of the tempered martensite laths, Fig. 2(b). Partial decay of martensite laths was observed, as well as chain like precipitations on former austenite grain boundaries and numerous coarse carbides most probably the  $M_{23}C_6$  type. It was shown that the creep strength of the material strongly relies on  $M_{23}C_6$  carbides which stabilize the subgrain structure [Aghajani et al., 2009]. In addition, optical microscopy investigation showed that there were no essential differences in microstructure degradation at surface and in the cross-section, Fig. 2(a,b). Coarse carbide network on the former austenite grain boundaries is not characteristic of the material in regular virgin state [Dobrzanski, 2005].

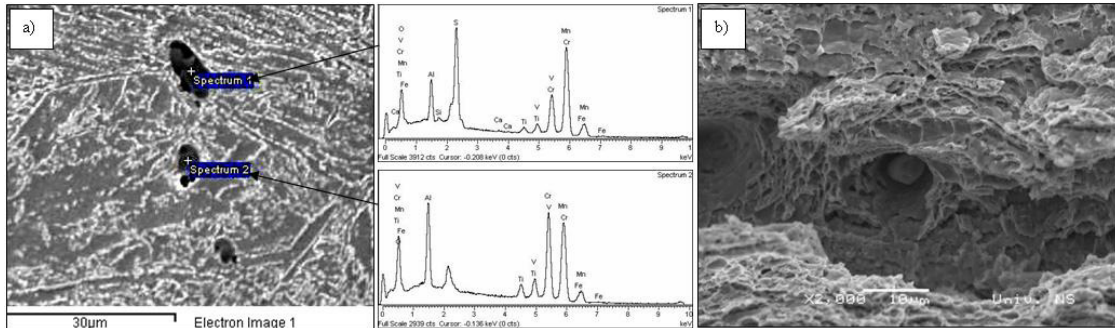
Two other precipitate families, VC and Laves phase, were also detected. Laves phase particles were formed during creep and EDS analyses of Laves phase particles confirmed high molybdenum content, as well as chromium and iron suggesting that basic composition are  $(Fe, Cr)_2Mo$ . EDS of some of analyzed particles revealed low content of Si and P in their composition. According to Aghajani et al., (2009) the chemical composition of the Laves phase particles is not affected by stress and does not change during long-term creep, but the size of particles change. In this case, relatively large particle of Laves phase, 0.5-0.8 $\mu$ m is the effect of prolonged service. Furthermore, a lot of large, different, non-metallic inclusions observed in the microstructure were to be expected due to lower purity and higher limitation in S and P content in older manufactured steels. EDS analyses show that inclusions are mostly MnS type, but some of them are complex like  $TiOx-Al_2O_3$  complex oxides on which MnS inclusion was formed during fabrication as a surface layer, Fig. 3(a). Also, inclusions are initial places of void coalescence during fracture, Fig. 3(b).

Fig. 3. Inclusions in the matrix: a) complex oxides  $TiOx-Al_2O_3 + MnS$ ; b) fracture surface at 80°C; MnS inclusion in the cavity.

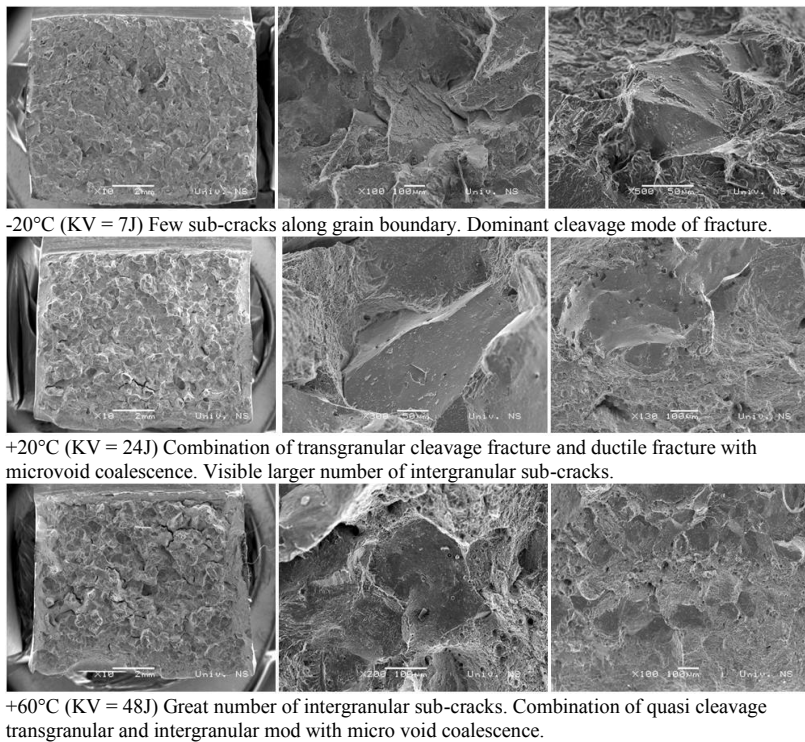
Fig. 4. Fracture surfaces of Charpy V notch specimens at different temperatures.

SEM characterization of Charpy V notch specimens fracture features indicate on fracture mode transition with temperature increase, from completely brittle mod at  $-20^{\circ}\text{C}$  to mix mode at higher temperatures, with micro void coalescence mod contribution increase beside cleavage, and increase number of intergranular sub-cracks on former austenite grain boundaries, Fig. 4. Microvoids during fracture are initiated on different particles, mainly non-metallic inclusions according to EDS analyses. Also, it was reported [Dobrzanski, 2005; Van Zul et al, 2005; Eggeler, 1989] that nucleation of voids during creep of the steel with the tempered martensite structure in the initial state may be connected with the material decohesion on the interstitial phase boundary between matrix and particles of the carbide precipitates for fine voids or non-metallic inclusions for larger one. It was observed that the voids nucleate most often on grain boundaries of the former austenite and the martensite lathes with beneficial orientation for crack propagation. At a given carbon content, toughness of martensitic steel depend on the level of chemical impurities such as phosphorous, sulphur and nitrogen as well as the presence of coarsened carbides in the grain boundaries during long-term exposed service at high temperature [Hu et al., 2004], due to weaken cohesion strength of grain boundaries. All observed fracture details indicate the extensive level of material exhaustion due to long term high temperature service, thus providing explanation for lower values of toughness, as well as relatively high values of hardness.
