Procedia Materials Science 3 (2014) 1167 - 1172

20th European Conference on Fracture (ECF20)

Hydrogen embrittlement of low carbon structural steel

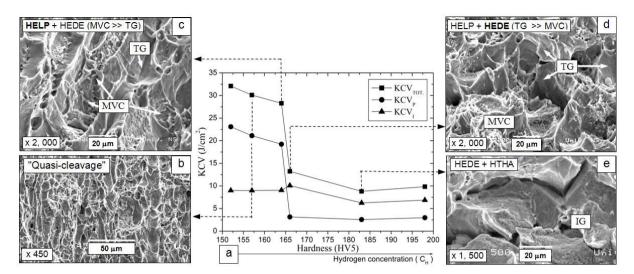
Fracture surfaces can generally be described as "quasi-cleavage" based on surface appearance, Fig. 3(b). The fracture modes reflected by the fracture surfaces are neither intergranular fracture nor cleavage fracture; however they are showing signs of plasticity. Over recent decades "quasi-cleavage" has been used to describe any fracture surface appearance that cannot otherwise be explained as either intergranular, microvoid coalescence (MVC) or true cleavage. Ultimately, the hydrogen-assisted fracture mechanisms which lead to these imprecisely defined fracture surface appearances are still unknown [Nibur at al., 2010]. Based on careful analysis of fracture surfaces with very fine features, two distinctive fracture features can be distinguished: areas of transgranular ("cleavage like") fracture, marked as TG on Fig. 3(c,d), and very fine MVC (<2 µm) with relatively poorly defined dimples, marked as MVC on Fig. 3(c,d). The general fracture appearance is arguably similar to plasticity related hydrogen induced cracking (PRHIC) [McMahon Jr. at al., 2009]. Simultaneous action of the HELP and HEDE mechanisms (HELP+HEDE), Fig. 3(b-d), is characterized by a distinctive mixed mode of fracture with the simultaneous presence of brittle transgranular-TG fracture features of ferrite (confirmed by EDS analysis), predominantly by HEDE mechanism, and locally ductile fine MVC fracture feature of pearlitic microconstituent due to HELP mechanism [Djukic, 2012a].

Fig. 3. (a) Variation of the impact strength (KCV_{TOT.}) and its crack propagation component (KCV_P) and crack initiation component (KCV_I) of a Charpy specimens, as a function of the specimens hardness (hydrogen concentration); (b-e) SEM fractographs of the fracture surfaces of particular Charpy specimens tested

Simultaneous appearance of HELP and HEDE mechanisms is further supported in a model proposed by Jokl et al. (1989). The initial dominant activity of HELP is followed by a negligible drop in the impact strength (KCV_{TOT.}) and its component of crack propagation energy (KCV_P) and steady value of crack initiation component (KCV_I), Fig. 3(a) – hardness: 150-165, and decreases with increasing in hydrogen concentration (hardness). Relatively sudden manifestation of HEDE mechanism, on reaching a critical value of hydrogen concentration, is followed by a sharp ductile–brittle fracture transition, Fig. 3(a). This drop is not only due to cohesive strength decline, which may not be significant, but also due to a noticeable reduction in the appearance of hydrogen-enhanced local plasticity. Expressed observations are consistent with a model of the simultaneous effects of HELP and HEDE [Gerberich at al., 2009].

At the lower hydrogen concentration (lower hardness), HELP mechanism is dominant, which is manifested by an increase in ductile MVC fracture features in "quasi-cleavage" like fracture surface (MVC>>TG), Fig. 3(c). On the other hand, prevailing transgranular fracture features - TG of ferrite, without obvious traces of plasticity (TG>>MVC), Fig. 3(d), followed by a sharp drop in KCV_{TOT} (reduced by a factor of two) and especially KCV_P (reduced by a factor of five), with a negligible increase in the KCV_I, Fig. 3(a), is a consequence of increased activity of HEDE mechanism, i.e. hydrogen-induced decohesion, with increasing in hydrogen concentration [Djukic, 2012].

Occurrence of the brittle intergranular (IG) area on fracture surface at the high hydrogen concentration (higher hardness), is associated not only with action of HEDE and reduction of the HELP mechanism effects, but also with HTHA mechanism activity (HEDE+HTHA), Fig. 3(e). HTHA failure mechanism initially occurs in the areas where the concentration of individual methane cavity is significantly increased, which is reflected in an additional increase in the brittleness of material. When the HTHA mechanism is dominant, in addition to the formations of the voids, fissures and micro cracks along the ferrite grains (complete degradation of pearlite microconstituent during HTHA), there is also significant additional drop in the both KCV_I and KCV_{TOT} (reduced by a factor of two), Fig. 3(a).
