ECF22 - Loading and Environmental effects on Structural Integrity

Damages of burner pipes due to the working conditions and its repair welding

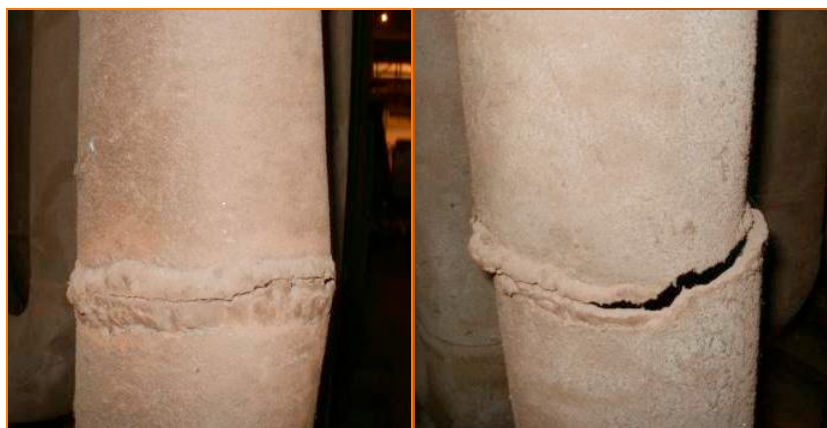
Due to high temperatures, reaching up to 850°C, and the “explosions” during gas ignition, cracks may occur in the entry part of the “W” burner. Some of the damages to the “W burner” are shown in figure 1, whereas they were present in the base material. It should be noted that the welded joints represent the locations most vulnerable to crack initiation. Shown in figure 1 are certain cases in which cracks in the burner pipes have occurred along the length of the welded joint itself, which is rarely encountered in practice.

Fig. 1. Damages to the entry part of the “W” burner pipe; cracks along the welded joint.

During previous repairs (repair welding) of burner pipes in the Zelezara Smederevo, electrodes with 25% Cr and 20% Ni content (Hereinafter referred to as type 25/20 electrodes) were used. Practical experience had shown that in most welded joints made using these electrodes, cracks initiated in the weld metal, due to the working conditions to which the pipes were subjected, including high temperature and its cyclic change.

Damages to the pipe resulted in the need to consider the use of a different electrode and another repair welding technology.

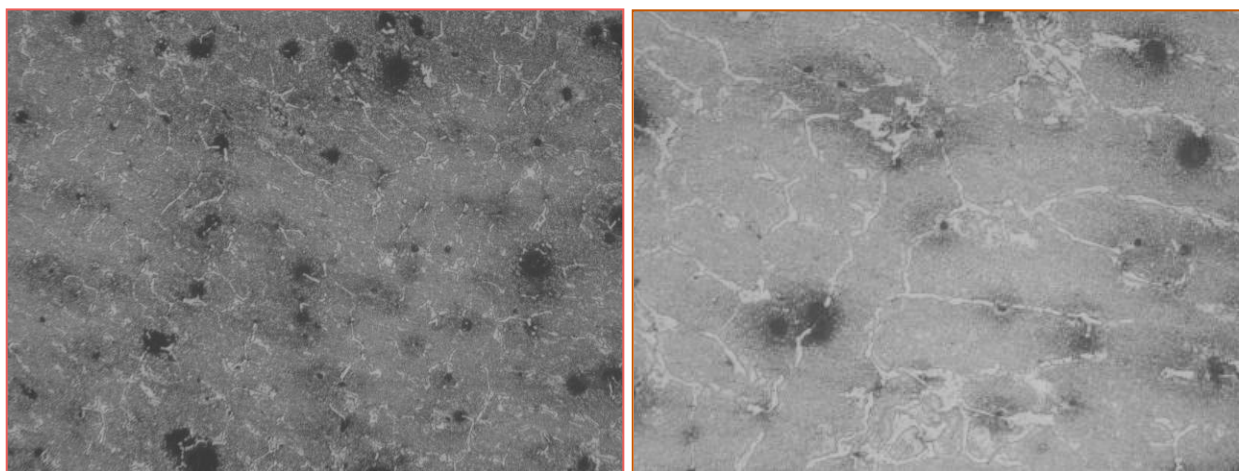
Damages of burner pipes resulted in the need to repair the pipe in question. The repair process involved the cutting off of the damaged part and replacing it with a new pipe, which was connected to the burner by welding. Steel X12NiCrSi35-16, a stainless nickel alloy, was used as the base material for the pipes, and its chemical composition is shown in table 1. It belongs to a group of uncommon austenitic and austenitic-ferritic heat resistant steels. The mechanical properties of this steel are given in table 2. Shown in figure 2 is the micro-structure of the base material, which is austenitic with spheroid pearlite. A significant amount of carbides can be observed in the base material structure.

Fig. 2. Micro-structure of base material used for burner pipes (X12NiCrSi35-16); a large amount of carbides can be observed in the micro-structure.

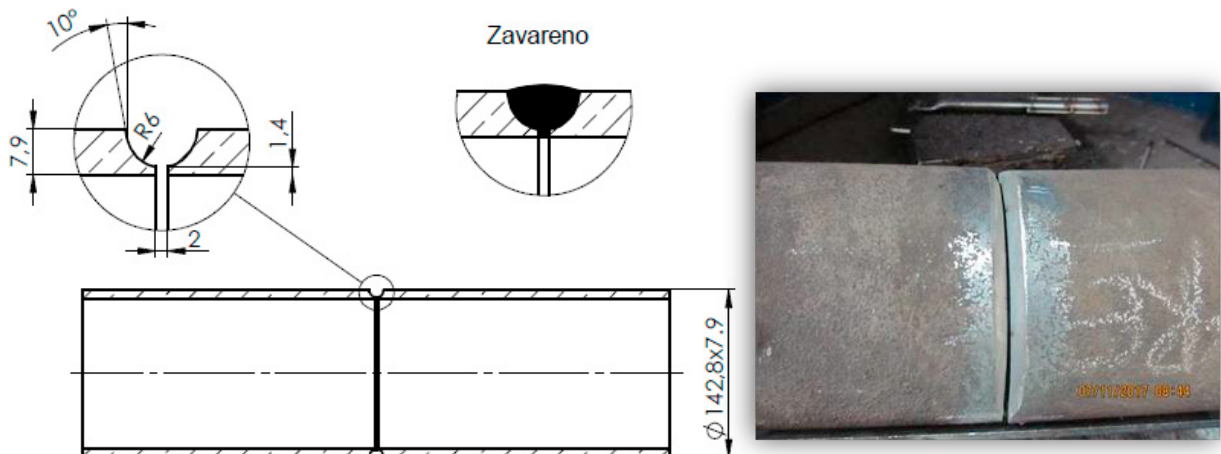
Figure 3. Prepared U groove in the pipe.

Welding of pipes was performed using the manual arc welding procedure (MAW). Shown in figure 3 is the appearance of the prepared U groove, which was made by grinding.

Welding amperage was 70 A, whereas the voltage ranged from 20-22 V. Welding was performed in 4 passes, with frequent interruptions, i.e. the whole joint was made using short welds in order to avoid overheating of the material above 100°C (similar to grey cast). Welding of the burner was performed in the „wall“ position without electrode swinging.

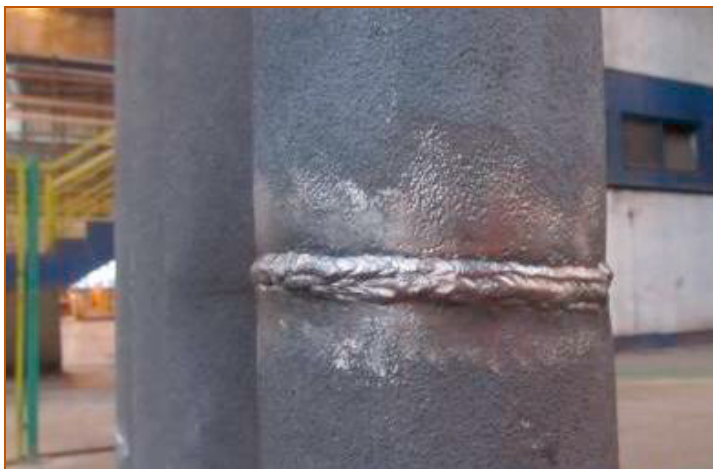
The appearance of the welded burner pipe (the welded joint) is shown in figure 4. The weld was tested using the penetrant method and no defects were detected in it. After this, the repaired pipe was put in exploitation.

Fig. 4. The appearance of the repaired burner pipe.

For the purpose of repairing of burner pipes, a selection was made for the new electrode, and Castolin 6825 was tested. Repair welding was performed with this new electrode, in four passes. Its diameter was $\varnothing 3.25$, with an amperage of 70 A, and a temperature which did not exceed 100°C during the welding process. Chemical testing of the fourth (final) welded layer was performed, and certain differences were observed, compared to catalog values. After penetrant testing was performed, no defects were detected and the pipe was put in exploitation, while its behaviour was being monitored. The fact that the pipe was exploited without problems confirms the justifiability of the use of the new electrode.
