ECF22 - Loading and Environmental effects on Structural Integrity

Structural integrity of butt welded connection after fire exposure

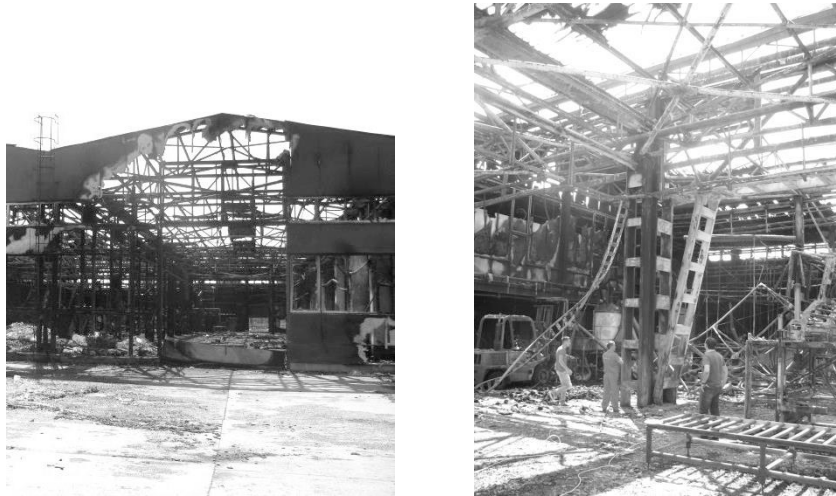
Fire action on the structure has been accidental. The time of exposure to heat was estimated at 60-90 minutes, with a random propagation of fire. Usually, the materials inside the building on fire provide accurate information related to temperature regime, by identifying the status and knowledge of their post-fire occurs melting temperature at which these materials. It has been estimated an average temperature of 600°C.

Fig. 1. Building affected by fire - photos taken after fire occurrence

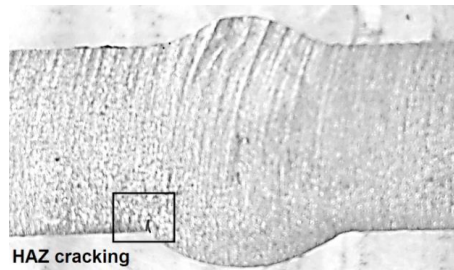
Following the investigations, considering the initial site welding, there were discovered surface flaws in the continuity joints of the overhead crane steel beams (figure 6).

Fig. 6. Flaws in the butt weld

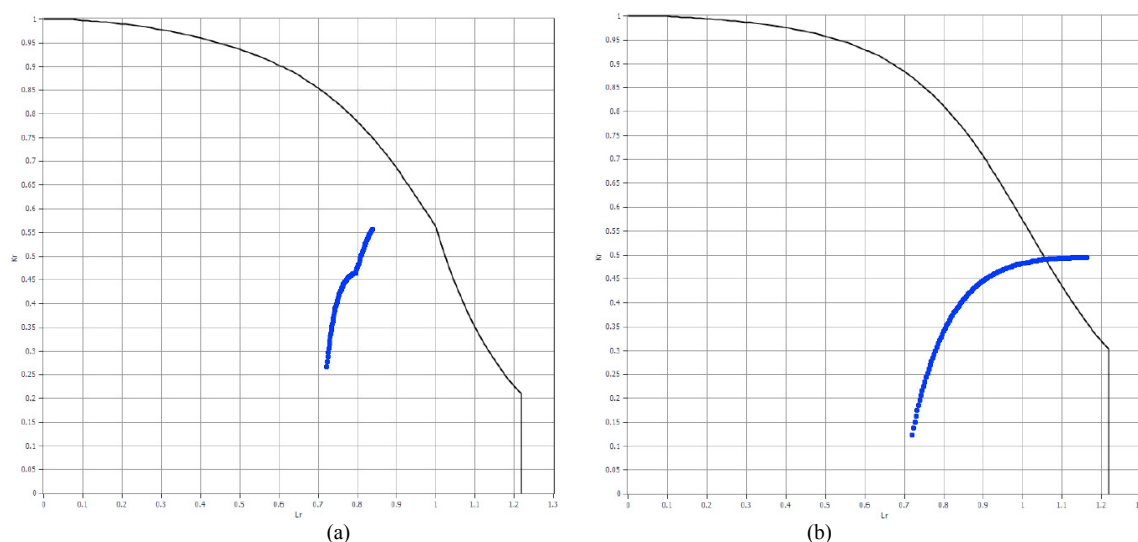
There were considered and assessed ten types of flaws – surface flaws (FP-SF type) and buried flaws (FP-BF type) and it was determined the limit value of the flaw for each flaw type and position (table 2 and figure 7). The input data for FAD-2 assessment was: yield strength $f_y = 355 \text{ MPa}$; ultimate strength $f_u = 510 \text{ MPa}$, specific for S355J2 steel type; $K_{mat} = 84.10 \text{ MPa}\cdot\text{m}^{1/2}$, $P_m = 289.44 \text{ N/mm}^2$ - Primary stress with value determined following FEM analysis.

Fig. 7. Critical flaws assessment: (a) FP-SF-2; (b) FP-BF-2
