CHRONOLOGY OF LOST STRUCTURAL INTEGRITY INITIATED FROM MANUFACTURING DEFECTS IN WELDED STRUCTURES

Originalni naučni rad / Original scientific paper

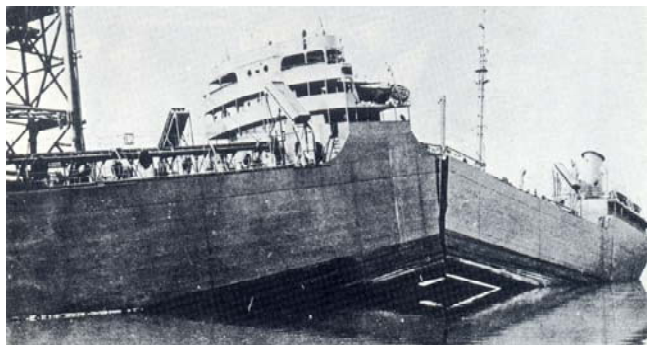
Many fractured Liberty class ships failed due to steel susceptibility to cracking below nil-ductility transition temperature, as identified in this case study analysis, /1/. Figure 1 shows the breaking in two of a new "Schenectady" Liberty class tanker at outfitting birth on 16th January 1943 at 10:30 PM after successful sea trial. The water was calm and cold (4.5°C) and -3.5°C air temperature.

Sudden fracture started near amidships at the junction of fashion plate to the sheer strake at the starboard corner of the bridge superstructure, and ran very fast across the deck and down both sides to the turn of the bilge. Only the bottom plating held, being capable to arrest fast growing crack. Welded ship structures are of more monolithic nature in comparison to previously riveted or bolted ships and it is presumed that this affects fracture behaviour. The failure of

Figure 1. "Schenectady" fractured in two, 16th January 1943, /1/.
Slika 1. „Šenektedi“ prelomljen na dva dela, 16. januara 1943, /1/

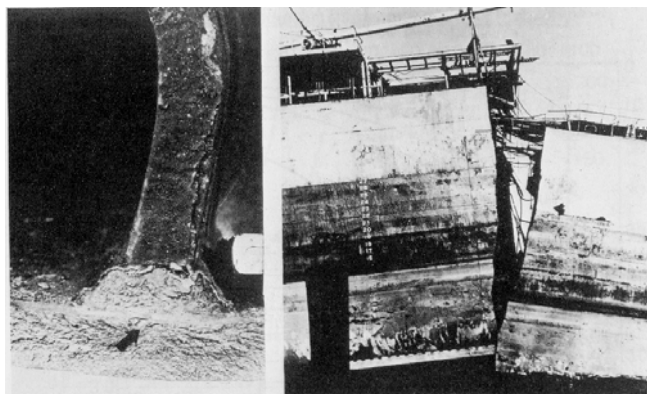
Another example of failed Liberty ship is presented in Fig. 2, /2/. This failure occurred during welding, starting from previous arc-strike (Fig. 3) and ended in instantaneous splitting of the ship.

Figure 2. Dock side ship fractured from the arc strike (arrow).
Slika 2. Bočna strana preloma od početnog elek. luka (strelica)

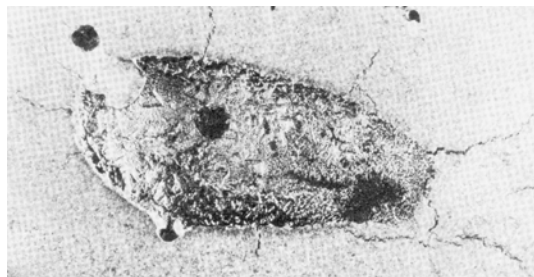
Figure 3. View of arc strike. Cracks approximately 2 mm in size developed in hard HAZ surrounding the fusion line.

Inevitable *stress concentration*, supposed as more dangerous in a welded structure than in riveted ships, was reduced by shape improvement, but a large number of T2 ships again, fractured in two pieces. The total fracture of "Ponagansett" originated from arc strike near the auxiliary

attachment, as presented in Fig. 3. Such minor features can not alone produce complete rupture of a structure.

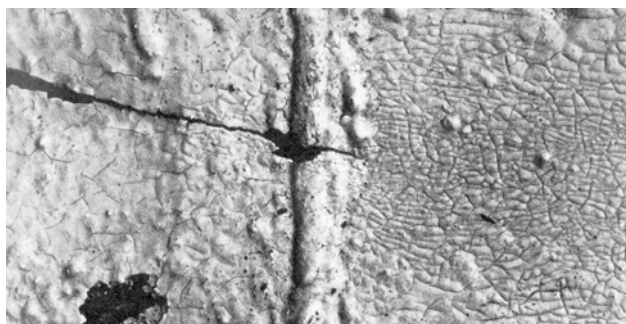
It was noted that cracks arrested in service when entering a new plate in regions of uniform low stress (Fig. 4). The painted surface had crazed at the arrest point due to higher fracture toughness of new plate, indicating yielding level.

Figure 4. Arrested ship fracture. Crazing of paints indicates yielding in the crack arrest region, /2/.

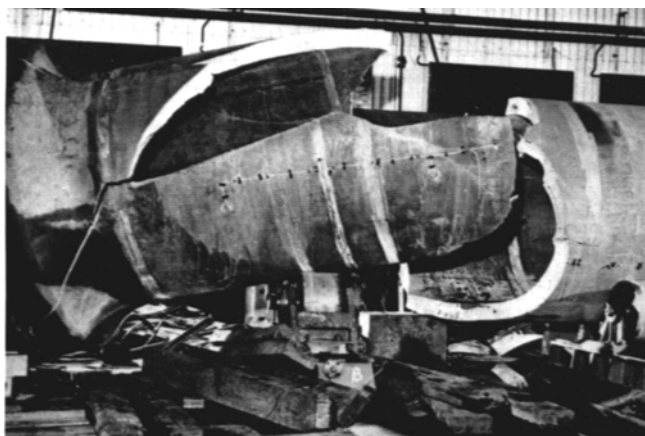
Failure of a thick-wall pressure vessel, /4/, presented in Fig. 5, is selected as well analysed example. This failure is caused by a crack in HAZ. A large pressure vessel designed for use in an ammonia plant at 350 bar of pressure and 120°C failed at 340 bar during hydrostatic proof testing, /4/, well below maximum test pressure of 480 bar. The vessel weighed 166 ton, measured 18.2 m in length and 2.0 m outside diameter. It was fabricated from ten Mn-Cr-Ni-Mo steel plates 150 mm thick, which were rolled and welded in ten cylindrical shell sections and three forgings of similar steel. The forgings formed two end lids and a flange for attaching one of the forged end lid to the vessel.

Figure 5. Large thick-wall pressure vessel – an ammonia converter, fractured because of a crack in HAZ.
Slika 5. Velika posuda pod pritiskom – konvertor amonijaka, polomljen usled prsline u HAZ

340 bar, and after 30 s the flange end exploded. The forging was completely through-cracked in two locations, and first two cylindrical sections damaged (Fig. 5).

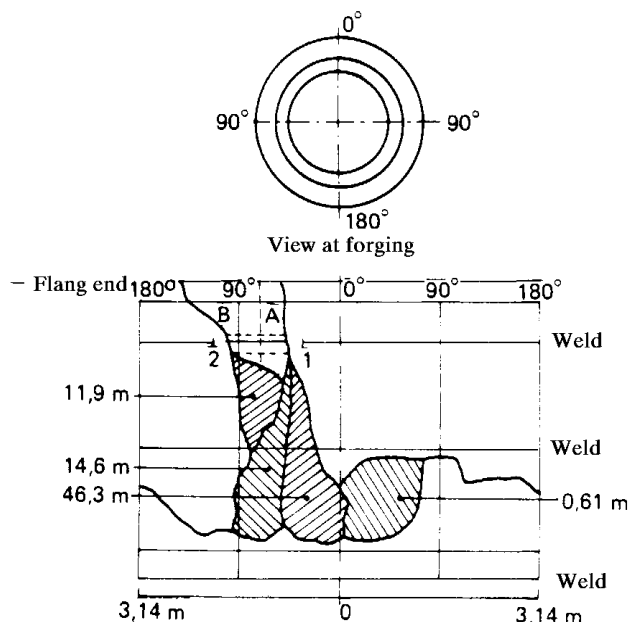
Extensive damage to one end forging and three adjacent shell sections was a failure consequence. Four large pieces were blown from the vessel; the largest, weighing about 2 ton, penetrated the shop wall and travelled a total distance of 46 m. Pieces of the failed vessel are shown in Fig. 6.

Figure 6. Pieces fractured from the vessel, with distances to which they were thrown.

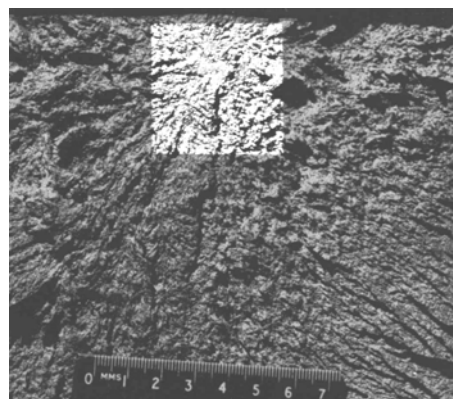
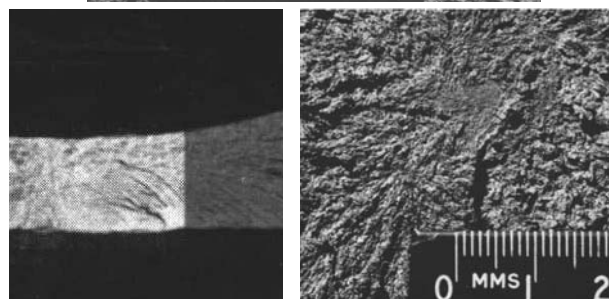
Metallurgical examination revealed fracture surfaces typical for brittle steel fracture. There were two points of origin, both associated with the circumferential weld between the flange forging and first shell section. The general appearance of fractured surface of flange forging is shown in Fig. 7, with enlarged views of regions of flat facet (major dimensions roughly 9 mm), 14 mm below the outer surface of the vessel, which was partly in the HAZ on the forging side of the circumferential seam weld. A slightly larger facet was found on another surface of the flange, near a fracture origin, 11 mm below the outer surface, also situated partly on the forging side of the HAZ. These facets in the HAZ were fracture-initiation sites. The structure just below facets in the HAZ was a bainite-austenite mixture (hardness 426 to 460 HV). Elsewhere, the structure of the HAZ was coarse bainite (hardness 313 to 363 HV).

Figure 7. Point of fracture initiation located at the weld, between shell and forged nozzle, /3/.

From two facets position and size (Fig. 7), although irregular shape, the crack length $2a = 8$ mm is assessed and $\psi = 2/\pi$ is taken as shape factor. Since the weld metal is brittle (Fig. 8), it is possible to calculate the significance of existing cracks. From Eqs. (1) and (3) it follows

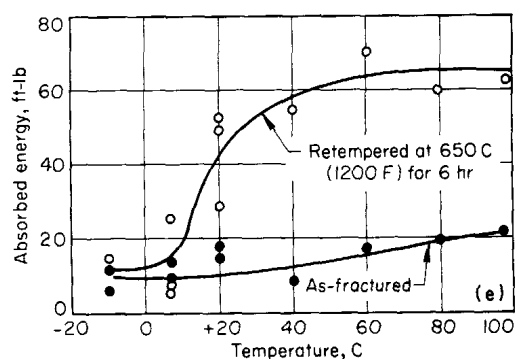
To further investigate the effect of stress relief on the properties of the vessel, standard Charpy V-notch specimens were prepared from the flange forging, plate, and weld. All specimens were oriented with their length parallel to the circumference of the vessel so that induced fractures would be parallel to the main fracture. Tests were performed on as-received vessel material over the temperature range from 10 to 100°C. Impact values met specifications for the forging and plate, but the weld metal was of inferior impact strength (lower curve, Fig. 8). None of the materials displayed a sufficient capacity for energy absorption (41 J for the forging; 69 J for the plate; and 16 J for the weld) to have arrested the crack growth that led to failure of the pressure vessel. Other weld metal specimens, re-tempered at 650°C for 6 h and tested over the same temperature range, showed an improvement in impact strength at or above 20°C (upper curve, Fig. 8). This confirmed the previous conclusion that stress relief of the vessel was at a lower temperature than specified.

Figure 8. Absorbed energy in Charpy V specimen test: lower curve—weld metal of fractured part; upper curve—after heat treatment at 650°C for 6 h.

Recommended final normalizing temperature was $Ac_3 + 50^\circ C$, and tempering temperature 650°C, where Ac_3 is the temperature for complete transformation of ferrite to austenite. After completion of each seam weld, preheating should be continued for a short distance along the seam. Forging practice should eliminate the banding in the flange.

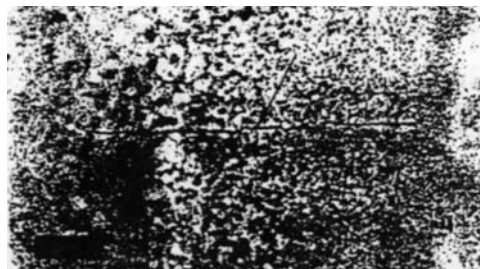
For weld metal values ($K_{Ic} = 58$ MPa \sqrt{m} , $\sigma_T = 761$ MPa, $a = 4$ mm), the critical stress for crack initiation is obtained: $\sigma = 669$ MPa. The value $\sigma_{T_0} = 389$ MPa is obtained from Eq. (2), and pressure to produce fracture is $p = 450$ bar, 30% higher compared to real fracture. In order to explain this discrepancy, the real crack is of irregular shape, and not circular, so ψ must be higher than assumed. Also, the applied stress, produced by pressure, is lower than yield strength of weld metal, so the effect of residual stress is higher. The conclusion of fracture mechanics analysis was that even a crack, very small compared to wall thickness can be imitated in a critical situation. It is proved by a crack in the HAZ of forging after welding (Fig. 9), not detected,

Figure 9. Not detected weld crack in HAZ of forging.
Slika 9. Ne otkrivena prslina pri zavarivanju u HAZ otkovka

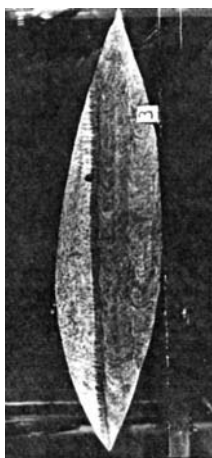
Figure 11. Boat form sample with crack
Slika 11. Uzorak oblika čamca sa prslinom

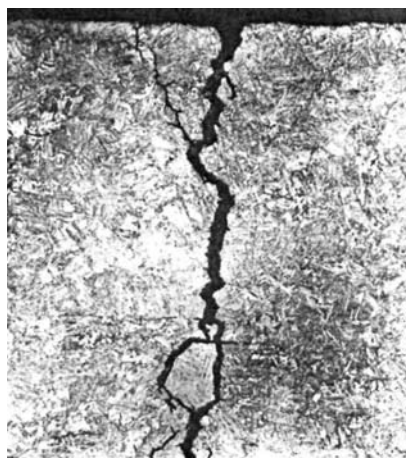
Figure 12. Crack initiation location in the underbead zone.
Slika 12. Mesto inicijacije prsline u oblasti ispod zrna

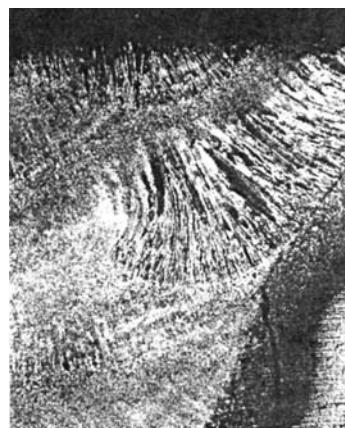
Figure 13. A small embedded crack in the heat-affected-zone
Slika 13. Mala unutrašnja prsline u zoni uticaja toplote

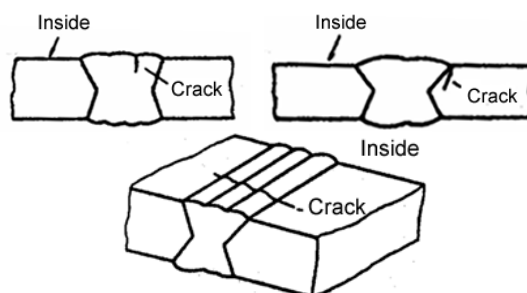
Many of about 100 tanks in service in Yugoslavia failed due to cracking (Fig. 14). The first failed in 1982 by transversal crack leakage at ambient temperature 20°C under 12 bar pressure, some weeks after regular in-service inspection and proof pressure test at 24 bar (Fig. 15). Careful ultrasonic and magnetic particle tests revealed a significant number of cracks on the inner surface, /7/.

Figure 14. Longitudinal (up) and transverse (down) cracks.
Slika 14. Podužne (gore) i poprečne (dole) prsline

Several spherical tanks are in service at HIP-AZOTARA, Pančevo. Regular in-service inspection in 1993 revealed many defects, mostly cracks (Fig. 14) on the inner side of a sphere, /7/. Crack occurrence is particularly expressed in fine-grain microalloyed high strength steels, but cracks were also detected in tanks of carbon steels after long-term service. On one of the tested vessels, cracks were detected at the joint between mantle and lid on the outer side, on one

During regular inspection of spherical tanks for storage of vinyl chloride monomer (VCM), volume 2000 m³, introduced in 1977, a great number of cracks of different directions and sizes (Fig. 14, Tables 4 and 5) were detected by NDT in 1986-90 and in 1996 on inner wall side, in welded joint regions, /11/. In three cases, the cracks were detected in the parent metal, and their origin is probably the tack welding of temporary holders during sphere assembly. In some cases during grinding it was confirmed that the crack ends in the pore or the inclusion, involved in the manufacture. In all tested spheres, cracks most frequently occurred in radial welded joints (R, Fig. 10), typically in its middle (upper) part, at the liquid and gas phase border.

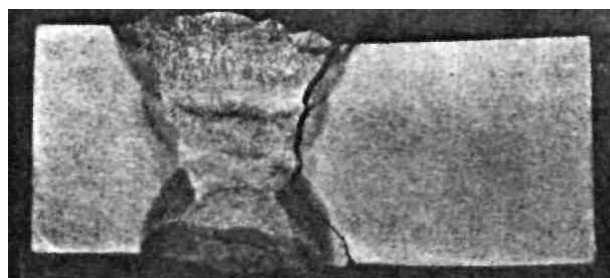
Figure 15. Macrostructure across welded joint with through crack.
Slika 15. Makrostruktura zavarenog spoja sa prolaznom prslinom

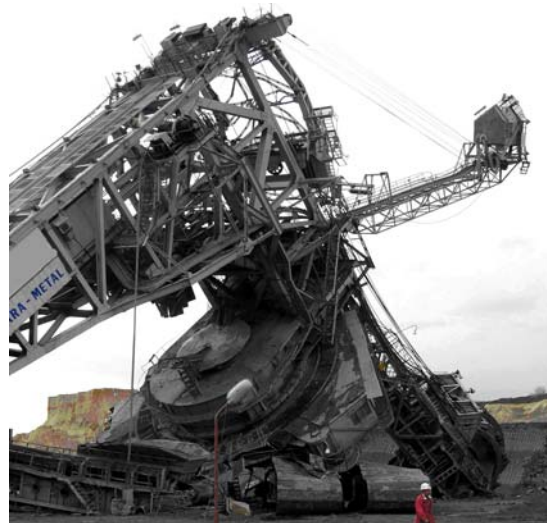
Collapse of rotor excavator (Fig. 16) in an open surface mine occurred due to fracture of lugs on counterweight holder (Figs. 17, 18), and magnified in Fig. 19. The borders between different fracture types are shown in Fig. 20.

Figure 16. Collapse of rotor excavator.
Slika 16. Kolaps rotornog bagera

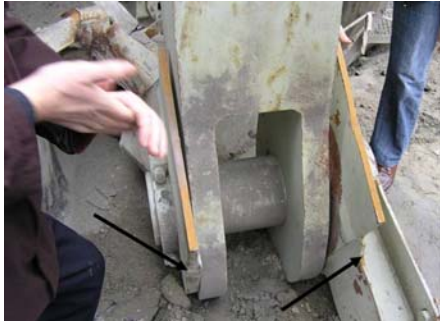
Figure 17. Fracture of two lugs caused the rotor excavator collapse.
Slika 17. Lom dve uške izazvao je kolaps rotornog bagera

In-situ visual examination was sufficient to recognize fracture scenario. Cracks originated in T welded joints, connecting lug and web. Starting from these cracks, in a determined time period variable service loads produced fatigue cracks on both sites of lug plate (upper part in Figs. 18 and 19). At the end of fatigue crack, stable crack growth in plane stress condition with clearly recognized shear lips started after crack tip blunting and developed final stretch zone (Figs. 19, 20a). On both sides from the T weld, stretch zones developed at the end of stable cracks (ZP, Figs. 19, 20c; CA, Figs. 19, 20b). Final stretch zone in position ZP developed in one stage before final brittle fracture took place. On the other side, at position CA, stretch zone partly

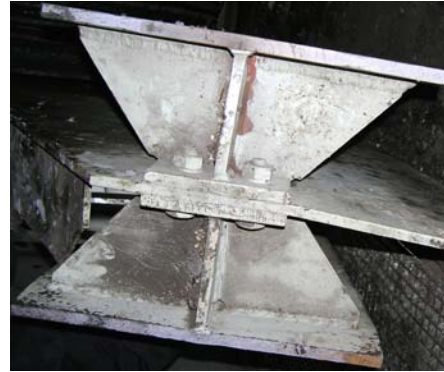
Figure 18. View of fractured assembly: combined fracture of right lug and brittle fracture of lug, left in Fig. 17 (lower part).
Slika 18. Izgled loma sklopa: kombinovani lom desne uške i krti lom uške, levo na sl. 17 (dole)

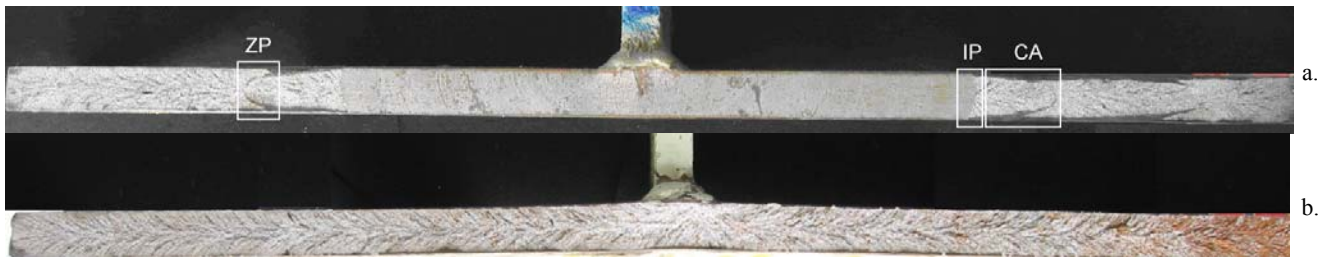
Figure 19. a) Combined fatigue, stable crack growth with shear lips and final brute fracture of upper part.
b) Brittle fracture of lower part, indicating initiation point from both sites (compare to Fig. 18).
Slika 19. a) Kombinovani zamor, stabilan rast prsline sa usnama smicanja i konačni lom gornjeg dela
b) Krti lom donjeg dela, ukazuje na mesto inicijacije za obe lokacije (uporediti sa sl. 18)

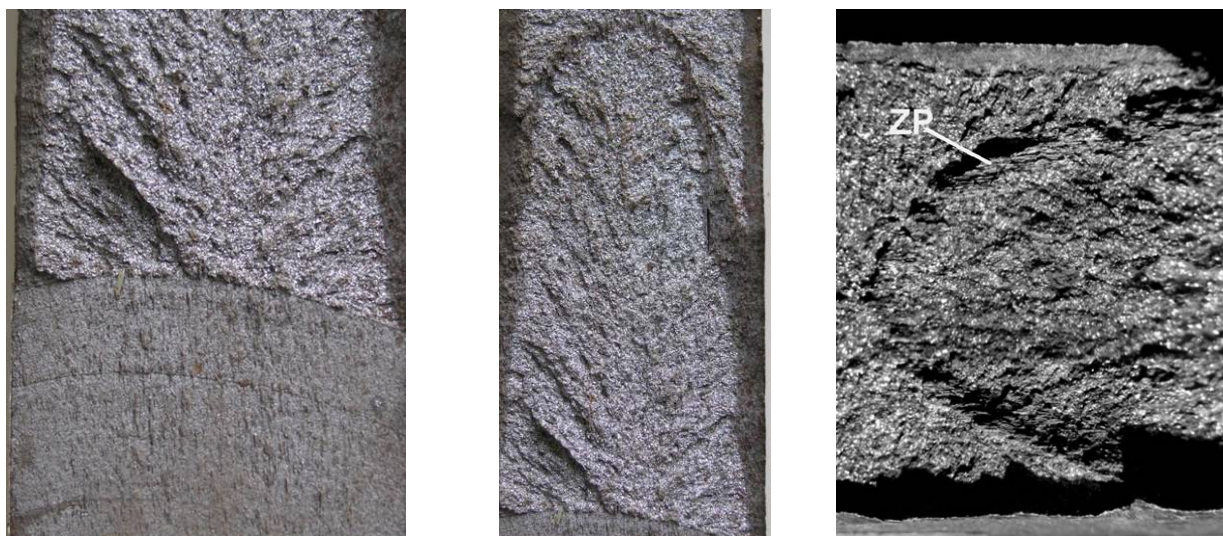
a) Transition from fatigue to stable crack growth, shear lips visible (IP) b) Extend of crack till formation of first final stretch zone (CA) c) Second final stretch zone (ZP) before final brute fracture

Figure 20. Typical regions in fracture process, indicated in Fig. 19.
Slika 20. Tipične oblasti u procesu loma, vidljivo na sl. 19

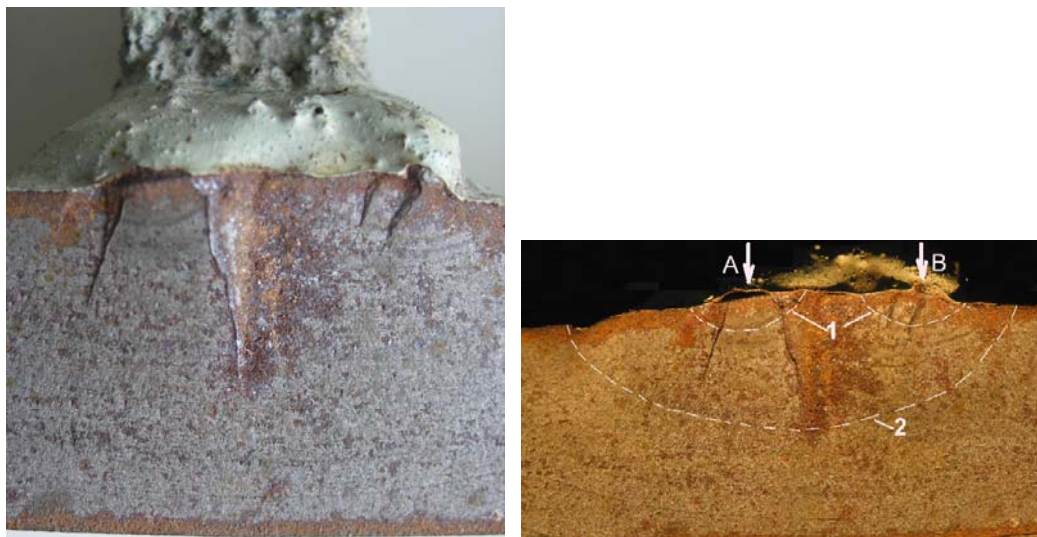
Figure 21. Enlarged view of T welded joint (up) and marked initial fatigue crack development (1) followed by final fatigue crack (2).
Slika 21. Uvećan prikaz T spoja (gore) i početak razvoja zamorne prsline (1) praćen konačnom zamornom prslinom (2)

Fatigue fracture initiated in the fusion zone between two weld passes, locations A and B. The size of initiation region approximately equals the thickness of the supporting web (length C, Fig. 22). Ratchet marks LZ were completely in weld metal, with stress concentration due to geometry and weld metal overfill. Beach marks—striations LO determined two dominant locations of crack initiation, marked A and B. Two fatigue cracks developed at these locations (1), after meeting each other and forming one dominant fatigue crack (2).

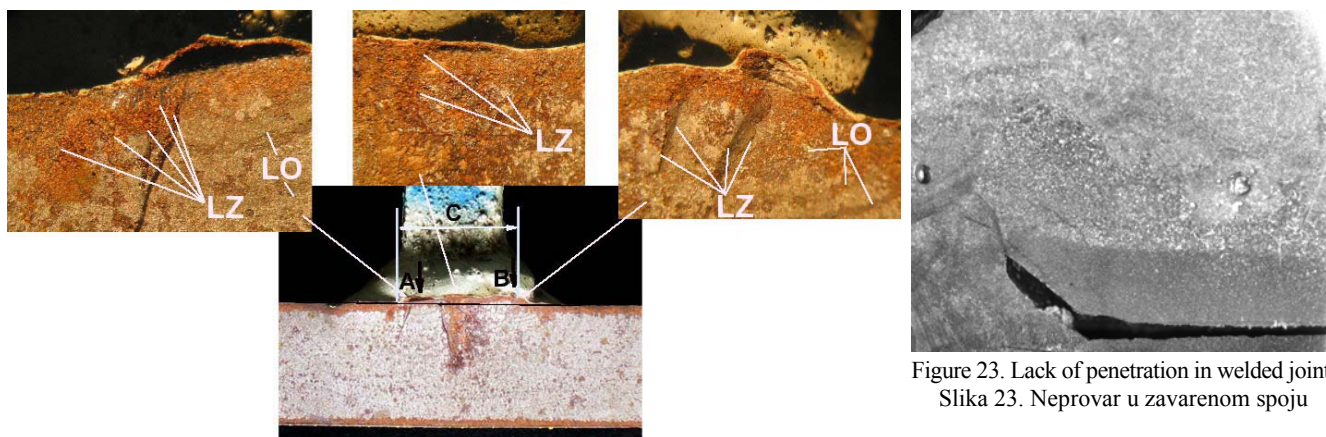
On the opposite side of weld metal there is lack of penetration, ending in the same region, Fig. 23. At the location of crack initiation microstructural heterogeneity-like border between two passes and the residue of slag was detected. The significance of all imperfections and defects could not be assessed, since welding and inspection documentation was not available. Tested values of impact and fracture toughness of parent metal, steel St. 52.3 (DIN), indicated fracture above nil-ductility transition temperature, corresponding to fracture surface in Fig. 19.

Figure 22. Crack initiation: A and B—regions of fatigue crack initiation; LZ—ratchet marks; LO—striations; C—length of crack region.
Slika 22. Inicijacija prsline: A i B—oblasti inicijacije zamorne prsline; LZ—tragovi nazublivanja; LO—strije; C—dužina oblasti sa prslinom
