DETERMINATION OF DAMAGE AND REPAIR METHODOLOGY FOR THE RUNNER MANHOLE OF KAPLAN TURBINE AT THE HYDRO POWER PLANT 'DJERDAP 1'

Originalni naučni rad / Original scientific paper

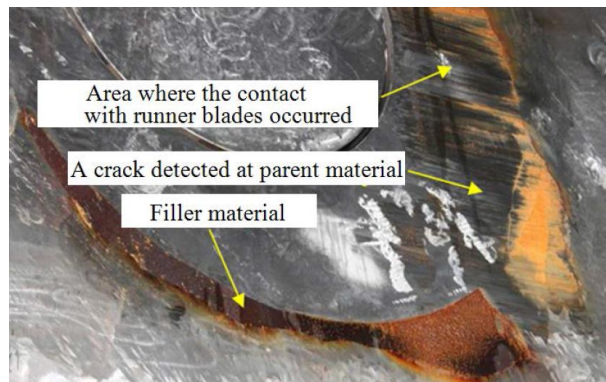
a) Damage in a manhole area toward the runner

Figure 6. Damages that occurred in the manhole area.

- areas where damages or cracks occurred, after the preparation of surfaces by grinding using suitable grinders, have been locally preheated at 150°C;
- welding/surface welding is executed by electrode ЭА 395/9, with diameters ranging from 2.5 to 4 mm;
- after the execution of welding/surface welding, treated areas are heated to 150°C for another hour, and then isolated from all sides and left to cool slowly;
- after the repair is performed in areas with damages and cracks by welding/surface welding, these areas are treated by suitable grinders in order to achieve demanded geometry and surface roughness.

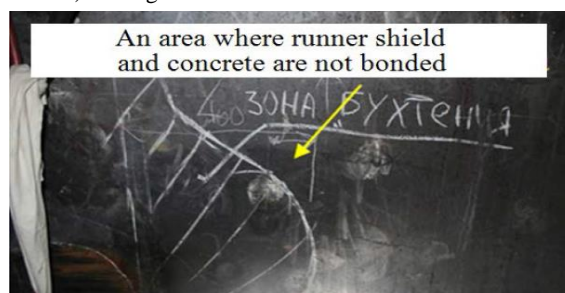
b) Damage detected at the runner shield

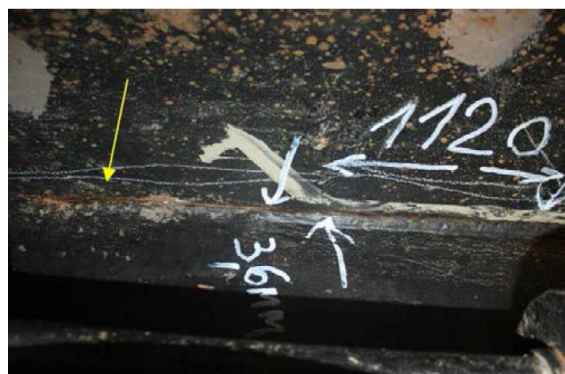
a) Crack at the welded joint of runner shield with concrete

Figure 7. Appearance of a crack in welded joints.

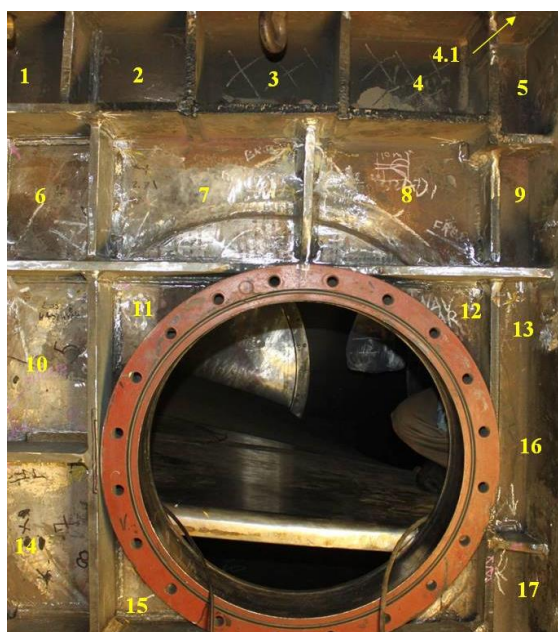
A segment of the flow tract in the manhole area is presented in Fig. 4 (numbers and letters mark the elements and welded joints at the manhole), while areas in which the water leaking occurs are shown in Fig. 5. Some of the characteristic spots in the parent material and welded joints of the manhole where damages occur, detected by visual inspection /3/, are shown in Figs. 6 and 7.

Figure 5. Appearance of manhole area at which leaking occurred.

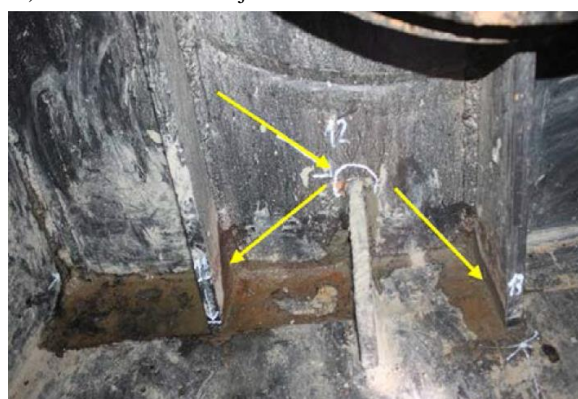
b) Cracks at welded joints between rib sand runner shield

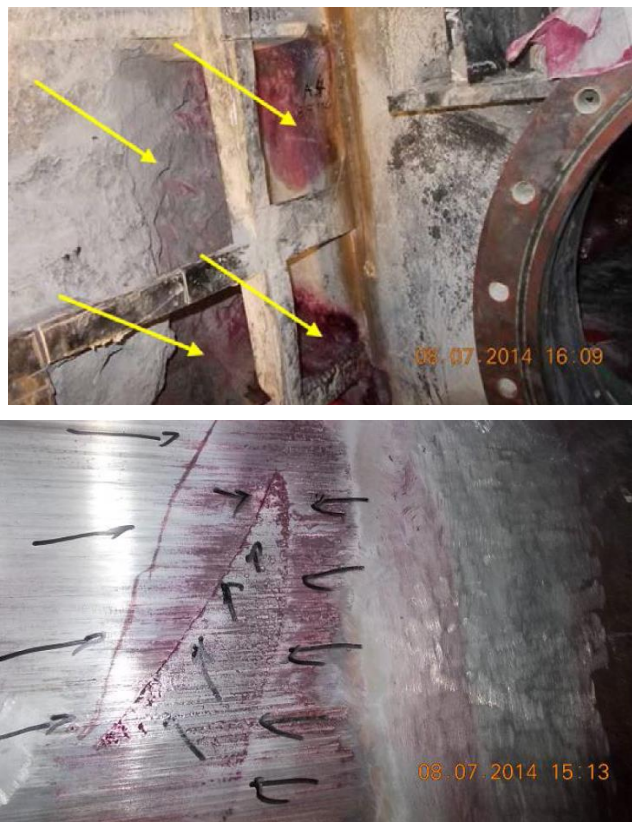
A few characteristic areas where surface damage occurred in the parent material and weld metal of the manhole, detected by penetrant testing [4], are shown in Fig. 8.

Figure 8. Characteristic surface damages in parent material and weld metal in the manhole and runner areas.

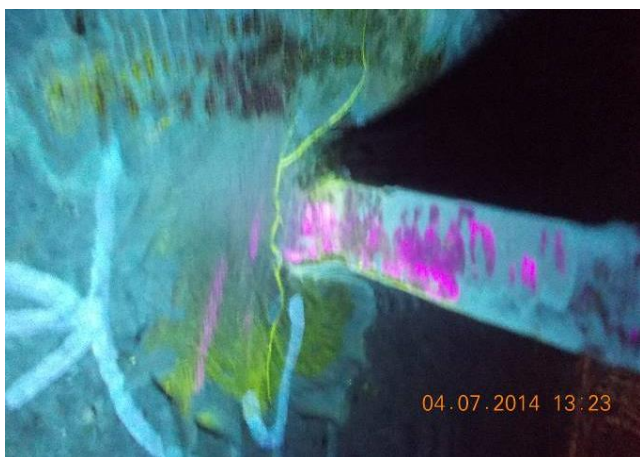
A few characteristic areas where surface damaging at the parent material and weld metal of the manhole and runner, detected by magnetic particle testing occurred, /5/, are shown in Fig. 9.

Figure 9. Surface crack detected by MT at the welded joint, between the strengthening rib and runner shield.

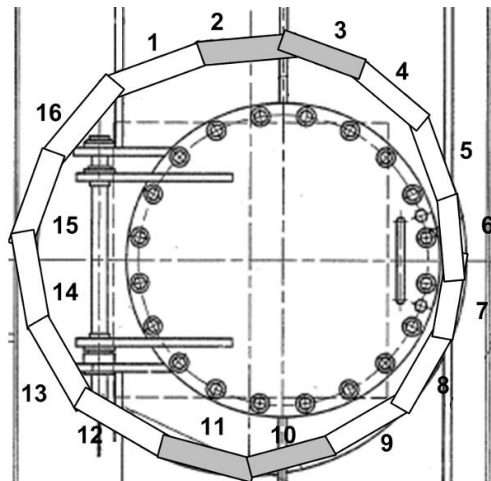
- Radiographs at which unacceptable defects in the butt-welded joint are detected.
- Radiographs at which no unacceptable defects in the butt-welded joint are detected.

Figure 10. Radiographic testing of the homogeneity of the circumferential butt-welded joint, disposition of radiographs.
