13th International Scientific Conference on Sustainable, Modern and Safe Transport
(TRANSCOM 2019), High Tatras, Novy Smokovec – Grand Hotel Bellevue,
Slovak Republic, May 29-31, 2019

Analysis of the cause of the girth gear tooth fracture occurrence at the bucket wheel excavator

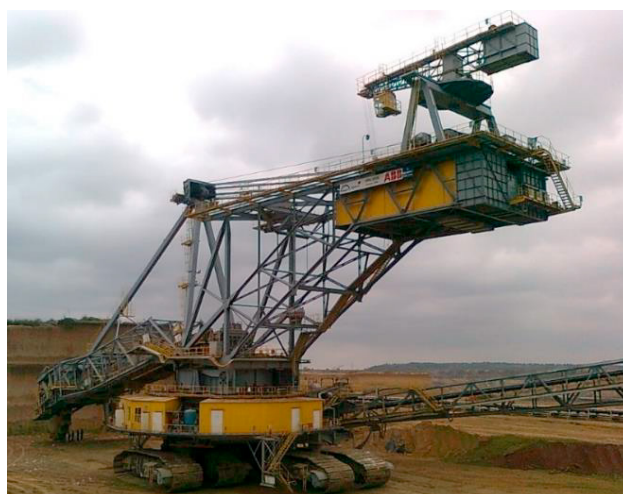
Fig. 1. Bucket wheel excavators SRs 2000 x 32/5.0 "Kostolac" (Serbia).

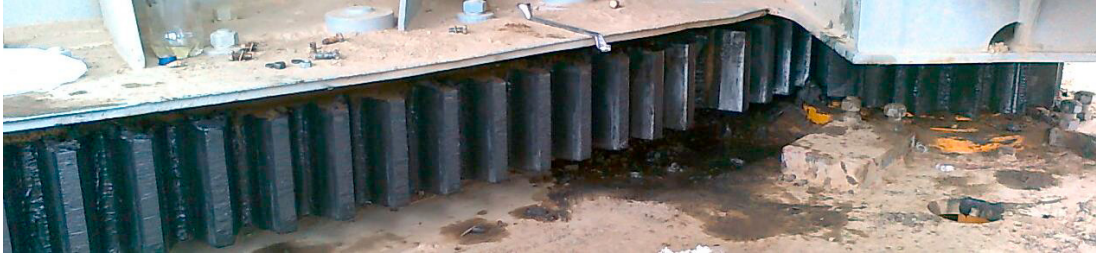
Based on the calculated number of cycles of the load changes until the tooth fracture, it can be concluded that the fracture occurred due to fatigue load and because there was an initial crack in the broken tooth base. In Figs. 2 and 3 are shown gears, the pinion and the girth gear and the fracture surface the broken tooth and the broken tooth. Analysis

Fig. 2. Appearance of the girth gear and the pin for rotation of the excavator's upper structure.

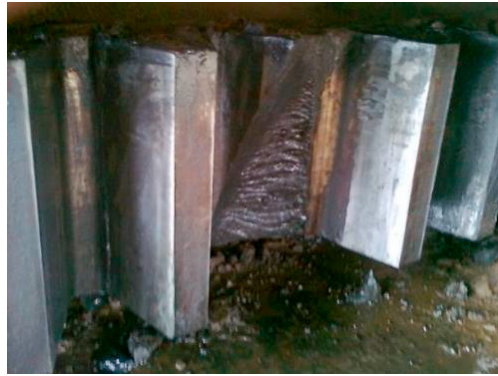
of the broken tooth fracture surface clearly shows that the very small portion of the tooth was loaded in fatigue (smooth fracture surface of the girth gear) and that the much larger portion was subjected to static fracture (the rough fracture surface of the girth gear), Fig. 3.

Based on the fracture surface appearance and calculated total number of the fatigue loading (stress) cycles of the girth gear tooth, $N = 3.6 \times 10^4$, one can conclude that the fracture occurred due to existence of the initial crack in the tooth base, which originated during the girth gear manufacturing.

Fig. 3. Appearance of the fracture surface of the girth gear at the broken tooth spot.

Analysis of the fracture mechanics parameters confirmed that the girth gear tooth fracture was caused by the initial crack existing in its base, which originated during the gear's manufacturing.
