## REPAIR WELDING OF PRESSURE EQUIPMENT WITH UNACCEPTABLE DEFECTS REPARATURA ZAVARIVANJEM NA OPREMI POD PRITISKOM SA NEPRIHVATLJIVIM GREŠKAMA

*The paper describes non-destructive testing and the repair welding technology for eliminating defects in the pressure equipment of RHE BB (Bajina Bašta) (located in Serbia). The obtained results had justified the proposed technology.*

### INSPECTION OF PRESSURE VESSEL 977

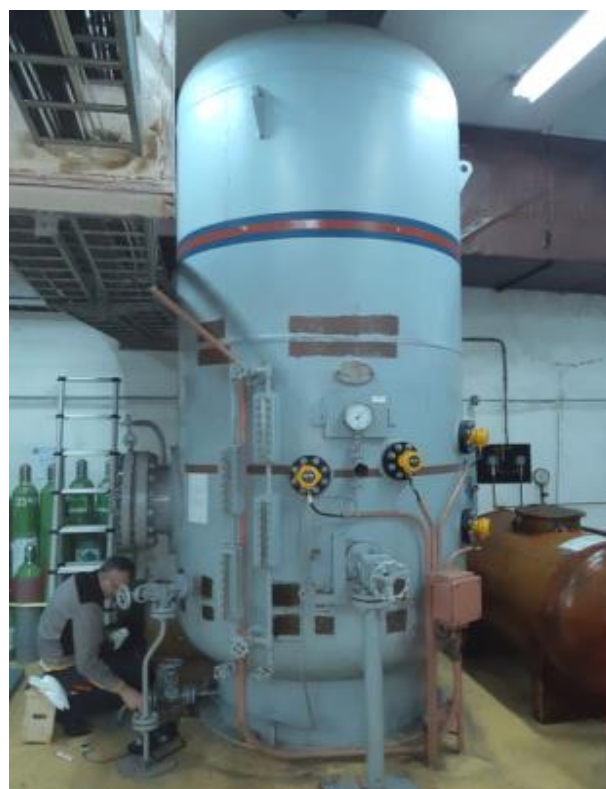
Figure 1. The pressure vessel 977 at RHE BB.

It should be noted that the basic material for inspected vessels is microalloyed steel NIOVAL 50, /1-3/. The vessel 977 pressure (Fig. 1) is  $p = 78$  bar. Geometry of the vessel is: thickness  $t = 42$  mm with mean diameter  $D = 1958$  mm. The vessel 977 was inspected with 100 % ultrasonic testing on two vertical welded joints, and on three circular welded joints.

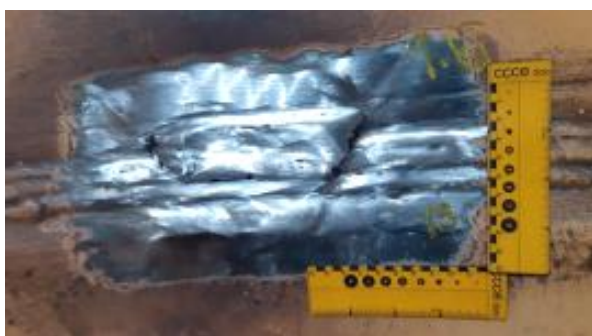
After the final UT testing of the vessel 977, defects marked 1.6 and 2.5 are found with the following geometry and location:

- defect 1.6: length 20 mm and width/depth 15 mm in the central circular seam, from 27 to 42 mm,
- defect 2.5: length 170 mm and width/depth 14 mm in the central circular seam, from 28 to 42 mm.

Figure 2. Position and size of defect 1.6 in vessel 977.

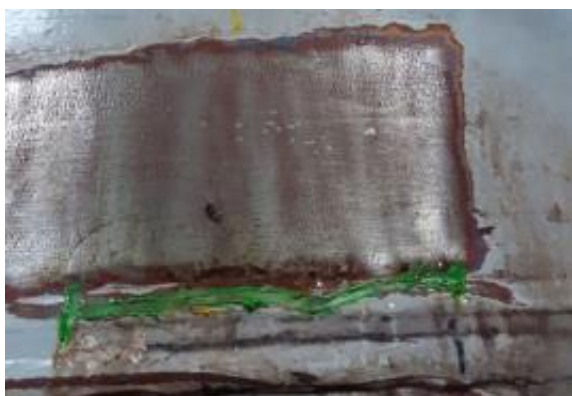
Figure 3. Position and size of defect 2.5 in vessel 977.

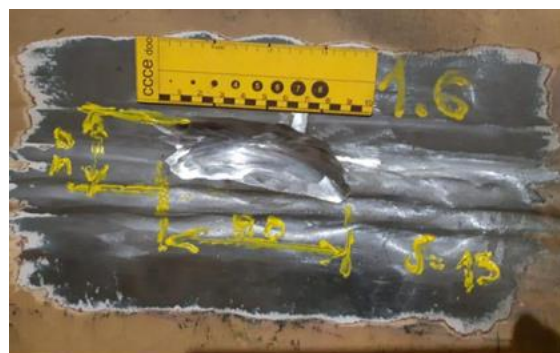
Figure 5. Welding groove after the removal of defect 1.6.

We start the repair by digging out defects 1.6 and 2.5 and creating grooves for welding. Welding grooves for defects 1.6 and 2.5 are shown in Figs. 5 and 6.

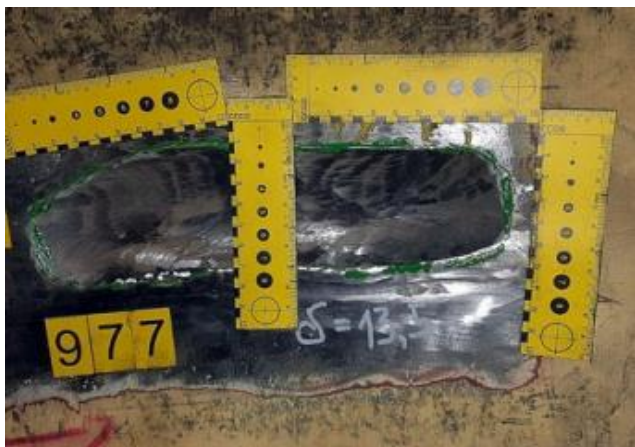
Figure 6. Welding groove after the removal of defect 2.5.

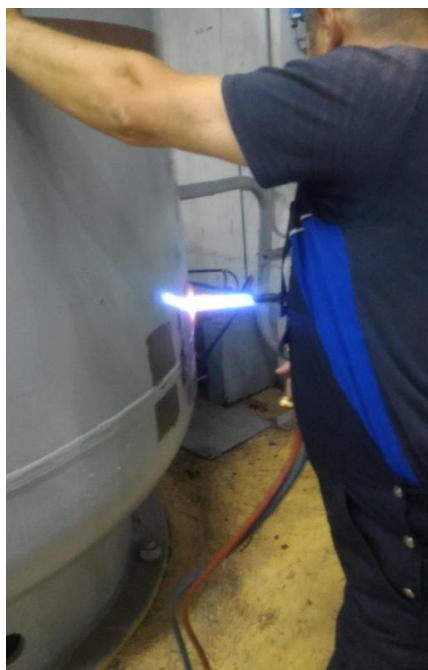
Figure 7. The preheating procedure.

Electrodes are dried at 300-350 °C for approx. 2 hours. Before the start of welding, the base material is preheated to a temperature of 200 °C. Preheating is performed with a gas flame on the outside surface of the vessel, Fig. 7, using equipment shown in Fig. 8. During preheating, the temperature is measured from the inside with a contact thermometer shown in Fig. 9. Prior to the welding itself, performed by the device in Fig. 10, the welder created a pair of test passes as shown in Fig. 11.

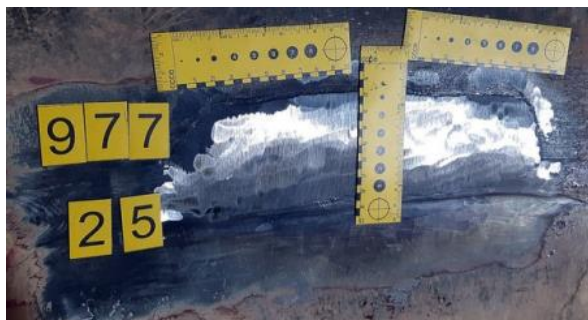
Figure 12. The inner surface after the repair - vessel 977.

After creating the groove, the preheating procedure and the welded test passes, the welding process is carried out according to defined procedure (WPS), using the shielded manual arc welding (SMAW) technique. Figures 12 and 13 show the weld repaired inner and outer zone of the vessel.

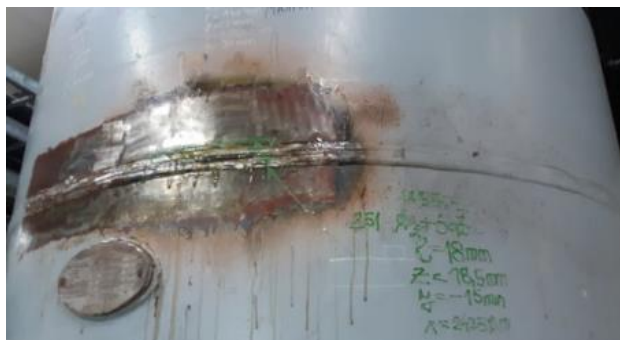
Figure 13. The outer surface after the repair - vessel 977.

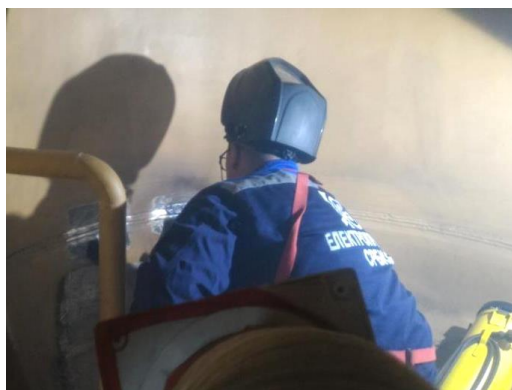
Figure 14. Interpass temperature measurement.

During the welding process, the welder removed the slag after each pass and measured the intermediate temperature with a contact thermometer. The intermediate temperature was maintained at 180 °C throughout the process, Fig. 14.

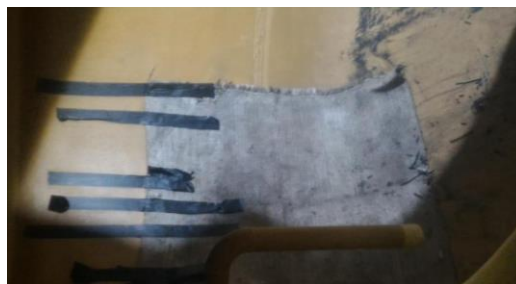
Figure 15. Asbestos cloth on the inner side of vessel.

Upon the completion of welding, heating took place at a temperature of about 180 °C for 1 h. Reheating is performed on the outside of the vessel, using the apparatus for preheating. The temperature was controlled by a contact thermometer on the inside of the vessel near the welded joint. After reheating, the welded joint is protected from drafts and immersed in asbestos cloth to slow down the cooling as much as possible, as shown in Figs. 15 and 16.

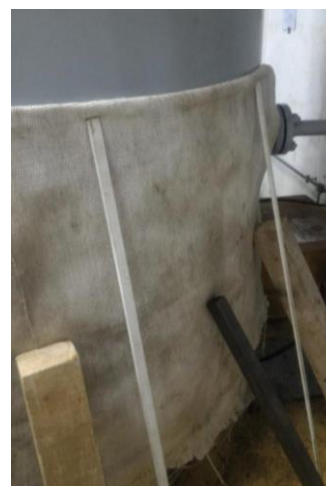
Figure 16. Asbestos cloth on the outer side of the vessel.

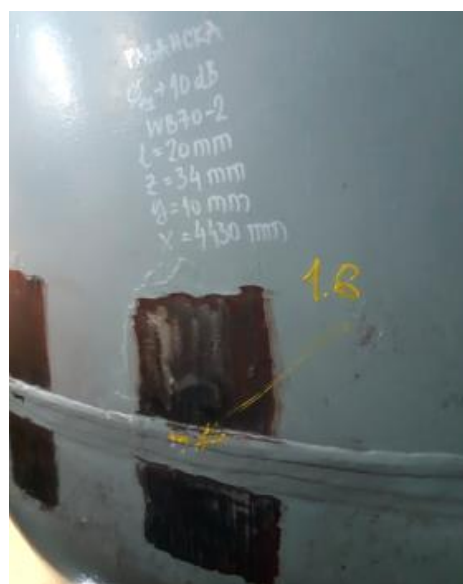
As already mentioned, inspection is performed by magnetic, visual and ultrasonic methods before and after the repair welding. Only some details of the NDT inspection of vessel 977 after repair are presented here. Figures 17-20 show details of the NDT tests of vessel 977 at defect zones 1.6 and 2.5. It should be noted that after the repair welding, NDT has shown that defects 1.6 and 2.5 were successfully removed.

Figure 17. Defect zone 1.6.

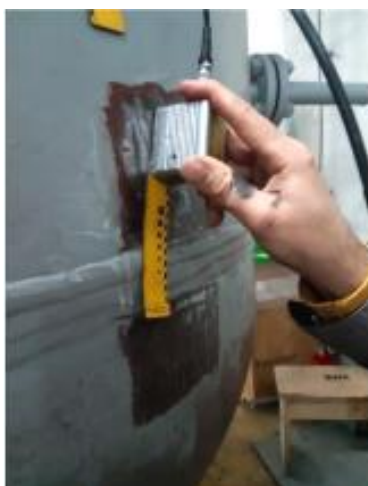
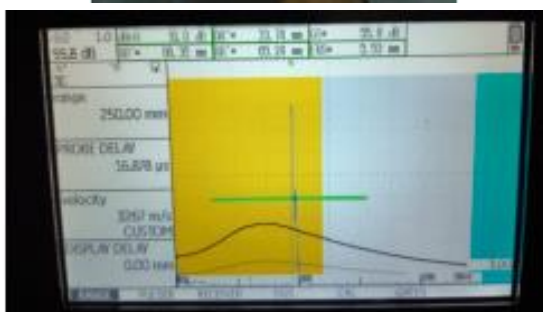
Figure 18. Ultrasonic inspection of vessel 977 - defect 1.6.

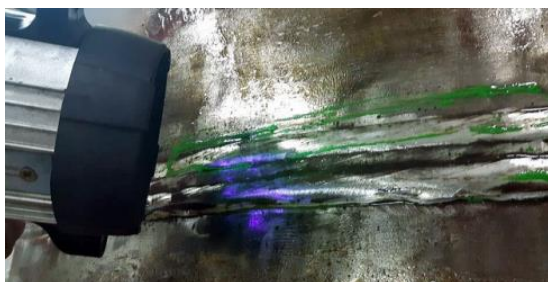
Figure 18. Magnetic particle tests on the outside wall of vessel after the repair welding of defect 2.5.

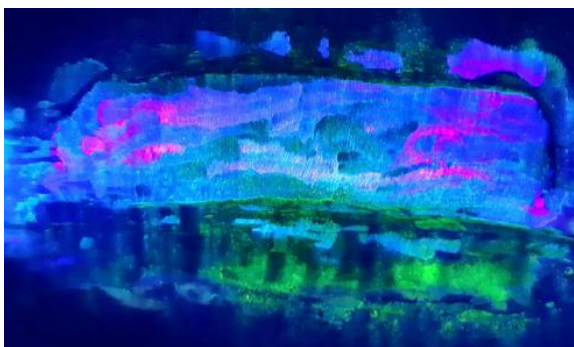
Figure 19. Magnetic particle tests on the inside wall of the vessel after repair welding of defect 2.5.
