Snail Trails and Cell Microcrack Impact on PV Module Maximum Power and Energy Production

Index Terms—Electroluminescence (EL), microcracks, photovoltaic (PV) modules, PV system reliability, snail trail phenomena.

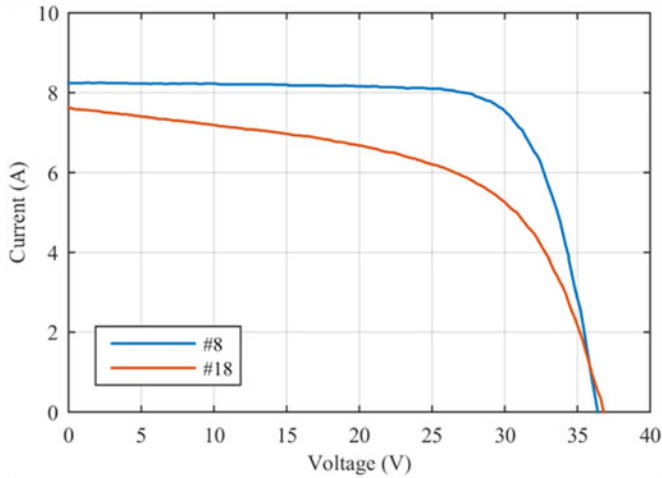
Fig. 2. Measured I - V curves of PV modules without major visual defects (#8) and with several snail trails (#18).

value below the nominal power; the reduction ranges from -9% to -27% with respect to the nominal power available from the datasheet.¹ In particular, a decay of the current at MPP can be outlined, while the I_{SC} and voltages are only marginally affected.

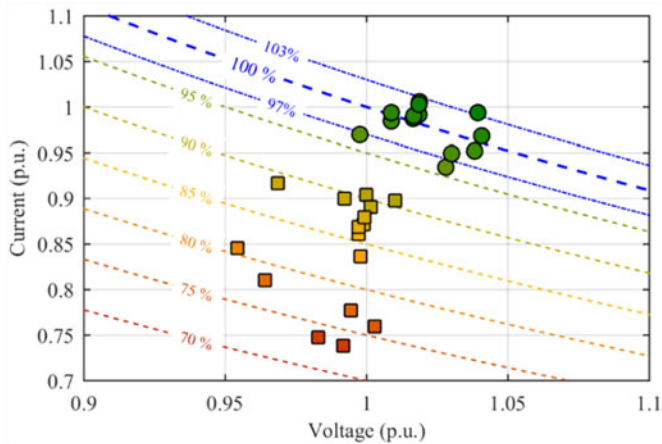
Fig. 3. MPP of the PV modules under analysis (except the one affected by diode failure) measured at STC in comparison with datasheet value (100%).

Fig. 3 summarizes the voltage and current at MPP referred to the values indicated on the datasheet of the PV module.

The dashed lines are percentages of the maximum power. The modules not affected by snail trails are between or close to the blue-dashed lines, which represent the nominal power output $\pm 3\%$ of tolerance. Modules with snail trails have power output ranging from 75% to 90% of the nominal ones, which is mainly due to current density reduction.

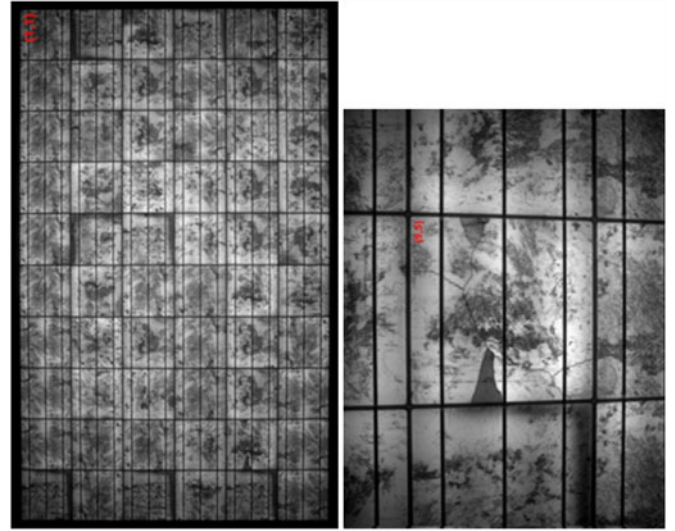
Fig. 4. EL image of PV modules #14.

The last indoor test was the EL which was performed on all the modules. As a term of comparison, the EL image of a PV module without visual defects (#14) is reported in Fig. 4.

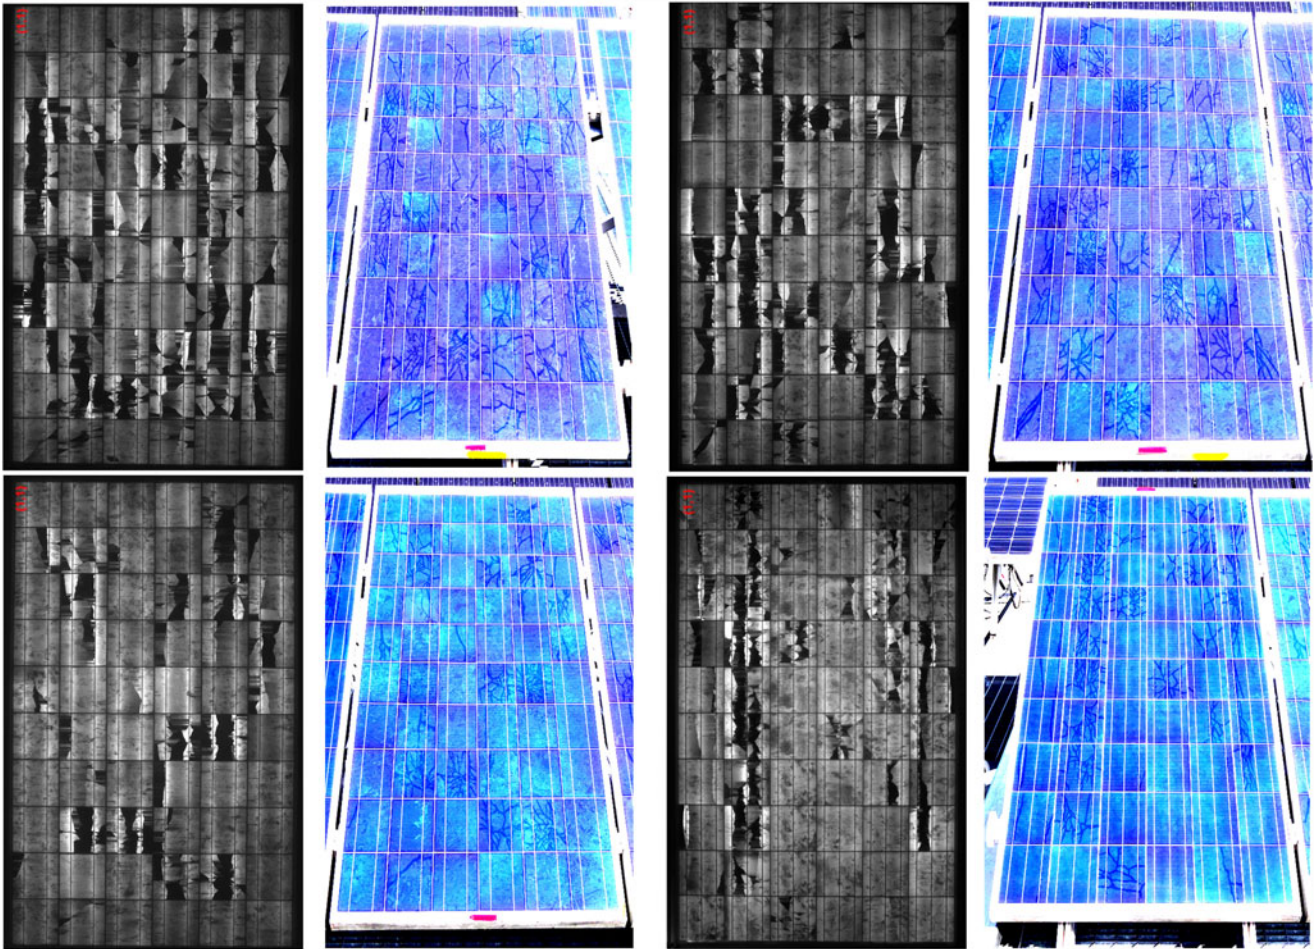
Fig. 5. EL image and picture of PV modules #17, #18, #23, and #24 starting from top-left.

Starting from PV module #17, several snail trails are visible, e.g., in positions (3,1), (4,1), and (5,1). Furthermore, cracks are distinguishable in some cells located in positions (6,3) and (10,2). In addition, poor finger contacts are visible [see cell (5,4)]. Same considerations can be extended to the module #18 and #24, where snail trails are visible in cells (2,1), (2,2), and (3,3) in #18, while in #24, they are located in positions from (1,2) to (6,2). In addition, in these cases, poor finger contacts are present in cell (4,4) and position (6,1) and (7,1) in #18 and in #24, respectively.

In the case of PV module #23, several snail trails are visible, e.g., in position (1,5), (1,6), and (1,7); these correspond to electrically separated areas in EL images. Furthermore, cracks are distinguishable in some cells, e.g., in position (5,3). Again, poor finger contacts are visible, e.g., on cell (5,4), and not uniformity in light is present, e.g., on cells (7,4) and (5,3). For the module

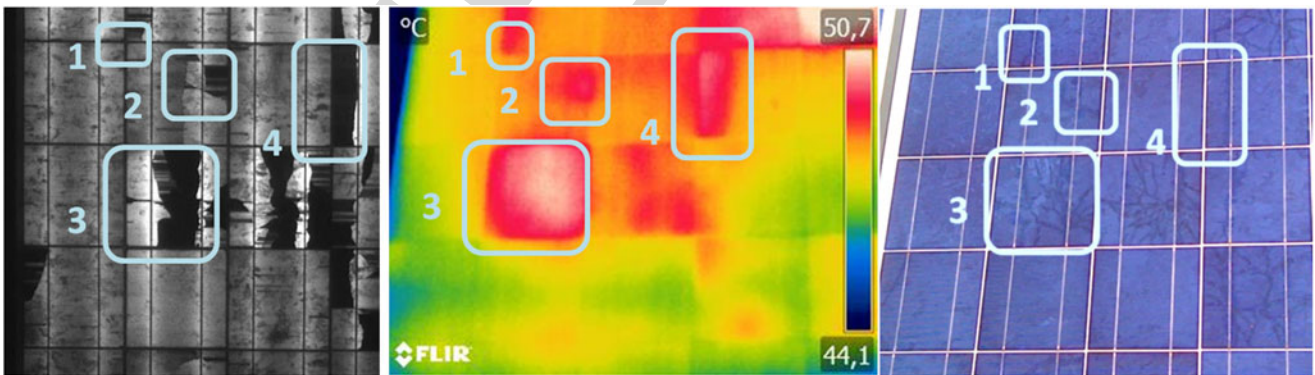
Fig. 6. EL, thermal, and visual images of #23 PV-module from (7,1) to (9,3) cells.

260 #23, in addition to EL analysis which outlined the same issues
 261 of the previous models, a thermal image together with EL and
 262 visual images of cells from (7,1) to (9,3) cells are shown in
 263 Fig. 4. Comparing the three images, it is possible to identify a
 264 link among visual defects, hot parts, and electrically separated
 265 areas.

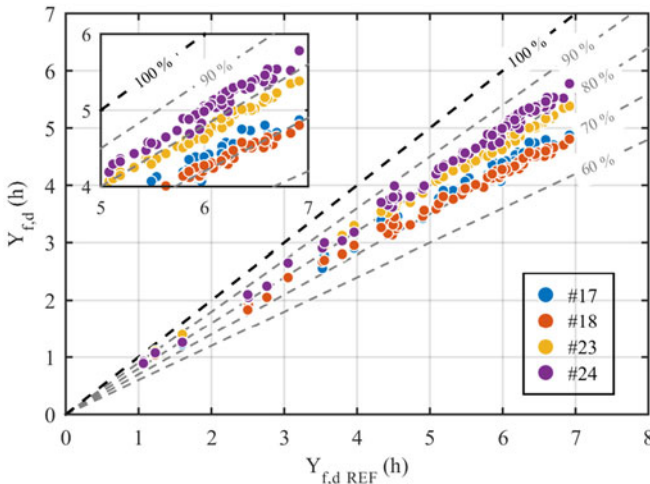
Fig. 7. Daily final yield of the PV modules #17, 18, 23, and 24 in the period April 2015–August 2015 referred to the daily final yield of the reference PV modules.

290 The energy produced by the PV modules in the period from April 2015 to August 2015 was recorded to quantify the influence
 291 of snail trails/cracks in terms of daily and total energy within the conducted test period. The daily energy generation—
 292 in terms of final yield ($Y_{f,d}$)—by PV modules referred to the final yield of REFPV module ($Y_{f,d,REF}$) is summarized in Fig. 7.
 293 The energy generation of the REFPV module, in terms of equivalent hours at peak power, is the black-dashed line.

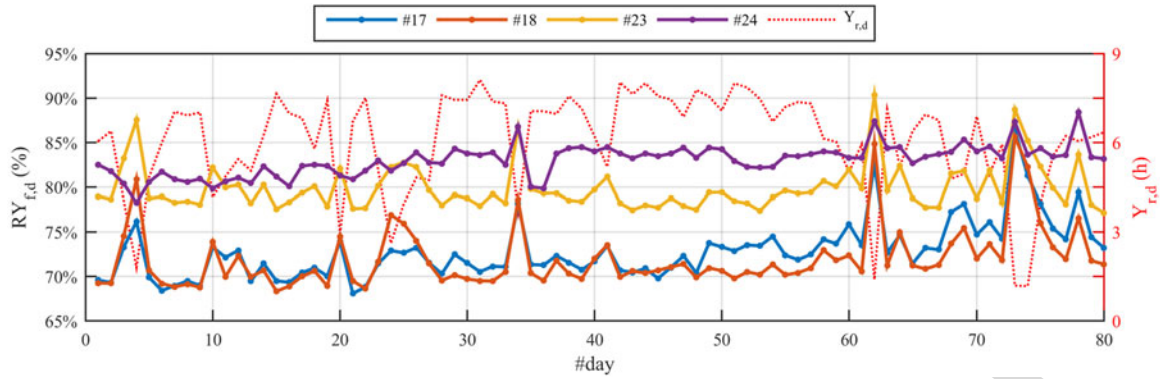
Fig. 8. Relative daily final yield index of the four PV affected modules #17, #18, #23, and #24 for 80 days in the period of analysis. The daily reference yield index for the same days has been reported on the secondary y-axes.

315 Fig. 8 illustrates the variation of relative daily final yield index ($RY_{f,d}$) for the four affected PV modules (#17, #18, #23,
 316 and #24) for each measured day. As illustrated in Fig. 8, the performance decay is higher during high solar radiation days
 317 characterized by high $Y_{r,d}$. Table II summarizes the final yield and relative final yield for the different months and the entire
 318 period of analysis. It is important to underline that the numbers of days in which the data are available are different for each
 319 month. PV modules #17 and #18 presents the highest reduction in energy production by about 30% than the REFPV module.
 320 Modules #23 and #24 show a lower energy reduction: they produce about 20% less in term of energy than the REFPV. These
 321 results are similar to the ones obtained by the maximum power tests. Besides diverse measurement accuracies and references

322 adopted (REFPV instead of datasheet), the energy analysis represent the average behavior of the module under real operating
 323 conditions, which can differ from the ones at MPP. The energy results outline that the average behavior cannot be easily predicted:
 324 two modules (#17 and #18) have an energy reduction higher than the one at MPP, while the opposite occurs for #23
 325 and #24.

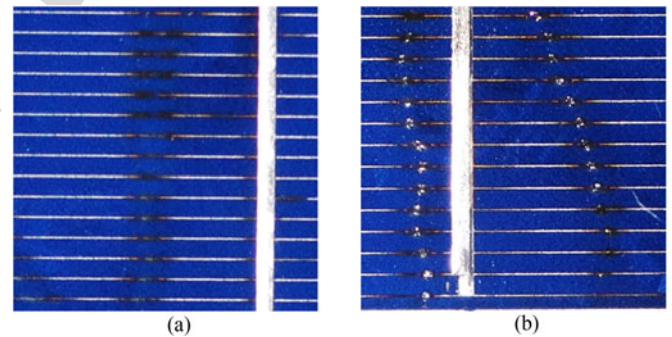
Fig. 10. Status of the fingers under the snail trails. (a) Year 2013 and (b) year 2015.

340 Moreover, only in a few cells of each module, a variation of the fingers close to the snail trails was observed moving from
 341 case a to case b.

- 342 1) *Case a*: Fingers are not interrupted, and there is only a color variation from metallic gray to black [see Fig. 10(a)].
- 343 2) *Case b*: Fingers look broken, and small metal agglomerates with spherical shape are present in the center of the
 344 finger [see Fig. 10(b)].

There is no clear explanation of this snail trail evolution. Over the two-year period, no further decrease of performance was observed, and only very minor evolution of new grid finger discoloration occurred. A localized hot spot caused by the high current density near the cracks in the PV cell can be the justification. Over time, the initial damage that looks like a burn evolves to a localized fusion of the metallic material, leading to a permanent damage of the cell and of the encapsulant. A microscopic change of “old” discoloration represents a reason that has to be investigated further.

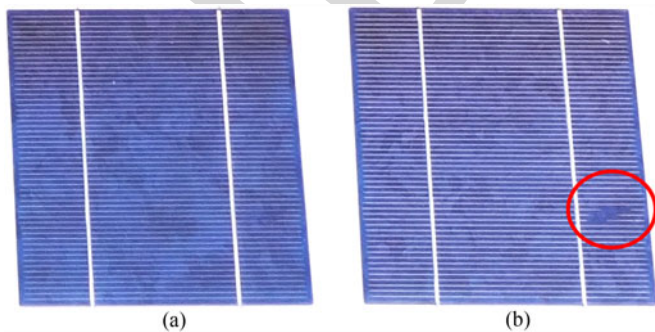
Fig. 9. Comparison among the state of the same PV cell. (a) year 2013 and (b) year 2015.

336 Furthermore, a comparison in terms of visual images was performed. The PV cell visual inspection outlined only minor
 337 variations from 2013 to 2015. In general, only one or two cells in each PV module showed new snail trails, affecting a very
 338 limited area of the PV cell. This can be seen in Fig. 9, where in 2015, a small defect, which was not present in 2013, has
 339 appeared in the bottom right area of the PV cell.

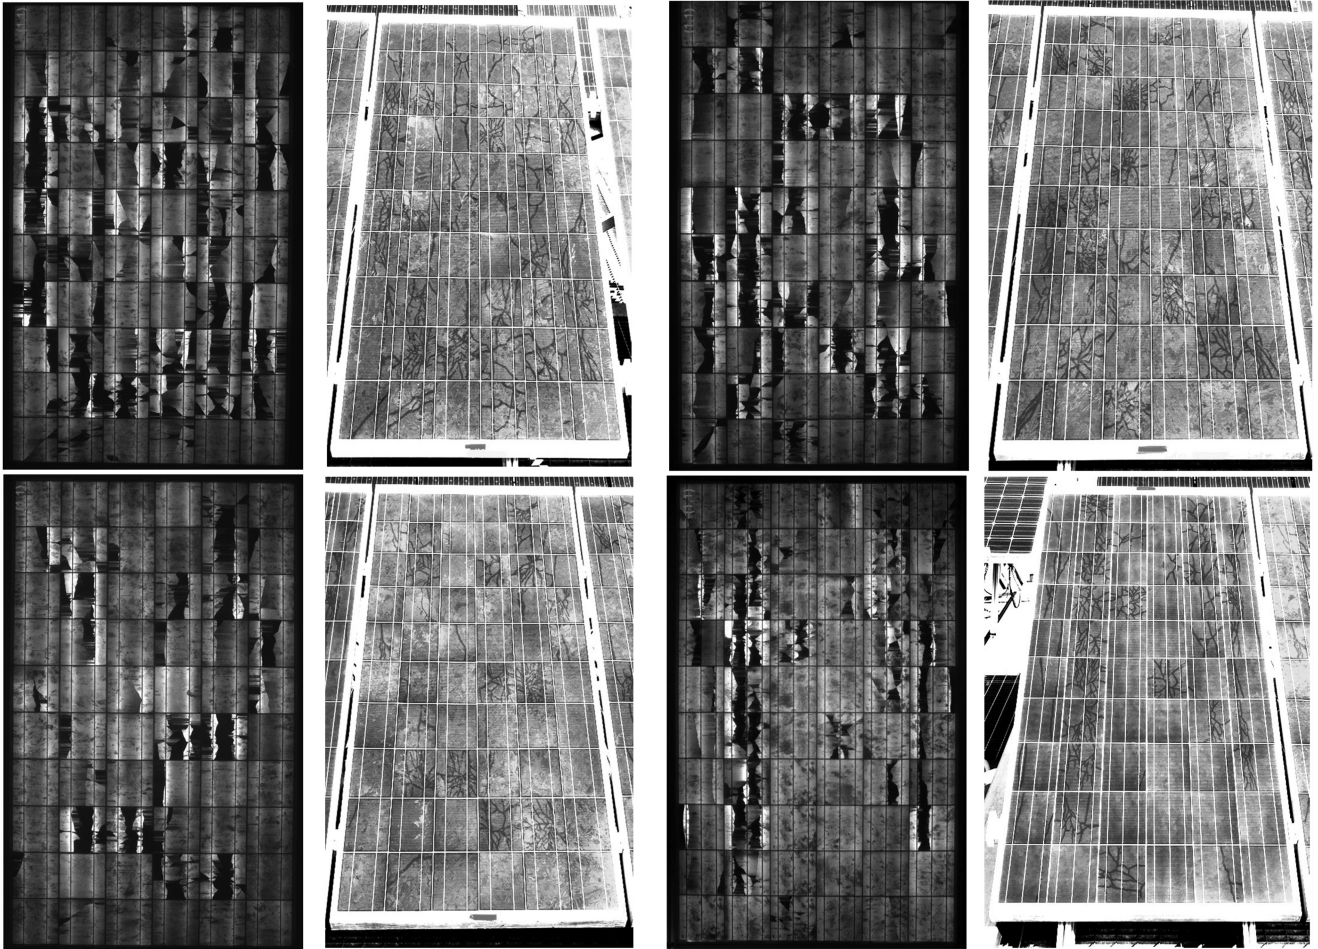
Fig. 5. EL image and picture of PV modules #17, #18, #23, and #24 starting from top-left.

Starting from PV module #17, several snail trails are visible, e.g., in positions (3,1), (4,1), and (5,1). Furthermore, cracks are distinguishable in some cells located in positions (6,3) and (10,2). In addition, poor finger contacts are visible [see cell (5,4)]. Same considerations can be extended to the module #18 and #24, where snail trails are visible in cells (2,1), (2,2), and (3,3) in #18, while in #24, they are located in positions from (1,2) to (6,2). In addition, in these cases, poor finger contacts are present in cell (4,4) and position (6,1) and (7,1) in #18 and in #24, respectively.

In the case of PV module #23, several snail trails are visible, e.g., in position (1,5), (1,6), and (1,7); these correspond to electrically separated areas in EL images. Furthermore, cracks are distinguishable in some cells, e.g., in position (5,3). Again, poor finger contacts are visible, e.g., on cell (5,4), and not uniformity in light is present, e.g., on cells (7,4) and (5,3). For the module

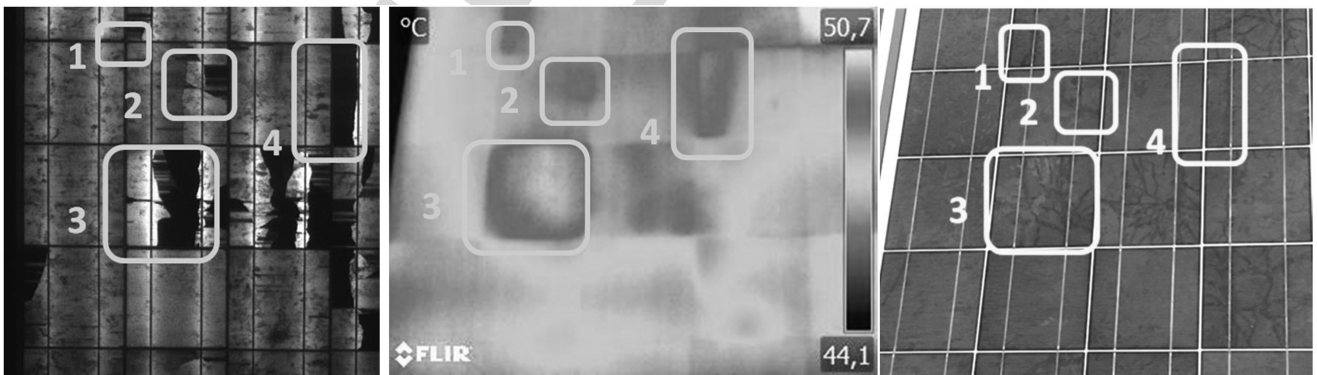
Fig. 6. EL, thermal, and visual images of #23 PV-module from (7,1) to (9,3) cells.

260 #23, in addition to EL analysis which outlined the same issues
 261 of the previous models, a thermal image together with EL and
 262 visual images of cells from (7,1) to (9,3) cells are shown in
 263 Fig. 4. Comparing the three images, it is possible to identify a
 264 link among visual defects, hot parts, and electrically separated
 265 areas.

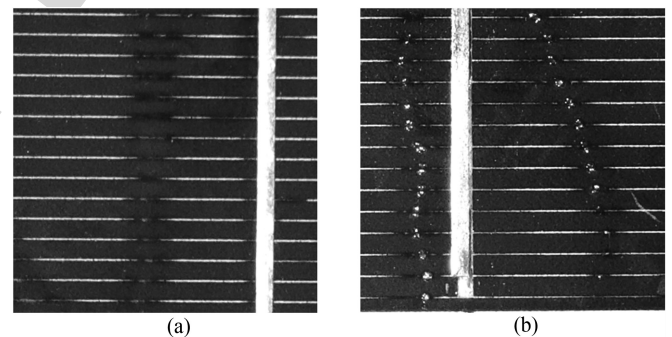
Fig. 10. Status of the fingers under the snail trails. (a) Year 2013 and (b) year 2015.

333 Moreover, only in a few cells of each module, a variation of the fingers close to the snail trails was observed moving from case a to case b.

- 334 1) *Case a*: Fingers are not interrupted, and there is only a color variation from metallic gray to black [see Fig. 10(a)].
- 335 2) *Case b*: Fingers look broken, and small metal agglomerates with spherical shape are present in the center of the finger [see Fig. 10(b)].

There is no clear explanation of this snail trail evolution. Over the two-year period, no further decrease of performance was observed, and only very minor evolution of new grid finger discoloration occurred. A localized hot spot caused by the high current density near the cracks in the PV cell can be the justification. Over time, the initial damage that looks like a burn evolves to a localized fusion of the metallic material, leading to a permanent damage of the cell and of the encapsulant. A microscopic change of “old” discoloration represents a reason that has to be investigated further.
