Investigation of A Neuro-Stimulator Retrieved Posthumously

A neurostimulator was investigated in this paper posthumously. Device was presented to our anatomical gift program. Investigation was multi-fold and contained visual inspection, using an optical microscope, and mechanical and electrical testing of leads and its insulator. It was concluded that the device could have been damaged during implantation, *in vivo*, during removal, and/or during transportation to author's laboratories. The damage observed on the lead insulation is similar to that which can occur due to anchoring of the lead and hardening due to oxidation. Insulation stiffness was determined to be 1/10 of new insulator. The results reported here on the insulation may or may not have affected the electrical operation of the neurostimulator.

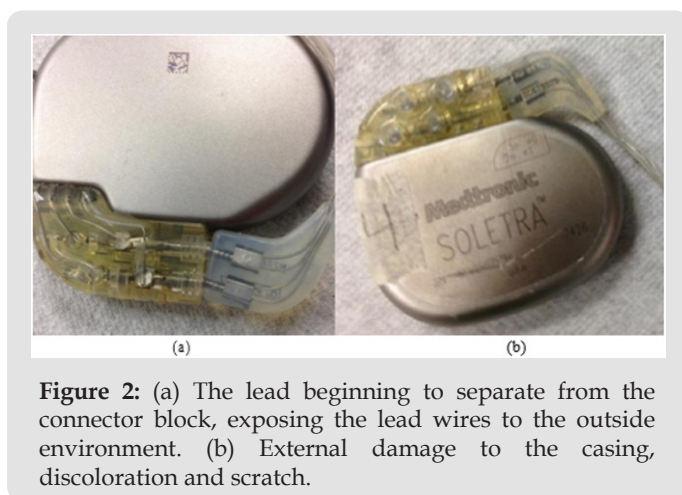
Figure 2: (a) The lead beginning to separate from the connector block, exposing the lead wires to the outside environment. (b) External damage to the casing, discoloration and scratch.

The lead of the neurostimulator is considered to be a quadripolar, multifilar, co-radial lead⁴. The current neurostimulator under investigation has visible signs of damage. These damage features include a scratched casing, separation between the connector block and the lead, missing and damaged portions of the insulation of the lead (Figure 3) and some discoloration on the lead insulation. The bulk of the damage on this device is to the lead insulation, which is not uncommon. Insulation defects are the most frequent cause of lead failure [14]. Figure 2 shows the condition in which the device was received.

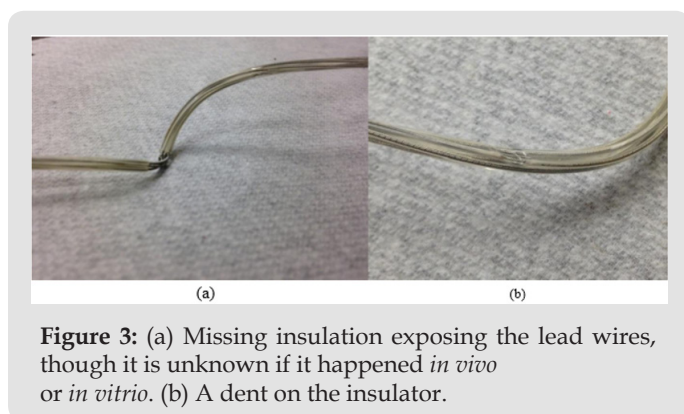
Figure 3: (a) Missing insulation exposing the lead wires, though it is unknown if it happened *in vivo* or *in vitro*. (b) A dent on the insulator.

It was determined that two areas of the lead wires were exposed due to damage on the insulation. If the lead wires were exposed while the device was in vivo, it may have affected the local tissue structure, which was not available for study. Neurostimulators fail due to the oxidation of lead wires after insulation damage. Therefore, observations made from this paper are valuable. The

Insulation break up as shown in Figure 3b, was noted in a predicate study³ neurostimulator, where the patient complained of returned migraines and a burning sensation in her left posterior neck triangle. The burning sensation in the patient was attributed to the exposure of the conducting surface of the lead wires. After investigation and surgery, it was discovered that the lead insulation was eroded at the anchor site³. Features reported in Clarke, are very similar to what we observed in Figure 3b. The force of the sutures used to anchor the lead along with the flexion and extension movements of the body at this site caused the lead insulation to break down. This analogy may be applied to the present investigation.

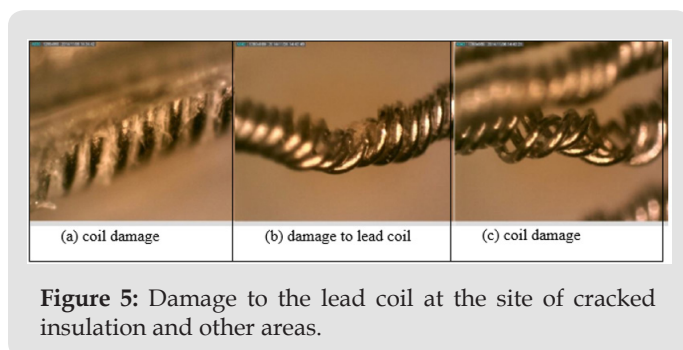
The optical microscope used for this analysis is the WILD Photomakroskop M400. The insulation was cracked at several places exposing the lead wires. Growth of biological materials was also seen between the insulator and the lead-wires, Figure 5. If the exposed lead wires maintain their protective coating, then the leads are to be considered corrosion free and undamaged observed during this investigation. It is also likely the excessive forces applied to retrieve the device may have damaged the lead, widen its pitch, and likely to pull from connector block assembly. These features are not reported here. These features in Figure 5 are consistent with pulling during retrieval. Also, the lead coils were not broken.

Figure 5: Damage to the lead coil at the site of cracked insulation and other areas.

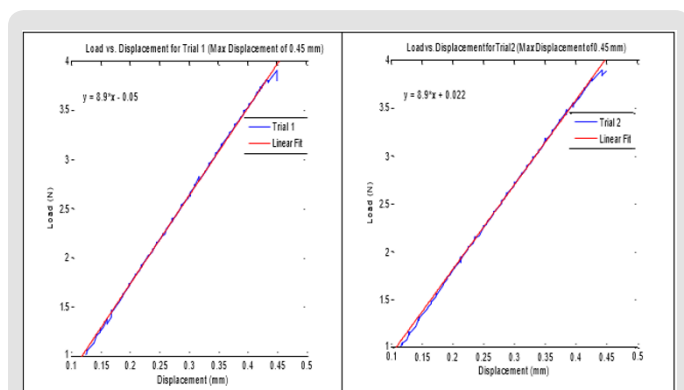
Figure 6: Axial stiffness of lead insulator, linear fit applied to the data within the linear region.

Typical axial stiffness values of new polyurethane for cardiac leads are greater than 120 N/mm². The results of our tensile tests concluded that the axial stiffness of our polyurethane lead insulation was about 8.9 N/mm. If the polyurethane material of the neurostimulator lead insulation is assumed to be similar to that of a polyurethane cardiac lead, then the axial stiffness of this device has reduced considerably, an order of magnitude. This could be due to the aging of the insulation and exposure to the chemical and biological reactions of the body. Because of the decreased axial stiffness, may have been due to oxidation, the lead insulation could crack, of its own, with very little forces that could arise due to sudden movement, sleep posture or attending to the activities of daily living. However, because of this reduced axial stiffness, it is also possible that the insulation could have become damaged, cracked or run-off during removal [20].
