FLANGE BOLT FAILURE ANALYSIS

Tarun Goswami

ABSTRACT

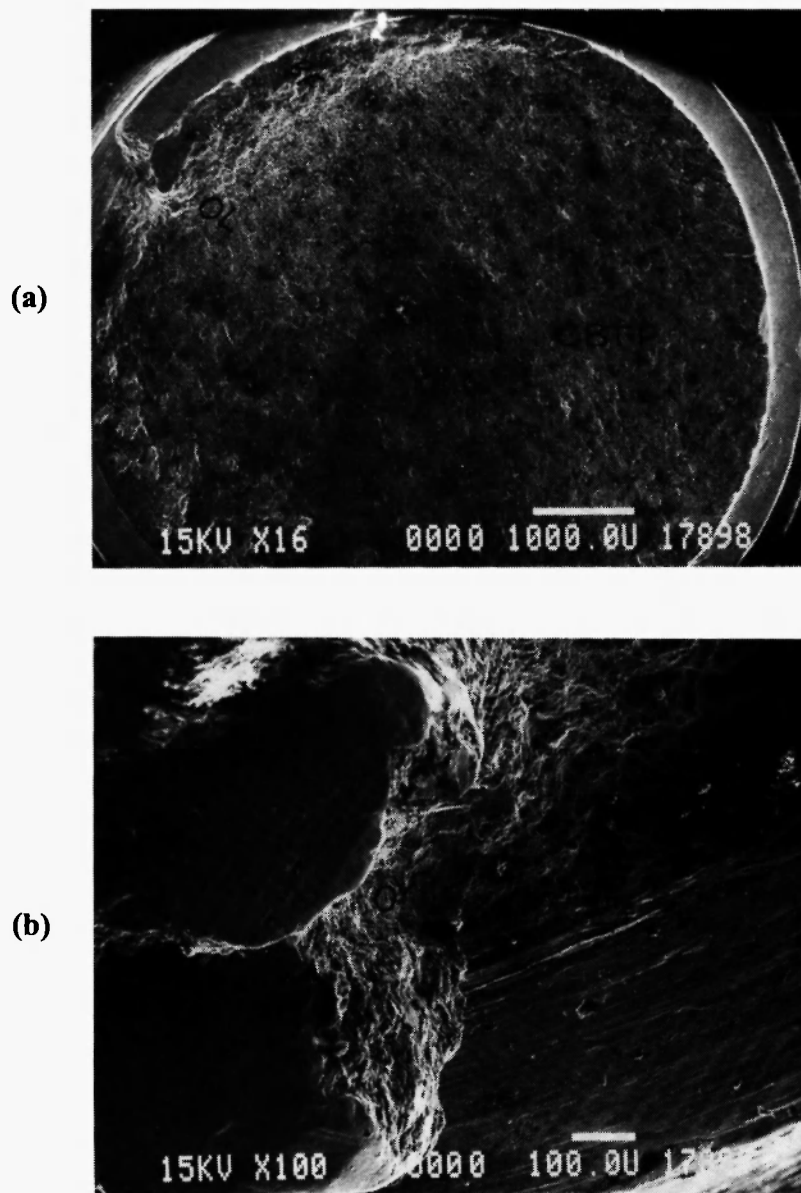
Figure 3 shows the fracture surface of the bolt. The BF area nucleated from the root of a screw

Fig. 3: (a) Montage of fracture surface; (b) Failure origin.

thread. Three divisions made on the fracture surface show BF, Fig. 3(a), overloading (OL), Fig. 3 (b) and CBTF, Fig. 3 (a), on the montage of the fracture (Fig. 3 (a,b)). Each fracture surface from a set of six failed bolts had similar characteristics. They were:

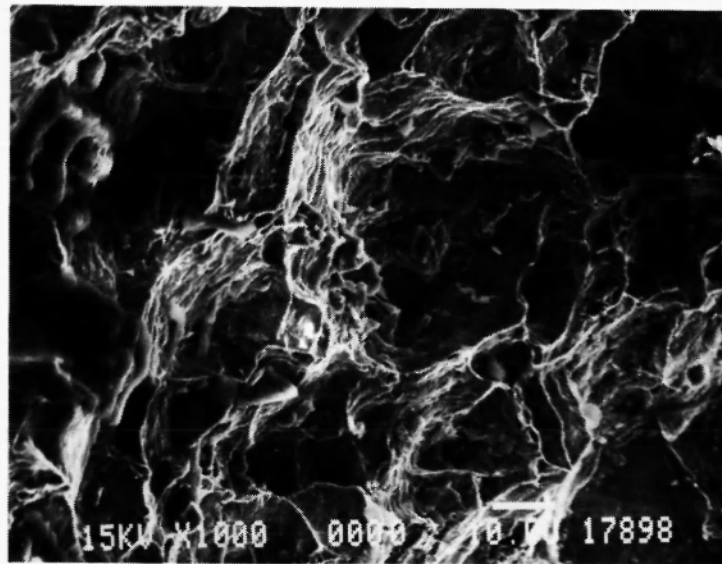
The striations, as shown in photomicrograph Fig. 4, ran from the left-hand side to right-hand side in the upward direction. Figure 3 (b) shows the area where the presence of micro-voids was documented, Fig. 5. Further right in this figure ductile dimples occur. Figure 5 shows a typical OL area and associated fracture features. Within this area micro-voids are clearly seen that were made due to the overloading nature of the loads. Macro-voids seen are a result of pulling of strengthening phases of carbide particles.

Fig. 5: Ductile dimples indicating OL mode.

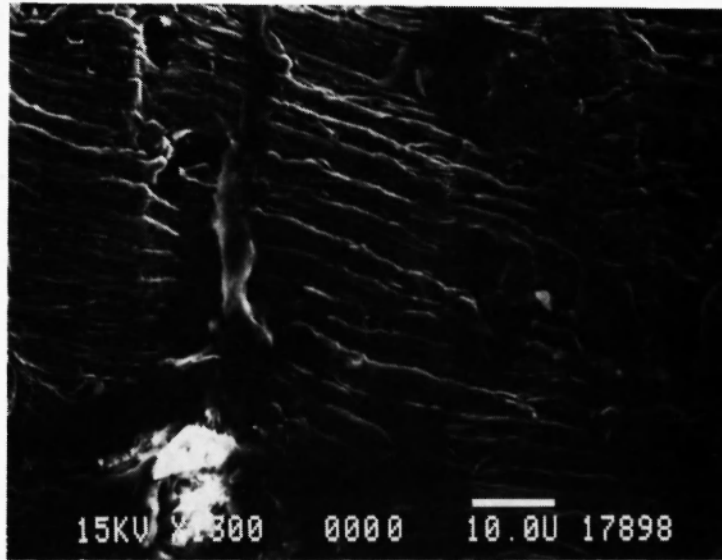
At the area close to the right-hand side of the fracture surface, Fig. 3, cleavage type features were observed. Since cleavage occurs at the low and high range of stress intensity factor, it does not occur in superalloys having tensile strength of 750 MPa or above. However, since this material is within that boundary in terms of tensile strength, some cleavage like features were found at an area close to RHS of the fracture surface. Kink bands discussed in BF were also observed in this area. Since the applied waveform was a mixture of high-low amplitude cycles, pitching of fracture plane was observed at several points. This pitching effect in the fracture surface may have been caused by the mean stresses arising from major cycles. Multiple cracks were generated in the case of CBTF, which had independent paths and directions and affected the CBTF crack growth patterns. Crack curvatures were different in different directions. Such a behavior presents complexities in the treatment and use of data for crack growth determination. However, this behavior was observed away from the path of the crack upward in the direction of the arrow shown in Figure 4.

Figure 6 shows striations and their progression in the CBTF area. The CBTF area was considerably larger than the BF and OL areas and therefore it was possible to identify striations ranging in different sizes in Figures 6 and 7. Voids were documented on the fracture surface together with striations, Figures 6 and 7, indicative of particle pulling and some overloading.

Fig. 6: Fatigue striations and cleavage.

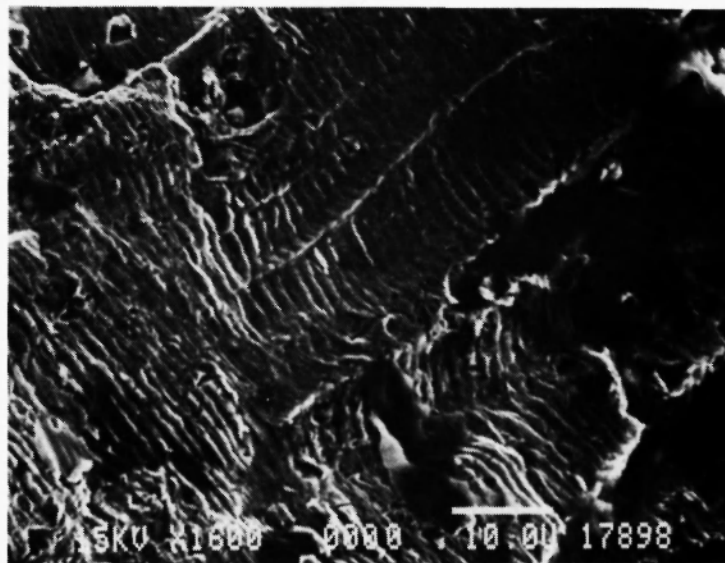
Fig. 7: Fatigue striations and dimples.

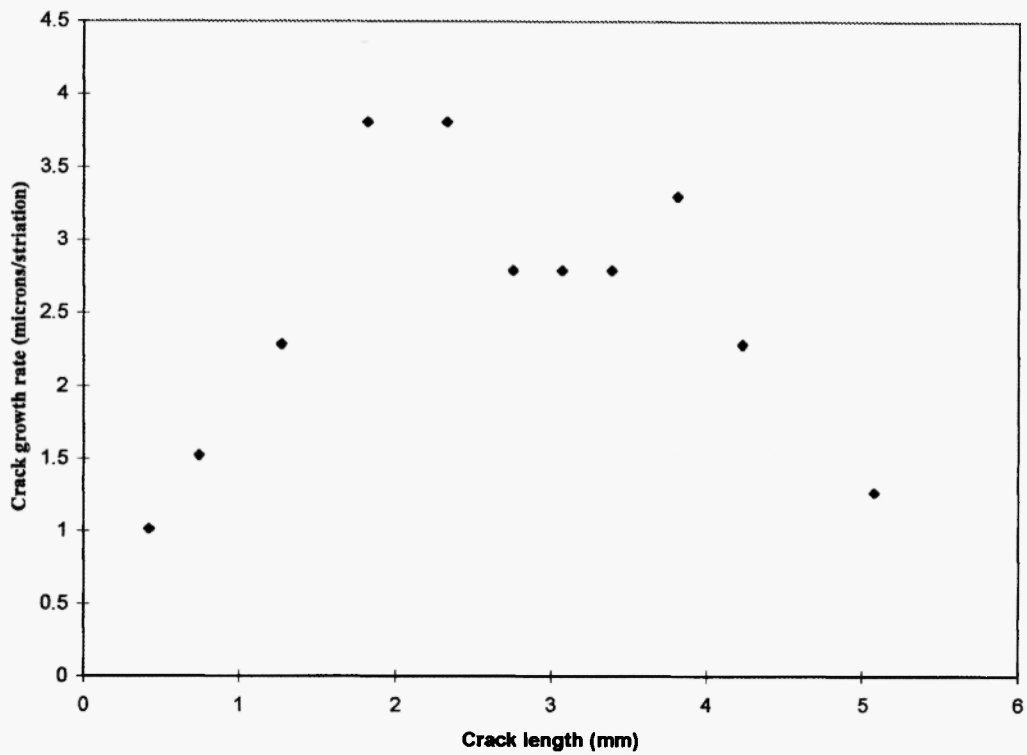
measurements made for the striation counts can be found in Figures 8 and 9. These figures show crack growth rate as a function of crack length and crack lengths as a function of striations, respectively. Figure 8 shows that the width of the striations increases from the LH side in the CBTF area towards a point between the CBTF and OL area. Further away from the CBTF point of origin, the width of

Fig. 8: Crack growth rate as a function of crack length.

striations does not change considerably, resulting in low crack growth rates. Figure 9 shows these trends and two linear phases between the crack length and the cumulative number of striations. The data generated in terms of crack length, crack growth rate and cumulative striations are presented in Table 4. A modified Bates equation /11/ can be applied to this data to determine crack growth rate, and mode I stress intensity factor range (ΔK) relations. Some of the fracture surface features, for example, cleavage, kink band formation, block striations were also reported by other workers /1-10/ in a range of materials.

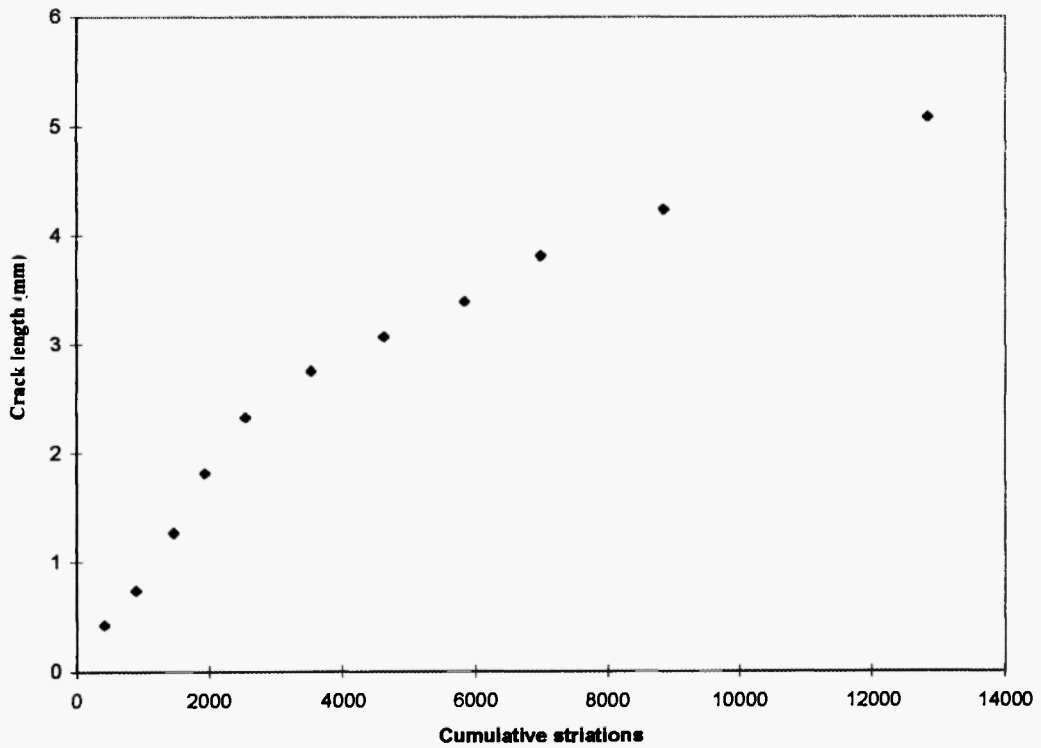
Fig. 9: Crack length as a function of cumulative striations.
