## **A material degradation study of novel FeCrAl alloys, stainless steels and nickel base alloy in fluidized bed heat exchangers of a waste-fired CFB**

Lindmark, H., Phother Simon, J., Olausson, M. et al (2023). A material degradation study of novel FeCrAl alloys, stainless steels and nickel base alloy in fluidized bed heat exchangers of a waste-fired CFB boiler. *Fuel*, 338. <http://dx.doi.org/10.1016/j.fuel.2022.127299>

# A material degradation study of novel FeCrAl alloys, stainless steels and nickel base alloy in fluidized bed heat exchangers of a waste-fired CFB boiler

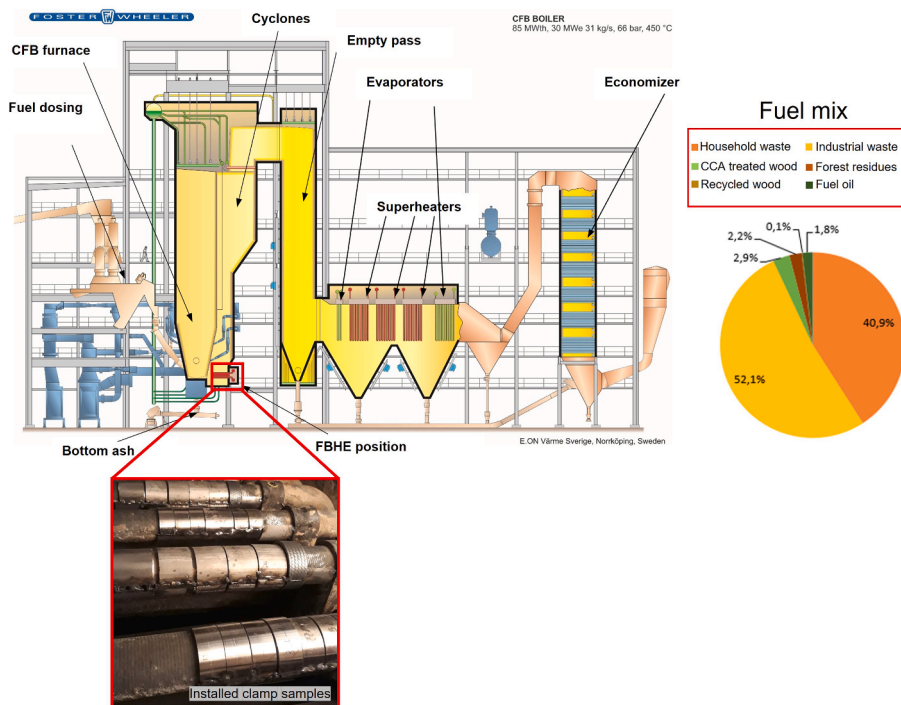
Two half-moon sample rings were prepared for each material and subsequently mounted on the top- and bottom-most rows of the fluidized bed heat exchanger (FBHE) tube bundle during boiler shutdown using TIG-welding with Alloy 625 wire. The two half-moon samples were characterized as a wind-side sample (facing down towards the loop seal air nozzles) and a lee-side sample (facing up towards the return leg of the cyclone). In this study, the wind-side samples (facing down) have been investigated. The installed clamps can be seen in the bottom left picture in Fig. 1.

**Fig. 1.** Clamps mounted onto the superheater tubes (below), a schematic picture of the boiler, and a summary of the supplied fuel (right).

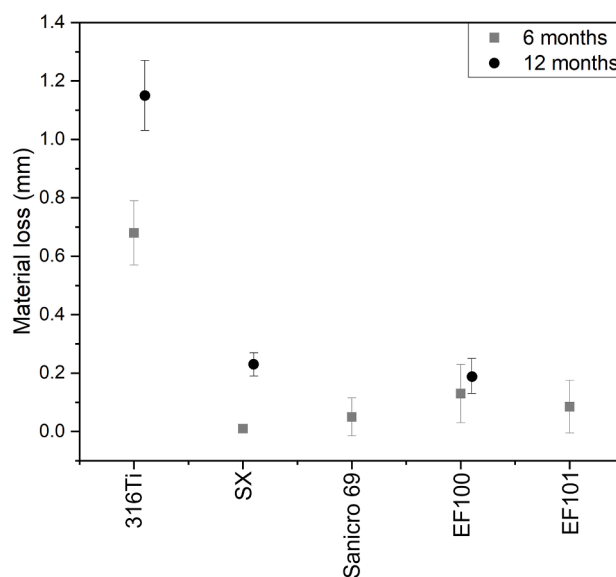
A summary of the results of material losses after 6 and 12 months of exposure is shown in Fig. 2. Material loss data of San69 and EF101 after 12 months of exposure could not be retrieved. A general trend was observed, showing that the material loss increased as a function of exposure time. After 12 months of exposure, 316Ti exhibited the highest measured material loss (1.15 mm/year). The FeCrAl alloy EF100 outperformed 316Ti after 12 months of exposure, obtaining a material loss of 0.19 mm/year, which was similar to SX (0.22 mm/year). Although material losses for 12 months could not be retrieved for San69 and EF101, they exhibited significantly low material losses after 6 months, roughly 0.08 mm and 0.1 mm, respectively.

**Fig. 2.** Material losses after 6 and 12 months of exposure.

316Ti presented the highest material loss after 6 and 12 months of exposure compared to the other materials (see Fig. 2). The material was subjected to a large degree of intergranular corrosion and the severity of the corrosion attack was increased as a function of time exposed to the present environment (see Fig. 3). In mild environments, austenitic stainless steels, such as, e.g., 347H, 304L, and 316Ti, are expected to form a chromium-rich and protective oxide [23]. In environments rich in alkali chlorides, this group of materials is readily attacked by both alkali and chlorine forming alkali chromates and metal with a corrosion product layer often consisting of an outward-growing hematite ( $\text{Fe}_2\text{O}_3$ ) and an inward-growing (mixed) spinel oxide layer ( $\text{Me}_3\text{O}_4$ ) [24]. In this study, only the inward-growing spinel oxide (rich in Cr and Ni, see Fig. 3), remains on the sample, whereas the outward-growing hematite as well as the deposited layer, have been lost. It is expected that the presence of alkali in the environment has destroyed the protective properties of the initial chromium-rich oxide [13,23]. Furthermore, an intergranular attack in the form of a steel grain boundary (GB) attack can be seen. In a recent study, the attack is associated with small levels of chlorine in

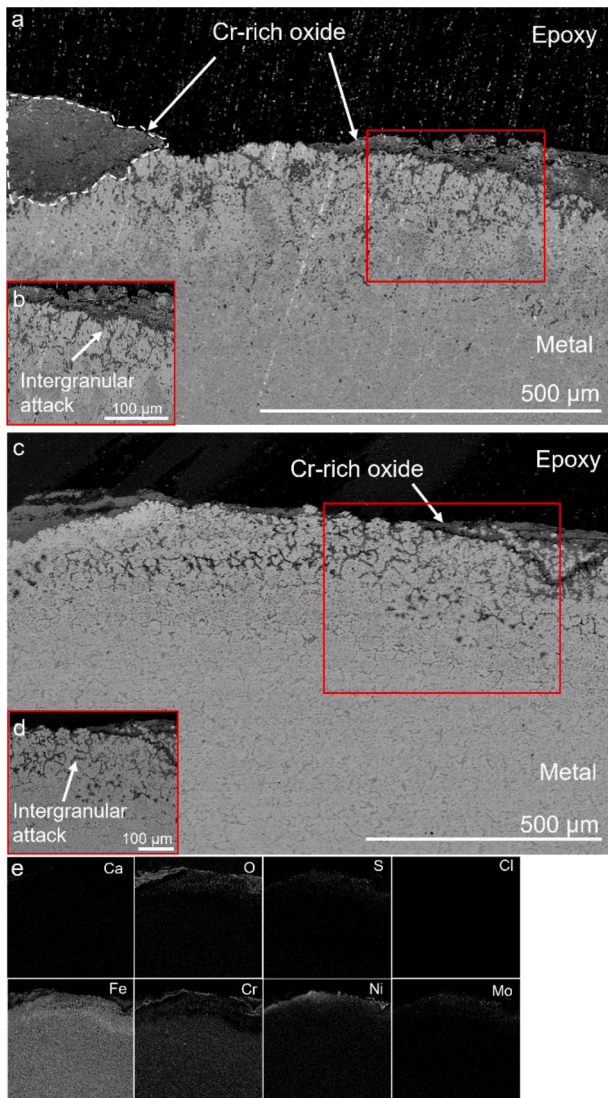
The cross-section images after 6 and 12 months of exposure for 316Ti are shown in Fig. 3a and c. Similar features were observed for both samples, and thus, chemical analysis via EDX mapping is only shown for the sample exposed for 12 months. For 316Ti, the cross-section showed little or no deposit layer as well as a minor indication of the formation of an outer corrosion product layer. Instead, the cross-sections revealed signs of intergranular corrosion attacks (see Fig. 3b and 3d). Compared to the FeCrAl alloys, the material loss was considerably higher, as the 6-month 316Ti sample exhibited a material loss roughly 7 times higher than the FeCrAl alloys (see Fig. 2).

Fig. 3e shows the EDX mapping of 316Ti exposed for 12 months. A thin outer layer of oxide was observed on top of the sample consisting mainly of Cr and trace amounts of Fe. 316Ti suffered from an intergranular corrosion attack after 6 months of exposure (see Fig. 3b). This attack progressed with increased severity as a function of exposure time. The corrosion products formed in the steel grain boundaries consisted mainly of a Cr-rich oxide. In addition, from the EDX map analysis it was confirmed that no sign of any chlorine species was detected throughout

the sample. Below the metal/oxide surface, a roughly 150 μm thick Cr-depleted region had been formed throughout the sample (See Fig. 3e).

Fig. 3. SEM BSE cross-section image of 316Ti (a) 6 months of exposure. (b) Insert of intergranular attack after 6 months. (c) 12 months of exposure. (d) Insert of intergranular attack after 12 months. (e) EDX mapping of (c).

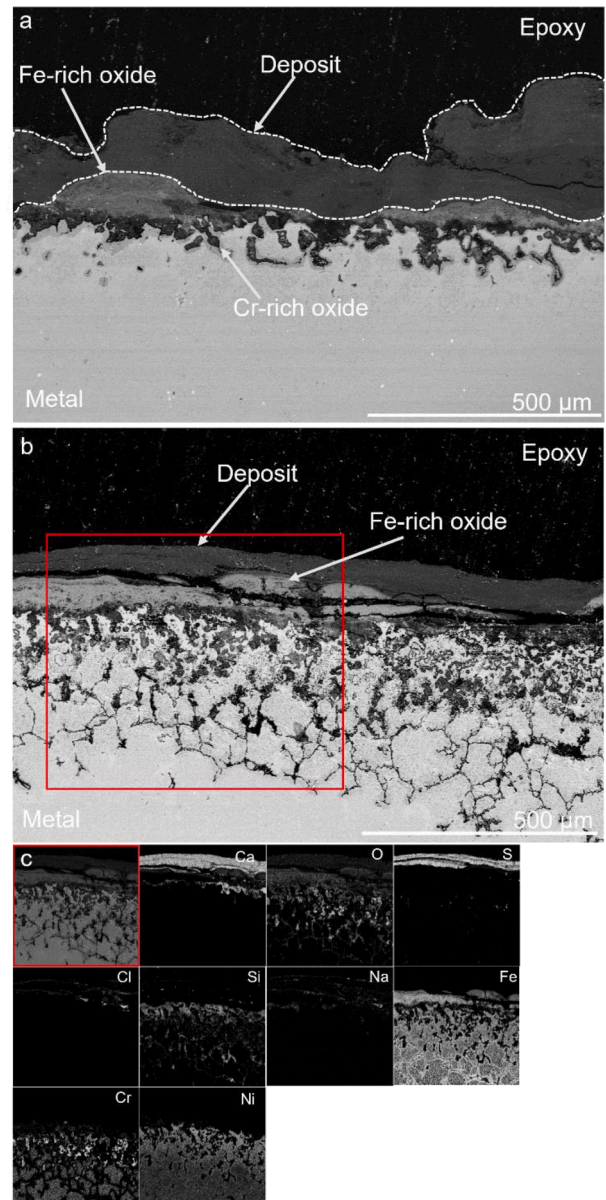
Fig. 4a and b show the cross-sections of the SX samples exposed for 6 and 12 months. Similar features were observed for both samples, and thus, chemical analysis via EDX mapping is only shown for the sample exposed for 12 months. A homogenous deposit layer was observed on both samples and consisted mainly of Ca, S, O, and traces of Na. In addition, minor traces of Cl were detected in the inner regions of the deposit. The thickness of the deposit was in the order of 60 – 150 μm for 12 and 6 months, respectively. SX formed an adherent outer corrosion product layer composed mainly of a Fe-rich oxide (see Fig. 4c). The outer oxide layer became less adherent with time, which is displayed in Fig. 4b, where large cracks after 12 months of exposure were observed. As with 316Ti, intergranular attacks were noticeable after 6 months of exposure and became more severe with time (compare Fig. 4a with 4b). The internal oxidation at the metal/oxide interphase consisted mainly of a Cr and Si-rich oxide and was propagating via grain boundaries through the material. After 12 months of exposure, at roughly 60 μm below the metal/oxide interphase, the chemical composition in the grain boundary

Fig. 4. SEM BSE cross-section image of SX after (a) 6 months of exposure. (b) 12 months of exposure. (c) EDX mapping of SX from the highlighted area in (b).

region changed, and a Cr-depleted region were obtained with the formation of Si-rich oxide in the grain boundary together with Fe-enrichments at the border of the grain boundaries (see Fig. 4c).

The austenitic alloy SX exhibited a qualitatively similar corrosion attack as 316Ti. However, the material loss was significantly lower. Compared to 316Ti, the SX alloy contains about twice the amount of Ni and about five times the amount of Si (see Table 1). It has been shown earlier that alloying with Ni usually results in a lower corrosion rate in aggressive corrosive environments [22]. Persdotter et al. have proposed

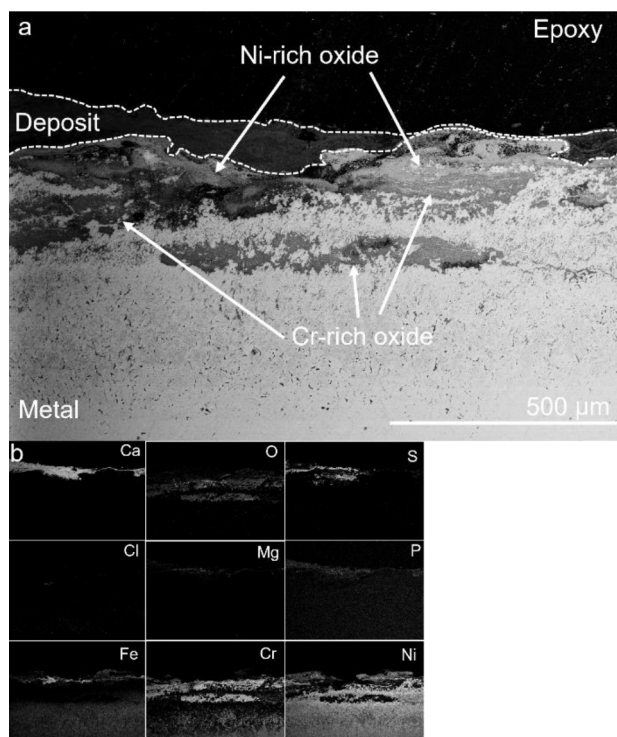
Fig. 5a shows the cross-section image of the San69 sample after 6 months of exposure. An approximately 50  $\mu\text{m}$  thick deposit layer was observed containing mainly S, Ca, and O with traces of P and Mg (see Fig. 5b). No significant amount of deposit was identified in the formed oxide scale. A Ni-rich oxide was formed underneath the deposited layer, and at the metal/oxide interphase, an oxide containing a high amount of Cr was observed. In addition, a Cr-rich oxide was also detected further into the metal as an internal oxidation region approximately 80  $\mu\text{m}$  below the corrosion product layer. This feature is presumably a 3D effect of this 2D cross-section imaging. The EDX mapping shows that the metal is mainly depleted of Cr, while nickel remains the main alloy element in the material matrix close to the corrosion front. The material loss measurement of San69 was negligible after 6 months of exposure. However, based on the SEM/EDX analysis, the internal corrosion attack can be seen up to 0.3 mm into the metal.

Fig. 5. SEM BSE cross-section image of San69 (a) after 6 months of exposure. (b) EDX mapping of (a).

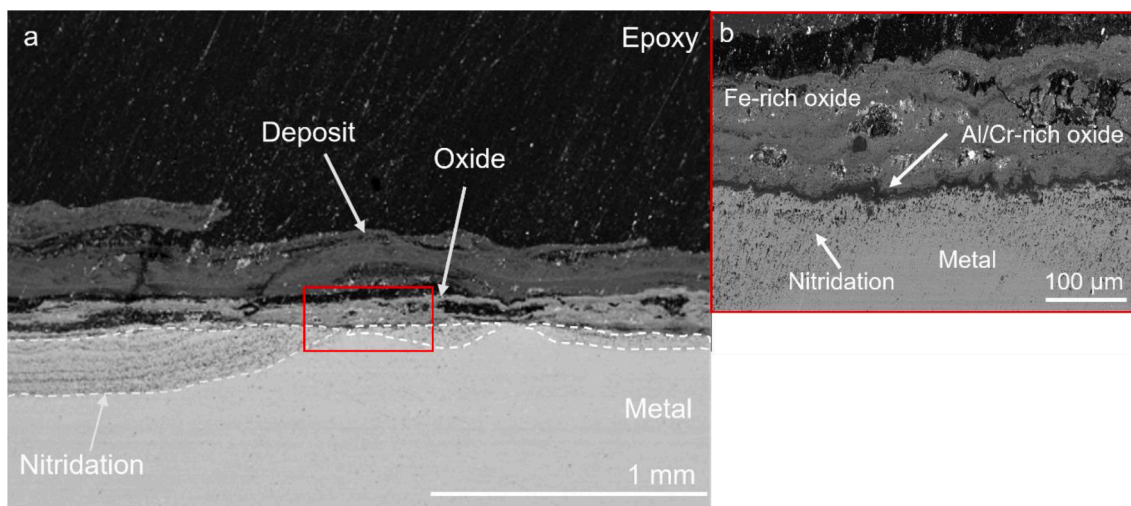
A SEM cross-sectional view of the EF100 sample exposed for 6 months is shown in Fig. 6a. An approximately 250  $\mu\text{m}$  thick deposit was observed, consisting primarily of S, Ca, and O. Beneath the deposited layer, an approximately 100  $\mu\text{m}$  thick iron oxide had formed. The oxide contained small cracks and displayed void formations, whereas it was difficult to distinguish regions of inward and outward oxide layer formation. A roughly 10  $\mu\text{m}$  Al/Cr-rich thin oxide layer was detected across the metal/oxide interphase (see Fig. 6b). The SEM analysis revealed no indications of internal oxidation for this material. However, a nitridation zone could be seen below the metal/oxide interphase. The thickness of the region varied greatly (between 0 and 200  $\mu\text{m}$ ) and was observed in a patch-wise fashion throughout the cross-section of the sample.

Fig. 6. (a) SEM BSE cross-section image of EF100 after 6 months of exposure. (b) Higher magnification of the marked area in (a).

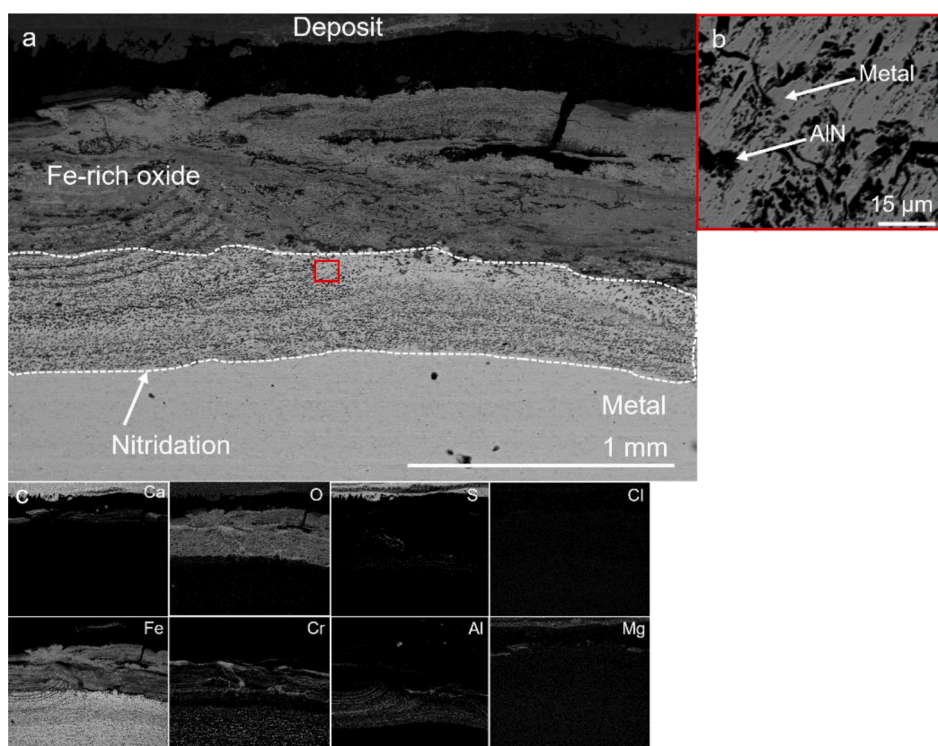
EF100 displayed similar features after 6 and 12 months of exposure

(compare Fig. 6a and Fig. 7a). However, for the sample exposed for 12 months, most of the deposited layer had spalled off. This may however be an effect of sample outtake and subsequent sample preparation for post-analysis measurements. A Fe-rich oxide was observed (about 600  $\mu\text{m}$  in thickness) containing voids and cracks as well as traces of Cr and Al (see Fig. 7a and c). The nitridation zone had also grown larger compared to after 6 months of exposure (about 400  $\mu\text{m}$  in thickness) and was observed throughout the cross-section of the sample in a homogeneous fashion. The EDX analysis confirmed that the dark particles shown in the nitridation zone consisted of Alumina Nitrides (AlN) precipitates embedded in a Fe-rich alloy matrix (see Fig. 7b). The observed microstructures and corrosion attacks agree well with the measured material losses. The material loss for EF100 after 6 and 12 months was 0.13 and 0.19 mm, respectively. The SEM/EDX analysis after 12 months of exposure also shows that a region (roughly 125  $\mu\text{m}$  thick) depleted in Cr was detected at the nitridation/metal interphase (see Fig. 7c). This Cr-depletion zone was homogeneous and observed throughout the sample. No Cl was detected in the corrosion front or the deposit. Regardless of exposure time, the sample was covered by corrosion products and, for the 6-month exposed sample, deposit. Thus, it is suggested that the material loss is primarily driven by a corrosion process rather than erosion.

Fig. 7. SEM BSE cross-section image of EF100 (a) after 12 months of exposure. (b) Higher magnification of the marked area in (a). (c) EDX mapping of (a).

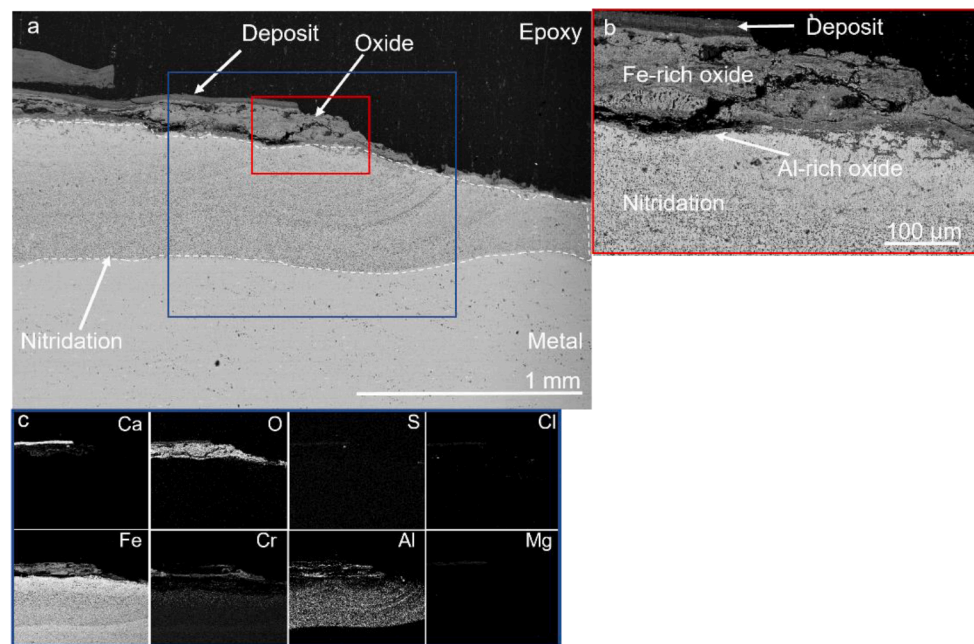
EF101 displayed similar features as EF100 after 6 months of exposure (see Fig. 8a). The EDX map analysis of EF101 shows that a thin deposit layer (about 25  $\mu\text{m}$  in thickness) had formed above the oxide layer containing large amounts of Ca (see Fig. 8c). The oxide scale was composed of a Fe-rich oxide containing cracks and voids (see Fig. 8b). Traces of a Cr rich oxide were also observed but to a lower extent. Below the Fe-rich oxide a roughly 8  $\mu\text{m}$  thin Al-rich oxide layer was observed. In addition, below the metal/oxide interface, a Cr-depleted zone of approximately 100  $\mu\text{m}$  was seen. Compared to EF100, the EF101 sample exhibited a more pronounced nitridation zone. The thickness of the nitridation zones was 450  $\mu\text{m}$  and 200  $\mu\text{m}$  for EF101 and EF100, respectively, after 6 months. For EF101, the SEM analysis revealed no or small amounts of deposit components. In addition, no traces of chlorine-containing species were observed in the cross-section (see Fig. 8c).

**Fig. 8.** SEM BSE cross-section image of (a) EF101 after 6 months of exposure. (b) Higher magnification of the small marked red area in (a). (c) EDX mapping of the sizeable, marked area in (a). (For interpretation of the references to colour in this figure legend, the reader is referred to the web version of this article.)

The EF101 obtained a thicker nitridation zone after 6 months of exposure compared to EF100 (compare Fig. 6a and 8a). The resistance towards nitridation can be due to several factors, such as the concentration of Cr in the alloy, the integrity of the alumina scale including micro defects in the oxide, which allows the nitrogen to diffuse through the deposit and oxide scale. The nitridation is, from a corrosion point of view, not desirable as the aluminum in the alloy is tied up locally in the formation of AlN rather than forming a protective alumina scale. Despite this, the newly developed FeCrAl alloys showed good material performance in this environment, and the material losses of the investigated materials were rather low.
