High Voltage Performance Degradation of the 14UD Tandem Accelerator

Heavy Ion Accelerator Facility, Australian National University, Canberra, ACT, 2601,
Australia

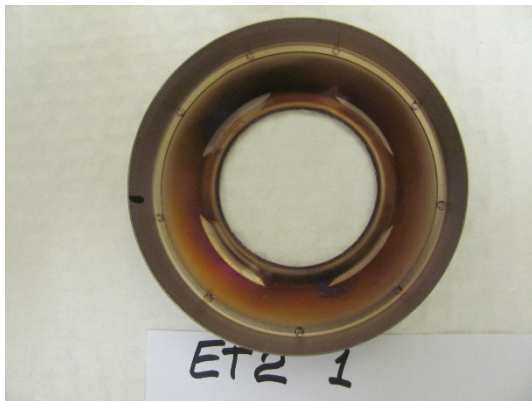
Figure 1 and figure 2 show the top of the first titanium electrode in unit 19, acceleration tube 2 (exposed to the ion beam) and the bottom of the last electrode in the same tube (chiefly exposed to electron flux). SEM images of the same electrodes are shown in figure 3 through figure 6. These images show varied but common features observed, such as porosity, metal vaporisation and material build up. Titanium sheet samples were also analysed as a comparison (figure 7) and the surface was shown to be relatively pure, with sparse embedded particles with a high oxygen and carbon content.

Figure 1. Top face of electrode 1 in unit 19, acceleration tube 2 after over 40 years of operation.

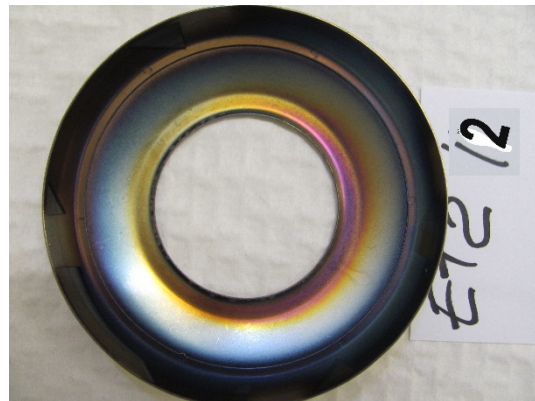
Figure 2. Bottom face of electrode 12 (last) in unit 19, acceleration tube 2 after over 40 years of operation.

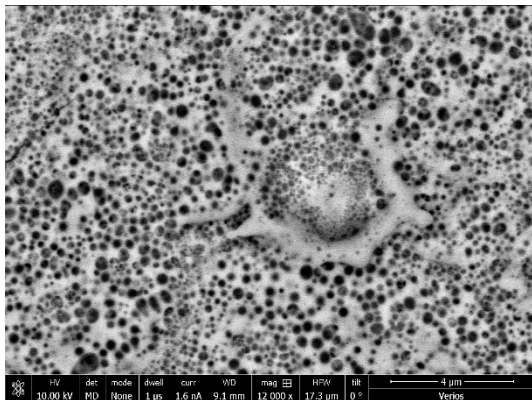
Figure 3. SEM image of the bottom of electrode 1 in unit 19, acceleration tube 2, showing metal vaporisation and surface porosity.

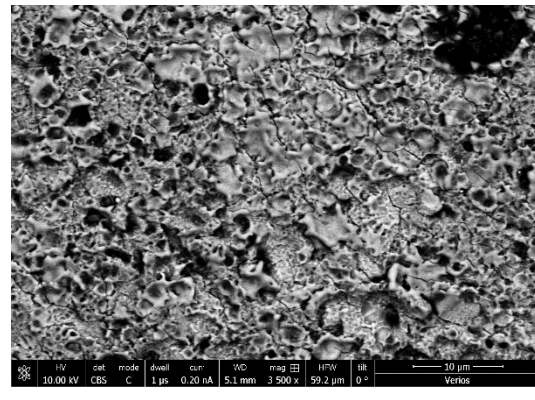
Figure 4. SEM image of the top of electrode 12 (last) in unit 19, acceleration tube 2 showing re-crystallisation of the surface layer of the Ti electrode.

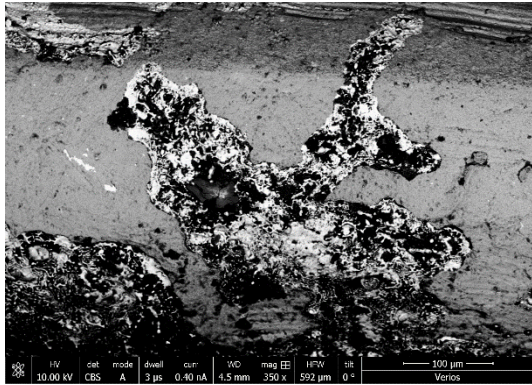
Figure 5. SEM image of the bottom of electrode 12 (last) in unit 19, acceleration tube 2, showing metal vaporisation.

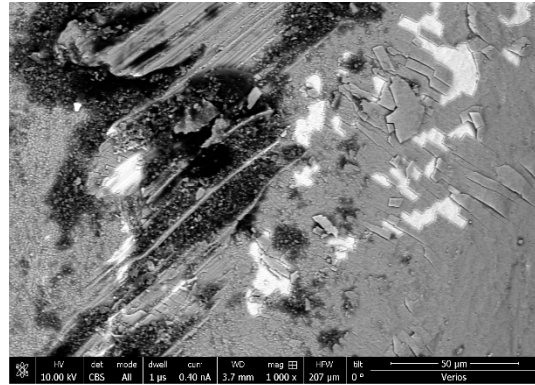
In combination with the SEM images, the oxygen and carbon content suggests a build-up of oxide and carbon layers, which aside from impacting the voltage gradient, would provide particulate material for increased initiation of vacuum breakdown. The supply of oxygen comes from residual gas in the acceleration tubes and oxygen gas that was historically used as a gas stripper media. Most of the carbon contamination is likely to be from broken carbon stripper foils.

The presence of fluorine is further evidence of SF₆ leakage into the vacuum space.

Figure 6. SEM image at the inner edge (toward the beam axis) of the bottom side of an acceleration tube electrode showing severe layer build up and subsequent possible flaking. The black regions are carbon rich layers and the white areas are pure Ti. The grey areas are loose films contaminated with O, F, S.

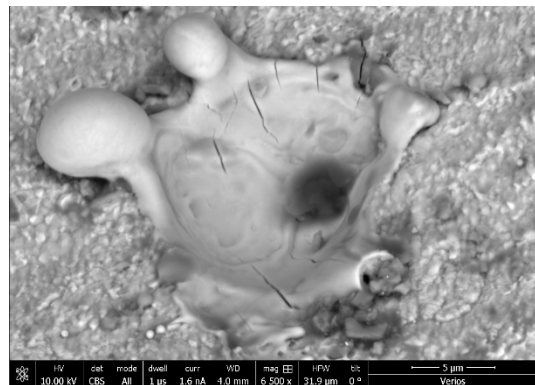
Figure 8. SEM image at the inner edge (toward the beam axis) of an acceleration tube electrode showing severe metal vaporisation.

Other features were also observed upon disassembly of the acceleration tubes. Pure physical damage to electrodes was observed, with craters in electrode surfaces and sputtering of titanium. This then creates protrusions that then act as a trigger for the release of electrons. An example of cratering is shown in figure 8.
