## Failure analysis of the mobile elevating work platform

Srđan M. Bošnjak<sup>a,\*</sup>, Nebojša B. Gnjatović<sup>a</sup>, Dejan B. Momčilović<sup>b</sup>,  
Ivan L.J. Milenović<sup>a</sup>, Vlada M. Gašić<sup>b</sup>

<sup>a</sup> University of Belgrade, Faculty of Mechanical Engineering, Kraljice Marije 16, 11120 Belgrade, Serbia

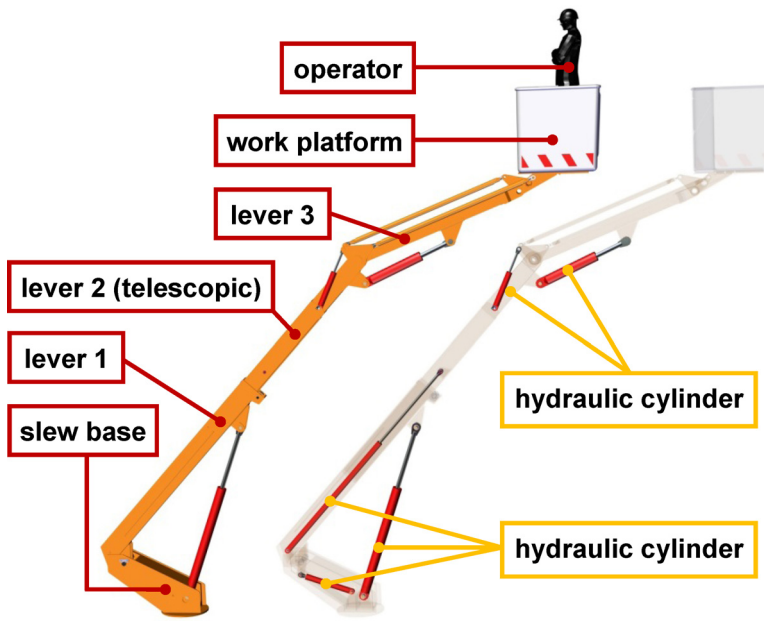
The extending structure of MEWP HP 13 is of a telescopic articulated type, Fig. 1. Failure of lever 3 occurred during startup of the extending structure from the transport position and at that along almost the entire surface of the cross-section in the vicinity of the end eye girder used for hydraulic cylinder connection, Fig. 2.

Fig. 1. Extending structure of the MEWP HP 13.

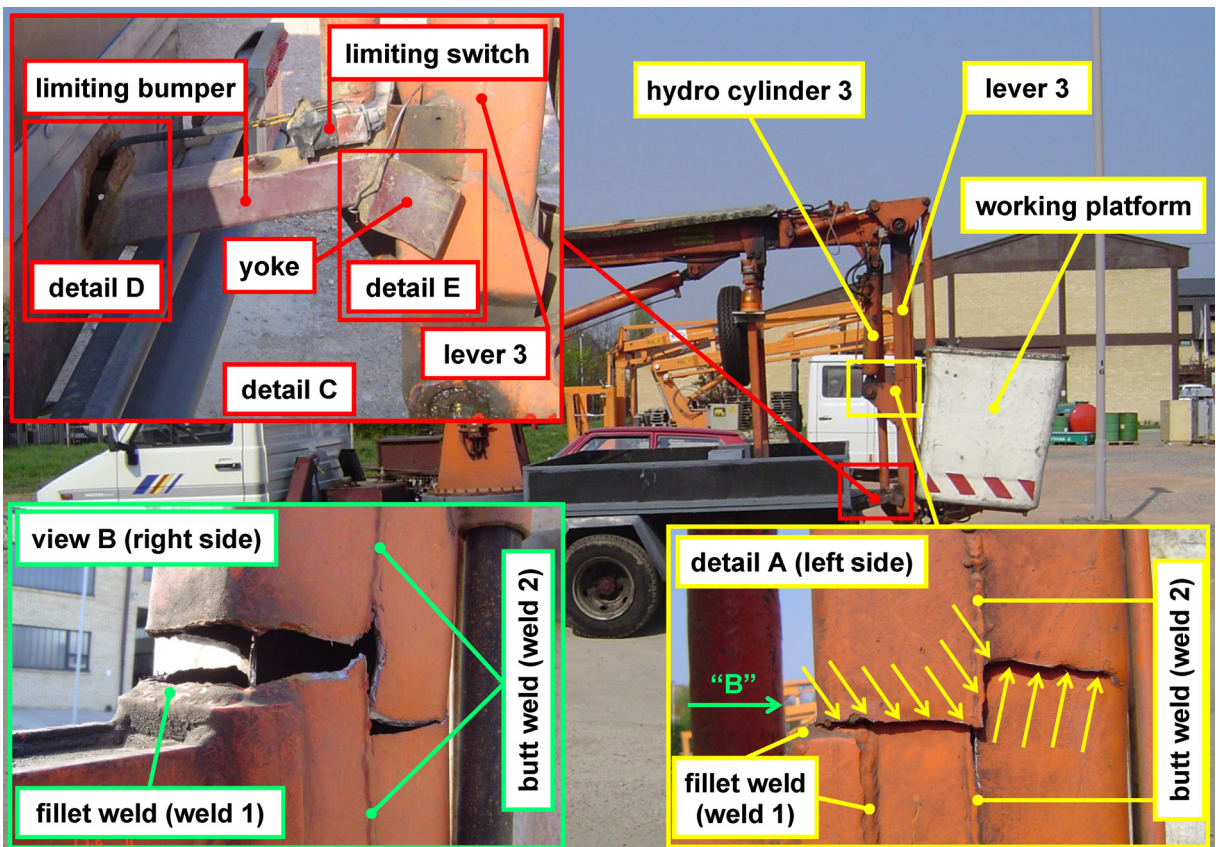
Fig. 2. Failure of lever 3.

Visual examination [9] revealed that the thickness of weld metal 1, Fig. 2(detail A, view B) is from 2.5 to 5.5 mm which is different from the design requirements of 3 mm. The weld face shows spattering and irregular width of weld metal with partly continuous and partly intermittent undercuts along the full length of the weldment.

Plastic deformations of the limiting bumper yokes as well as failure of the welded connection between limiting bumper and auxiliary chassis were determined during visual examination, Fig. 2(detail C). Apart from that, observation disclosed that the limiting switch had suffered mechanical damage thus causing malfunction.

- The overload caused by the effect of the retraction force of the hydraulic cylinder 3 (LC2) is unambiguously testified by the appearance of plastic deformations of the limiting bumper yokes, Fig. 2 (detail C).

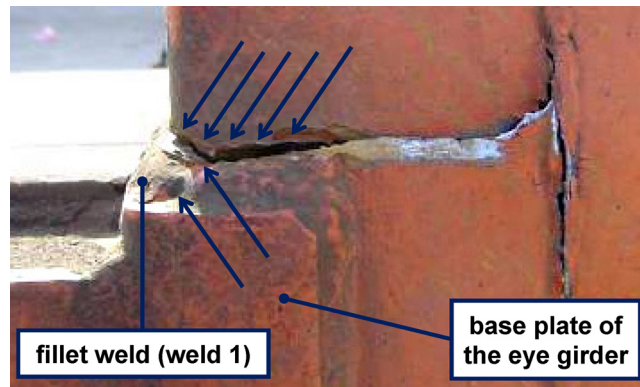
Fig. 3. Undercuts of weld 1.

Generally, all weldments on the lever and eye girder, no matter what type (butt or filet) are made with unacceptable quality. Particularly dangerous are fillet welds with spotted continuous undercuts that connect the eye girder with the lever. The marked undercuts, Figs. 3 and 4, were significant stress raisers on the lever material with factor  $K_t$  higher than 3 [10]. Moreover, a closer look at the fracture zone reveals that the crack path follows the welding undercut zones, Fig. 4.

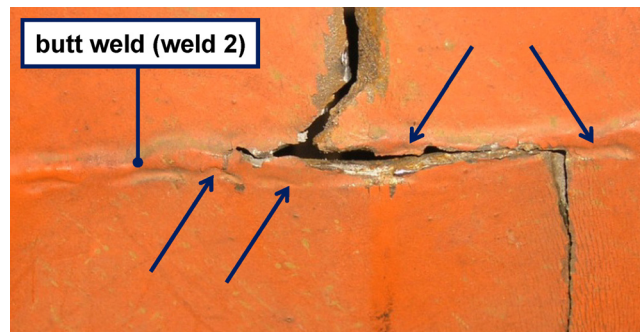
Fig. 4. Crack path vs. undercut zones of weld 2.

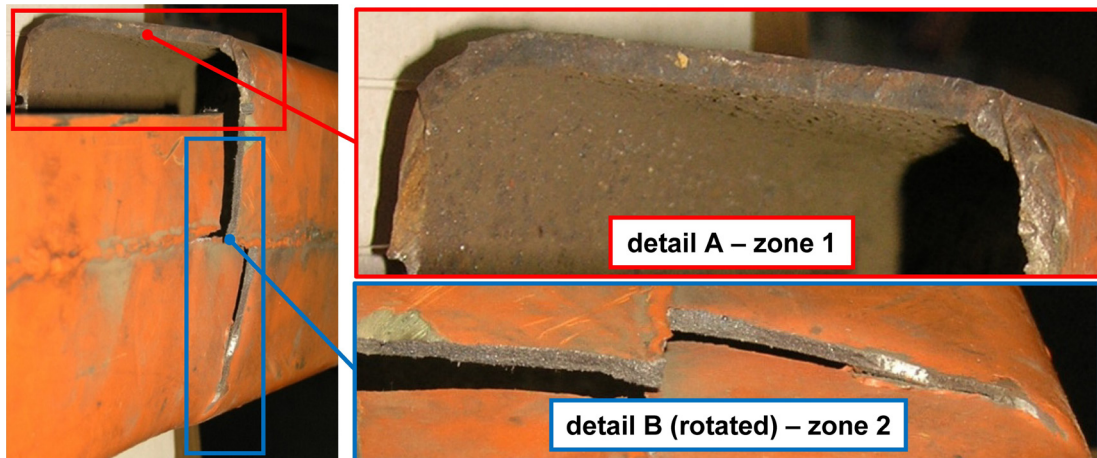
Two characteristic zones are observed on the crack surface, Fig. 5: zone 1 (detail A) cracked first, the conclusion based on obvious corrosion due to exposure to atmospheric conditions, and light zone 2 (detail B), light colored which indicates recent fracturing.

Fig. 5. Crack surface.

- The results of visual examination lead to the conclusion that initial cracking occurred in HAZ in close vicinity of the undercuts (zone 1, Fig. 5, detail A), due to the overload as a result of the limiting switch failure. The propagation of the crack, due to repeated overloads, led to final failure by cracking of lever 3 near the eye girder (zone 2, Fig. 5, detail B).

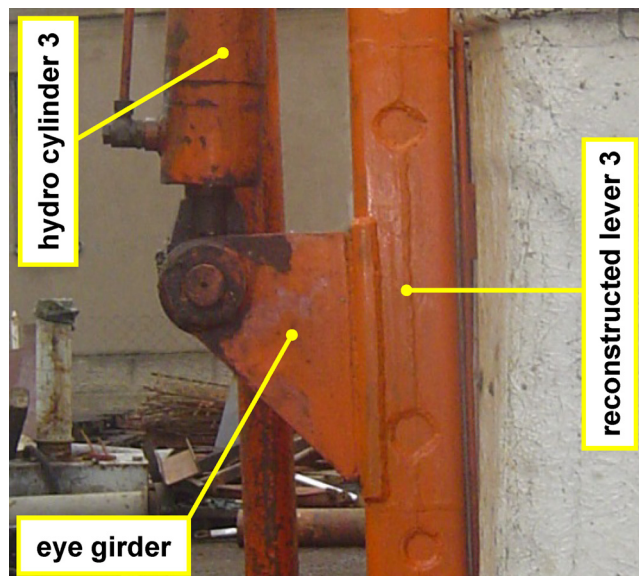
Due to the fact that the undamaged eye girder was mounted on the reconstructed lever 3, Fig. 6, all examinations were performed on specimens sampled from the damaged part of lever 3, Fig. 7.

Fig. 6. Detail of the reconstructed lever 3.

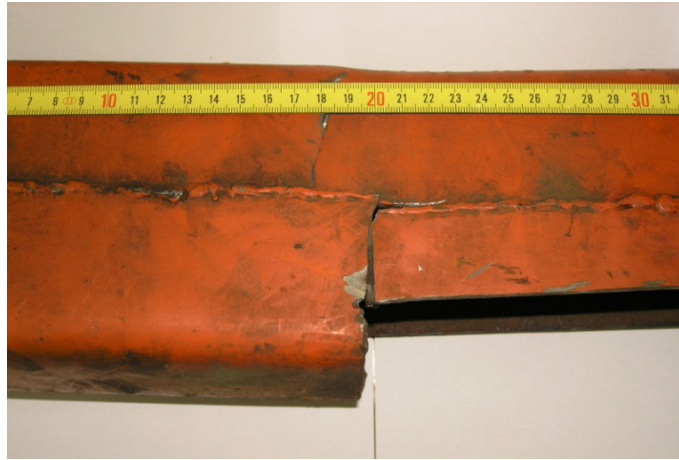
Fig. 7. Part of the damaged lever 3 used for sampling.

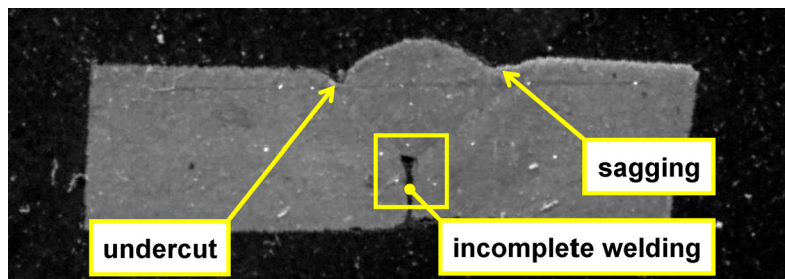
A macro examination of the polished specimen revealed incomplete welding, an undercut and sagging, i.e. an incompletely filled groove, Fig. 8.

Fig. 8. Multiple weld defects of weld 2.

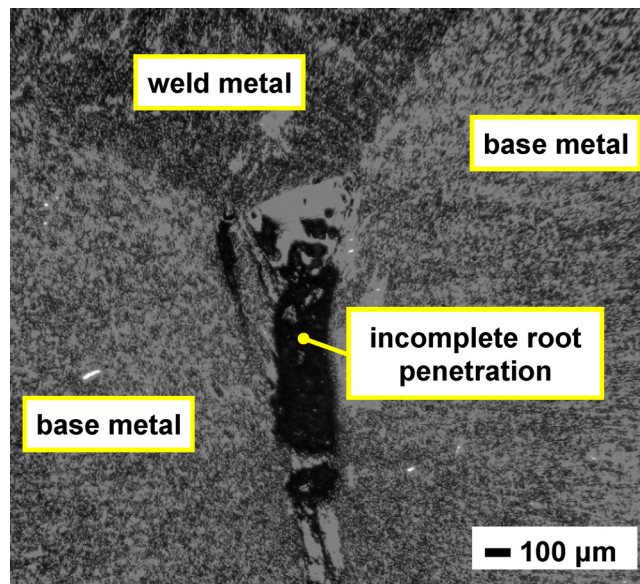
Fig. 9. Micrograph of the incomplete root fusion (squared detail shown in Fig. 8).

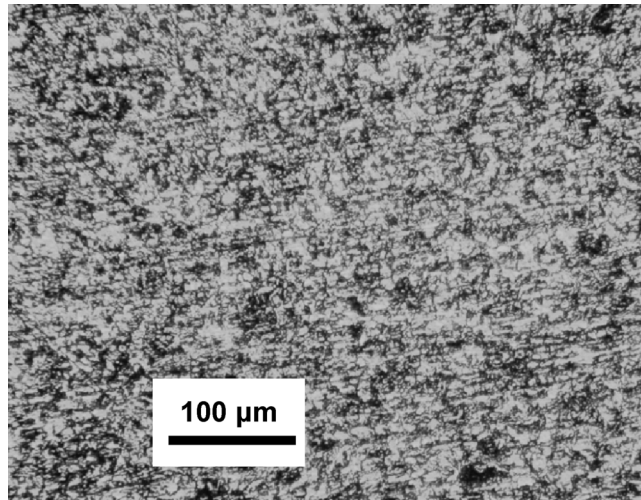
Fig. 10. Ferrite–pearlite microstructure of the base metal (common for general structure steel).

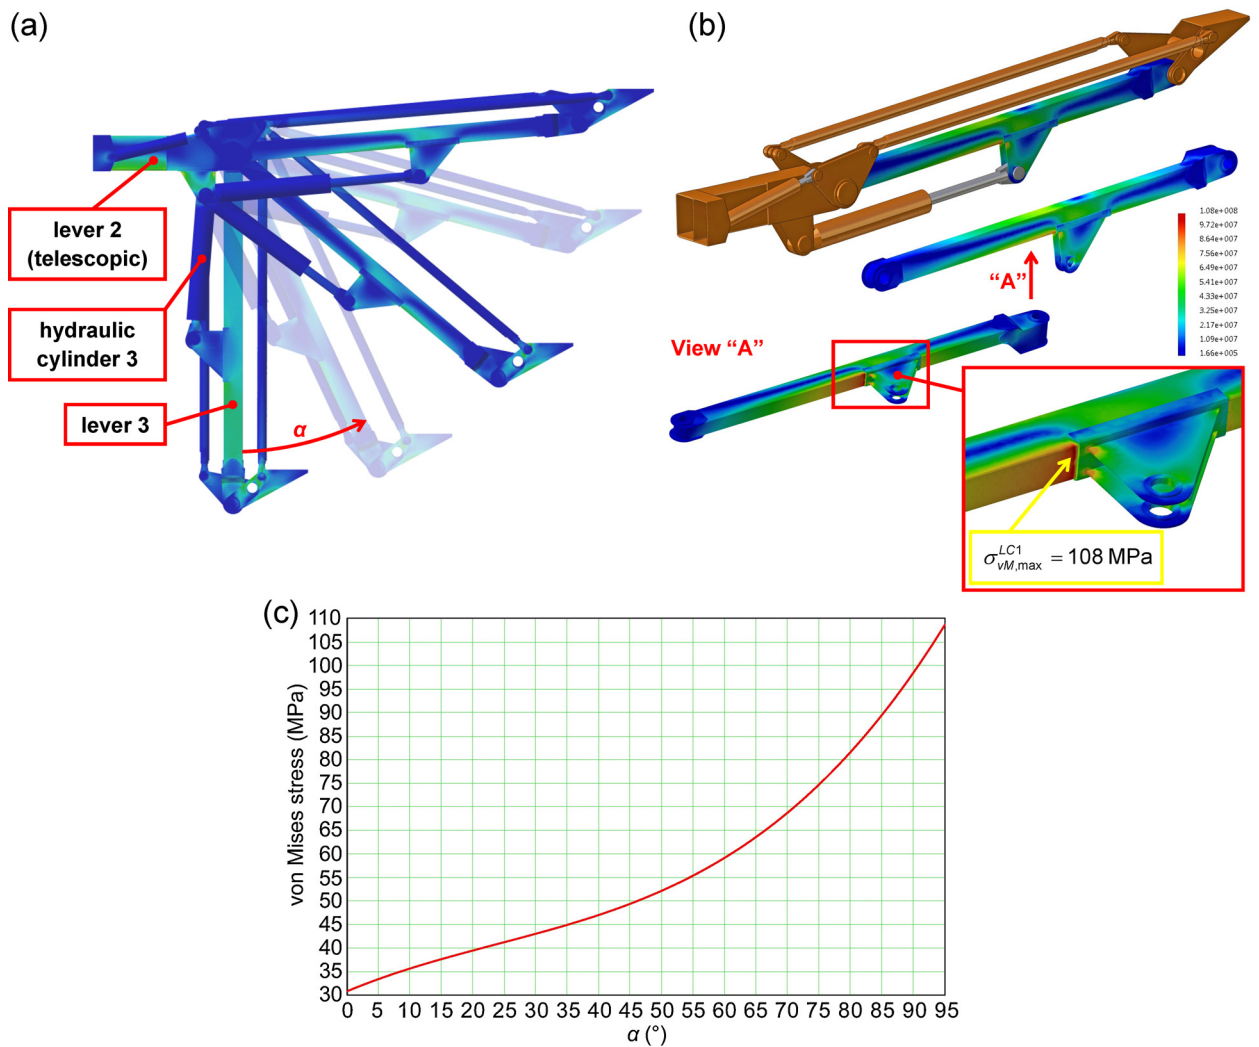
The identification of the stress state is done by applying the linear finite element method (LFEM). In LC 1 for the complete working envelope of lever 3, Fig. 11a, the maximum von Mises stress values in the zone of crack occurrence do not exceed  $\sigma_{vM,max}^{LC1} = 108$  MPa, Fig. 11b. That value is obtained when the hydraulic cylinder 3 is completely extended, Fig. 11c, i.e. for  $\alpha = \alpha_{max} = 95^\circ$ . For LC 2 the maximum von Mises stress value in the critical zone is  $\sigma_{vM,max}^{LC2} = 418$  MPa, Fig. 12.

Fig. 11. von Mises stress state of level 3 in LC 1: (a) working envelope ( $\alpha_{min} = 0^\circ$ ,  $\alpha_{max} = 95^\circ$ ); (b) stress field for  $\alpha_{max}$ ; (c) dependence of the maximum von Mises stress in the critical zone on the angle between level 2 and level 3.

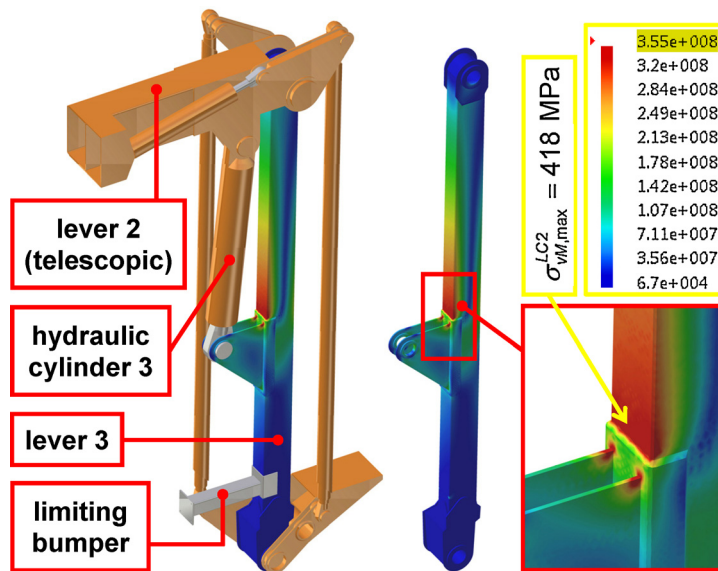
Fig. 12. Von Mises stress state of lever 3 in LC 2.

- The calculated stress value in the critical zone for LC 2 ( $\sigma_{vM,max}^{LC2} = 418$  MPa, Fig. 12) is higher for 7.5% than the maximum yield stress value obtained by testing ( $\sigma_{YS} = 389$  MPa, Table 2). Furthermore, the finite element model does not include unfavorable influence of the welding defects observed during visual examinations (Section 2), which substantially, more than three times [10], multiplies the local level of stress states. Accordingly, we can conclude that even for intensities of the retraction force of the hydraulic cylinder 3 that are lower than its maximum value, stress values higher than the ultimate tension stress values (obtained by testing, Table 2) are certain to appear.
