CRACKING DUE TO REPAIR WELDING OF THE TREIBER ROLL STVARANJE PRSLINA NAVARIVANJEM NA TRAJBER ROLNI

Originalni naučni rad / Original scientific paper
UDK /UDC: 621.791.92:621.771.067
Rad primljen / Paper received: 2.10.2017

Adresa autora / Author's address:
¹⁾ HESTEEL Iron and Steel d.o.o, Smederevo, Serbia
²⁾ University of Belgrade, Innov. Centre of Faculty of Mech. Engng., Serbia b.djordjevic88@gmail.com

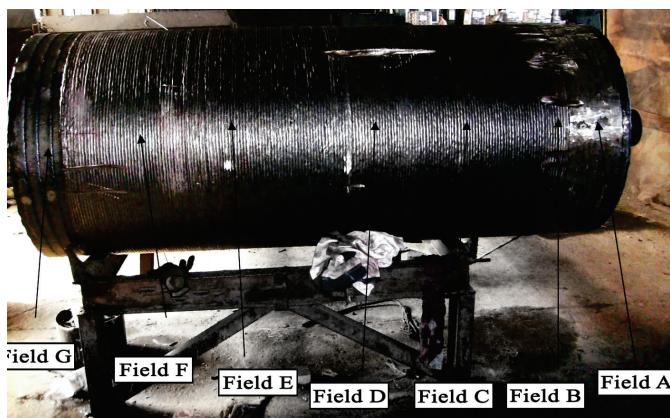
The diameter of the roll after welding is between Ø910 and Ø912 mm. The roll was not annealed after the welding process. Cracks have occurred in certain zones of the roll. The detected cracks were grooved by grinding. It is determined that the cracks cannot be eliminated and is assumed that they have propagated into the pre-machined parent material. One part of the grooved cracks with designated fields is shown in Fig. 2.

Figure 2. The Treiber roll after welding and grooving.

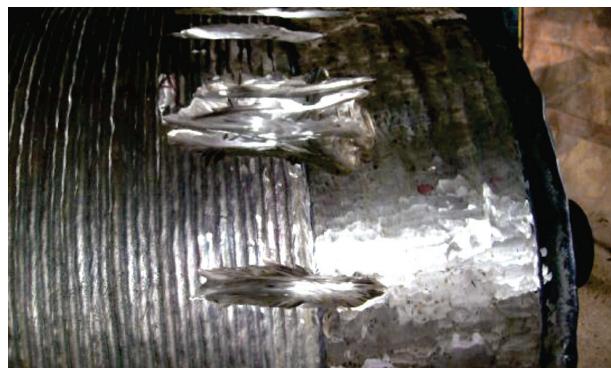
Cracks in field A

Field A is ground with a width of 300 mm along the circumference. Magnetic flux testing in this field detected small mesh cracks (Fig. 3a).

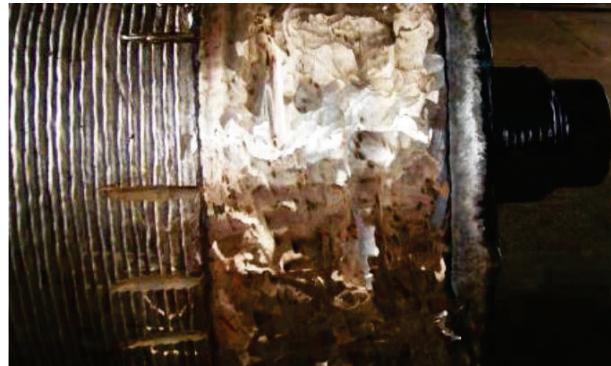
Cracks in field B

Field B is 200 mm wide and grooved along the circumference. A total of 19 cracks are detected in this field. Two of the cracks are eliminated by grooving, with the groove depth of 20 mm. The depth to which the cracks have propagated could not be accurately determined, since there is no documentation about it (Fig. 3b).

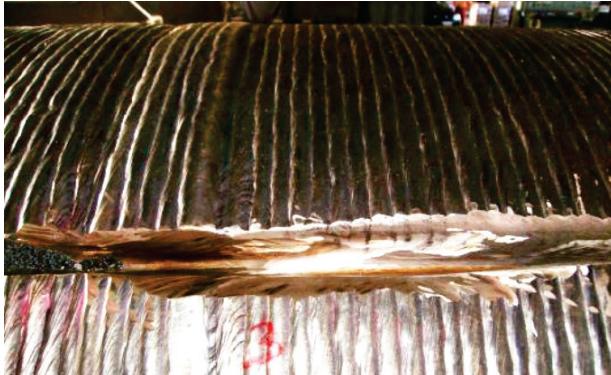
Cracks in field D

Field C is 400 mm wide, and no cracks are detected along the circumference. Field D, with a width of 300 mm, contained 13 cracks along its circumference. One of the cracks shown in this field (Fig. 3c), is eliminated by groov-

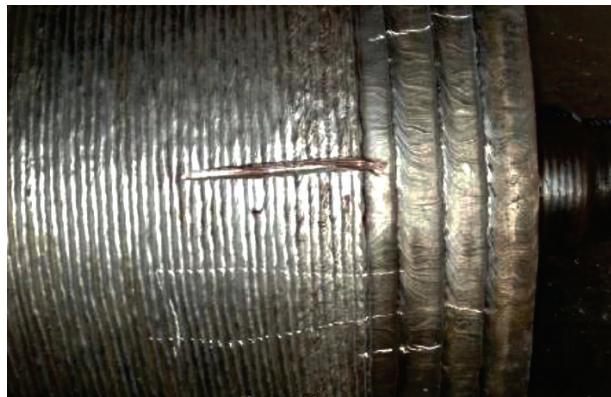
Cracks in field F

ing to 25 mm depth. Field E is 600 mm wide, and no cracks are detected along the circumference. Field F is 200 mm wide, and 14 cracks are detected along the circumference (Fig. 3d). Field G, with a width of 280 mm has not been ground on the opposite side and no cracks are detected in it.

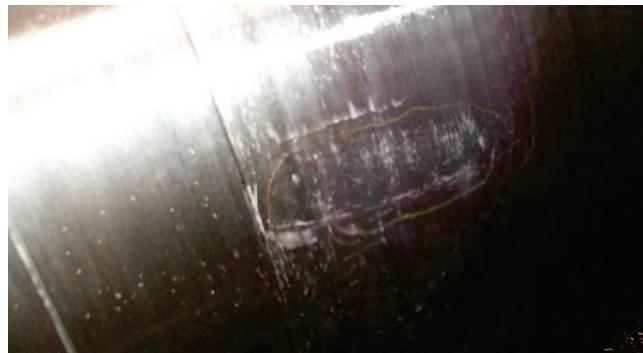
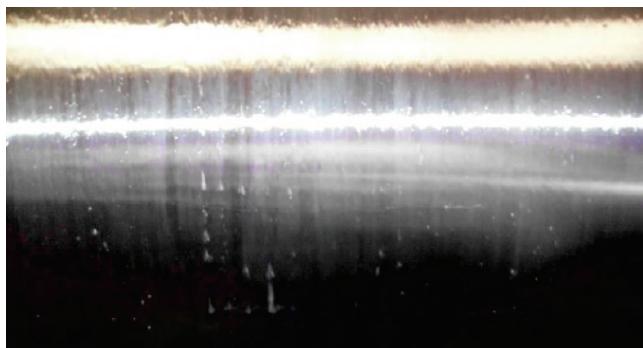
After filling of the grooves, the Treiber roll is machined to a diameter $\varnothing 905$ mm, thus 5 mm are removed per circumference. Visual control is performed along with magnetic flux testing. Cracks have remained, and new ones occurred as well. Namely, cracks have occurred in locations where additional surfacing was performed (filling of grooves with a depth approximately 20 mm), and where there were none previously, along the whole circumference and depth, which suggests that this part was simply 'glued on' (Fig. 5). It can be seen in the figures that cracks are continuous along the welded surface circumference. Cracks have occurred as the consequence of the lack- or inadequate pre-heating in these locations, i.e. filling of grooved locations is performed in cold conditions. Parts with thickness greater than 20 mm need to be preheated and they cannot be adequately welded without preheating, /2, 5-9/.

Figure 5. Cracks in grooves of fields B (top) and D (bottom) after additional welding, caused by the lack of preheating.

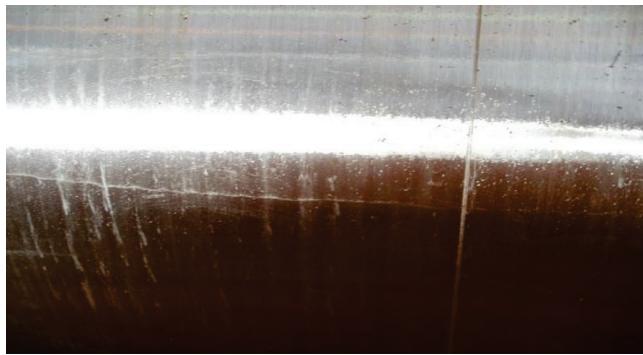
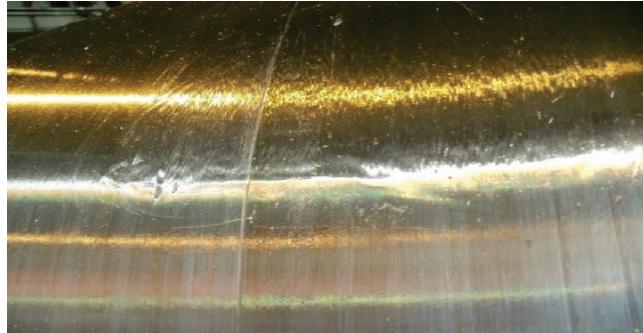
It was decided to continue machining the roll to a diameter of $\varnothing 900$ mm, followed by additional magnetic flux and ultrasound tests. After machining, magnetic flux tests are performed and it is determined that the cracks remained the same as after the first machining, whereas they could now be visually detected as well (Fig. 6 top). Ultrasonic tests determined that the current depth of cracks is 17 mm (Fig. 6 bottom).

Figure 6. Cracks in grooves, fields B and D after additional welding due to lack of preheating, which can be detected visually.

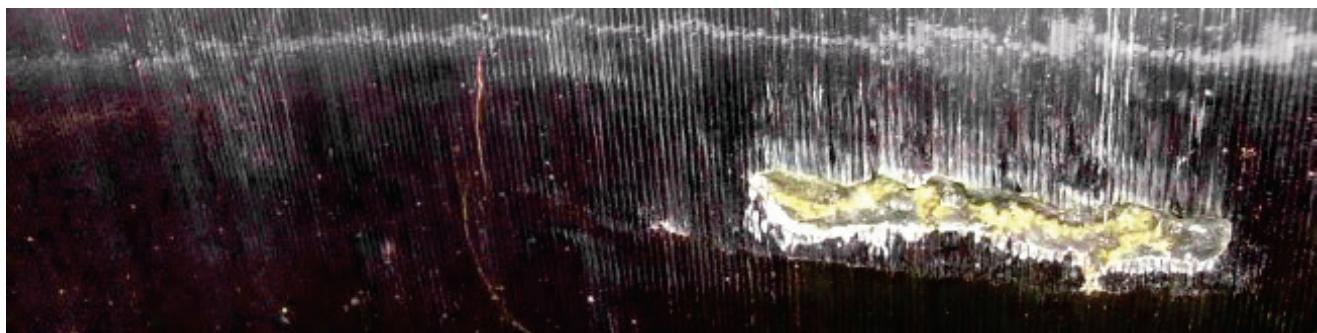
It was decided to continue with further machining for the purpose of removing cracks and determining their depths. After machining to a diameter of $\varnothing 882$ mm, magnetic flux tests determined that small mesh cracks in field A, shown on Fig. 2, were eliminated. As for field B, the cracks were positioned in the layer that was additionally welded. Crack depth was around 10 mm. Weld separation from the parent

material was also determined (Fig. 7). Within the remaining area of field B, a number of cracks remained. No cracks are detected in field C, whereas one crack remained in the additional weld in field D, with a depth of 10 mm. Within the remaining area of field D, as well as in fields F and G, a number of cracks had remained.

Figure 7. Location in field B where the weld is separated from the parent material.

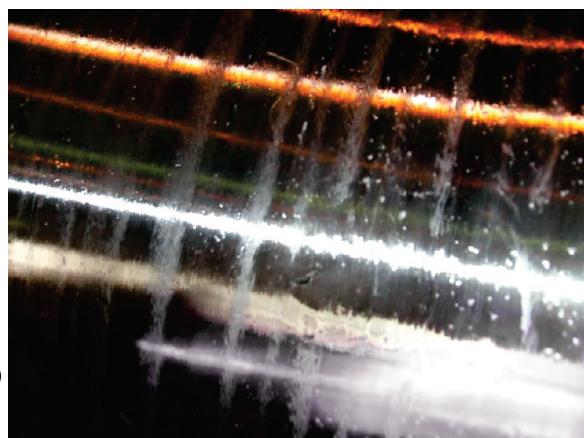
(a)

Figure 8. a) Holes in field B as a result of additional surfacing; b) crack in field D, with a depth of around 8 mm.

After the fourth machining of the roll to a diameter of $\varnothing 873$ mm, additional magnetic flux and ultrasonic tests were performed. These tests determined that the small mesh cracks in field A have been completely eliminated, as well as in field B, although 2 mm deep holes remained (Fig. 8a). As for field D, a crack with depth of 8 mm remained in the additionally welded layer used for filling of grooves (Fig. 8b). Other cracks in this field have been completely removed. No cracks are detected in field E, whereas three cracks with depth of 20 mm remained in the field F.

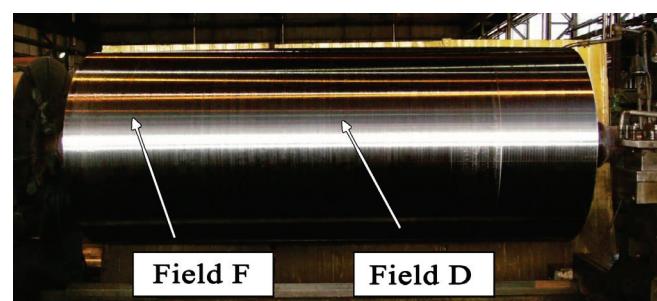
After the fourth machining, the number of cracks has reduced to 3+1 (caused by inadequate additional grooves filling). It is determined that three remaining cracks have propagated into the parent material not because of reduced stress but because of inadequately performed grooving and welding. For the purpose of complete removal of the weld up to the parent material, the fifth final machining is performed. It is decided to machine the roll to a diameter of $\varnothing 870$ mm. After this, additional magnetic flux and ultrasonic tests were performed. Shown in Fig. 9 is the appearance of the Treiber roll after the fifth machining.

Figure 9. The Treiber rolls after fifth final machining, with designated fields F and D.

The overview of the number of cracks in the non-machined $\varnothing 910$ mm, as well as after the fifth machining to a diameter of $\varnothing 870$ mm, is shown in table 5. In the field D, an 8 mm deep crack remained in the welded layer after additional welding and grooving. Other cracks have been completely eliminated. As for field F, three cracks with a depth of 20 mm remained. In this part, the roll has greater thickness and due to increased mass, sudden temperature output and inadequate (non-uniform) preheating, the hard welded layer cracked and the cracks propagated to the parent material.

Future activities recommended for the purpose of removing these four cracks include grooving crack locations and additional repair welding in order to fill the parent material, along with mandatory inspection using NDT methods. Only after it would be concluded that there are no cracks or other defects, the whole treiber roll can be repair welded again to a diameter of Ø910 mm.
