### Humboldt Bay Independent Spent Fuel Storage Installation: Site-Specific License Renewal Application

Humboldt Bay  
Independent Spent Fuel Storage Installation  
**Site-Specific License Renewal Application**

Pacific Gas and Electric Company

Revision 0 July 2018  
NRC Docket No. 72-27

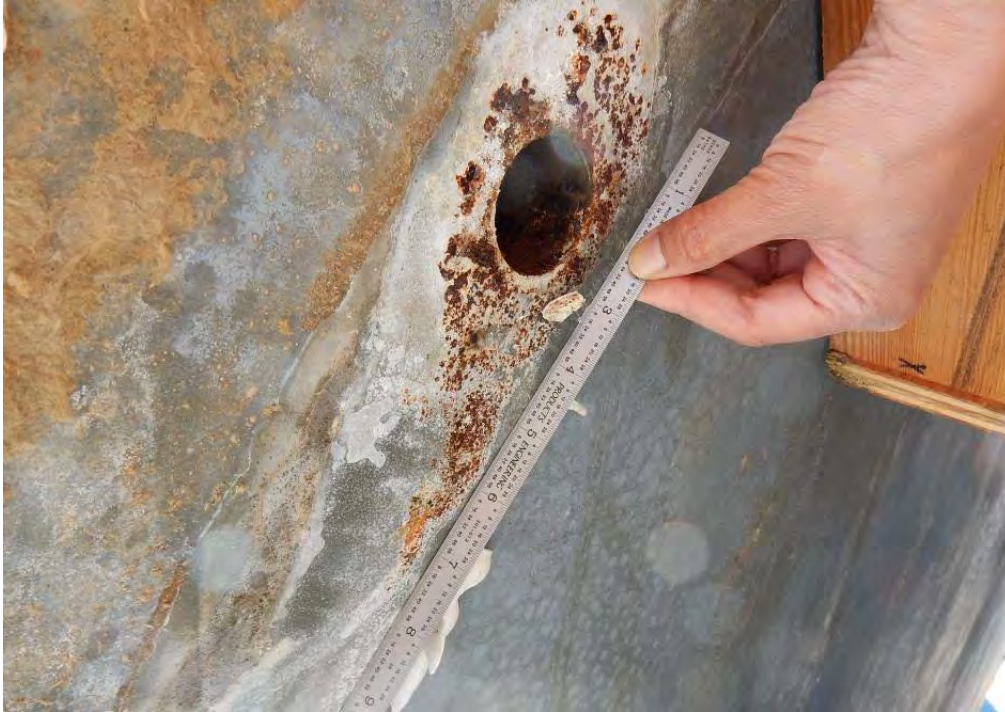
6. Underside of lid general view

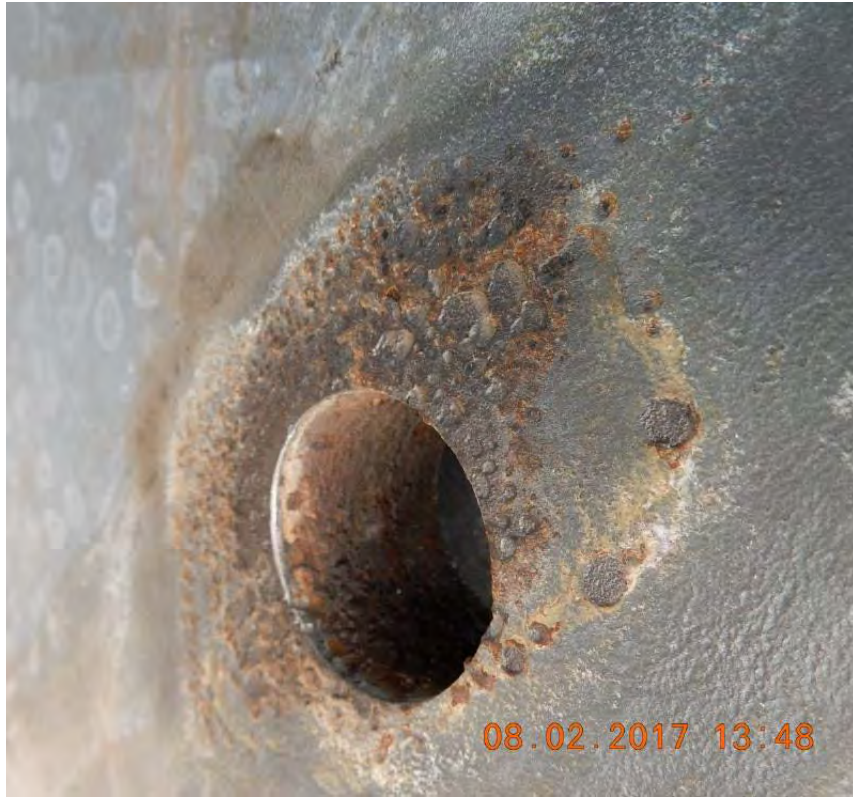
8. Underside hole #5 showing corrosion prior to cleaning

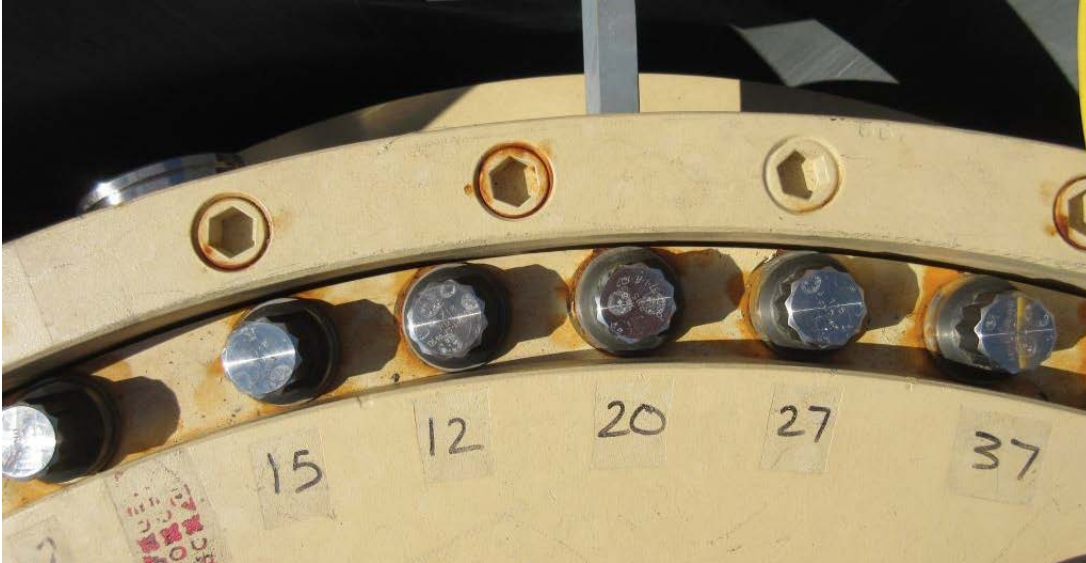
15. Rust staining around overpack lid closure bolting

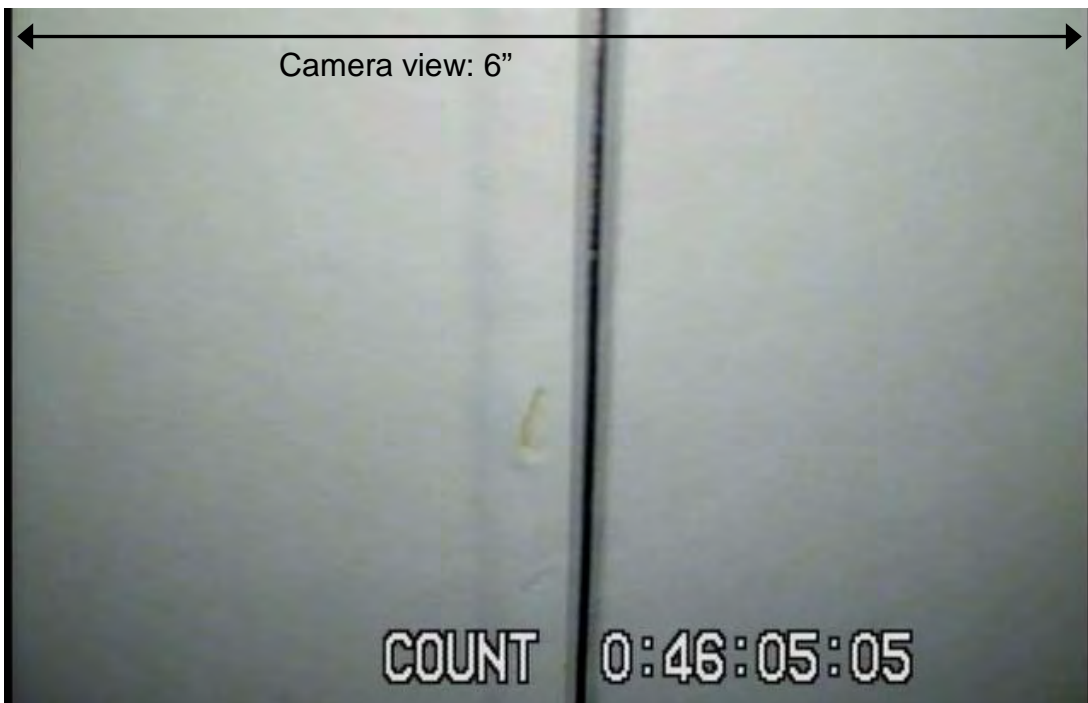
26. Scan 22 rub mark

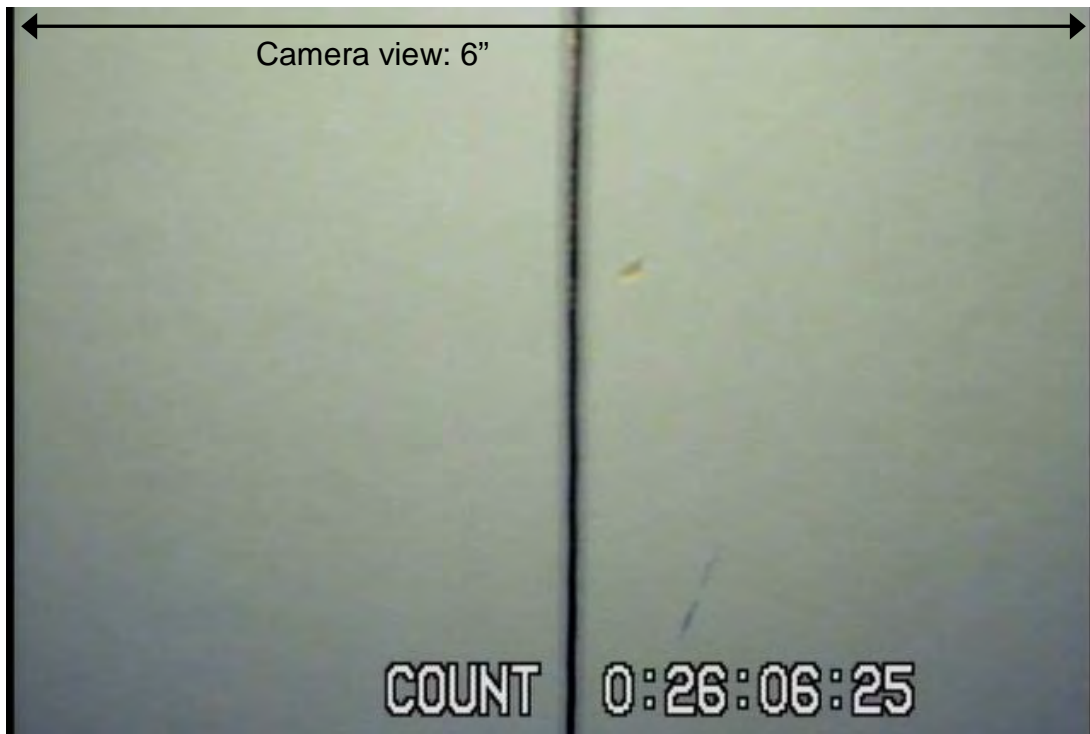
34. Scan 42 coating scrape

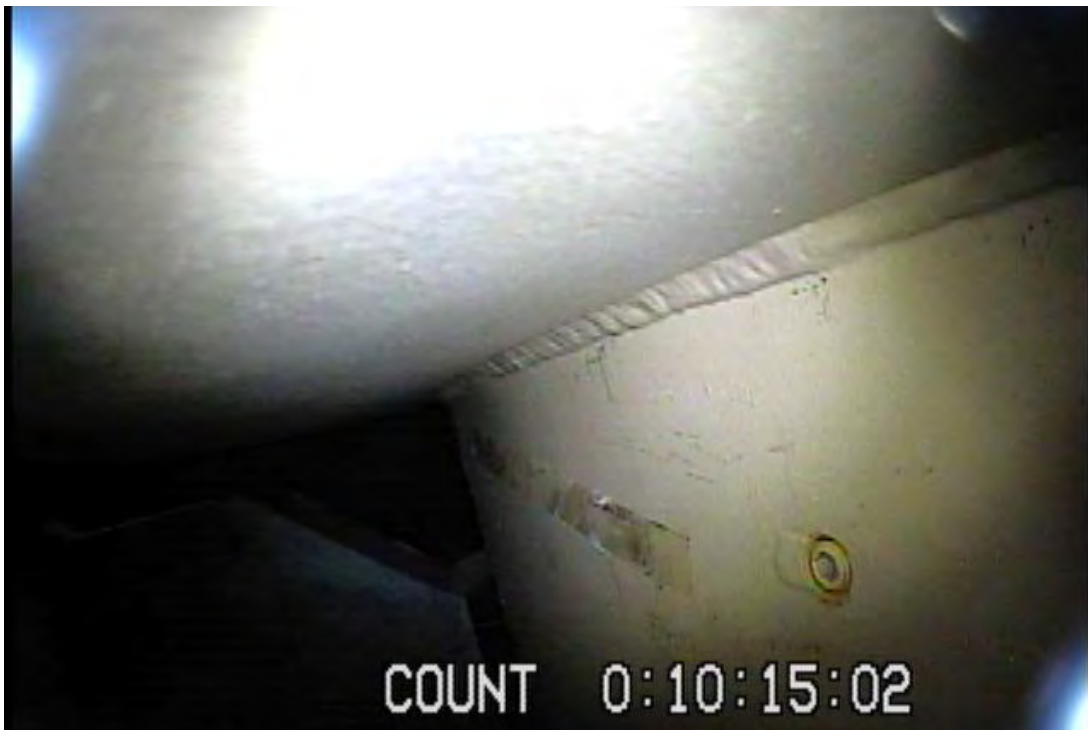
42. Overpack south east section coating scrape adjacent to seismic shim

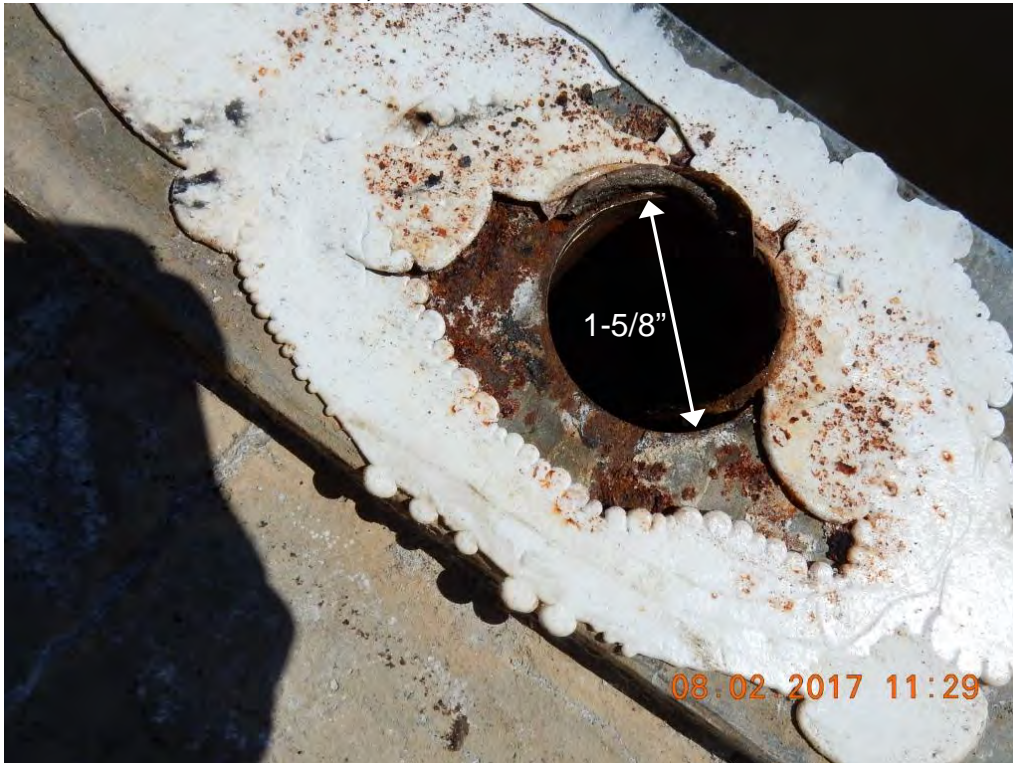
46. Vault lid ring bolt hole #3 corrosion products

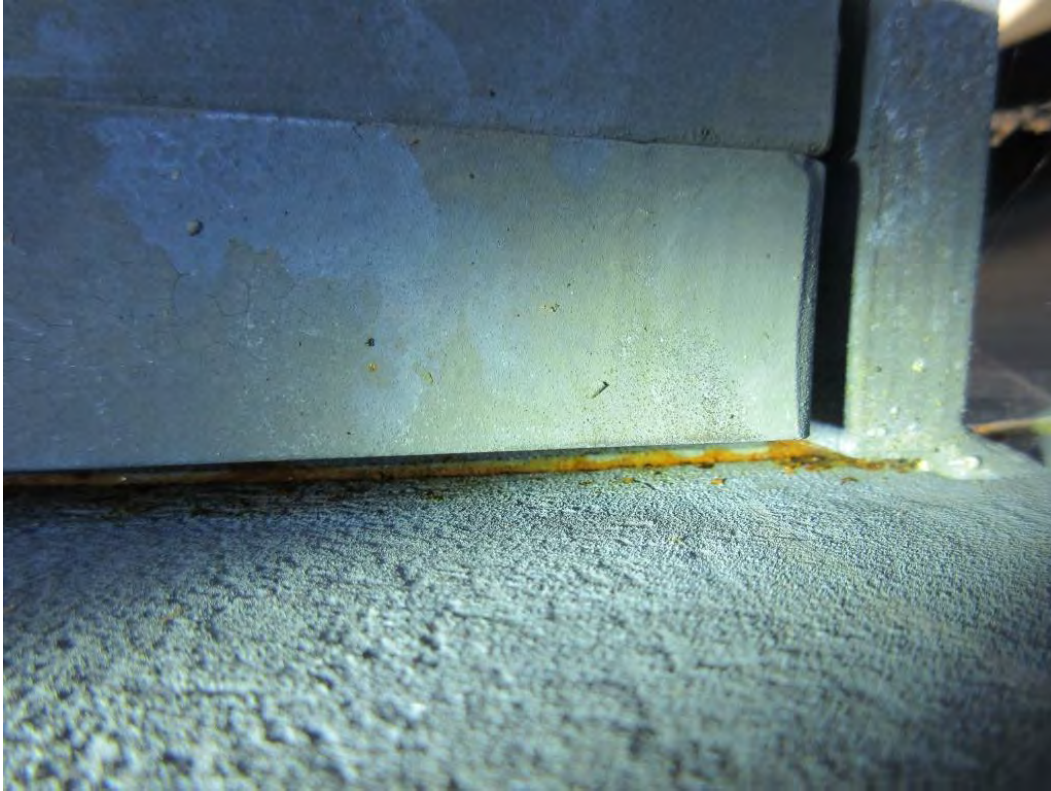
52. Rust staining at vault lid ring to vault liner interface  
(view looking down along liner with seismic shim in upper portion of the picture)

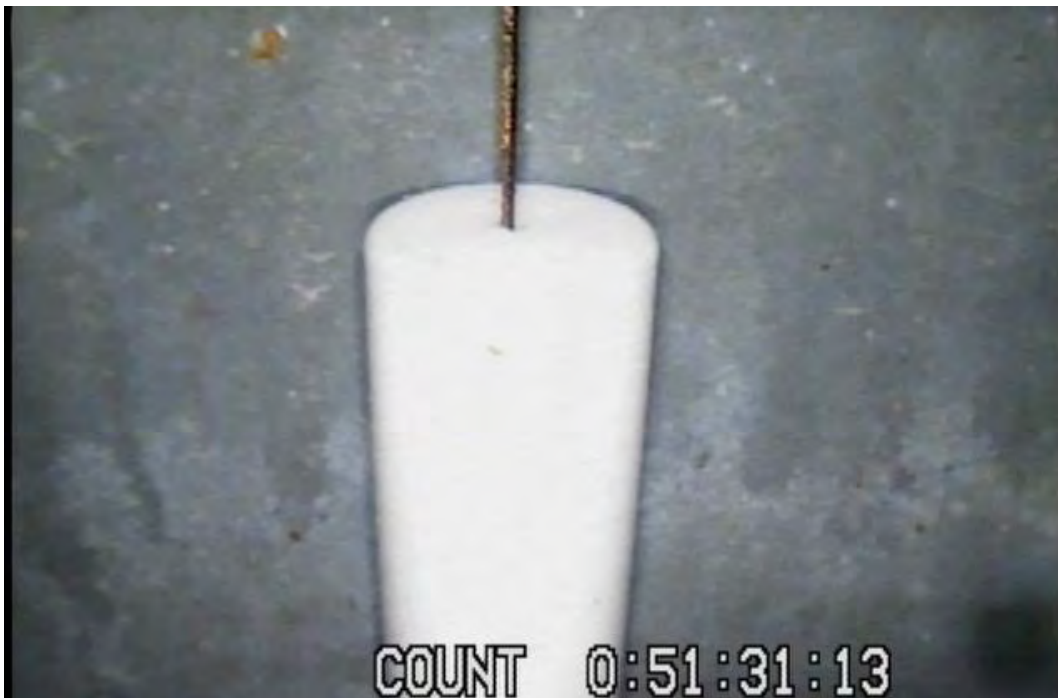
53. Scan 2 rust spot (for size comparison, the wire cable supporting the plumb bob is 1/32" dia.)

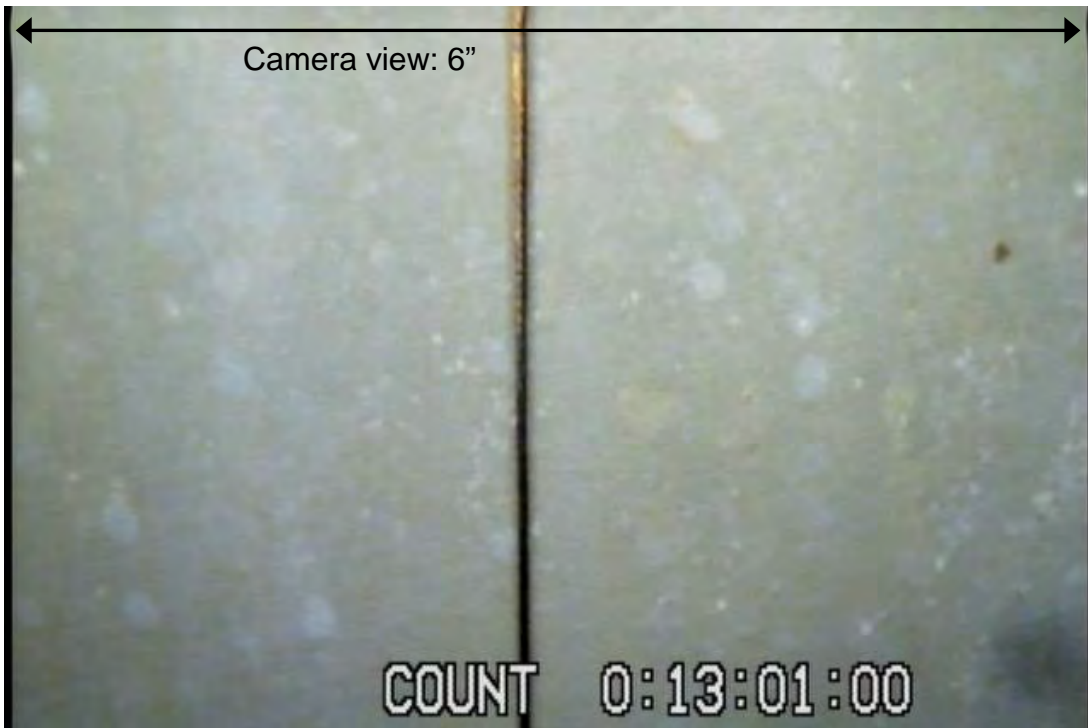
57. Scan 8 rust spot

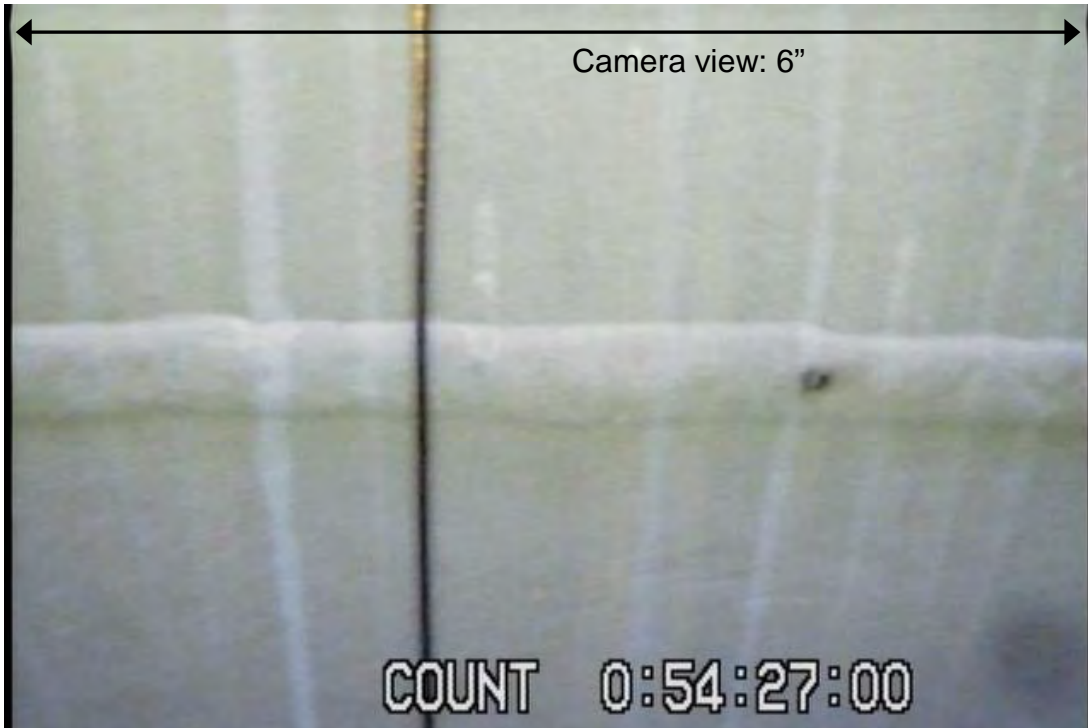
60. Scan 38 Dark spot – possible coating damage – no rust discoloration

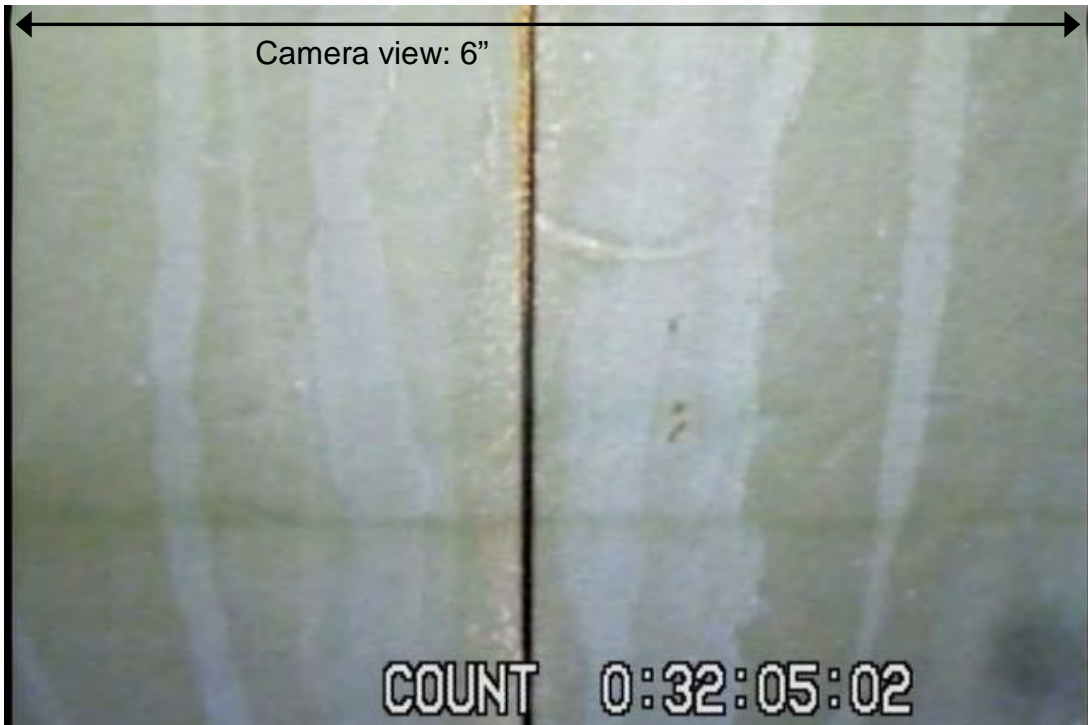
61. Scan 76 rust spots
