Concluding destructive investigation of a nine-year-old marine-exposed cracked concrete panel

This study undertaken on a nine-year-old cracked concrete panel further investigates the impact of cracks on the corrosion performance of conventional steel reinforcement in marine-exposed concrete to explain observed monitoring data. The present data covers seven 1.80 m long (12.6 m) reinforcing bars embedded in good quality concrete ($w/b = 0.40$ and cover >75 mm). Each bar was crossed by two horizontal cracks (surface crack widths 0.20–0.30 mm). The investigation showed no corrosion on the surface of the reinforcing bars, in either cracked or uncracked areas. Two of the seven reinforcing bars were instrumented in the vicinity of the cracks. Extensive corrosion was found in the interior of all instrumented parts of these bars. This may explain the monitoring data despite the lack of corrosion on the exterior surface of the two instrumented rebars. However, with no other weaknesses, the remaining conventional rebars showed no impact from the cracks.

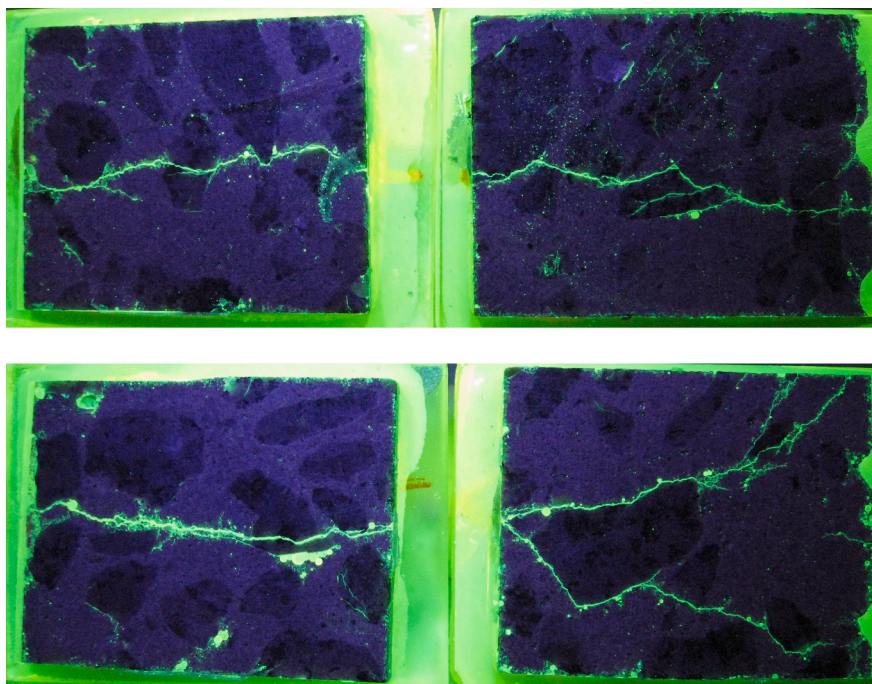
Fig. 6 shows impregnated pieces cut off after thin sectioning prepared from cores from the tidal (C2) and submerged (C5) exposure zones of the panel. Open cracks are observed to reach the reinforcement level in both cores.

One crack is seen in core C2 from the surface of the concrete to the imprint of the rebar. The crack traverses aggregate and occasionally splits into smaller cracks. The main crack has a width of 60–80 μ m at the surface and narrows to 15 μ m at the rebar. The cracks are generally open, but the main crack is bridged by calcite for the last 0.2 mm up to the surface.

The initially introduced crack in core C5 is seen from the surface of the concrete to the imprint of the rebar. An empty crack, possibly formed when the rebar was removed from the concrete, has been generated along this crack. The initial crack traverses aggregate and occasionally splits into smaller brittle cracks. The main crack has a width of 200 μ m at the surface and narrows to 13 μ m at the rebar. The initial cracks are generally open, but the main crack is bridged by calcite for the last 3 mm up to the surface.

The petrographic investigations indicate that the cracks are still open, as seen in fluorescent light mode (Fig. 6), but various deposits are seen on the crack faces and in the crack. These deposits were identical in the two tidal (C2) and submerged (C5) exposed cores and were as follows from the exposed surface and inwards in the crack: calcite, followed by brucite, and deeper inside the cracks, first portlandite (calcium hydroxide, $\text{Ca}(\text{OH})_2$) and then ettringite. These observations are similar to observations made on cores from the cracked beams of three different types of infrastructure concrete after 25 years of marine exposure [20]. Table 8 summarizes the findings from the petrographic study and shows the depths from the surface to which the deposits were observed. The petrographic study also showed shallow and uneven carbonation of the outer exposed surfaces (C2: 0–1.2 mm, C5: 0–2 mm), as well as shallow carbonation along the crack faces at greater depths from the exposed surfaces (C2: 0.8–20 mm, C5: 3–8 mm) and carbonation in part of the

Fig. 6. Fluorescent impregnated thin sections (two per core) showing impregnated (green) cracks in cores C2 (tidal exposure) and C5 (submerged). The exposed surface is to the left in the left-hand thin sections, and the imprint after the rebar is to the right in right-hand thin sections. The dimensions of the fluorescently impregnated pieces cut off from the thin sections are $30 \times 45 \text{ mm}^2$.

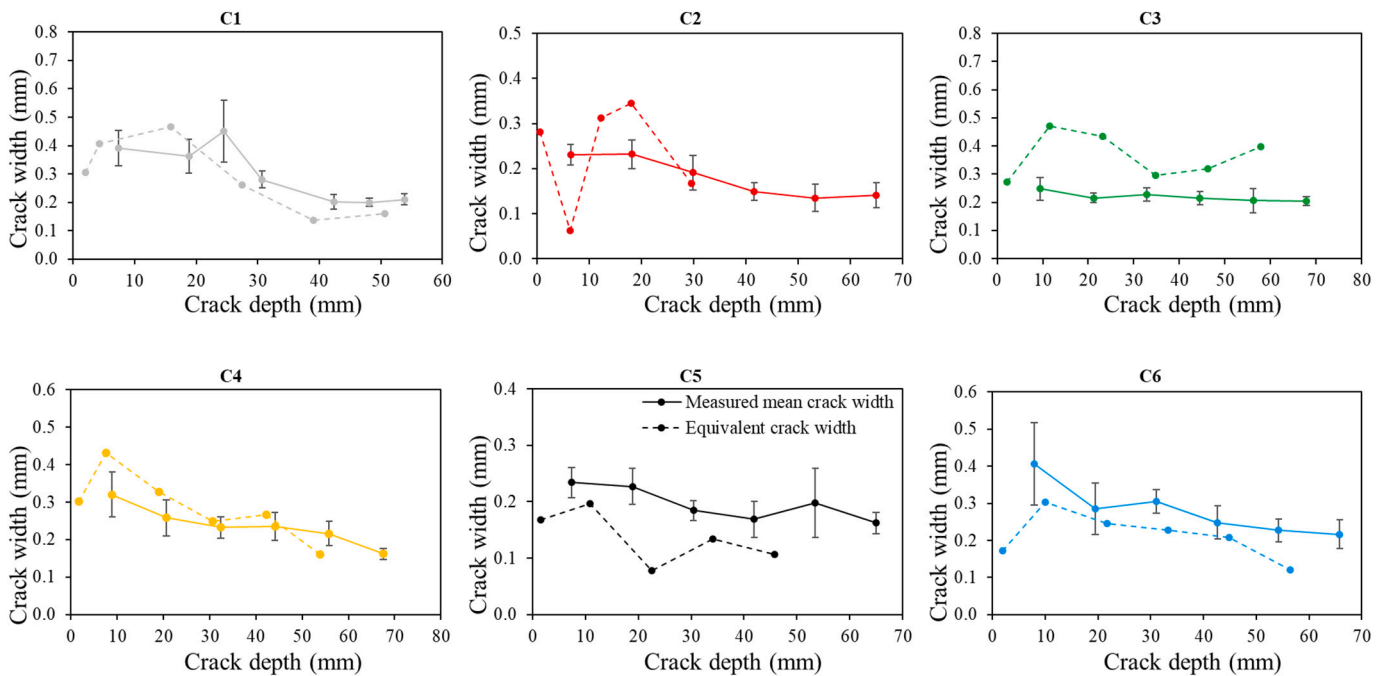
The results enable a comparison of the crack geometry between all six cores investigated, cancelling the effect of crack location in the core. Except for core C2, an increase in equivalent crack width is observed during the transition from the exposed surface down to 10 mm of crack depth, which agrees with the results shown in Fig. 7. While fluctuations are also present, a general trend of decreasing crack width values is observed beyond 10 mm crack depth. Fig. 8 compares the two different methodologies adopted. Good agreement can be observed, considering the limitations related to the resolution.

Fig. 8. Comparison between the two methodologies adopted to quantify crack widths from μ -CT scans.

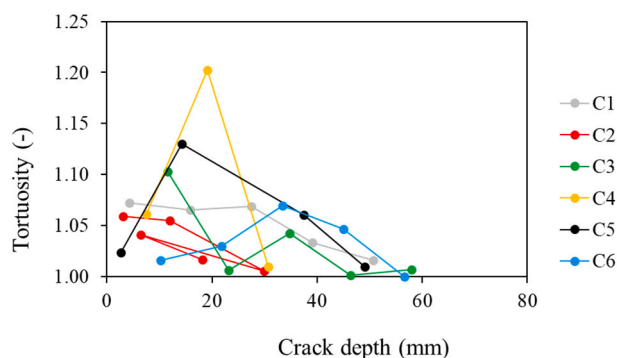
Finally, crack tortuosity was also investigated using the available μ -CT image dataset. Representative 2D XY plane projections (five per core) were used to calculate the effective and the nominal crack length (Section 2.4) in the XY plane. The results are illustrated in Fig. 9. Numbers close to 1.00 might be explained by self-healing, closing part of the crack and reducing the effective crack length.

Fig. 9. Crack tortuosity distribution across crack depth for all six cores investigated using μ -CT. (For interpretation of the references to colour in this figure legend, the reader is referred to the web version of this article.)

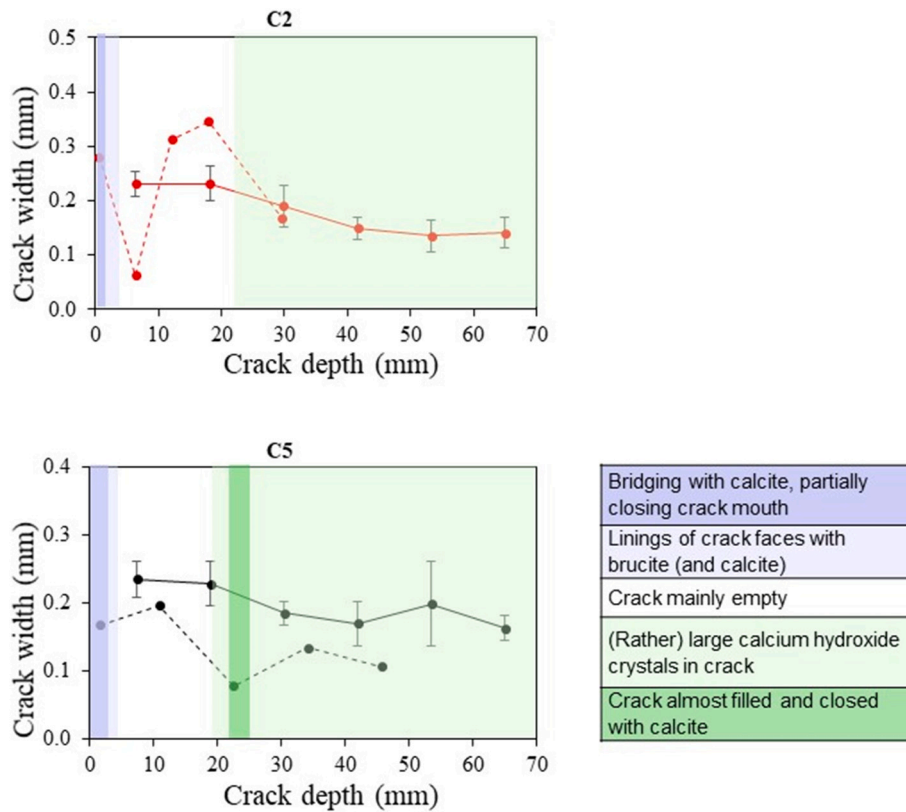
Fig. 12. Comparison of crack characterization using μ -CT (equivalent crack width (dotted line) and measured mean crack width (solid line), data from Fig. 8) and zones identified using petrography (data from Table 8) for cores C2 (tidal exposure) and C5 (submerged exposure). (For interpretation of the references to colour in this figure legend, the reader is referred to the web version of this article.)

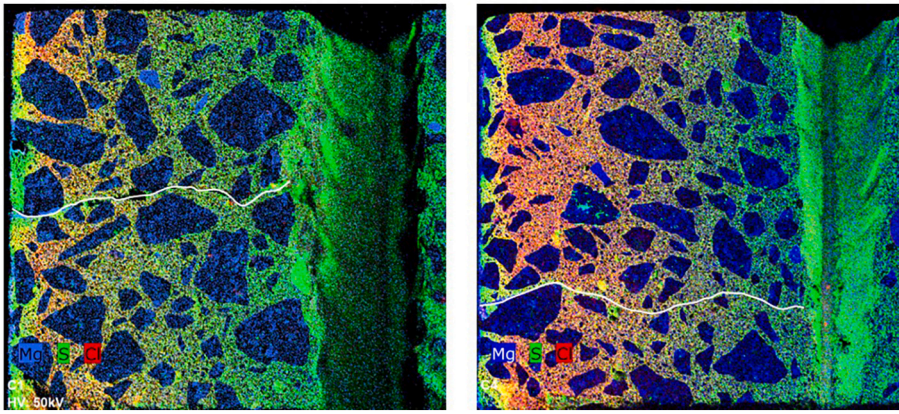
The petrographic study showed that the first 5 mm of the paste was fully de-calcified with increased porosity in the tidal and submerged zones. If the elemental maps of Mg, S and Cl obtained by μ -XRF (Fig. 13)

Fig. 13. Elemental zonation of Mg (blue), S (yellow) and Cl (red) in core C1 (left) and C4 (right). Cracked and exposed surfaces of panels to the left and imprints of rebars to the right in both figures. Mg is visible within the first 10 mm of the crack. Note that the apparent high S content in part of the steel–concrete interface of core C1 is an artefact due to mechanical damage during sample preparation. (For interpretation of the references to colour in this figure legend, the reader is referred to the web version of this article.)

are combined, a clear elemental zonation as reported by Jakobsen et al. [22] can be observed, with a thin Mg-rich surface layer, followed by a layer of about 0.5 cm enriched in S, followed by Cl. Fig. 13 shows that precipitation of Mg-rich phases was detected within the first 10–15 mm in both cracks. This is in line with observations reported of cracked concrete beams after 25 years of marine exposure in northern Norway [20].

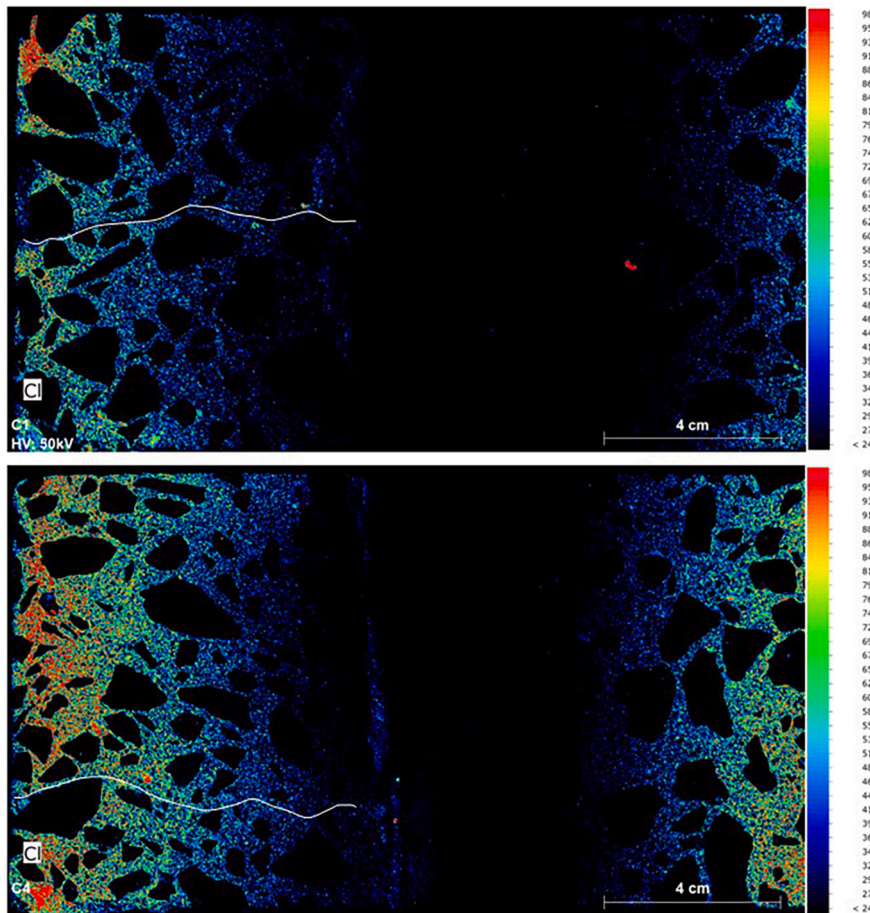
Fig. 14. Map visualizing chloride ingress depth in relative intensities: core C1 (tidal exposure) at the top and core C4 (submerged) at the bottom. The cracked surface of the panel is to the left. Cracks are marked in white. (For interpretation of the references to colour in this figure legend, the reader is referred to the web version of this article.)
