Environmental stress cracking of polymers: case studies from industry (ABS and LDPE)

Thomas Dooher¹, Abu Saifullah², Jawad Ullah¹, Ciarán Magee³, Adrian Mulholland⁴, Dorian Dixon^{1*}

Abstract

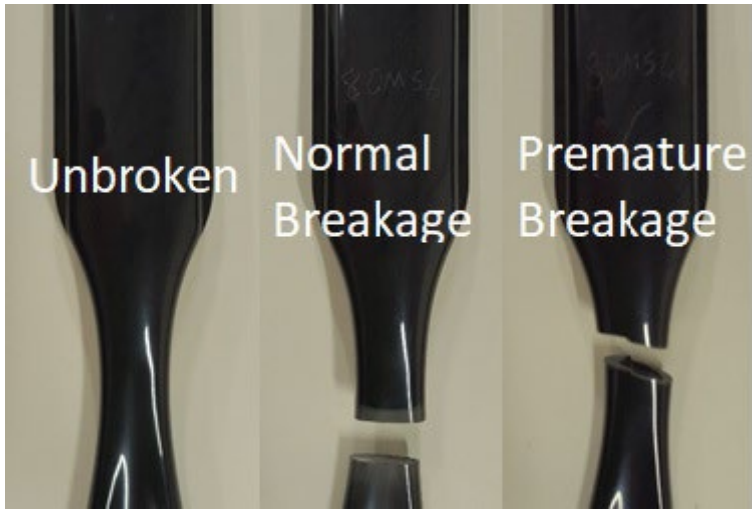
A photograph of parts after tensile testing is shown in Figure 1 and it is apparent that exposure to Grip-It™ can alter the failure behaviour. Normally breakage occurred at the thinnest portion of the part in a ductile manner with evidence of necking and an area of white grazing extending ~5mm at either side of the failure. However, in the parts which failed prematurely after exposure to Grip-It™, the breakage occurred at the interface between the solid and hollow section. After exposure to Grip-It™ the parts failed in a brittle manner which matches reports of ESC in literature[8].

Figure 1. Breakage of the samples

Additional analysis was conducted using Thermogravimetric Analysis (TGA), Differential Scanning calorimetry (DSC) and Fourier Transform Infrared (FTIR) spectroscopy but these methods showed no significant differences after exposure to Grip-It™. As a result of this work, the company decided that the simplest and most cost-effective measure was to simply stop using the assembly agent (Grip-It™). Although this made assembly more difficult as they were reliant on mechanical interlocking to keep the parts together, it solved the issue.

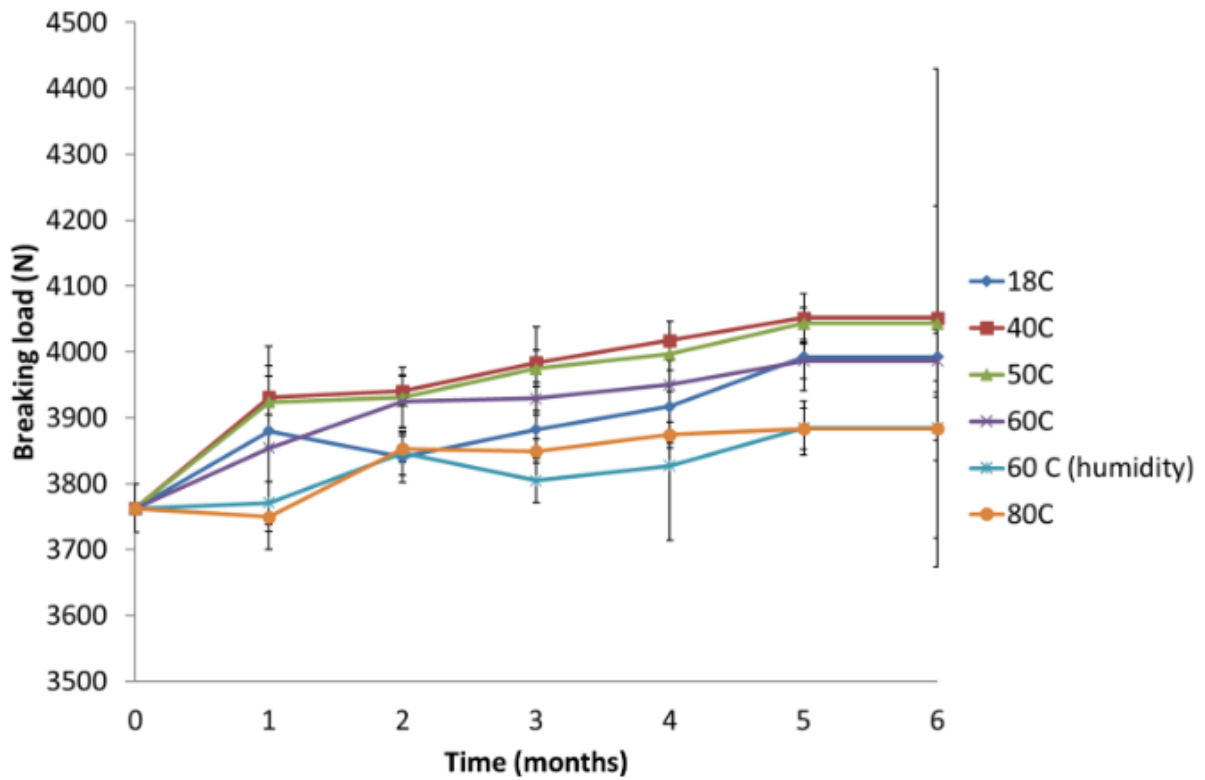
The breaking load of the parts without Grip-It™ can be seen in Figure 2. It would appear that the parts have a slight increase in the breaking load as a result of the exposure to elevated temperature. Thermal ageing has been reported to improve the tensile strength and modulus of polymers including ABS but with reductions in toughness as a result of embrittlement [1]. In the case of ABS these changes during storage at elevated temperature have been attributed to a number of factors including cross linking at the part surface [17]. The relaxation of residual stress from the injection moulding process may also play a role. All of the as-received parts tested broke in the expected region of the part with none displaying premature brittle failure. The results for the parts which were exposed to Grip-It™ can be seen in Figure 3. A significant drop in the breaking load of the parts was noted compared to the parts which were not exposed to Grip-It™. The error bars in the graph are large because the parts either broke normally (at a similar load as the samples which were not exposed to Grip-It™) or at a much lower load (approximately 600-700N) due to premature failure. It was found that in addition to the samples breaking at a much lower load due to premature, the location of the break also changed and occurred in the hollow section. The average standard deviation in breaking load of the parts which were not exposed to Grip-It™ was approximately 60N; whereas for the parts exposed to Grip-It™ was approximately 660N. These results confirm the apparently random nature of ESC. There did appear to be some temperature dependence with parts aged at 18°C displaying the smallest reduction in breaking load, suggesting that elevated temperature accelerate ESC. The samples aged in the humidity chamber also showed a lower reduction in mechanical performance when exposed to Grip-It™ compared to the samples aged at the same temperature at ambient humidity. Other researchers have reported a reduction in the stiffness of ABS when aged in a humid environment [18,19]. It is likely that the moisture is absorbed into the acrylonitrile component of ABS [20–22] and acts as a plasticiser protecting against ESC to some extent.

Figure 2. Breaking load of the parts (not exposed to Grip)

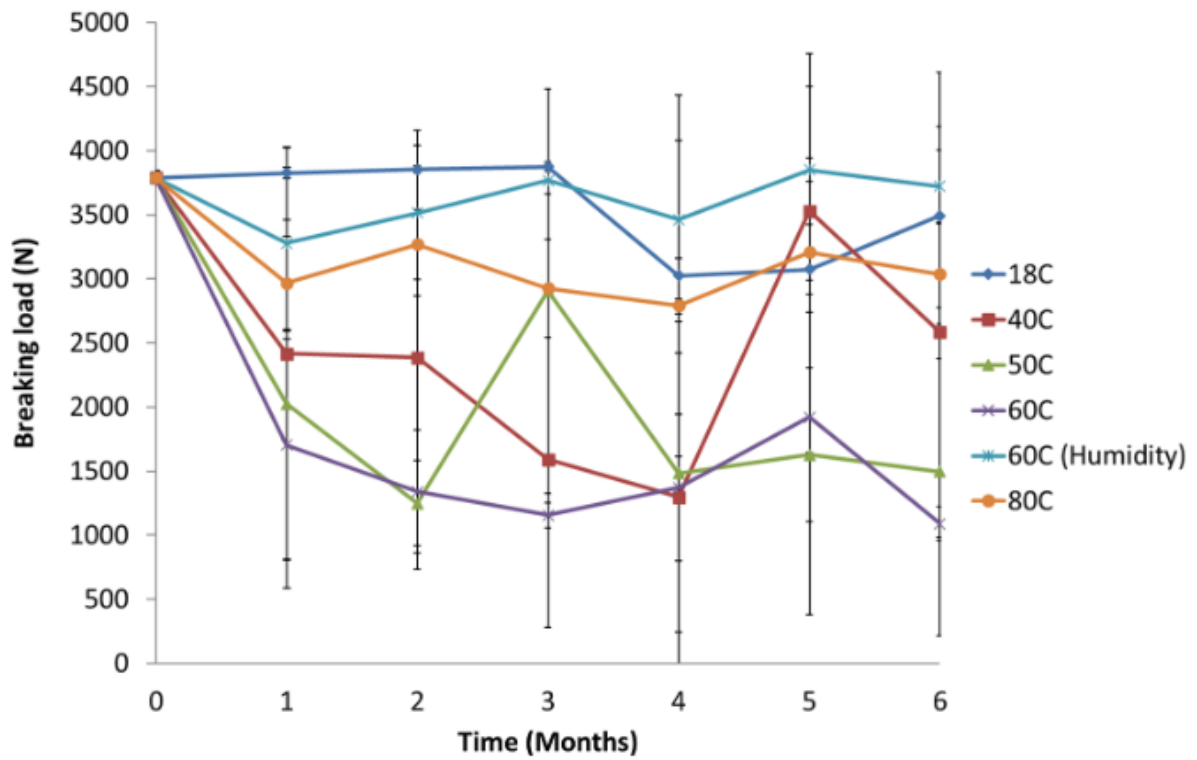
Figure 3. Breaking load of the parts (exposed to Grip-It)

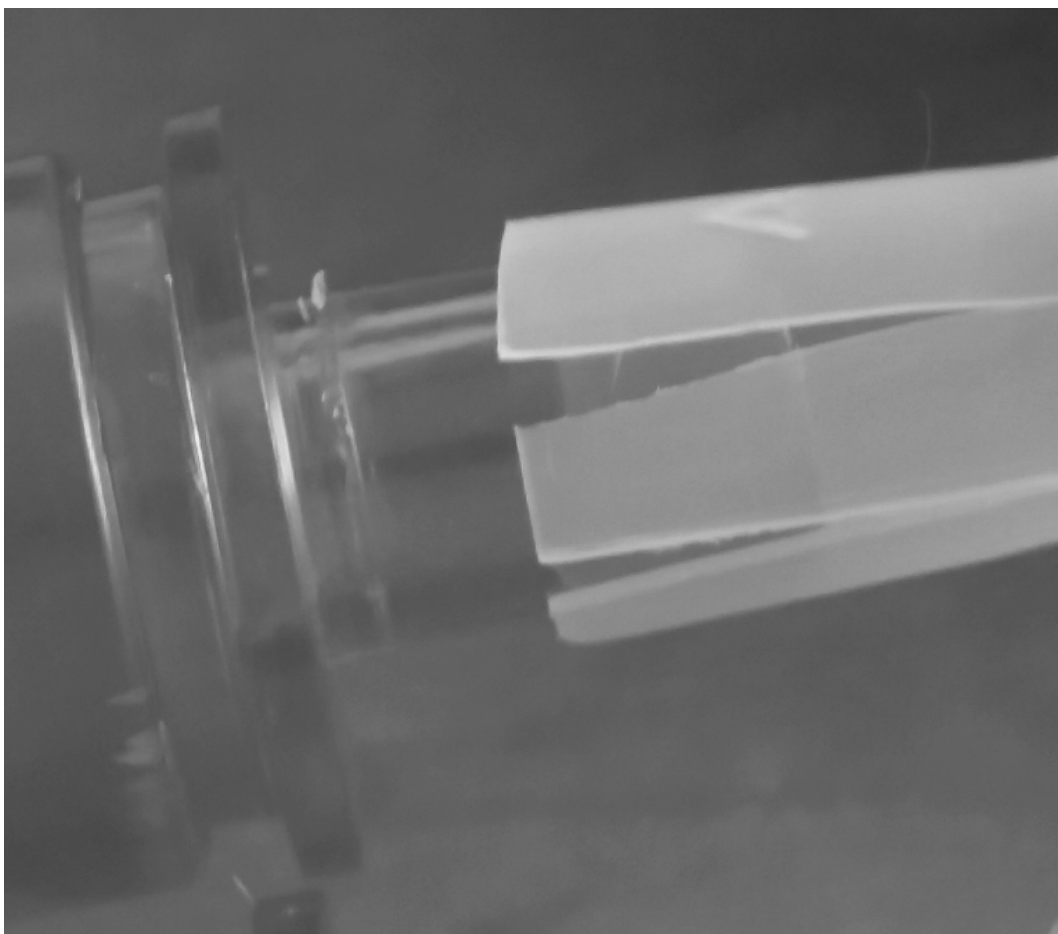
The company involved in this case study produce respiratory tubing for anaesthesia machines and ventilators. These supply respiratory gases, including vaporous anaesthetic agents in addition to oxygen and medical air. These gases can be dry or humidified. The tubing assembly comprises a flexible tubing limb with an integrated connector which push-fits onto corresponding connectors on the equipment. During assembly, Isopropanol (IPA) was wiped over the ends of the connectors before fitting the connectors to the tubing to make it easier to fit the parts together. It was found that after assembly and on occasion in-service, that some of the connections between the tubes and/or the tubes and the respirator displayed visible cracking leading to potential failure of the joints. This can be seen in Figure 4. While the company was not aware that the issue may have been caused by ESC, they did suspect that using IPA was playing a role. Prior to this project, the company tried altering the composition of the tubing and the assembly solvent in an attempt to overcome the issue.

Figure 4. Failure of the LDPE tubing

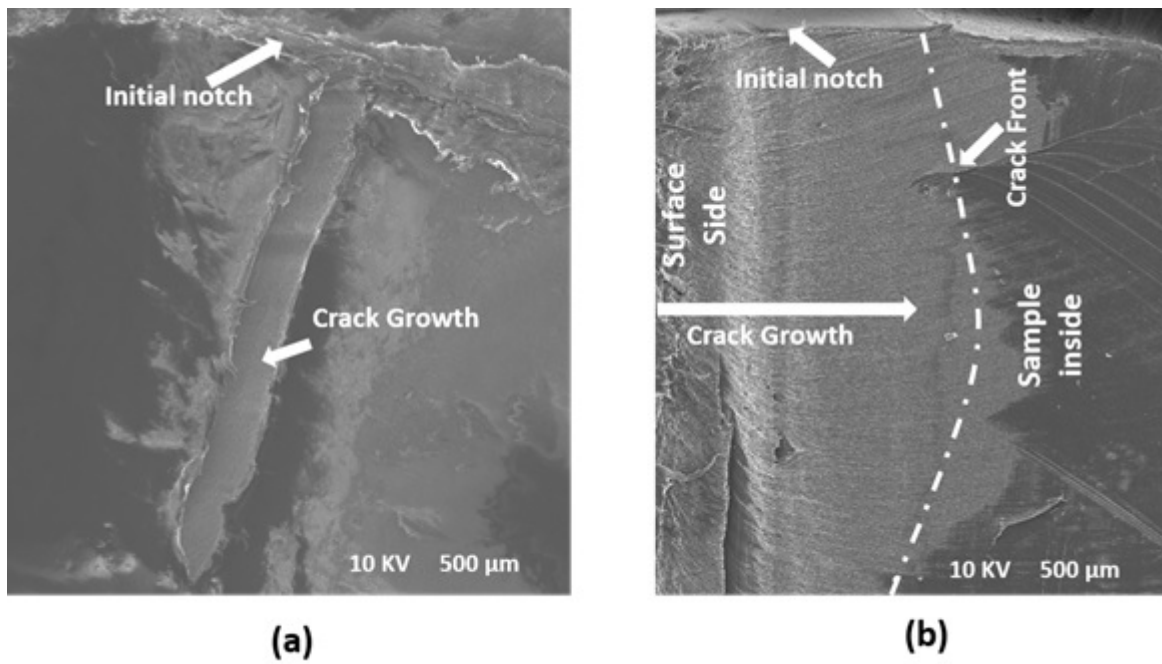
Figure 6 shows a SEM image of environmental stress cracking which occurred in the LDPE sample during ESC testing via ASTM D1693. It was observed that the crack grew perpendicular to the initial notch. The crack begins at the surface and propagates into the samples. Brittle fracture features were observed and no clear fibrillation or crack ridges to slow or stop the crack growth were apparent on the fracture surfaces. It has been reported that smooth crack surface is a typical characteristic of ESC [22]. These observations were supported by previous studies, where it was concluded that ESC is a brittle failure, starting from the surface due to the creation of micro-voids and cracks by the surface-active liquids or agents [6,11,27,28].

Figure 6. SEM of the LDPE samples exposed to MEK

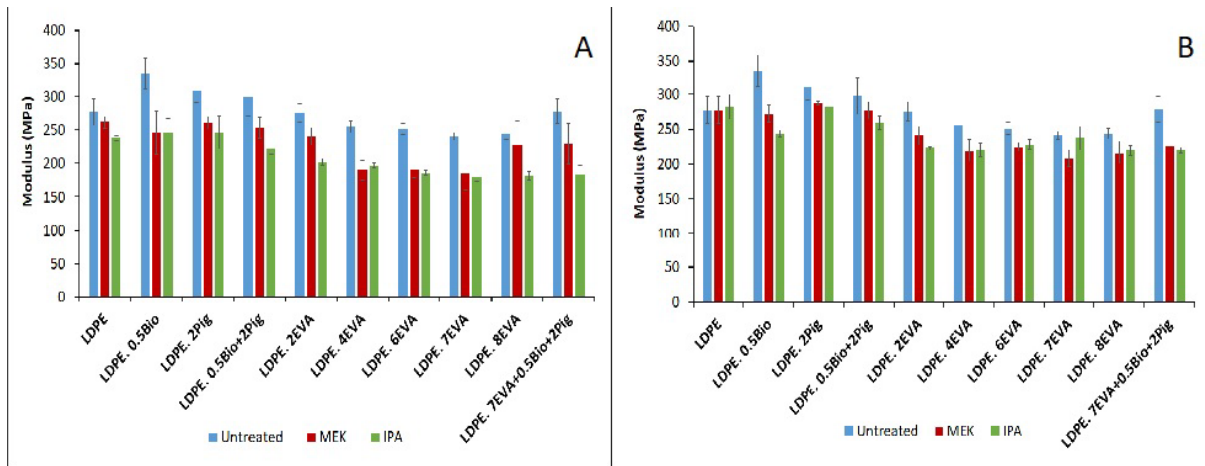
ISO bent strip testing was conducted in accordance with ISO 22088-3 to assess the effect of ESC on the mechanical properties of the blends with the unaged LDPE blends as a control. It was found that no cracks or failures were observed in any of the samples after 1000hrs/42 days. This is in contrast with the samples aged used in the ASTM standard and is attributed to lower strain which was applied to the samples during the ISO ageing process. It was also found that there were no significant changes in the strength of the samples (for each polymer blend) when exposed to either liquid (regardless of whether it was applied by dipping them in the liquids or painting it on). However, the stiffness of the samples was found to change when they were exposed to the two solvents. The Young's modulus of the samples which were dipped in the liquids can be seen in Figure 7.A and the Young's modulus of

the samples which had the liquids painted on can be seen in Figure 7.B. Interestingly, the data suggests that the additional of the Biocote and pigment increased the stiffness of the samples potentially rendering the material more susceptible to ESC failure. It is clear from both sets of data from Figure 7 that the presence of the two solvents lead to a significant drop in the Young's modulus, with IPA having the largest impact. The addition of increasing percentages of EVA reduced the Young's modulus of the blend which was expected as it is an elastomer and this reduction in stiffness could help protect against ESC. In agreement with the data from the ASTM tests it can be seen that the presence of the pigment and Bio-cote appear to have a determinantal effect on the ESC resistance. The effect of the MEK and IPA on Young's modulus are similar with some of the samples displaying a smaller drop in stiffness with MEK compared to that seen with IPA.

Figure 7. Tensile modulus of the polymer blends (A painted on, B dip in)
