Heidarzadeh, M & Feizi, S 2022, 'A cascading risk model for the failure of the concrete spillway of the Toddbrook dam, England during the August 2019 flooding', *International Journal of Disaster Risk Reduction*, vol. 80, 103214. <https://doi.org/10.1016/j.ijdr.2022.103214>

1 **A cascading risk model for the failure of the concrete spillway of the**
2 **Toddbrook dam, England during the August 2019 flooding**

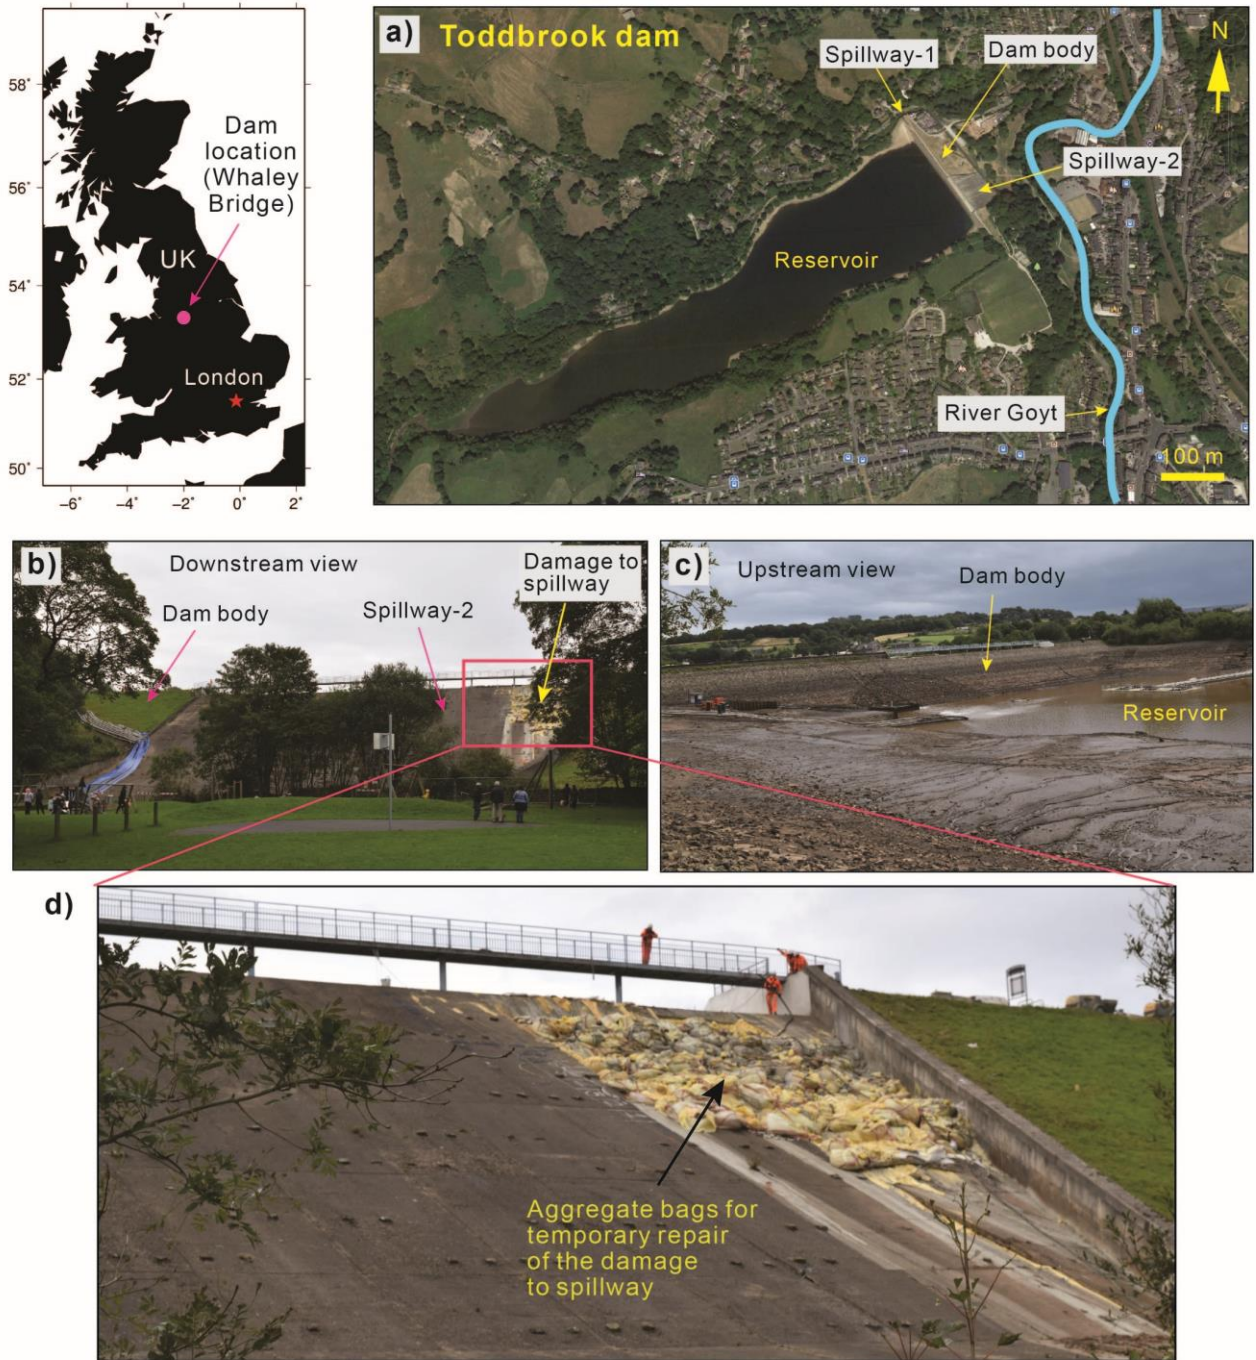
91 **Figure 1.** Location of the Toddbrook dam in the UK and its dam body and two spillways. The damaged part
 92 of the spillway is shown in panels “b” and “d”. The yellow aggregate bags, shown in panel “d”, were
 93 placed at the damaged part of the spillway to stop the spread of the damage as a temporary measure.
 94 Photos in “b”, “c” and “d” are taken during our field survey in August 2019 while panel “a” is from
 95 Google-Earth (<https://earth.google.com>). The pink box in panel “b” is enlarged in panel “d”.

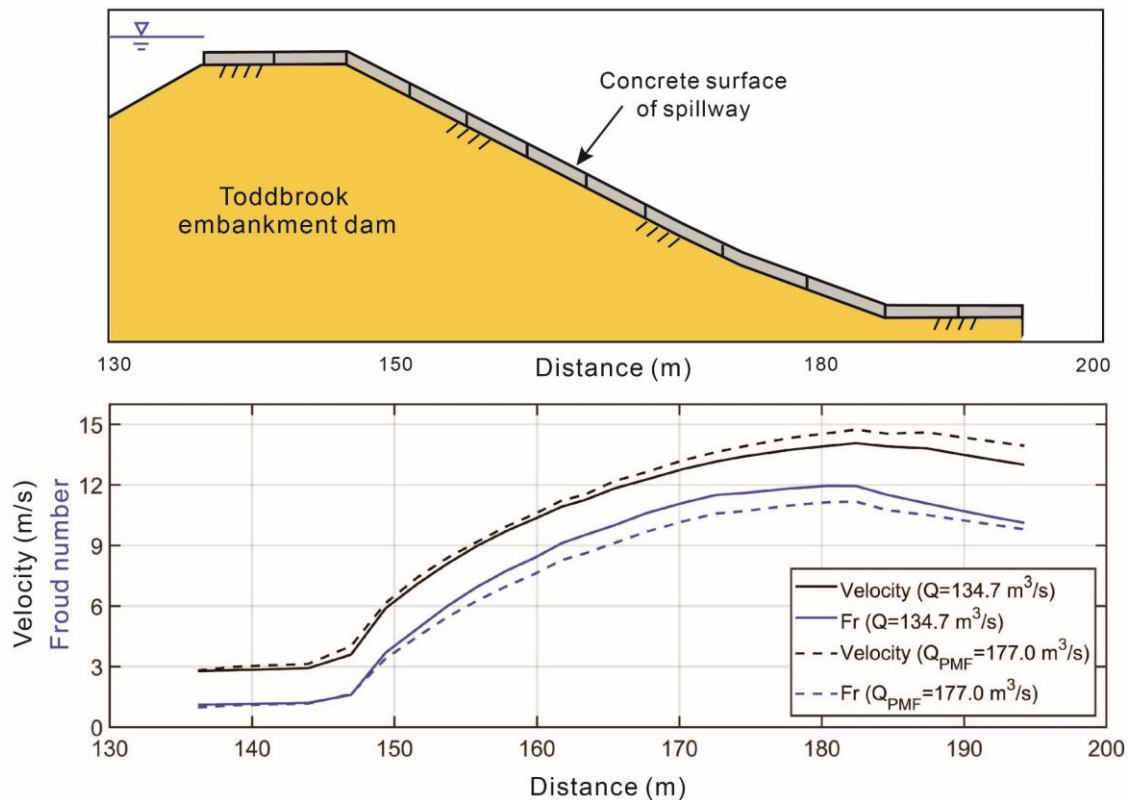
167
 168 **Figure 5.** Results of water velocity (black) and Froude number (blue) analyses along the concrete surface of
 169 the Toddbrook dam spillway-2 at two water discharges of $134.7 \text{ m}^3/\text{s}$ and $Q_{PMF} = 177.0 \text{ m}^3/\text{s}$.

249 For the case of the Toddbrook dam, our modelling revealed that spillway-2 experiences a maximum flow
250 velocity of approximately 15.0 m/s at the PMF (Figure 5). The spillway-2 is made of 15-cm thick concrete
251 slabs, which are not reinforced with rebars. Such relatively thin slabs appear to be insufficient; in particular,
252 as they are not reinforced as well. Another potential shortcoming is the profile of the spillway itself. It
253 appears that the profile of the spillway follows that of the downstream slope of the embankment rather than
254 being specifically designed for water flow with large volumetric rates and high speeds. On top of these
255 shortcomings, the spillway lacks any stilling basin (Figure 7b); as a result, severe scouring was observed at
256 the toe of the spillway during the August 2019 incident. We acknowledge that the design and construction of
257 spillway-2 was limited by the slope and shape of the dam body, but this does not justify the design of a

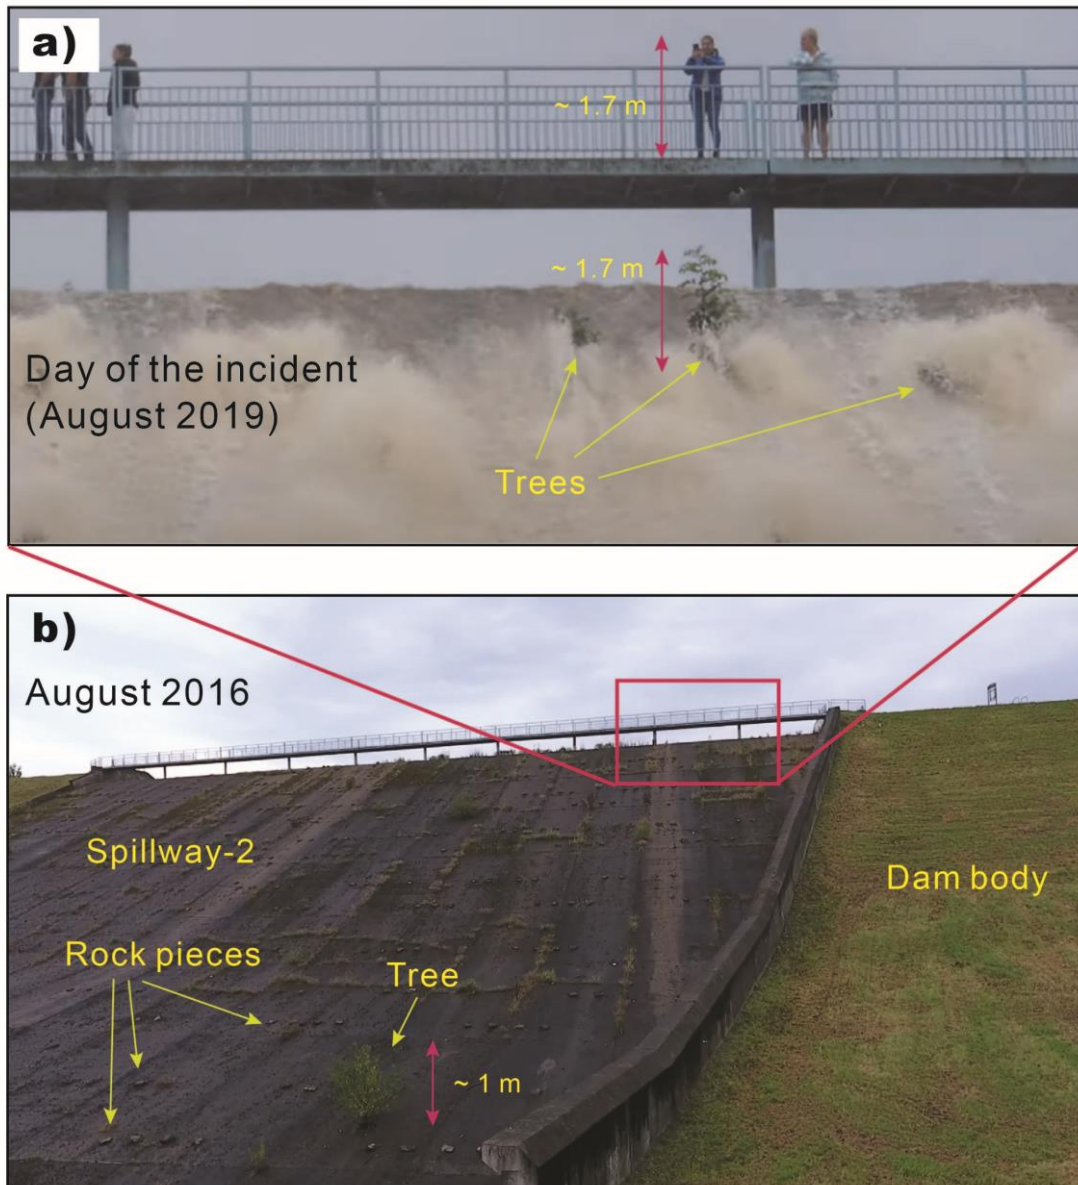
192 Analysis of photos and videos from the Toddbrook dam incident reveals that the concrete surface of the
193 spillway-2 was in a poor condition at the time of the incident. Dense vegetation including a few trees were
194 present on the surface of spillway-2 when high-speed flow was passing over it during the incident (Figure
195 6a). It is noted that at least three trees, one of them approximately 1.7 m tall, are seen at the damaged part of
196 the spillway during the incident. A review of satellite images of spillway-2 over the period of 1999 – 2020
197 (Figure 7) reveals that the spillway surface was cleaned up of vegetations and trees from time to time. For
198 example, the surface appears to be in a good condition in December 1999 (Figure 7f) and December 2005

203 In addition, the concrete surface of spillway-2 is embedded with numerous rock pieces (Figure 6b) at
204 certain intervals whose dimensions are approximately 22 cm (length) × 22 cm (width) × 22 cm (height)
205 (Heidarzadeh, 2019; Hughes, 2020; Balmforth, 2020) and some of them were removed before or during the
206 incident. It is not clear as why such rock pieces are placed on the spillway surface, but certainly they cannot
207 yield the hydraulic performance of chute blocks due to their small sizes and poor connection to the main
208 slabs. Rather, these small rock pieces could cause cavitation and damaging forces on the main slabs during
209 the passage of high-velocity flows. In addition, removal of some of these rock pieces could lead to increased
210 water injections beneath the slabs (Heidarzadeh, 2019; Hughes, 2020; Balmforth, 2020).

Figure 6. Photos of the Toddbrook dam’s spillway-2 from the day of the incident in August 2019 (a) and August 2016 (b) showing the growth of vegetation and several trees over the spillway. Photo in “a” is a snapshot from the video at: https://www.youtube.com/watch?v=_pOu5AHJ1U8&t=3s whereas the photo in “b” is from <https://www.youtube.com/watch?v=qQNh2lhYXBM>.

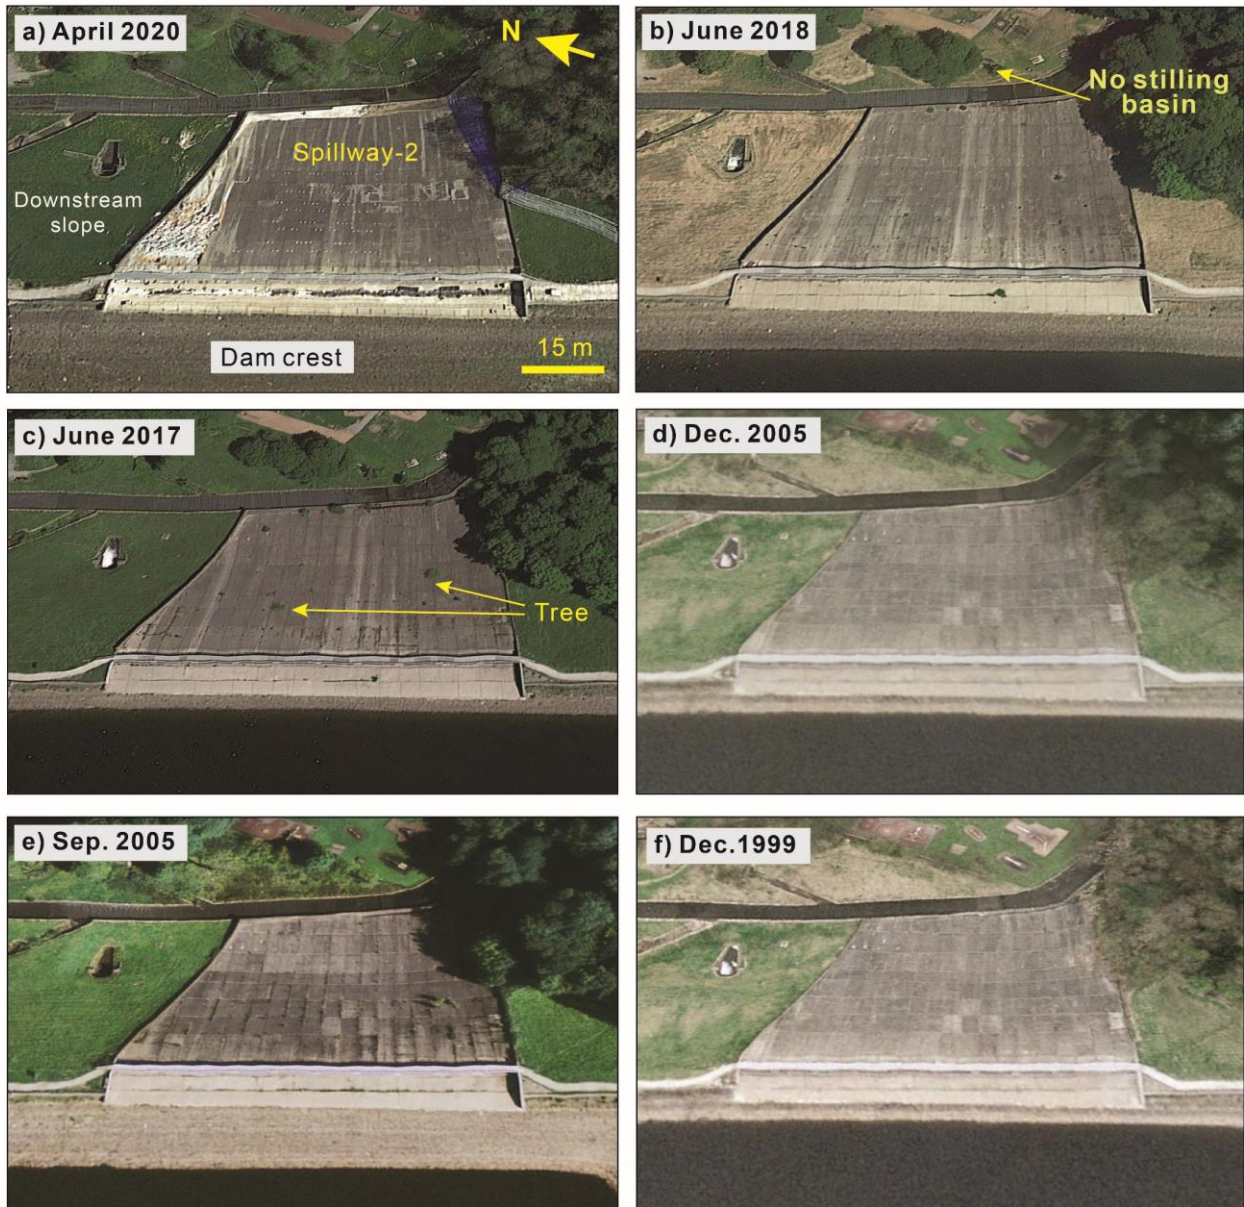
199 (Figure 7b), but it is covered with vegetation and trees in other times (Figure 7b,c,e). It is most likely that the
200 foundation of spillway-2 has been seriously undermined due to the extensive growth of vegetation and trees
201 over years; therefore, the concrete slabs were not resting on a solid foundation. As a result, any water
202 injection beneath the slabs could lead to erosion of the foundation and settlements of the slabs (Figure 8).

225 **Figure 7.** Satellite images of the Toddbrook dam spillway-2 at different times before and after the incident
 226 (August 2019) based on GoogleEarth data (<https://earth.google.com/>).

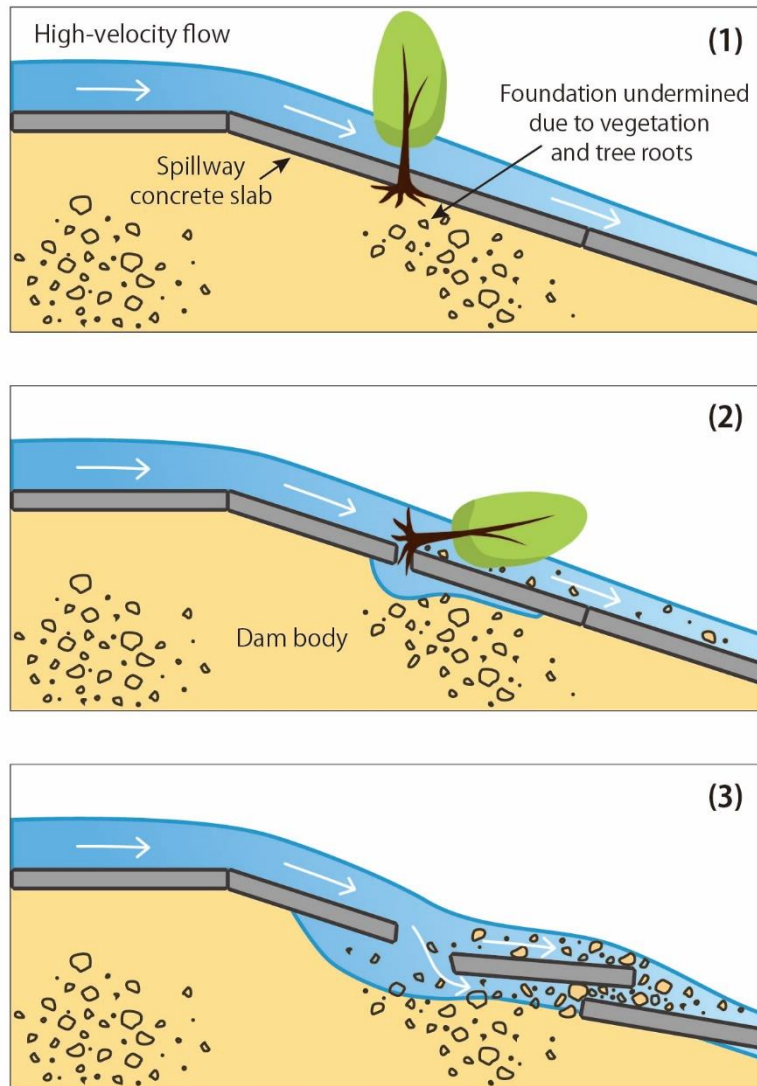
233 **Figure 8.** Sketch showing the sequence of events leading to the damage to the Toddbrook dam spillway-2 in
 234 August 2019.

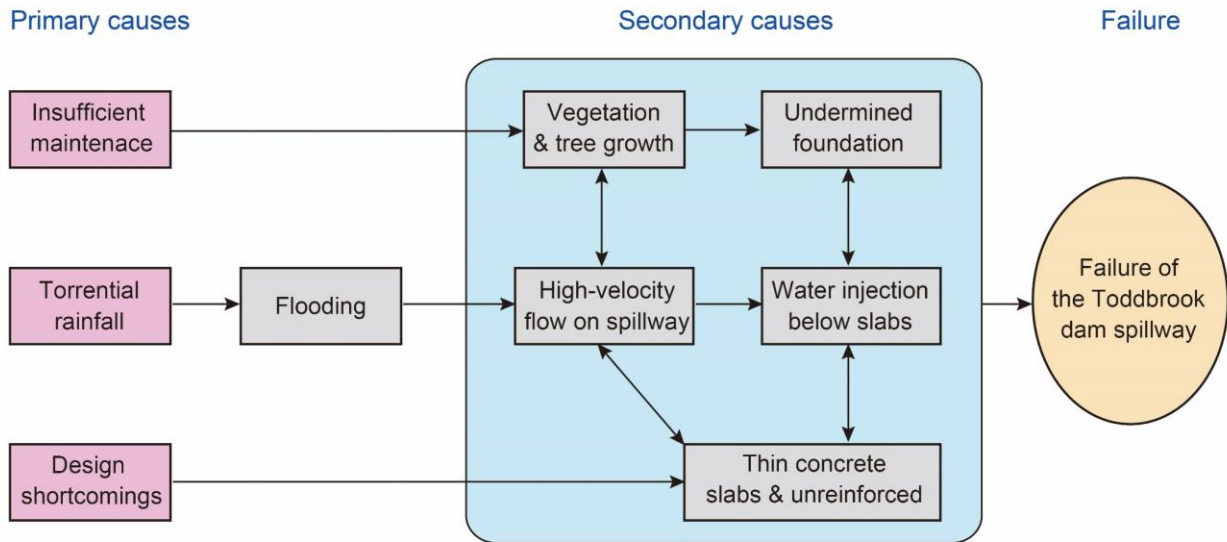
273 In summary, we attribute the failure of the Toddbrook dam spillway to a combination of three primary
274 factors comprising insufficient maintenance, design shortcomings and the torrential rainfall (Figure 9). Each
275 of these factors interacted with each other and cascaded to other causes to produce the failure of the spillway
276 (Figure 9). The construction joints and cracks, generated by vegetation and tree growth, largely facilitated
277 water injection beneath the spillway slabs. In addition, the foundation was significantly undermined over
278 years by extensive vegetation and the concrete slabs were relatively thin and under-designed (only 15 cm

279 thick and unreinforced). It is hard to exactly determine the contribution of each factor in creating the failure,
 280 but it is very likely that the failure was the outcome of a combination and cascade of different factors (Figure
 281 9).

283
 284 **Figure 9.** The cascading risk model showing a flowchart of events and various primary and secondary causes
 285 leading to the damage to the Toddbrook dam spillway-2 in August 2019.

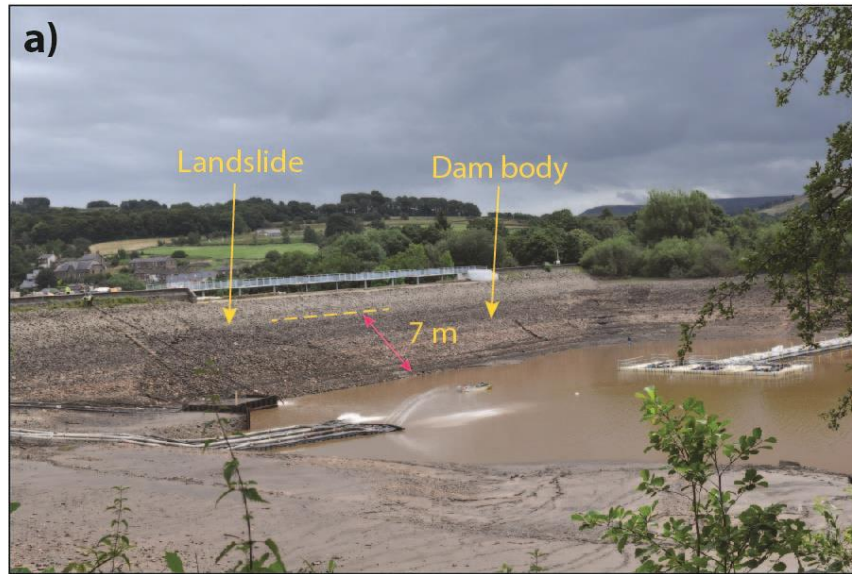
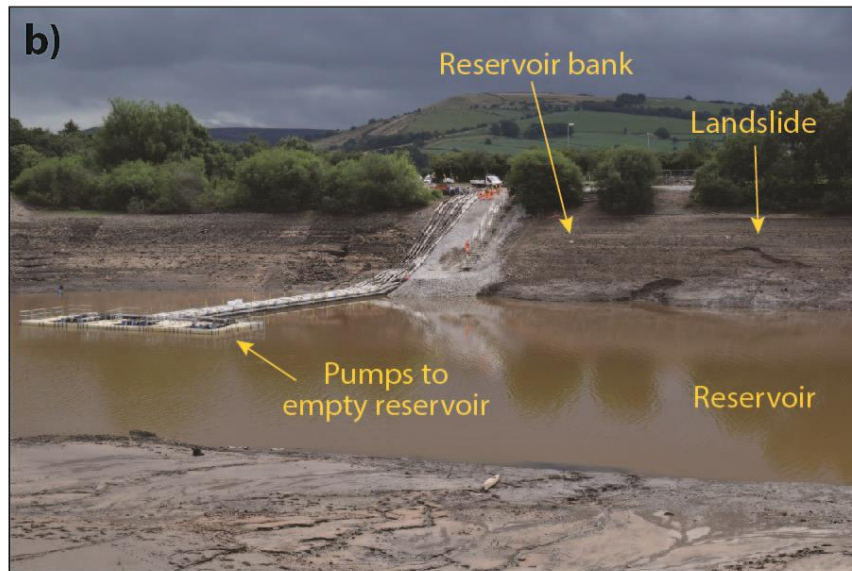
294 upstream slope of the embankment, which has a height of approximately 7.0 m (Figure 10a). Other
295 landslides occurred on the reservoir banks (Figure 10b). These landslides are evidence that the process of
296 decreasing reservoir water level occurred at a high speed, which posed a risk for the safety of the dam.
297 Although the landslides are minor and they did not create major risks, larger movements of the landslide on
298 the downstream slope of the dam could result in a major damage. In addition, large landslides on the banks
299 of the reservoir can generate large waves in the reservoir, which could overtop the dam.

Figure 10. Several landslides observed following the rapid drawdown of the Toddbrook reservoir in August 2019. a) Photo showing a landslide on the upstream side of the embankment. b) Photo of a landslide in the banks of the reservoir.

408 • We observed a landslide on the upstream slope of the dam as a result of the rapid drawdown, which
409 was reconstructed through our geotechnical modelling. This implies that a slower pace must have
410 been taken during the process of emptying the reservoir.

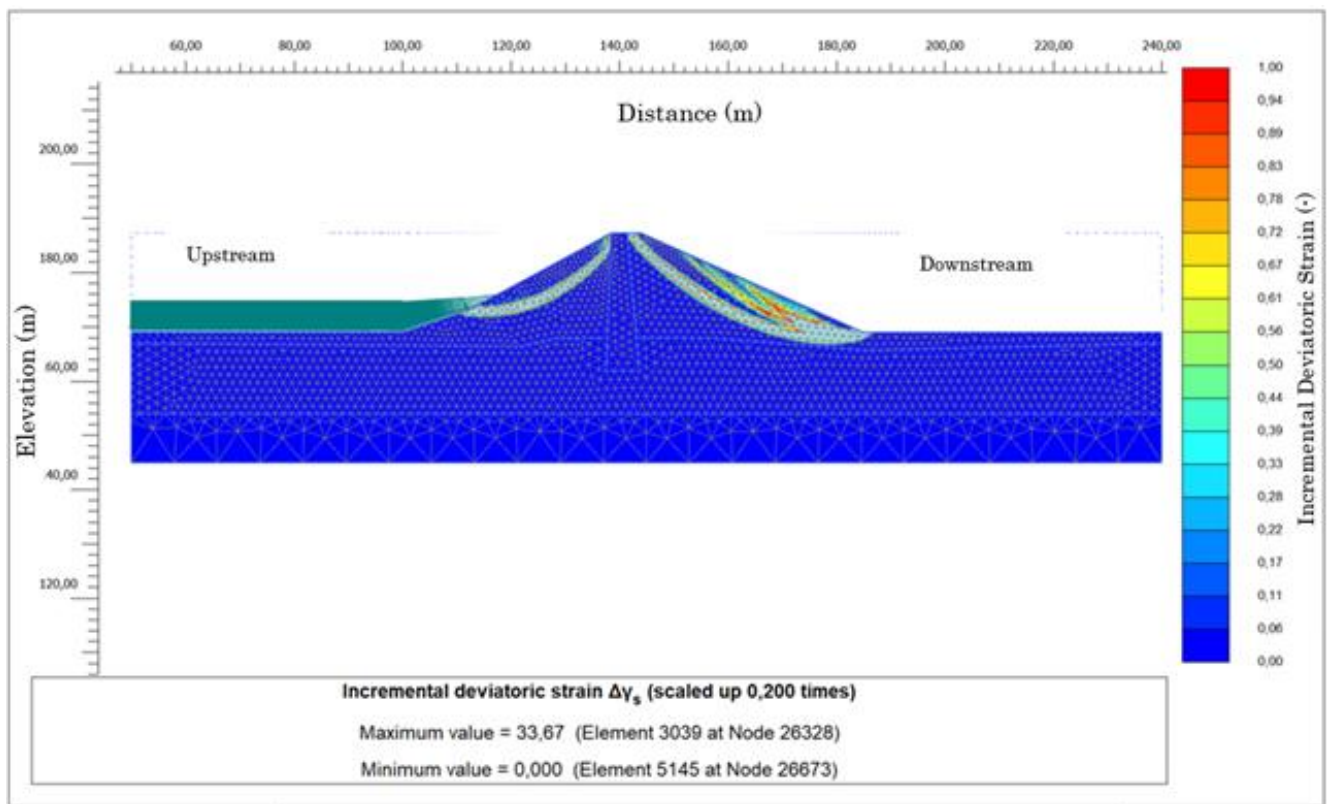
322 Figure 12 shows the results of dam stability analysis under the rapid drawdown situation. In case of rapid
323 drawdown from water level of 186.0 masl to a water level of 176.0 masl, the failure mechanics is observed at
324 the upstream side of the dam and many local failures and holes are generated resulting in a safety factor of
325 marginally below 1.0 (Figure 12). At the water level of 176.0 masl, however the factor of safety of the entire
326 dam is above 1.0 indicating that the failure of the entire dam is not likely, but parts of the upstream slope of
327 the dam are damaged (Figure 12). This means that the dam operator will need to introduce measures to repair
328 the damaged surfaces. The results of our PLAXIS modelling of the rapid drawdown are consistent with field
329 observations of the dam site following the incident, which identified a landslide on the upstream side of the
330 dam (Figure 10a).

367 **Figure 12.** The result of reservoir rapid drawdown analysis of the Toddbrook dam using the PLAXIS
368 modelling package during the August 2019 incident.

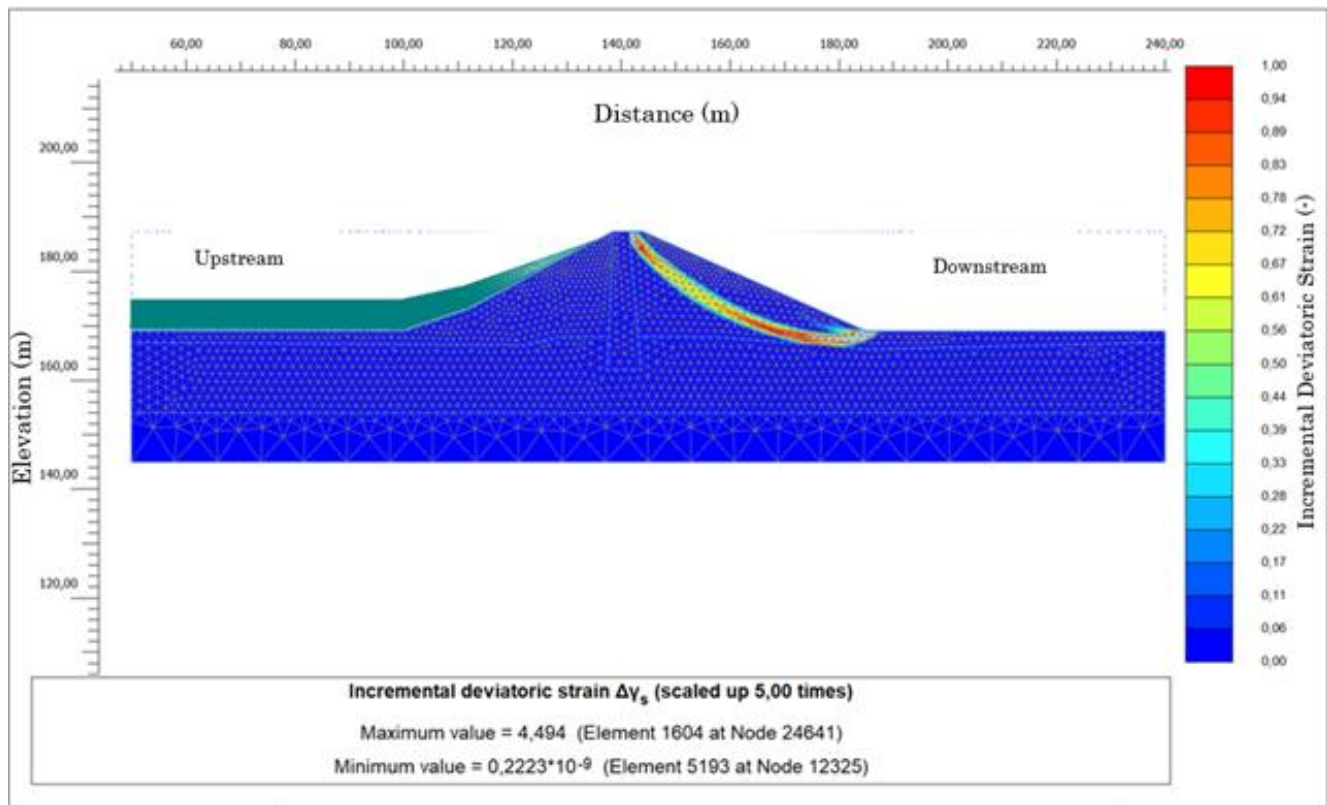
375 Figure 13 shows the results of the overall dam stability when the water level is at 186.0 masl. Results
376 indicate that, at such a high water level (i.e., 186 masl), the water pressure makes the upstream slope of the
377 dam more stable; therefore, the probability of occurring a failure at the upstream side of dam is low as long
378 as overtopping of the embankment does not occur. It is needless to say that, in case of overtopping, the entire
379 dam could be washed away in a few hours as soil embankments are very vulnerable to flowing water.

380 Analysis shows that the factor of safety at this water level (i.e., 186.0 masl) is marginally above 1.0 and the
381 main failure surface occurs at the downstream side of the dam (Figure 13).

384 **Figure 13.** General stability analysis of the Toddbrook dam slopes using the PLAXIS software during the
 385 August 2019 incident.
