## STIFFENER AS A SPECIAL DESIGN SOLUTION FOR PRESSURE VESSEL REPAIR

Originalni naučni rad / Original scientific paper  
UDK /UDC:

- 1) Reversible Hydropower Plant 'Bajina Bašta'
- 2) University of Belgrade, Innovation Centre of the Faculty of Mechanical Engineering, Belgrade, Serbia
- 3) University of Belgrade, Faculty of Mechanical Engineering, Serbia email: [asedmak@mas.bg.ac.rs](mailto:asedmak@mas.bg.ac.rs)

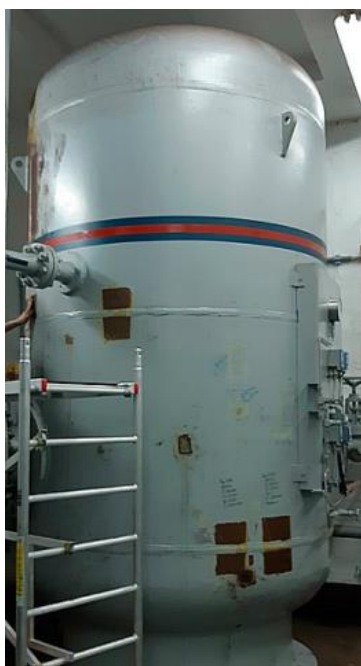
After long-term operation, defects are found in welded joints in pressure vessel 970, Fig. 1. Given the high price and often the inability to purchase new working parts, there is a need for repairs. As mentioned above, after a long exploitation of the parts, defects are noticed, that can compromise the integrity of the structure.

Figure 1. The pressure vessel 970, before repair.

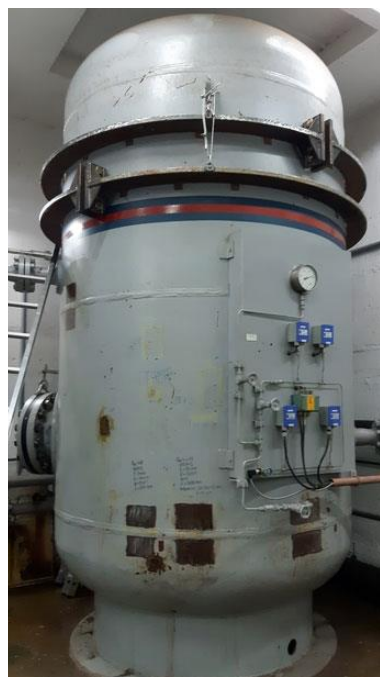
Figure 2. The pressure vessel 970, after repair with stiffener.

Defect 5.6 in vessel 970 presents a high risk, but in this case removal by repair welding was not a practical solution, so a special design solution is successfully made in the form of a stiffener to reduce the stress.

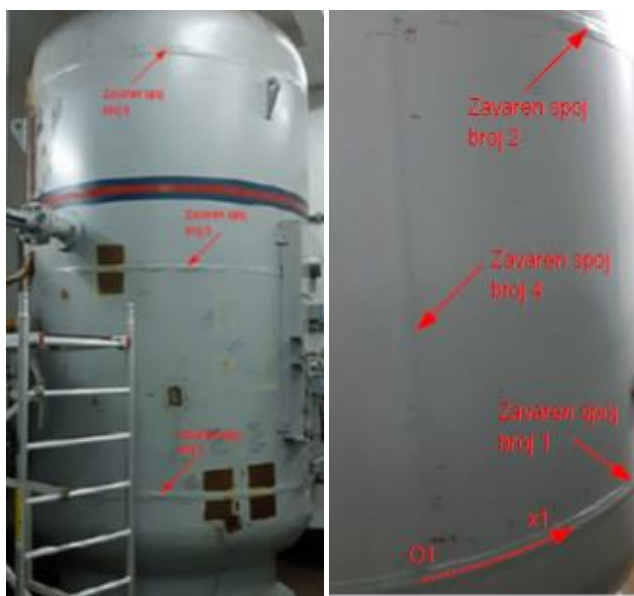
Vessels are made of microalloyed steel Nival 50, with pressure in vessel 970  $p = 81$  bar; thickness  $t = 50$  mm; and diameter  $D = 2150$  mm. The vessel 970 was inspected by 100 % ultrasonic testing of two vertical and three circular welded joints. Nine unacceptable indications (1.1-1.4, 5.1-5.4 and 5.6), as well as one with an echo height above the registration level (5.5) were detected.

Figure 3. Tested welded joints (marked by red arrows) on vessel 970, before repair.

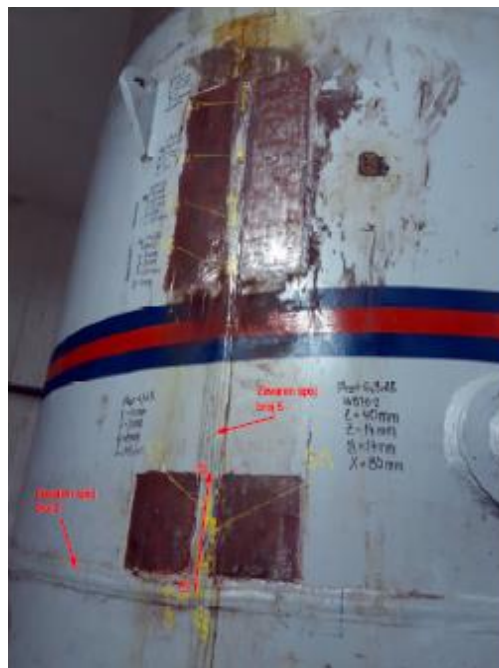
Figure 4. Tested welded joint 5 on vessel 970, before repair.

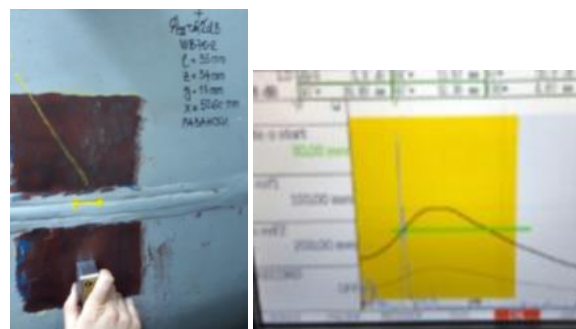
- defect 1.4; length 35 mm and width / depth 22 mm in the central circular seam, from 28 to 50 mm,
- defect 5.6; length 75 mm and width / depth 20 mm in the central circular seam, from 18 to 38 mm.

Figure 5. Position and size of defect 1.4 in vessel 970.

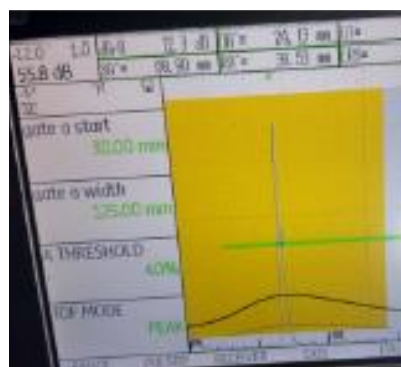
Figure 6. Position and size of defect 5.6 in vessel 970.

Risk-based analysis has been successfully used in recent years to evaluate possible effects on pressure vessel safety, /6-12/. As for the pressure vessel 970, since the risk was at a very high level, close to the worst case of the probabilities and consequences, and the position was not suitable for the repairer by welding, it was decided to make a stiff ring in order to reduce the stress on the welded joint, so that both the stress intensity factor and the stress acting on the defect 5.6 become significantly reduced.

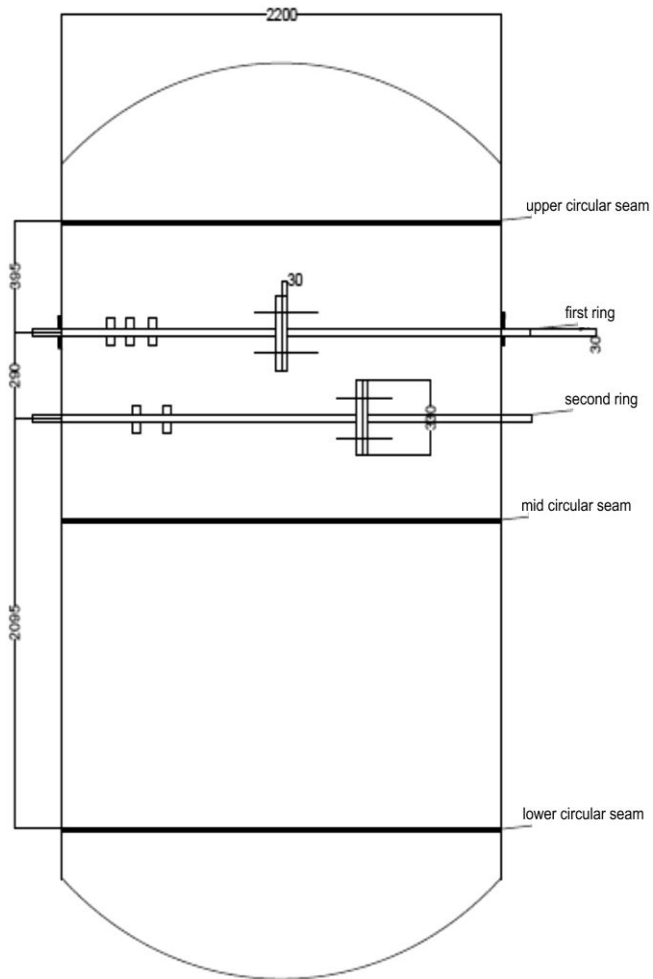
Figure 7. Scheme of vessel 970 reinforcement with outer stiffeners.

After the finished calculation, the scheme for installation and assembly of the stiffener on the vessel 970 are made, Figs. 7-9. The first stiffener had 16 plates, the second one 17, all of them are 5x50 mm.

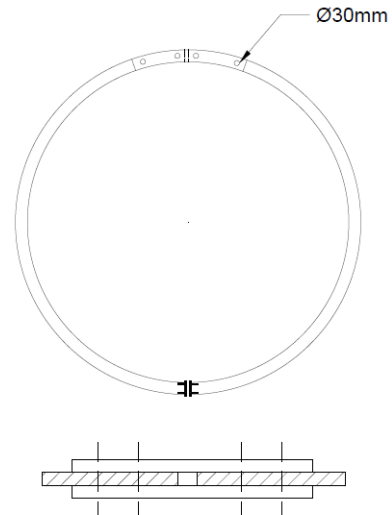
Figure 9. Schematic solution of connecting half of the rings.

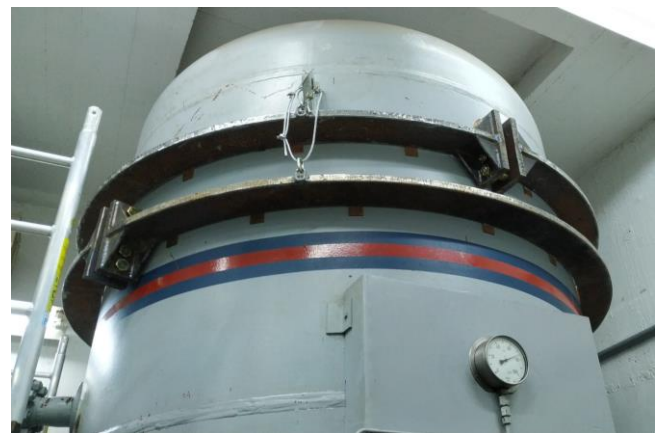
Figure 10. Details of the two-ring reinforcement solution.

After making the plan for the assembly and erection of the stiffener, it was successfully installed on vessel 970. Details are shown in Figs. 10-12.

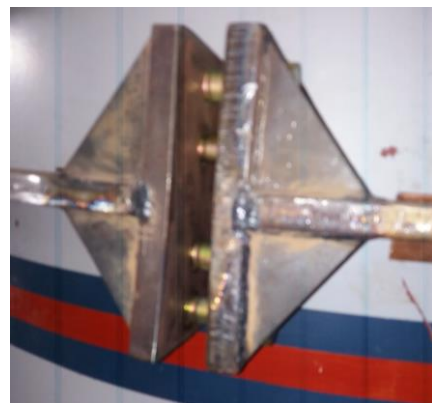
Figure 11. Flange joint details.

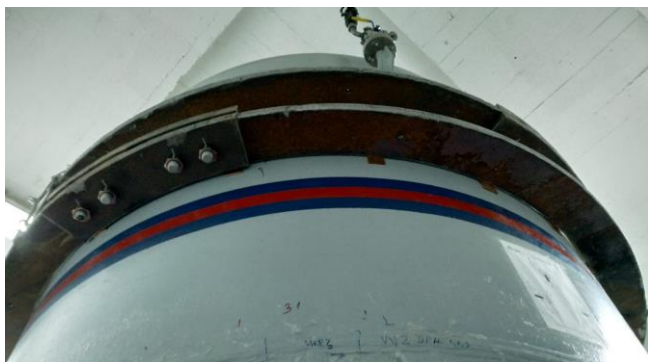
Figure 12. Stiffener bonding with 4 screws M30 (class 8.8).

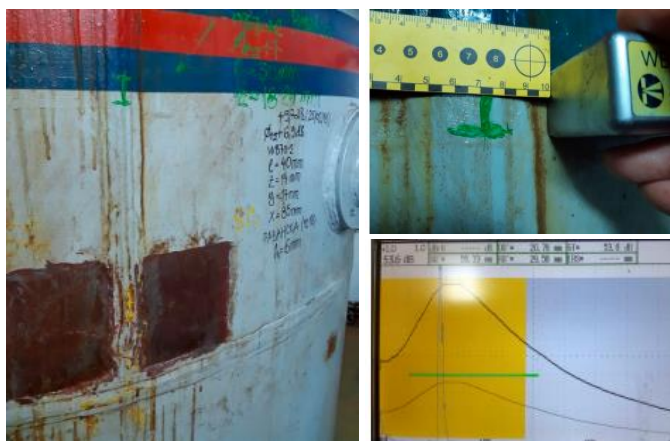
Only some details of the NDT inspection of vessel 970 after the erection of stiffener is presented. Figure 13 shows details of NDT inspection of vessel 970. It should be noted that after placing the stiff ring, the NDT methods show that the defect on the vessel 970 has not changed.

Figure 13. Ultrasonic examination of vessel 970, after repair.
