Use of Non-Destructive Tests for the Assessment of Integrity and Service Life of Hydro-Mechanical Equipment

Keywords: hydro turbine, non-destructive testing, degradation of material, structural integrity

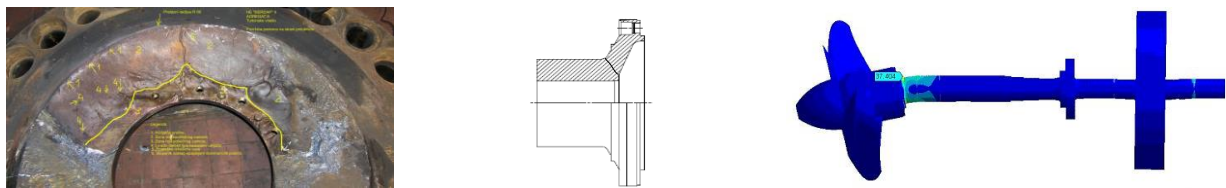
After more than 20 years of operation, at 1 of 10 hydroelectric generating unit turbine shafts a through-thickness crack and fracture were detected, Fig. 3, while at other turbine shafts cracks (damages) were detected and repaired through the use of an adequate repair welding technology, Fig. 4. Cylindrical section of the shaft was made of steel 20 SL, while flange was made of cast steel 20 GSL, in accordance with GOST 977/88.

Figure 3. Appearance of the fracture of the horizontal Kaplan turbine shaft, nominal power 28 MW

It was determined that fracture and damaging of turbine shafts at HPP Djerdap 2 were caused by small transitional radii between the cylindrical part of the shaft and flange, as well as by corrosion fatigue. Transitional radius was enhanced from $R=80$ mm to $R=100$ mm through the implementation of the repair welding technology for the turbine shaft, [1].

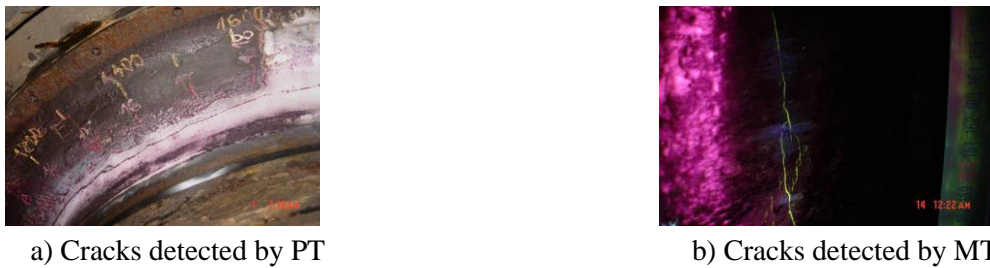
a) Cracks detected by PT

b) Cracks detected by MT

Figure 4. Appearance of cracks detected at turbine shafts

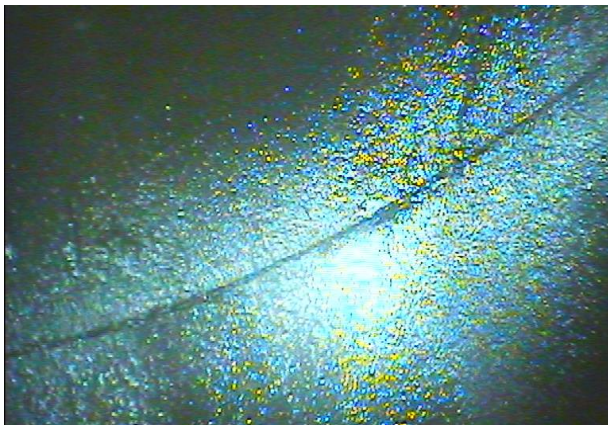
a) Incomplete root penetration – endoscopy

Figure 6. Appearance of characteristic damages that occur during the production and exploitation of pipes and elbows

On the basis of experimental tests the evaluation of the global deformation behaviour of welded pipes and elbows of turbine regulation system was executed, through the use of elasticity theory and three-dimensional elastic-plastic finite element analysis and depending on parameters that refer to the quality of welded joints and wall thinning, such as: type and location of defects in welded joints, decrease of wall thickness, length of section with thinned wall, circumferential angle of the elbow for different types of bending and various geometric characteristics of elbows. It was determined that the pressure which could be considered critical for the integrity of welded pipes and elbows, with defects that occur during production and exploitation, is $p=10$ MPa, [2].

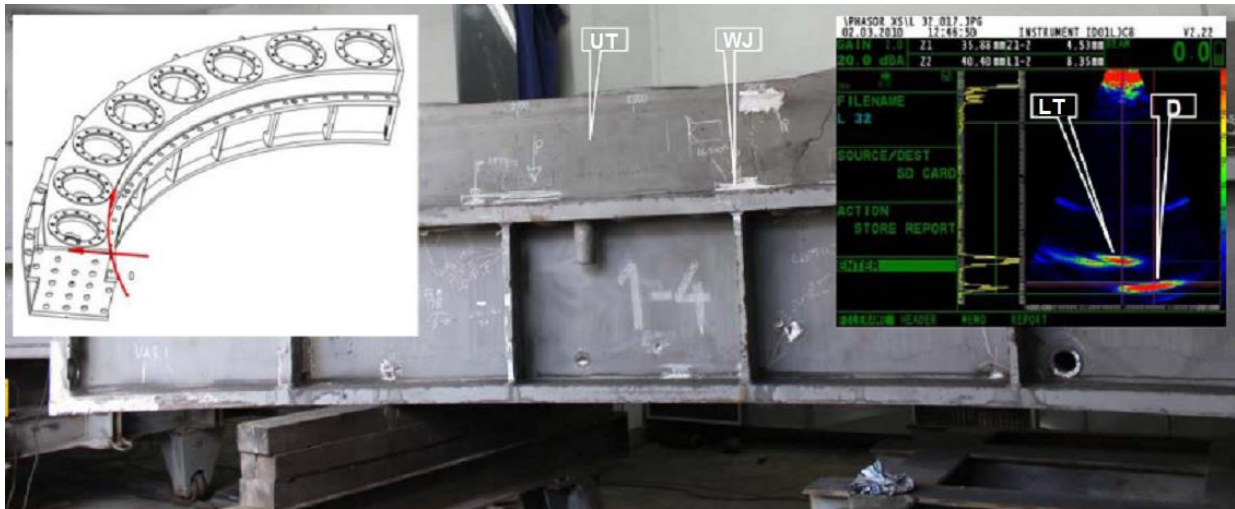
The upper ring of the turbine runner guide vane apparatus was fabricated by welding 4 segments made of steel St 3 together, in accordance with GOST 977/88, by flux-cored arc welding. Through magnetic particle testing a large number of fatigue cracks was detected at all 4 segments, while incomplete penetration and lamellar tearing (LT) and defect (D) were detected in the root area by ultrasonic testing, Fig. 7.

Figure 7. Display of results of ultrasonic testing performed at one of the segments

By comprehensive researches, executed on the basis of results of non-destructive tests, it was established that there are two equally significant causes of degradation of parent material and welded joints of the upper ring of guide vane apparatus, which is a constitutive part of the turbine runner, [3]:

- degradation caused by defects that occur due to steel production technology,
- degradation caused by defects that occur due to technology of fabrication of the welded structure.

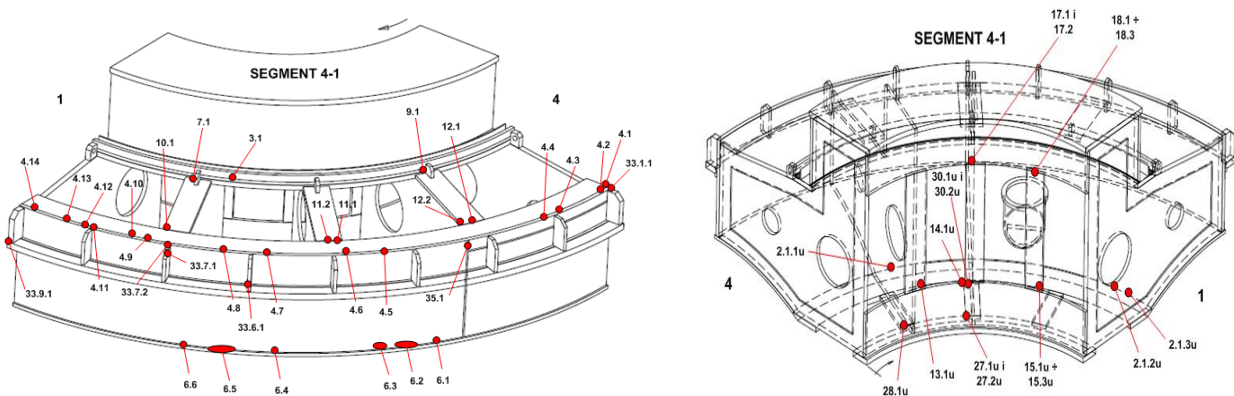
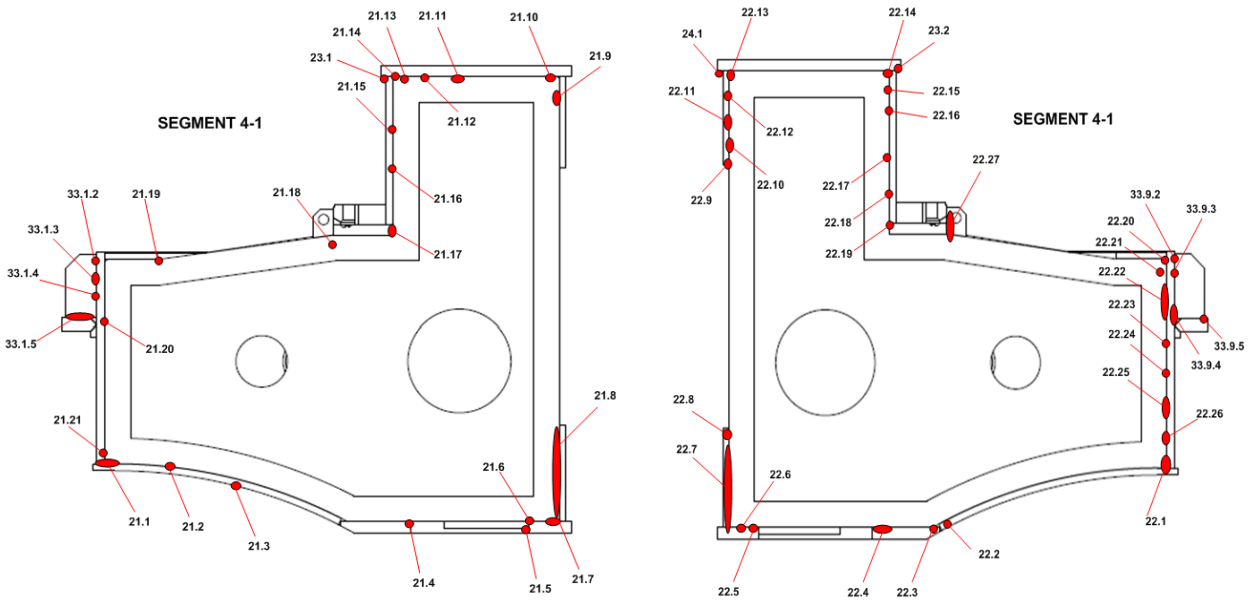
Turbine cover, which weighs 118636 kg, was fabricated by welding 4 segments made of steel St 3 together, in accordance with GOST 977/88. Models and results of magnetic particle testing (MT) carried out at welded joints of a turbine cover segment are presented in Fig. 8, Fig. 9 while Fig. 10 displays echographs taken during ultrasonic testing which show lamellar tearing in the area of the welded joint.

Figure 9. Results of magnetic particle testing (MT) performed at welded joints of a turbine cover segment

Linear indications that were detected at welded joints by magnetic particle testing are fatigue cracks that occur as a consequence of variable loading to which the turbine cover is subjected during service, while incomplete penetration of the root is a direct consequence of inadequate welding technology used during the fabrication of the structure, while lamellar tearing of parent material in the near proximity of welded joints is a direct consequence of the use of inadequate technology of steel production and flaws in the technology of fabrication of the turbine cover as a whole. Analysis of condition, integrity assessment and residual service life evaluation for the turbine cover is presented in the report, [4].

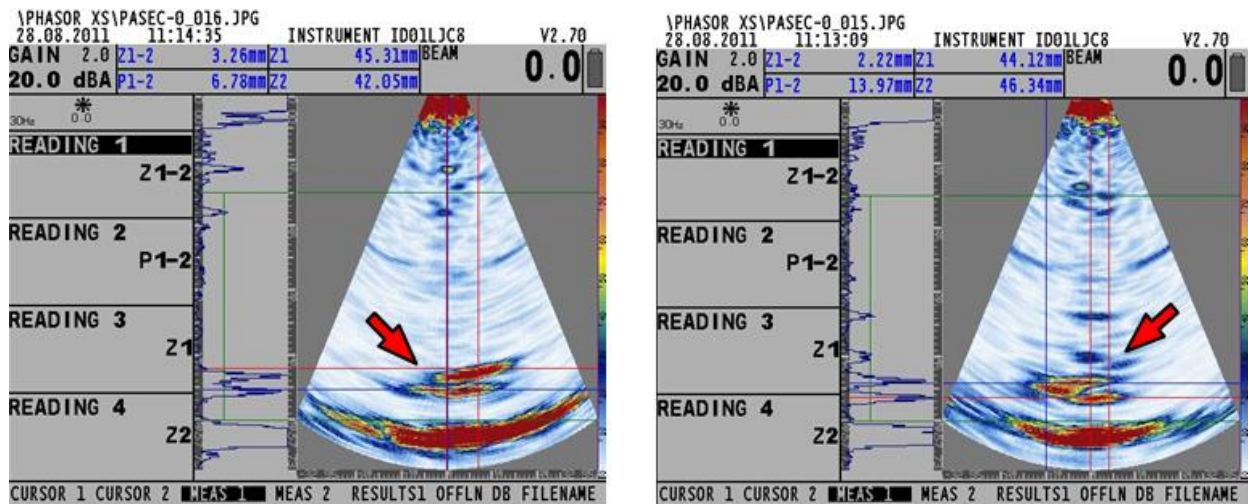
Figure 10. Display of echographs with lamellar tearing in the area of the welded joint

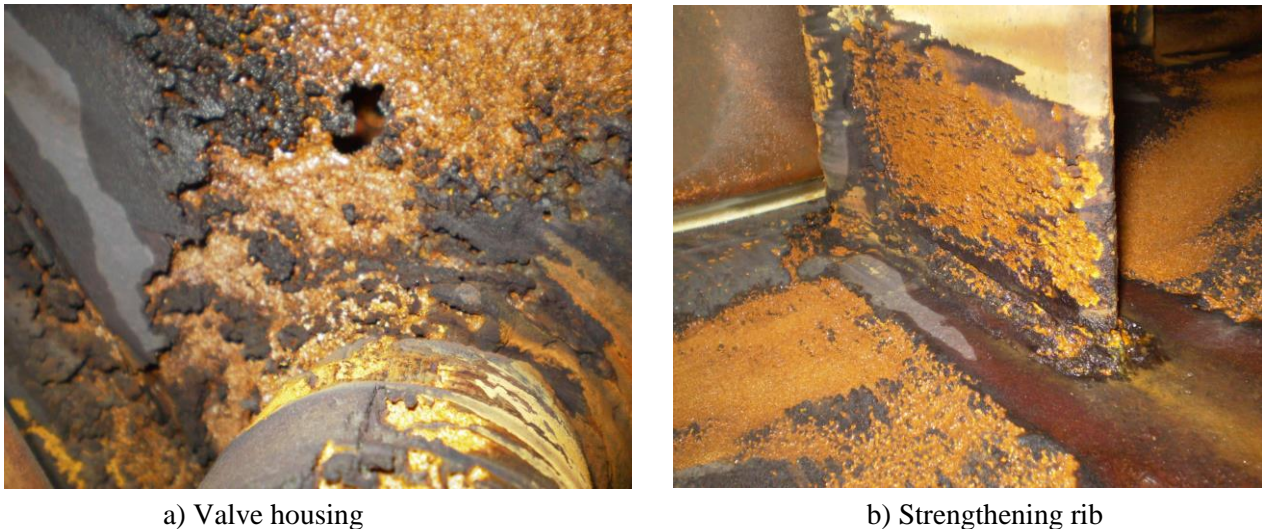
Function of the synchronous valve is to protect the runner and runner blades from the hydraulic impact of water when the turbine stops, or in other words to drain the water from the turbine when it stops working, because the water at that moment possesses such kinetic energy that it could cause the breakdown of the hydroelectric generating set as a whole. Test results showed that damages that occurred were caused by corrosion, erosion and cavitation, Fig. 11.

a) Valve housing

b) Strengthening rib

Figure 11. Damages detected at the synchronous valve

By determination of causes of degradation of parent material and welded joints of the Francis turbine synchronous valve, based on results of non-destructive tests, it was enabled to make a decision regarding the rehabilitation procedure. Taking into account the fact that damages caused by corrosion, erosion and cavitation were up to 10mm deep, repair of damages was executed by surface welding, [5].
