Concluding destructive investigation of a nine-year-old marine-exposed cracked concrete panel

ABSTRACT

The experimental study investigated a cracked reinforced concrete panel made from plain Portland cement after nine years of marine exposure, from June 2011 to October 2020.

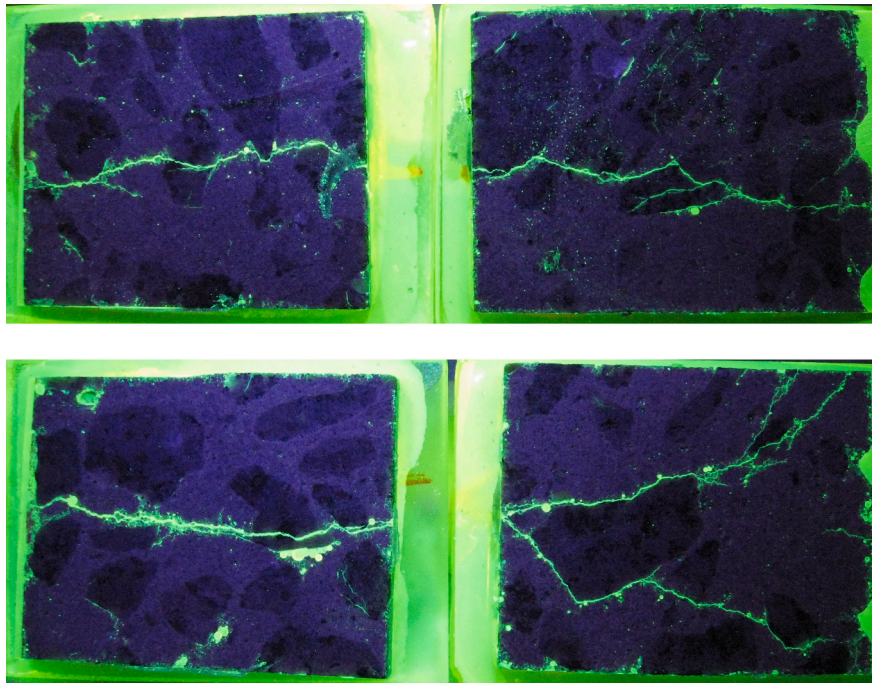
Fig. 6 shows impregnated pieces cut off after thin sectioning prepared from cores from the tidal (C2) and submerged (C5) exposure zones of the panel. Open cracks are observed to reach the reinforcement level in both cores.

One crack is seen in core C2 from the surface of the concrete to the imprint of the rebar. The crack traverses aggregate and occasionally splits into smaller cracks. The main crack has a width of 60–80 μ m at the surface and narrows to 15 μ m at the rebar. The cracks are generally open, but the main crack is bridged by calcite for the last 0.2 mm up to the surface.

The initially introduced crack in core C5 is seen from the surface of the concrete to the imprint of the rebar. An empty crack, possibly formed when the rebar was removed from the concrete, has been generated along this crack. The initial crack traverses aggregate and occasionally splits into smaller brittle cracks. The main crack has a width of 200 μ m at the surface and narrows to 13 μ m at the rebar. The initial cracks are generally open, but the main crack is bridged by calcite for the last 3 mm up to the surface.

The petrographic investigations indicate that the cracks are still open, as seen in fluorescent light mode (Fig. 6), but various deposits are seen on the crack faces and in the crack. These deposits were identical in the two tidal (C2) and submerged (C5) exposed cores and were as follows from the exposed surface and inwards in the crack: calcite, followed by brucite, and deeper inside the cracks, first portlandite (calcium hydroxide, $Ca(OH)_2$) and then ettringite. These observations are similar to observations made on cores from the cracked beams of three different types of infrastructure concrete after 25 years of marine exposure [20]. Table 8 summarizes the findings from the petrographic study and shows the depths from the surface to which the deposits were observed. The petrographic study also showed shallow and uneven carbonation of the outer exposed surfaces (C2: 0–1.2 mm, C5: 0–2 mm), as well as shallow carbonation along the crack faces at greater depths from the exposed surfaces (C2: 0.8–20 mm, C5: 3–8 mm) and carbonation in part of the

Fig. 6. Fluorescent impregnated thin sections (two per core) showing impregnated (green) cracks in cores C2 (tidal exposure) and C5 (submerged). The exposed surface is to the left in the left-hand thin sections, and the imprint after the rebar is to the right in right-hand thin sections. The dimensions of the fluorescent impregnated pieces cut off from the thin sections are 30 × 45 mm².

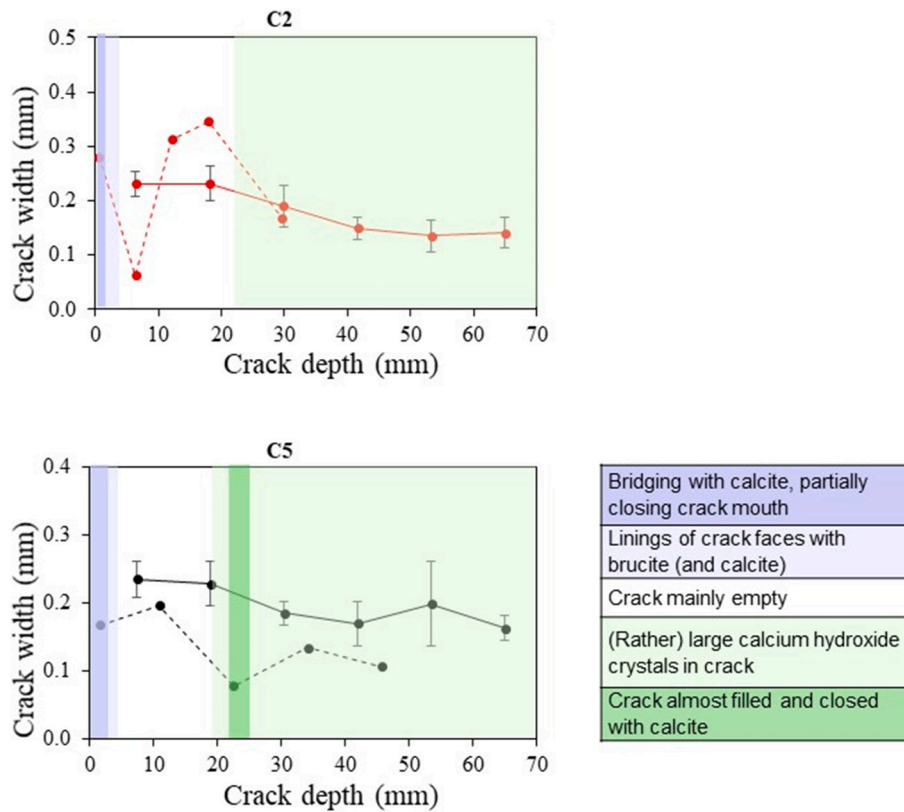
Fig. 12. Comparison of crack characterization using μ -CT (equivalent crack width (dotted line) and measured mean crack width (solid line), data from Fig. 8) and zones identified using petrography (data from Table 8) for cores C2 (tidal exposure) and C5 (submerged exposure). (For interpretation of the references to colour in this figure legend, the reader is referred to the web version of this article.)

surface. After nine years of submerged marine exposure, the observation of a reduced crack area can be explained by the precipitation of calcite, brucite and portlandite crystals, partly closing the crack near the exposed surface. If we generalize the findings from this study and consider a vertical surface, it should be noted that horizontal cracks (as in this study) are expected to have a greater ability to self-heal than vertical cracks [21].
