## CONSERVATION OF THE LATE ROMANESQUE SANDSTONE PORTAL OF THE CHURCH OF THE PREMONSTRATENSIAN CONVENT IN KRAKÓW, POLAND

### Abstract

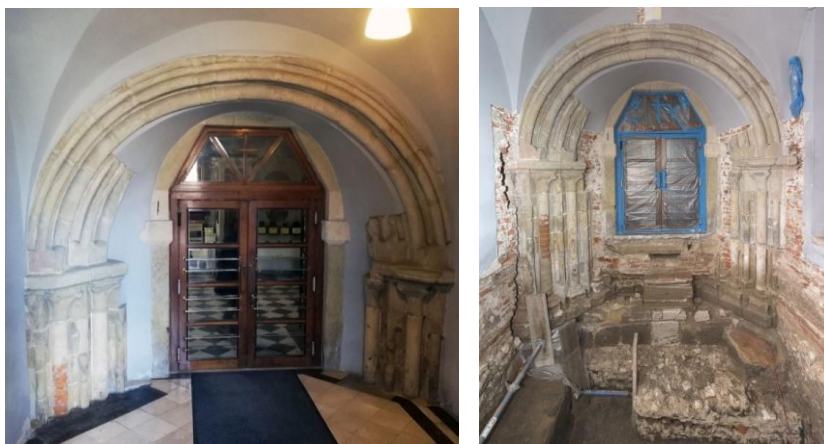
**Fig. 1.** The condition of the portal before the works in 2019 and after the completion of archaeological research in 2020

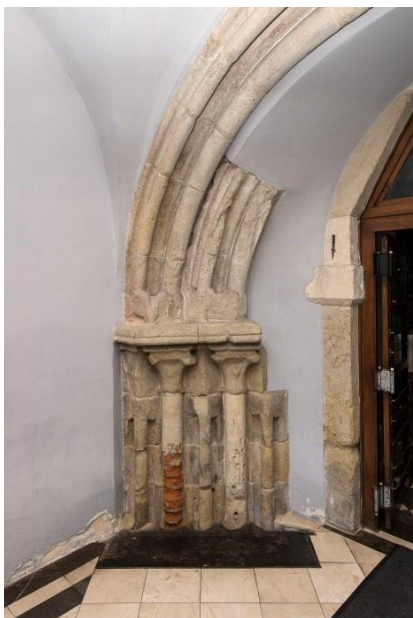
**Fig. 2.** A section of the portal, with visible decay of the material and the brick infill replacing a section of the former column. Condition before the removal of the bottom parts

5. In parallel, the brick infill added later to the portal will be replaced. A study of the distribution of salt concentration in the samples collected from the brick infill in the portal confirmed the typical feature of salt accumulation in the parts close to the surface. This indicates the ongoing process of migration of moisture to the surface of the materials, and the need to replace the brick infill due to the concentration of salt within it [33]. The infill ideally fulfils the role of a “compress”, which should be repeated by installing a new one, on principle with greater capacity of absorption by weight and porosity higher than that of the original

sandstone. Thus, once the process of salt removal has been completed, the brick infill will be replaced by stone with the abovementioned properties.

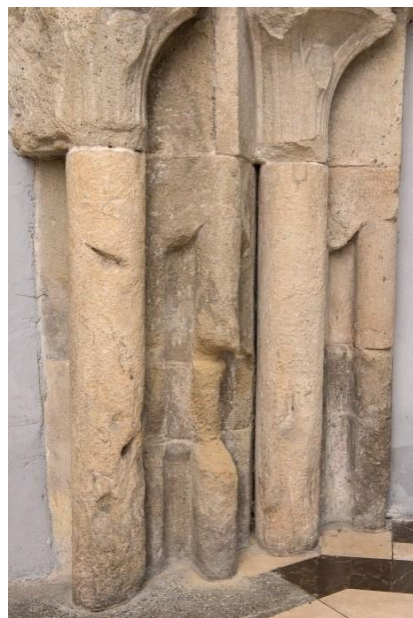
**Fig. 3.** A section of the portal, with visible damage of the elements of the portal jamb. Condition before the removal of the bottom parts

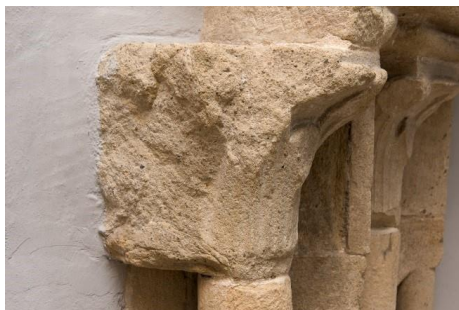
**Fig. 4.** Damages of the stone column capital

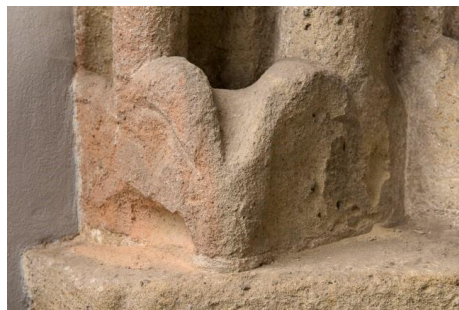
**Fig. 5.** Damage of the wavy archivolt base

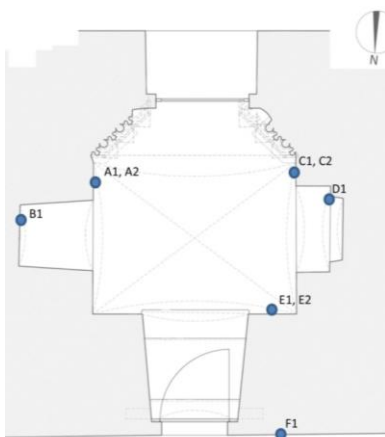
**Fig. 6.** The plan of the porch by the portal of the Church of St Augustine and St John the Baptist in the complex of the Premonstratensian Convent in Kraków's district of Zwierzyniec. Blue marks the locations of boreholes used to collect samples for examining dampness and salt contamination of the walls by the portal

In most cases the level of moisture indicated moderate to severe wall dampness. There are no regular moisture trends in the walls, and mass humidity does not decrease with the distance of the measuring site from the floor. In most cases, the samples collected from the deeper sections of the wall had higher concentrations of moisture.

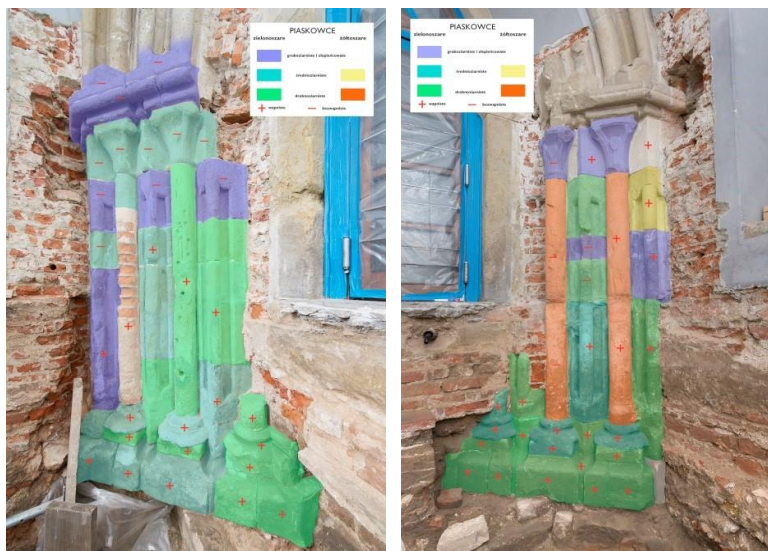
Fine- and medium-grained sandstones of green-grey colour with calcite content, most of them compact, have been well preserved (Fig. 7).

**Fig. 7.** Breakdown of the sandstones used for the jambs of the portal according to their colour, grain, and presence of calcium carbonate

They were chiefly used for the base and plinth of the portal. Some of the fine-, medium-, coarse-grained, and conglomerate sandstones of low or no calcite content of green-grey and yellow-grey colours are compact while others are hardly compact and crumbling. They were used for the columns and their capitals, and the archivolt.

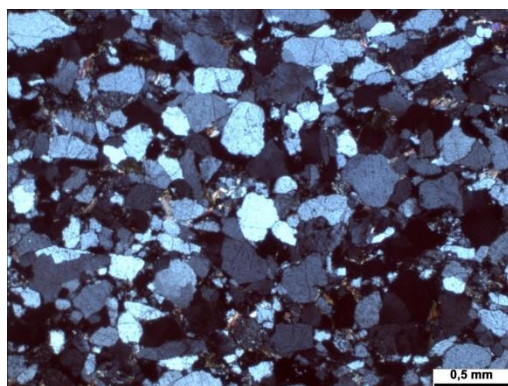
Sandstones in samples 2 and Np-2 have strongly packed clastic material, which results in numerous intrusions and intergranular contacts (Fig. 8).

**Fig. 8.** Sandstone from the church of the Premonstratensian Convent in Kraków (sample 2). Microphotography, cross-polarised light

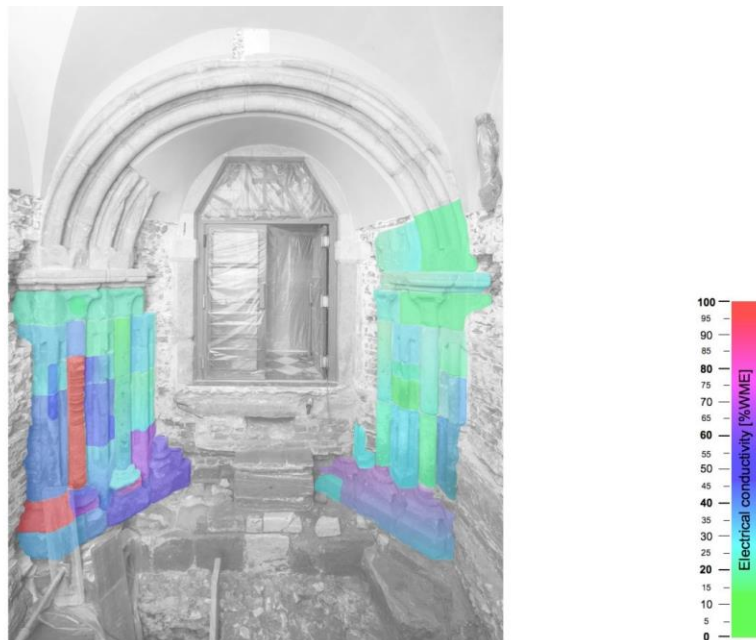
The lower parts of the portal and the left-hand jamb, in particular the brick portal infill and a section of portal base adjacent to it, conduct electricity better. Electric conductivity of materials depends on a number of factors, including the density of the tested material and the share of hygroscopic salts. However, it is moisture that provides the main factor influencing the

Fig. 10. Results of tests of electric conductivity of the stones of the portal

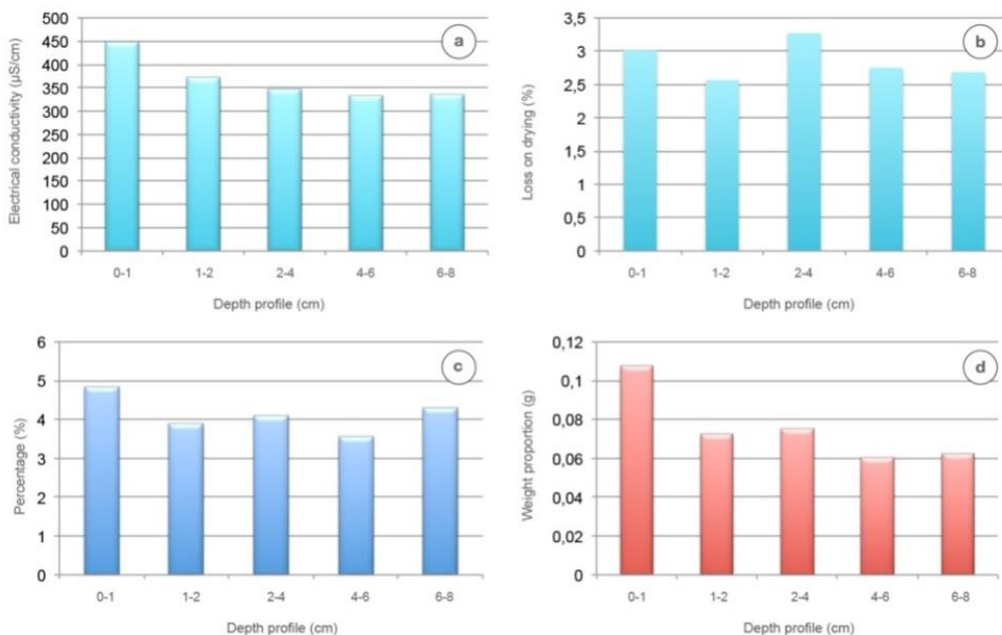
conductivity ranged from 448 to 332 $\mu$ S/cm. Salt is present at the levels ranging from close to 5 to 3.5% (Fig. 11a). The same observation applies to moisture loss of the sample after drying, where salt content ranges from 2.5 to 3% (Fig. 11b).

**Fig. 11.** a) Electric conductivity, b) The loss on drying of the samples, c) % share of salt in the drilling dust from the samples d) Soluble matter in the samples by weight
