Analysis and restoration of ancient masonry structures

Guidelines and Examples

PAULO B. LOURENÇO

University of Minho, Department of Civil Engineering, 4800-058 Guimarães, Portugal

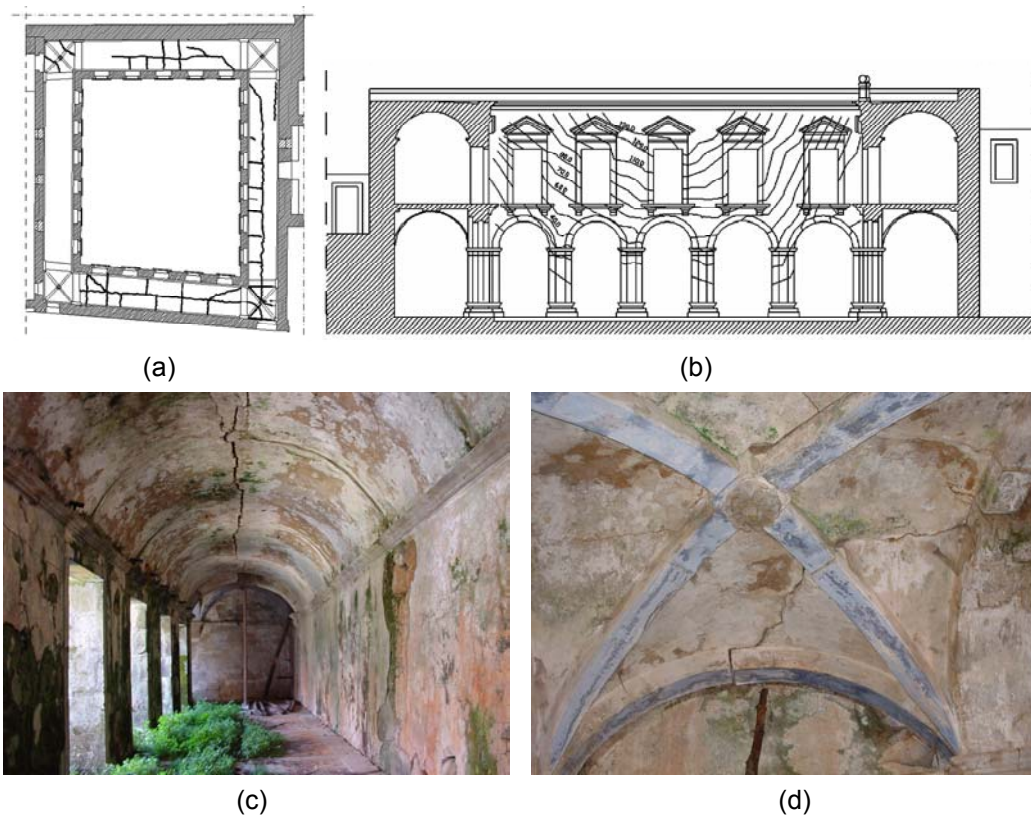
The largest and widest set of cracks occurs in the barrel vaults of the 2nd level, as well as in two corners. The cracks occur mostly in the longitudinal direction, even if some transversal cracks also occur, up to a crack opening of 40 mm. The vaults of the first level exhibit also cracks, up to a crack opening of 15 mm. One wing is supported on temporary wooden poles. The walls exhibit widespread cracking at the 2nd level and almost no cracking at the 1st level. With the exception of a few localized areas, cracking is minor (crack openings in the range of 1 to 5 mm). Vertical displacements up to 35 mm were measured at the key of the crossed vaults of the 1st level. But all the walls of the cloisters exhibit large horizontal movements that lead to the separation between the vaults and the walls, in a clear lack of verticality. The out-of-plumb displacement of the internal walls reaches values of up to 0.18 m. Several brackets supporting the crossed vaults of the first level show signs of compressive crushing. The tilting movement of the walls can explain

this. The absence of connection between the infill of the crossed vaults and the walls resulted in a very localized area to transfer the load, i.e. only the brackets. Also, a significant number of bricks show deterioration, particularly around the cracked areas. This occurs in both levels and can be explained by frost-thaw cycles and water infiltration, as the amount of rainfall per year in the region is high and the temperatures in the winter are excellent for ice formation (daily cycles with $\pm 0^\circ$). Other perturbing signs, less relevant from the structural point of view, include damage of the stone due to freeze-thaw cycles and overall biological colonization. Figure 7 details typical observed damage.

Figure 7 - Damage in the Salzedas' cloister: (a) mapping of cracks in the 2nd level; (b) out-of-plane displacements of an internal wall; (c) aspect of vault in the 2nd level; (d) aspect of corner in the 2nd level.

The conclusions of the study were that: (a) the non-symmetry between the internal and external walls of the cloister result in movements in the direction of the court, as observed in the construction; (b) a linear elastic analysis of the construction results in very limited displacements (in the order of the millimeter) and moderate stress values (maximum tensile stress of +0.25 MPa and maximum compressive stress of -0.6 MPa). The large displacements observed in the construction require a geometrical and physical non-linear analysis; (c) in order to obtain horizontal displacements in the order of the observed in the structure, it is necessary to consider the soil-structure interaction. It seems therefore that the foundations play a key-role in the observed damage; (d) the high movements recorded in the construction and the deterioration of the brick vaults indicate that the safety level of the structure is not compatible with any use and remedial measures are necessary.

The following measures will be undertaken: adjustable propping; removal of vaults infill (1 + 0.5 wings); elevation of the vaults (1 + 0.5 wings). Restoring the verticality of one inner wall and one corner; replacement of fractured brackets; relocation of the key stones and joints filling; placement of ties and strengthening with CFRP (1 + 2 x 0.5 wings); refill vaults with selected silty soil; water-proofing and drainage of the terrace; repointing of joints in walls; temporary closure of the openings.
