Arch Bridges  
ARCH'04  
P. Roca and E. Oñate (Eds)  
© CIMNE, Barcelona, 2004

## REPAIR OF STONE MASONRY ARCH BRIDGES

**Daniel V. Oliveira<sup>\*</sup> and Paulo B. Lourenço<sup>†</sup>**

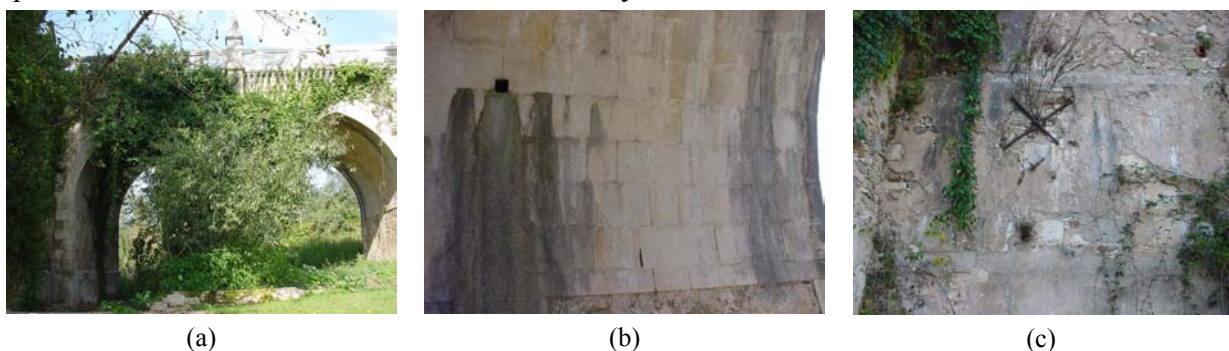
Due to its uncertain safety conditions and taking into account its heritage value, a survey of the Boutaca bridge was requested<sup>2</sup>. The detailed inspection carried out allowed to detect damage in several areas. The absence of periodic maintenance works promoted the growth of vegetation, as well as the lost of plaster and painting in large areas of the bridge. The deficient drainage system of the pavement caused the occurrence of humidity and biological colonization, detected in the visual inspection, see Figure 2. It was also found some minor longitudinal cracking at the intrados of some arches, as well as cracking in the buttresses, due to lateral forces generated through the fill and caused by dead and live loads.

The survey detected four metallic tie rods endowed with anchorages on one side of the bridge (downstream), to bind the walls. The anchorages were much deteriorated, with visible corrosion, and rather deformed being not possible to detected similar anchorages on the other side (upstream). The excessive deformation of the anchorages, as well as cracking in buttresses seem to indicate that masonry walls suffered outward movements after the placement of the tie rods and that buttresses may be overload.

Figure 2: Main damage: (a) vegetation; (b) humidity; (c) corroded anchorage (downstream view).

Taking into account the rehabilitation and the protection of the bridge, a set of remedial measures were recommended<sup>3</sup>, in accordance with the principles that guide interventions in the architectural heritage. To prevent the outward movement of the masonry walls and to lighten the load in the buttresses, it was proposed the execution of a set of horizontal anchors across the full width of the road, endowed with patress plates, which have been designed to be aesthetically attractive. Four vertically aligned tie rods between each two buttresses were adopted, as illustrated in Figure 3. For each anchor, a hole is drilled and a stainless steel rod with 39 mm diameter is placed inside. At the ends, two cylindrical stainless steel patress plates are tightened up. A slight force is applied to the tie rods by means of a dynamometric wrench, in order to put them in tension.

In order to reduce the lateral pressure on the walls and the appearance of humidity at the intrados of arches it was proposed to perform the waterproofing of the pavement and the reconstruction of all the drainage system. Also, the cleaning and removal of infesting vegetation in the bridge should be periodically carried out. The missing plaster and painting should be replaced, using materials as similar as possible to those used in the construction.

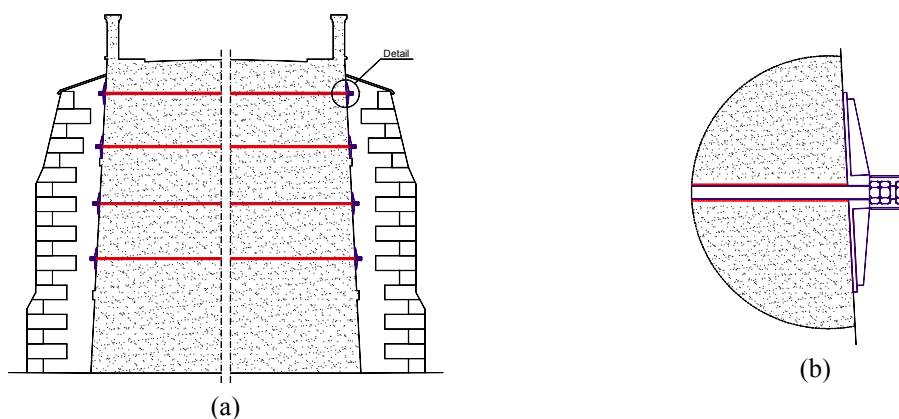
Figure 3: Strengthening of the masonry walls: (a) general view; (b) detail of the patress plate.

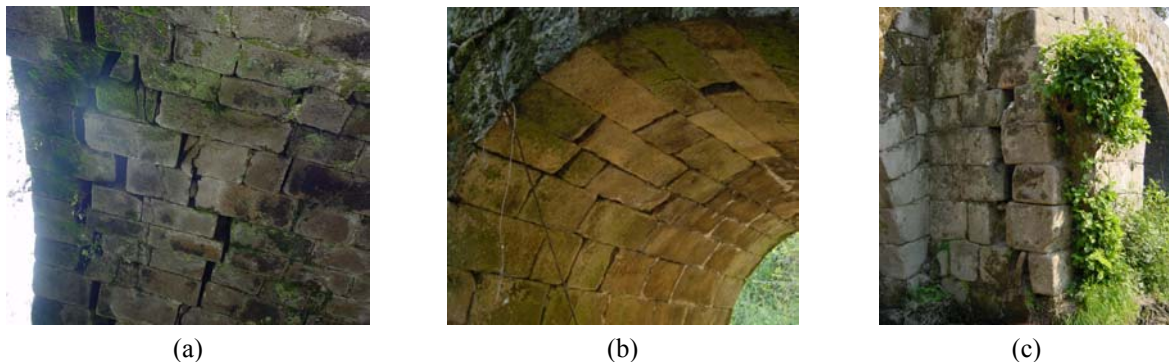
The survey<sup>4</sup> has showed that the structure presents a pronounced damage state. Both the left arch (A1) and the flood arch (A4) present extensive longitudinal cracking, clearly visible at the intrados, see Figure 5. The right pier is very damaged, where some stone blocks are cracked and a foundation stone is missing. The vegetation, spread all over the bridge, caused severe damage to the right cutwater. The spandrel walls were subjected to lateral movement and are clearly out of plumb. The general damage pattern observed was originated by the lack of maintenance in conjunction with increasingly heavy loads.

Figure 5: Relevant damage: (a) cracks in the left arch; (b) cracks in the flood arch; (c) cracks in the right cutwater.

justify the observed longitudinal cracking at the intrados of the arches. Both the detailed visual inspection and the numerical analysis pointed out that the strengthening of the bridge was necessary, namely to counteract the outward movement of the spandrel walls, to prevent their failure and to stop the progression of the longitudinal cracking along the arches, in order to re-establish the safety conditions of the bridge.

Given the historical significance of Donim bridge, the design of any strengthening measure was necessarily conditioned by the fulfilment of modern principles related to structural intervention. Therefore, the remedial measures designed and proposed to restore the safety of the bridge comprehend the structural strengthening of the arch A1, the flood arch and the cutwater of the right pier<sup>6</sup>.

The high level of damage found in the right cutwater, with several stones cracked and out of their original places, will be repaired by the dismantling of the most deteriorated areas. The rebuilding will be carried out using the same stones, previously numbered, or when not able to be used, with similar stones from the region. During the rebuilding, stones in a same course will be connected to each other by means of stainless steel cramps, at every three courses. The link between two consecutive courses is achieved through the use of vertical stainless steel latches. The repair of the cutwater still includes the replacement of the missing foundation stone block.

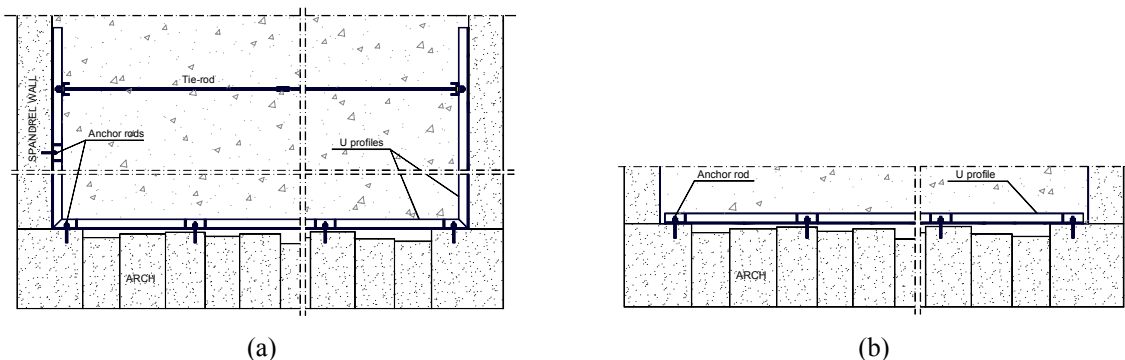
Figure 6: Strengthening of the arch A1 with U profiles: (a) in general; (b) close to the crown.

To reduce the enormous longitudinal cracking in the intrados of arch A1 (crack width greater than 8 cm) and return joint's thickness to its original width, the infill above the arch A1 will be removed and the voussoirs will be pushed in by means of rope-stretchers placed along the intrados of the arch, for which the arch must be previously propped along its entire span. The adopted strengthening comprises the fixing of six stainless steel U profiles to the extrados of the arch and to both spandrel walls, by means of anchor rods, as illustrated in Figure 6. A stainless steel tie rod, with a diameter of 16 mm, placed at the top of the vertical profiles and tightened by means of a dynamometric wrench binds the spandrel walls together and reduces considerably the bending of the profile. Close to the crown, the proximity of the pavement allowed only the use of a U profile clamped to the arch with anchor rods. After the completion of these works, the infill is put back in its place and the prop can be finally removed.

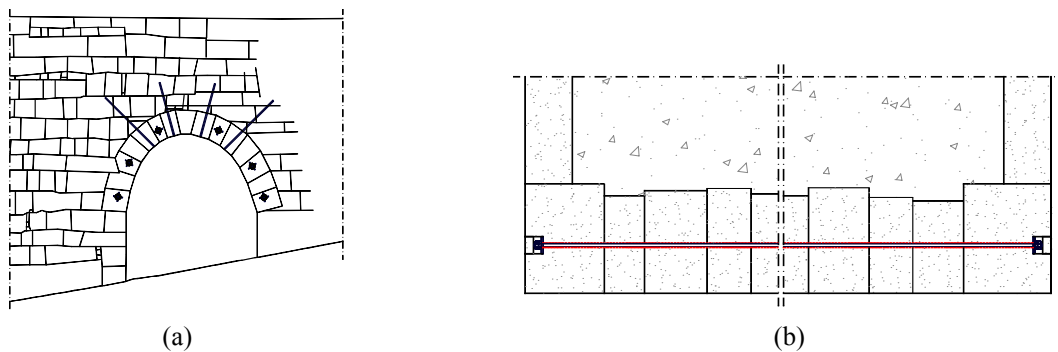
The cracking pattern observed in the flood arch has showed fewer degree of damage, with maximum crack width lower than 4 cm. Here, the objective was not to return the arch to its original geometry but to prevent any further spreading of the arch and to assure its stability. Thus, it was proposed to use six horizontal anchors across the full width of the bridge, endowed with cylindrical anchorage plates at each side of the arch, see Figure 7.

Figure 7: Strengthening of the flood arch: (a) adopted anchor scheme; (b) horizontal anchors.

In each anchor, after drilling an oversized hole using a rotating cutting device, a stainless steel rod with 16 mm of diameter involved by a sleeve, is placed in the hole and subsequently grouted with a cement solution, injected under low pressure between the rod and the sleeve. The use of the sleeve increases the efficiency of the anchor system since it inflates, preventing the injected grout to be lost in voids within the structure, or flee through cracks.

No tension is applied to the rods other than a tightening force resulting from their adjustment using a dynamometric wrench. Following grouting of the anchors, the hole is made good with a slip taken from the cores.

For the connection between the arch and spandrel walls a similar solution was developed. Four stitching anchors in each side of the arch (see Figure 7a), ranging between 1200 mm and 1500 mm length, were used with the purpose of linking the spandrel walls to the external voussoirs.
