Selected research and case studies in ancient Portuguese structures

Summary

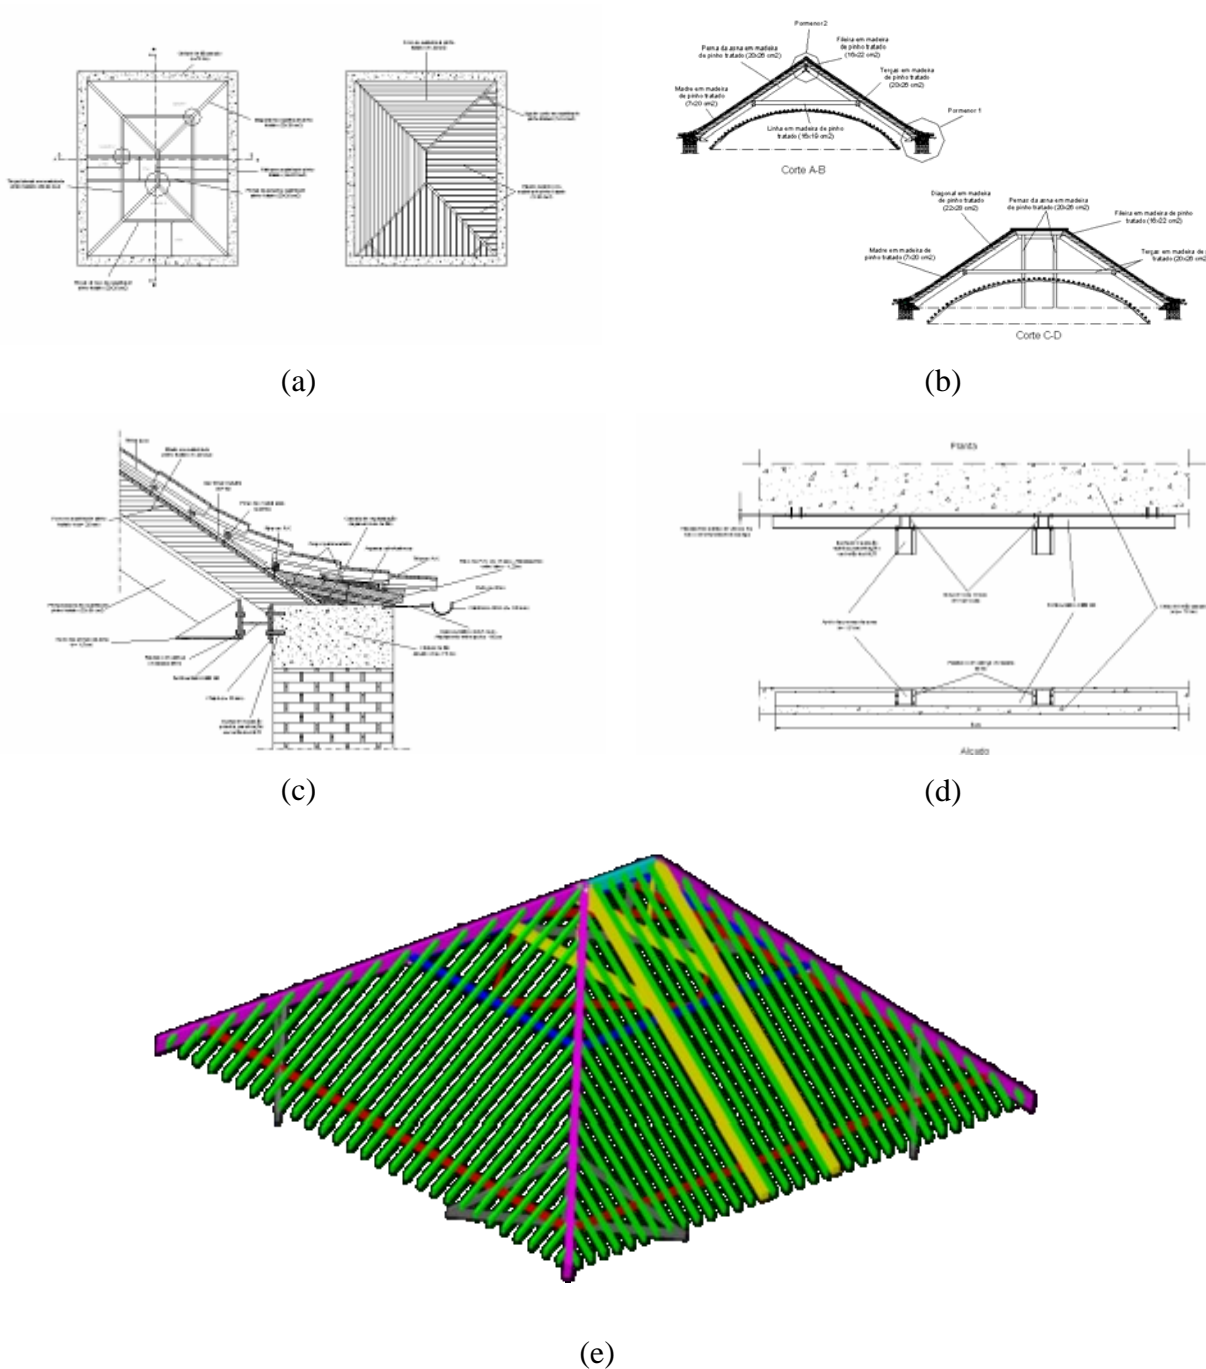
Fig. 4: Details of the replacing roof structure: (a) structure (plan, sheathing and strips); (b) sections AB and CD; (c) detail of the central truss support; (d) steel beam for central truss support; (e) 3D model of the new roof

Therefore, the solution includes four diagonal rafters and a ridge board, together with a set of purlins at mid-height of the rafters, two central trusses and four side trusses, aiming at reducing the span of the main truss elements, see Fig. 4. The supports of the diagonal rafters and the side trusses

will be made in existing recesses in the ring beam present in the masonry walls. The supports of the central trusses will be made in steel corbels connected to an additional beam, so that the bending moment in the masonry walls is reduced.

The steel connections of the new timber structural system are nailed or bolted with steel plates. All steel elements are made using stainless steel type AISI 316. The top ridge tiles are to be placed dry, in order to allow ventilation. The airflow will be ensured by small plastic tubes located in the bottom part of the roof. The final aspect of the new structure is shown in Fig. 5.

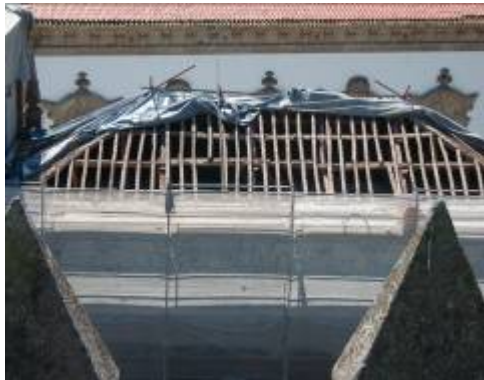
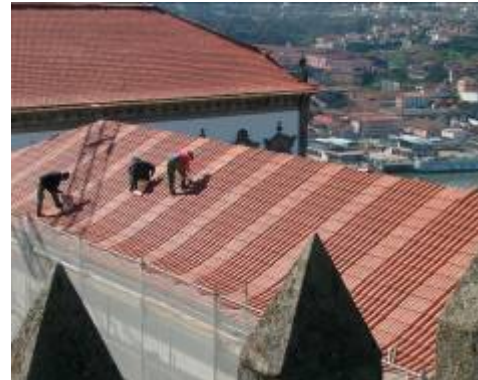
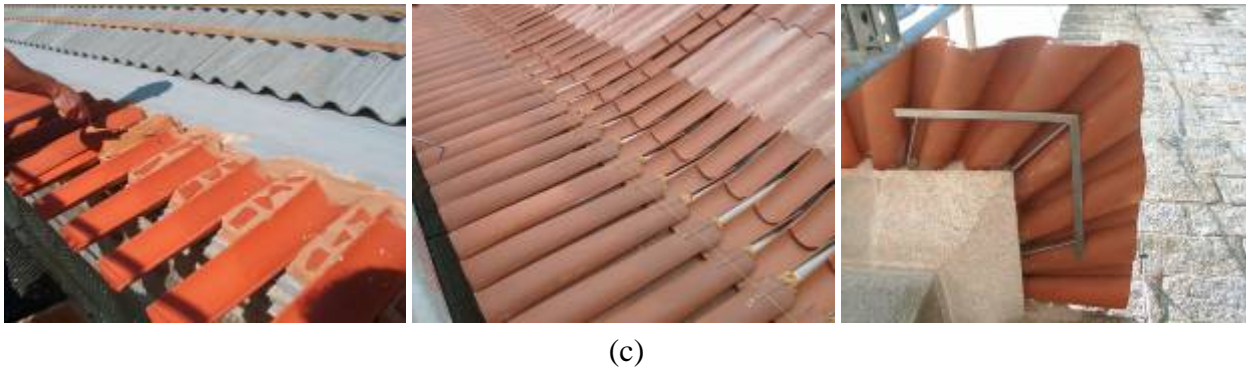
The origin of this building dates back to the middle of the 12th century and large conservation works have been carried out recently. With respect to waterproofing and roof structures, the works aimed at using traditional techniques and keeping remedial measures to the minimum. Remedial measures included cleaning, application of biocide, application of preservation products, consolidation, strengthening and local replacement, see Fig. 6. The decision was based in continuous *in situ* diagnosis and structural assessment.

Fig. 6: Typical roof details: (a) roof during and after works; (b) structural details and local replacements; (c) clay tiles details

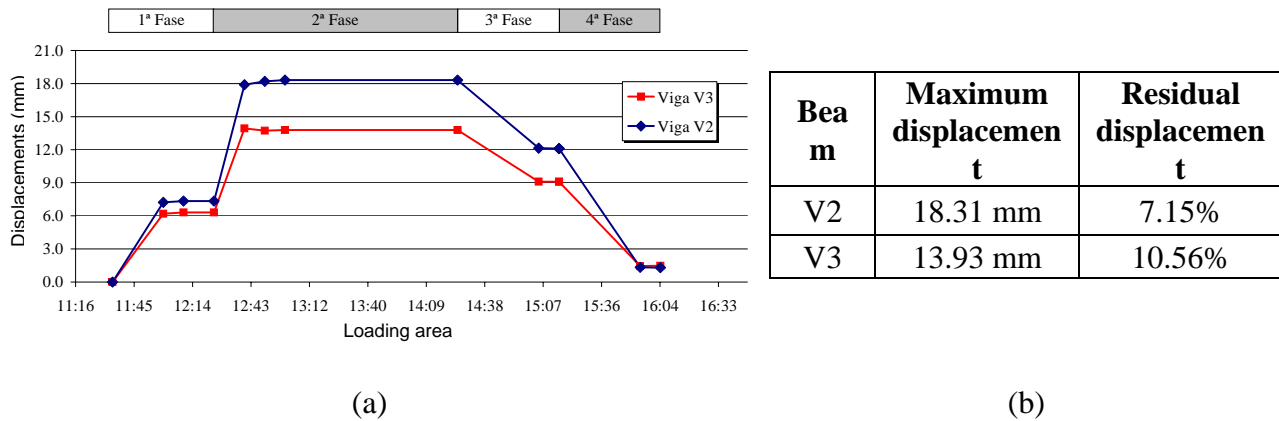
The load test was carried out in four loading steps: (a) 50% of the total load; (b) 100% of the total load; (c) unloading up to 50% of the total load; (d) total unloading. Each load step lasted between 25 and 40 minutes, making a total test duration of 5 hours, including the time intervals for loading / unloading decision. Upon completion of the test, residual displacements were observed in all displacement transducers, which is normal for any *in situ* load test. Fig. 9 illustrates the flexural response of beams V2 and V3. The maximum displacement measured in beam V2 is 18.3 mm, value that should be lower than 1/300 of the span for short term loading (21 mm). The average residual displacement is 9%, which is more than reasonable for this type of structure. Therefore, the floor structure can be used for a load of 3 kN/m², without strengthening.

Fig. 9: Load test results for beams V2 and V3: (a) diagram of vertical displacements vs. time; (b) maximum displacements at mid-span and residual deformation

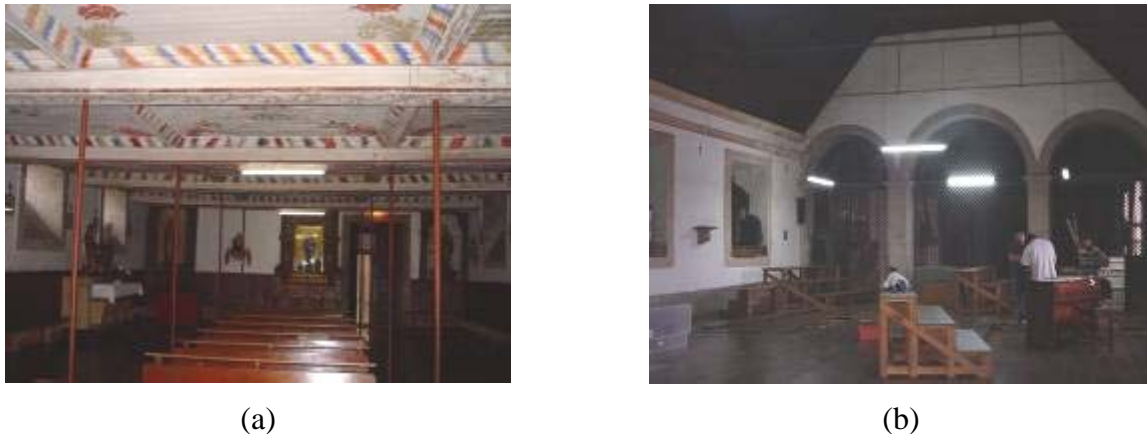
The present study aims at assessing the safety conditions of a floor structure in a church subjected to a change of use (from a choir not opened to the public in general, to a museum), see [6] for details. The floor is located in the Church of Our Lady of Conception dates from 1625, see Fig. 10, and exhibits considerable permanent deformation (sagging).

Fig. 10: Choir floor's views: (a) from below; (b) from above

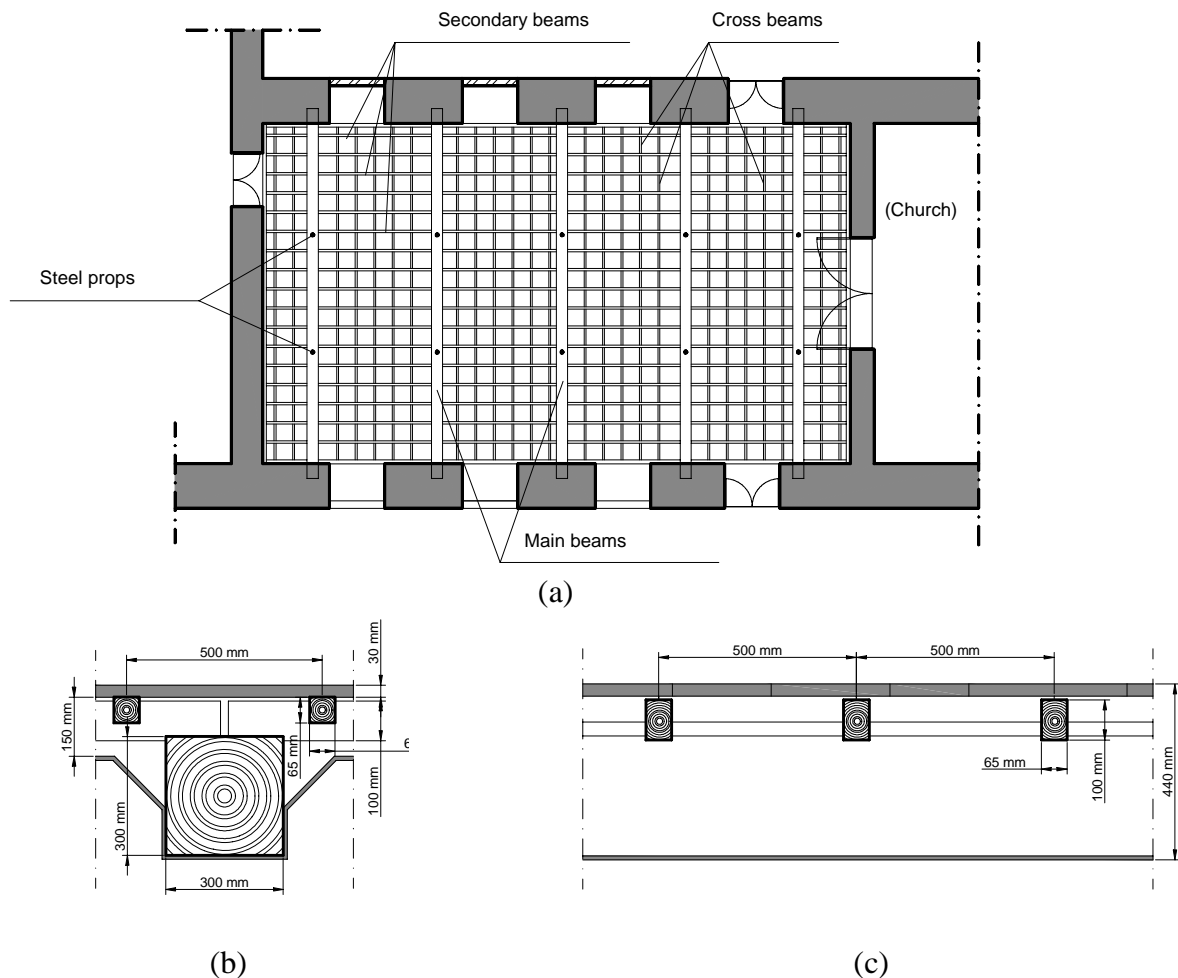
structural elements are in good condition, with the exception of one beam, see Fig. 11a. The floorboard close to the walls has a considerable reduction in the effective cross-section due to active biological attack. The biological attack in the structural elements is mostly superficial.

Fig. 11: Timber structure: (a) plan; (b) cross-section of the main beams; (c) cross-section of the secondary beams

The floor structure was then analyzed according to EC5. The structural analysis indicated that the secondary beams, the main beams and the steel props are not enough to support the code live load of 3 kN/m^2 . Therefore, strengthening is necessary. The aspects taken into account for strengthening design were: (a) keep the present floor configuration and preserve the existing materials; (b) economy; and (c) do not remove the polychromatic sheating under the floor, due to its artistic value.

The following strengthening solutions were suggested to the owner: (a) strengthening of the secondary beams, using a new set of timber beams in between the old beams, and addition of a steel profile for strengthening the main beam as a steel-timber composite beam (the steel props would be removed and the main beams would be forced back to the original position); (b) strengthening of the system by new steel columns (replacing the existing props) and, again, adding a new set of secondary beams.
