STRENGTHENING OF MASONRY ARCH BRIDGES: RESEARCH AND APPLICATIONS

Paulo B. Lourenço, Daniel V. Oliveira

University of Minho, Portugal

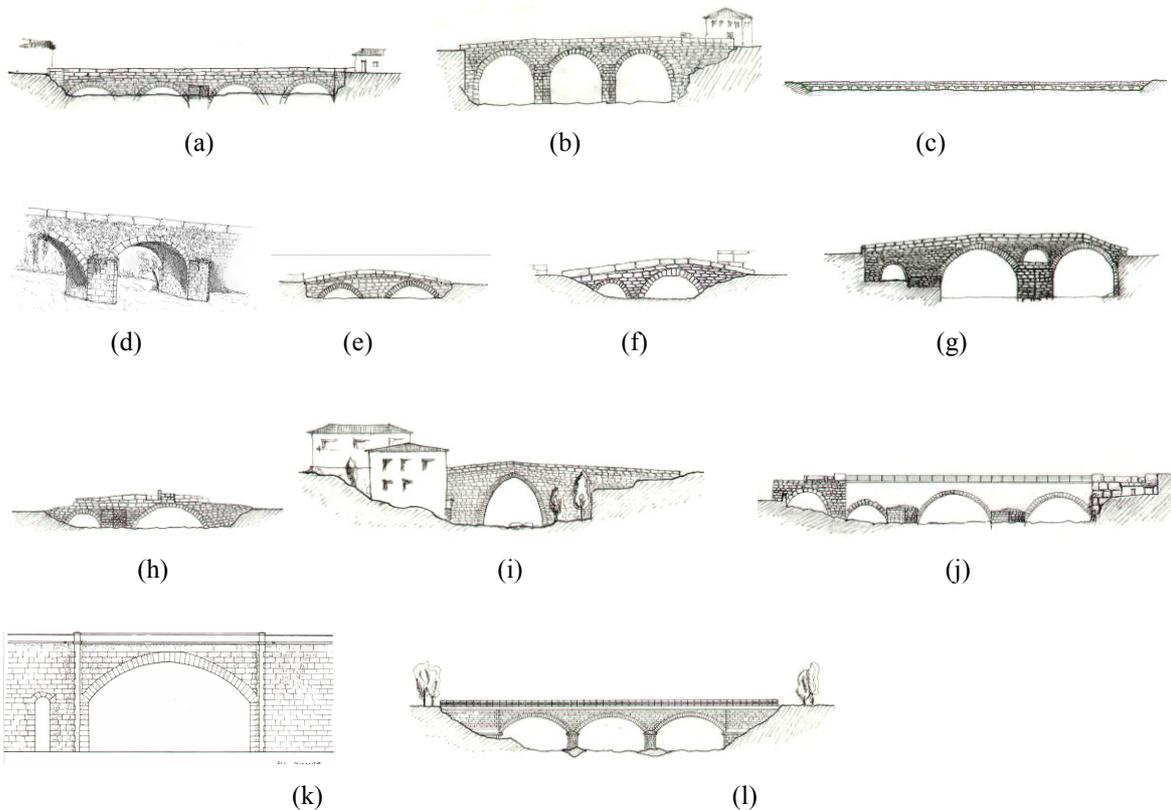
Name	Arches	Span	Bridge Length	Road Width	Cut-water	Flood Arches	Deck	Conservation
S. João	4 semi-circular	4 × 7.5 m	43 m	3.5 m	1	–	Horizontal	Regular
S. Martinho do Campo	3 semi-circular	2 × 7.6 + 8.0 m	40 m	3.2 m	2	–	Horizontal	Bad
Taipas	34 flat	34 × 1.2 m	62 m	3.9 m	–	–	Horizontal	Regular
Donim	3 semi-circular	9.4 + 11.8 + 6.6 m	63 m	3.4 m	2	1	Horizontal	Bad
Caneiros	2 semi-circular	6.4 + 5.8 m	13 m	2.3 m	–	–	Humpback	Good
Selho	2 semi-circular	2.4 + 4.4 m	17 m	2.4 m	–	–	Humpback	Regular
Velha	3 semi-circular	3.3 + 10.8 + 8.6 m	38 m	3.2 m	2	1	Humpback	Good
Pombeiro	2 segmental	4.3 + 10.5 m	29 m	3.4 m	1	–	Humpback	Regular
Domingoterres	1 pointed	16.7 m	44 m	3.0 m	–	–	Humpback	Regular
Serves	3 semi-circular	4.7 + 10.6 + 9.7 m	54 m	5.1 m	–	1	Horizontal	Good
EN205	1 segmental	18 m	35 m	4.5 m	–	1	Horizontal	Good
Silvares	3 segmental	6.4 m + 5.8 m + 6.2 m	40 m	2.3 m	–	–	Horizontal	Good

Fig. 2. View of the bridges: (a) S. João, (b) S.Martinho do Campo, (c) Taipas, (d) Donim, (e) Caneiros, (f) Selho, (g) Velha, (h) Pombeiro, (i) Domingoterres, (j) Serves, (k) EN205 and (l) Silvares.

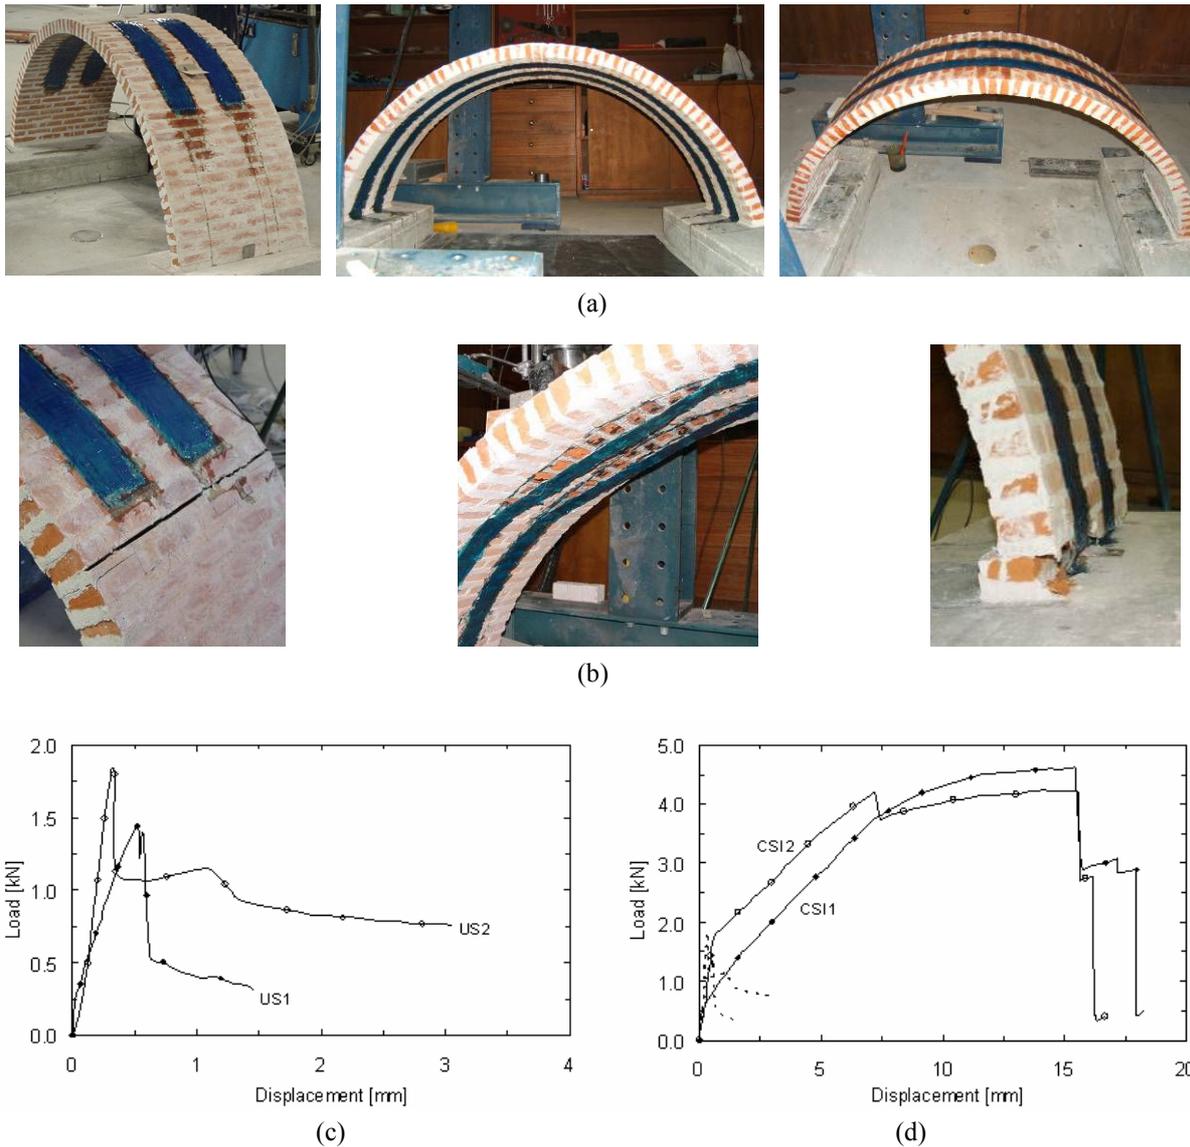
The unstrengthened specimens exhibited a structural behaviour characterized by the formation of the typical four-hinge mechanism, which occurred for small displacements and just after reaching the maximum load. On the other hand, all the adopted strengthening arrangements caused an increase in terms of load capacity. However, new dominant failure modes were observed, namely detachment of the fibres from the arch surface and sliding along a mortar joint, see Fig. 5b. The debonding phenomenon only affected the arches where the GFRP strips were placed at intrados, whereas for specimens strengthened at extrados failure occurred due to slipping of one part with respect to the other along a mortar joint. Another important feature of the continuously strengthened specimens is the large deformation capacity exhibited prior to failure, which provides the arches with important ductility behaviour. The experimental results show that the adopted continuous GFRP strengthening arrangements provided an enhanced arch behaviour, with respect to the unstrengthened specimens, both in terms of load capacity and in terms of ductility, see Fig. 5c. While specimens strengthened in the intrados got the maximum load increase, specimens strengthened in the extrados exhibited the larger ductility.

Fig. 5 FRP strengthened arches: (a) examples of location reinforcement; (b) examples of failure modes; load-displacement diagrams for (c) unreinforced arches and (d) arches strengthened in the

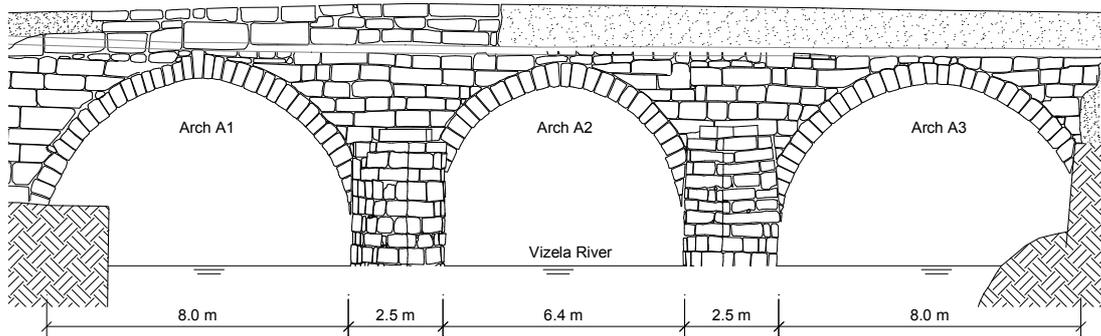
The multi-span Negrelos Bridge is located close to Guimarães over the Vizela river. With time, the bridge has lost its regional importance, though still assuming a great significance to the local network. The bridge has a flat roadway, supported by three semi-circular granite stone masonry arches, with different free spans (8.0 m + 6.4 m + 8.0 m), as schematically represented in Fig. 6. The bridge reaches a total length of approximately 30 m and has a roadway width of about 3.0 m. The central arch is supported by two massive piers, endowed with two triangular cutwaters at upstream and two rectangular cutwaters at downstream. Within a governmental program to clear the river from pollution, a drainage pipe was placed on the left shore, on top of an embankment made beneath arch A1 and close to the left abutment, see Fig. 6 (the pipe is not visible). Both the spandrel walls and

the parapets were built with stone masonry, but successive repair works carried out over the years have changed some original characteristics as it can be noticed by the parapet wall partially rebuilt with concrete blocks.

Fig. 6 Negrelos Bridge (upstream view).

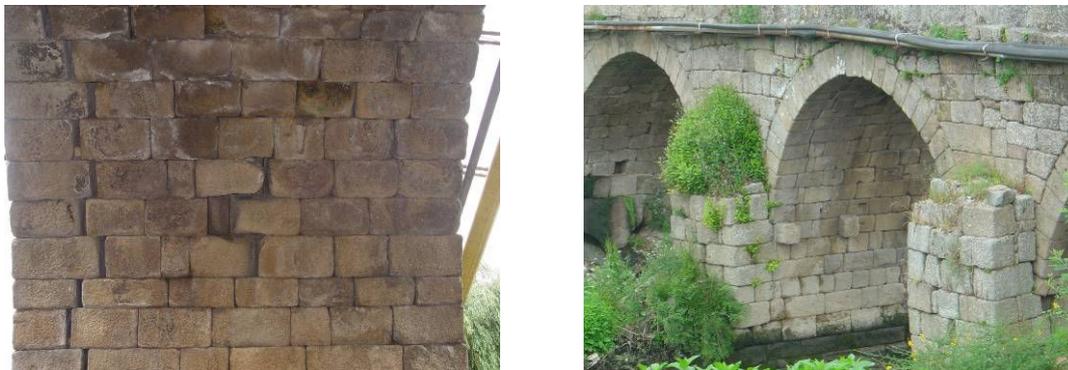
The survey carried out has showed that the bridge presented a pronounced damage state, where damage was mostly characterized by, see Fig. 7a: extensive longitudinal cracking exhibited by the central arch (A2), close to the downstream spandrel wall, clearly visible at the intrados. This is mainly caused by earth pressure in the spandrel walls; lateral movements of the spandrel walls near the left abutment, which became out of plumb, most likely originated by lack of maintenance in conjunction with increasingly heavy loads; generalized damage caused by vegetation, spread all over the bridge; extensive cracking in the left downstream cutwater and minor cracking in the other three cutwaters, mainly due to existing vegetation and the lack of adequate stone interlocking. Also, some stone blocks were cracked. Most probably, some of the cutwaters were built or extended after the construction of the bridge.

Fig. 7 Examples of damage: longitudinal cracking in the central arch and vegetation and cracks in the downstream cutwaters (downstream view).

The visual inspection carried out showed that a set of repair actions were necessary, namely to stop the progression of the longitudinal cracking along the central arch, to counteract the outward movement of the spandrel walls, to prevent the failure of the cutwaters and to clean all vegetation from masonry. Therefore, a set of four horizontal stainless steel anchors across the full bridge width, endowed with cylindrical steel anchorage plates at each side of the arch, were proposed, see Fig. 9. Two short stainless steel anchors were used close to each springing. In addition, it was recommended a light injection of the arch, at the intrados.

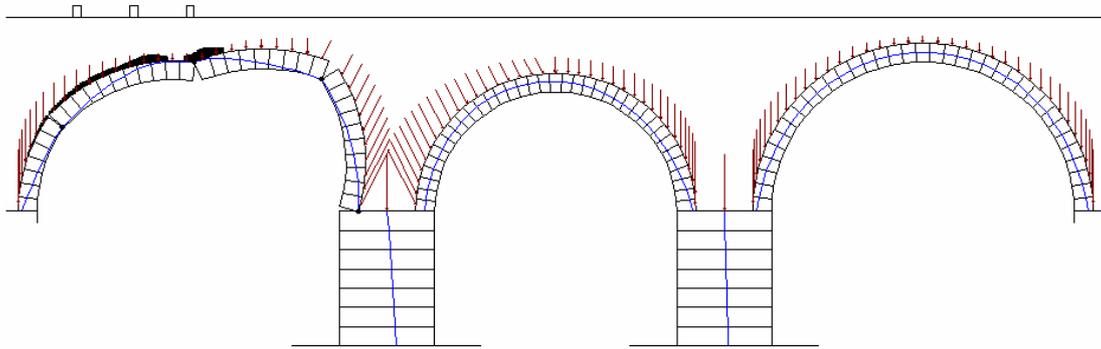
The bridge was modelled as an in-plane three-span semicircular arch bridge. The necessary geometrical data was obtained from topographic surveying and visual inspection. In the absence of in-situ test results, the material properties were considered to assume typical values found in similar structures, see [6] for details. Besides the self-weight of the materials (masonry and fill), a moving load was also considered, composed by three axles equally spaced by 1.5 m and with a 200 kN load per axle. Using a computer program developed within the rigid block limit analysis method [7], the minimum failure load factor is equal to 1.67. Fig. 8 illustrates the associated four hinges failure mechanism found, where both the dead and live load pressures applied to the arch, the hinges and the thrust-line are showed. Assuming that the vehicle crosses the bridge from left to right, the minimum

failure load factor was found for the vehicle central axle positioned at 31.9 % of the left arch free span (arch A1). Since symmetrical geometry and vehicle are used, the same result is obtained considering that the vehicle crosses the bridge from right to left instead.

Fig. 8 Minimum load failure mechanism of Negrelos Bridge.

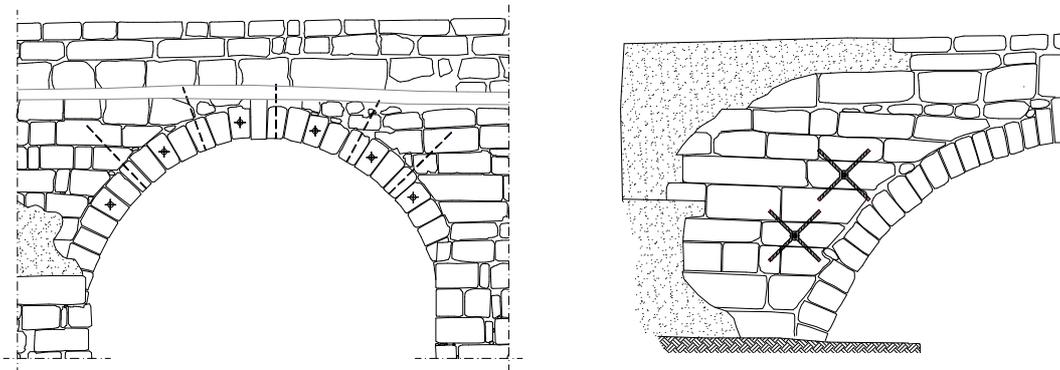
Fig. 9 Examples of adopted strengthening for central arch and spandrel wall.

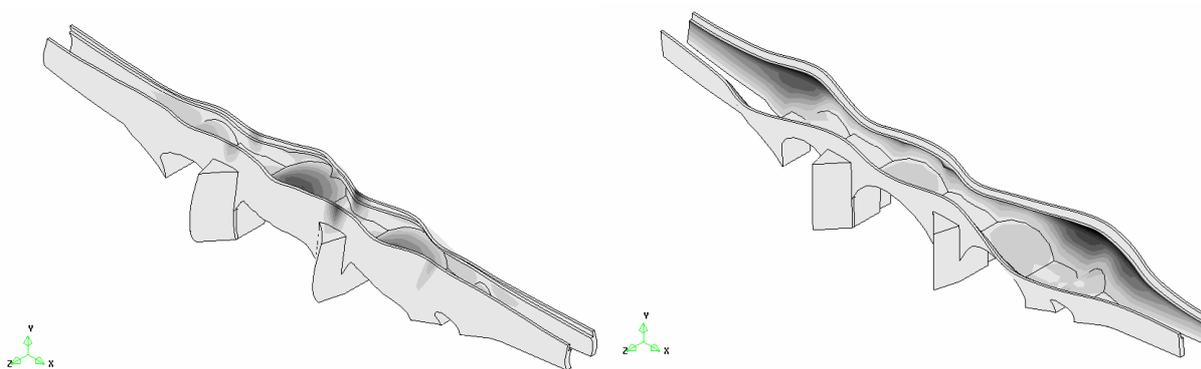
This structure presents a pronounced damage state, with extensive longitudinal cracking in the left arch and flood arch, clearly visible at the intrados, see Fig. 10. The right pier is very damaged, where some stone blocks are cracked and a foundation stone is missing. The vegetation, spread all over the bridge, caused severe damage to the right cutwater. The spandrel walls were subjected to lateral movement and are clearly out of plumb. Moreover, boroscopic inspection indicated that the infill is full with voids. In order to discuss the behaviour of the bridge and adopt an adequate model for the analysis, two different structural analysis models are shown, assuming that the truck is placed over the central, larger span arch. The models include the following features:

Structural fill and lateral soil pressure in the spandrel walls, and non-structural fill and lateral soil pressure in the spandrel walls. It is obvious that the lateral soil pressure could be obtained implicitly by considering inelastic soil behaviour but this would result in a significant number of additional parameters for the analyses. For this reason, the simplified lateral soil pressure coefficient was adopted. The results of a non-linear analysis for a unitary load factor are illustrated in Fig 10, see also [8]. Here, the maximum principal strains are a measure of cracking and can be assumed to indicate the expected damage in the bridge. The importance of the infill can be immediately observed from the deformed shapes and the predicted damage in the structure. If the lateral pressure from the infill is not considered as an external load, the spandrel walls move partly inwards, but, if the lateral pressure is considered, the spandrel walls move outwards. Damage in the structure is also localized in different areas. For the first model, damage occurs in the spandrel walls and, longitudinally, in the arches. For the second model, extensive damage occurs in the spandrel walls due to out-of-plane bending.

Fig.10 Examples of damage in Donim bridge, using a non-linear finite element analysis (arch splitting or spandrel collapse).

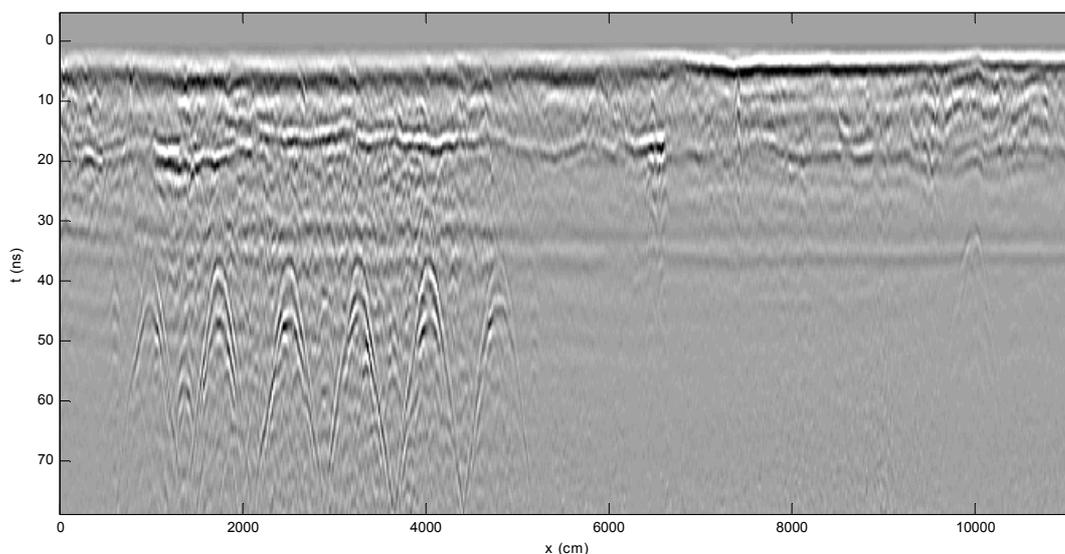
The Boutaca bridge has a flat roadway, supported by six pointed masonry arches equally spanned, as illustrated in Fig. 11. Lateral masonry walls, supported by a buttressing system, make the connection between the pointed arches and a semicircular masonry tunnel, belonging to the old railway network. The bridge reaches a total length of 60.0 m and has a roadway width of 7.0 m. At the ends, it is noticeable the existence of four box-houses used by road-menders. Diagnosis was carried out with the assistance of GPR, see Fig. 11. To prevent the outward movement of the masonry walls and to lighten the load in the buttresses, it was proposed the execution of a set of horizontal anchors across the full width of the road, endowed with plates, which have been designed to be aesthetically attractive. Four vertically aligned tie rods between each two buttresses were adopted. In order to reduce the lateral pressure on the walls and the appearance of humidity at the intrados of arches it was proposed to waterproof the pavement and the reconstruction of all the drainage system. Also, the cleaning and removal of infesting vegetation in the bridge should be periodically carried out. The missing plaster and painting should be replaced, using materials similar to those used in the construction.

Fig. 11 Boutaca Bridge: upstream view and detection of arch thickness and infill characteristics using GPR inspection.
