DEFECTS AND MOISTURE PROBLEMS IN BUILDINGS FROM HISTORICAL CITY CENTRES: A CASE STUDY IN PORTUGAL

Paulo B. Lourenço^{1*}, Eduarda Luso² and Manuela G. Almeida³

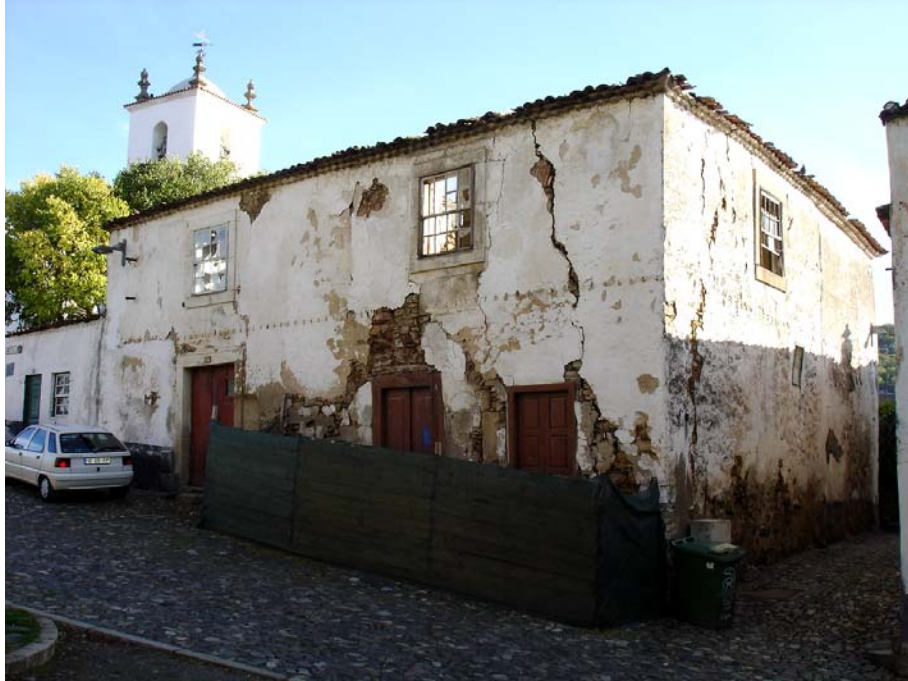
In order to characterize the existing damage in the building stock, eight groups of damage were considered in the envelope of the buildings, see Figure 7: (a) collapsed structures; (b) bulging walls; (c) stains in walls at soil level; (d) detachment of rendering and painting; (e) cracks; (f) mould, fungus and vegetation; (g) roof deterioration; (h) timber deterioration in openings frames or balconies. A more comprehensive classification of defects can be found elsewhere [4]. The results of the survey are merely qualitative, as a detailed quantitative evaluation of the building stock is outside the scope of the present work.

Figure 7 – Example of damage: (a) collapsed structures; (b) bulging walls; (c) stains in walls at soil level; (d) detachment of rendering and painting; (e) cracks; (f) mould, fungus and vegetation; (g) roof deterioration; (h) timber deterioration in openings frames or balconies

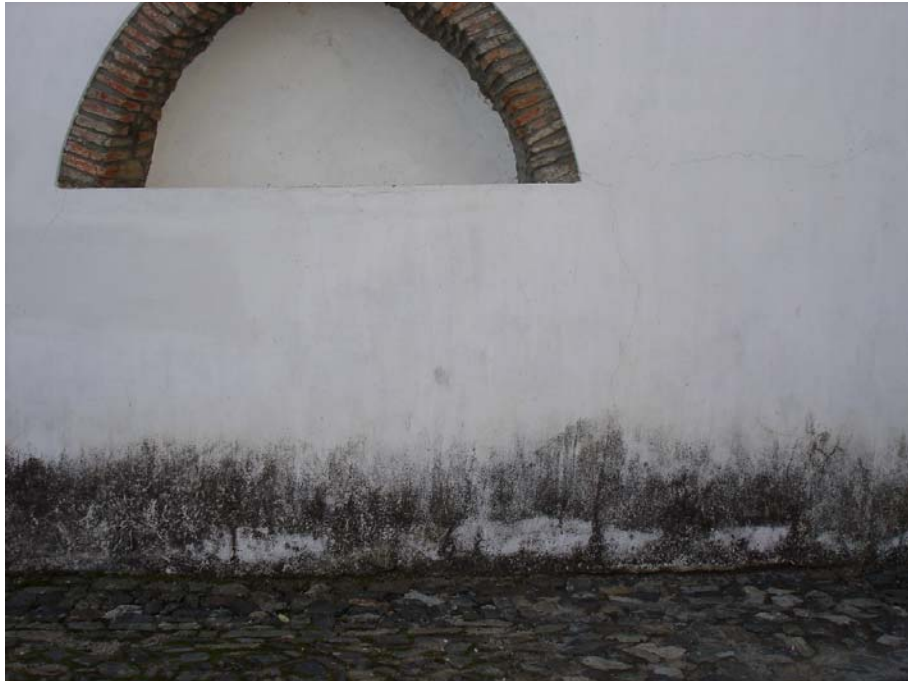
In the Citadel, 52% of the houses present wall stains at soil level, caused by rising humidity and rainwater splashing. It is stressed that 43% of the buildings do not exhibit gutters and 13% of the buildings have an incomplete downpipe [11], see also Figure 9. The bulging damage of the walls occurs essentially in buildings with at least two floors, and the 25% value found indicates that detailed structural inspection and diagnostic of the Citadel is needed. It is also stressed that cracks with large width were found in the Citadel, confirming the presence of structural damage. Adequate recommendations for methodology and remedial measures in these cases have been recently published by ICOMOS [12].

Figure 7 – Example of damage: (a) collapsed structures; (b) bulging walls; (c) stains in walls at soil level; (d) detachment of rendering and painting; (e) cracks; (f) mould, fungus and vegetation; (g) roof deterioration; (h) timber deterioration in openings frames or balconies

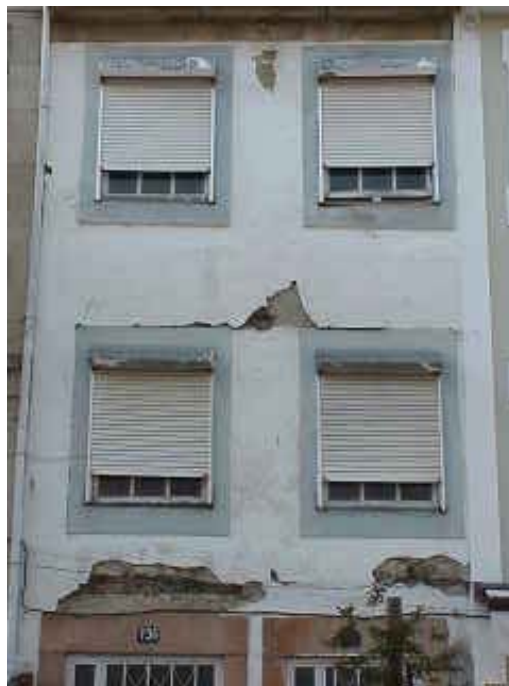
(d)

walls; as this is not expected, it seems clear that incompatible materials are being adopted for the rendering and painting.

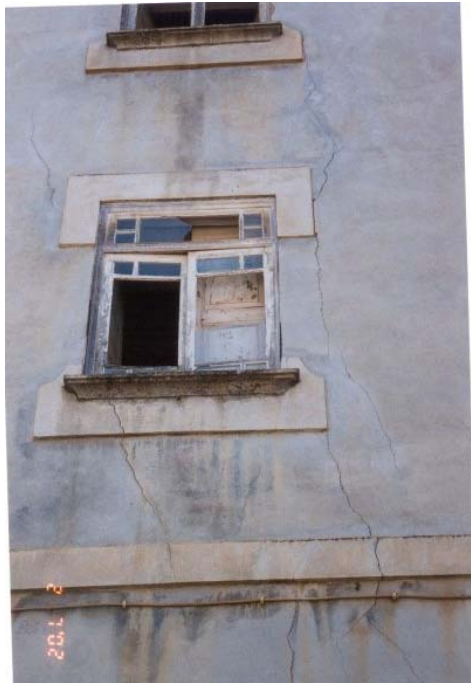
Figure 7 – Example of damage: (a) collapsed structures; (b) bulging walls; (c) stains in walls at soil level; (d) detachment of rendering and painting; (e) cracks; (f) mould, fungus and vegetation; (g) roof deterioration; (h) timber deterioration in openings frames or balconies

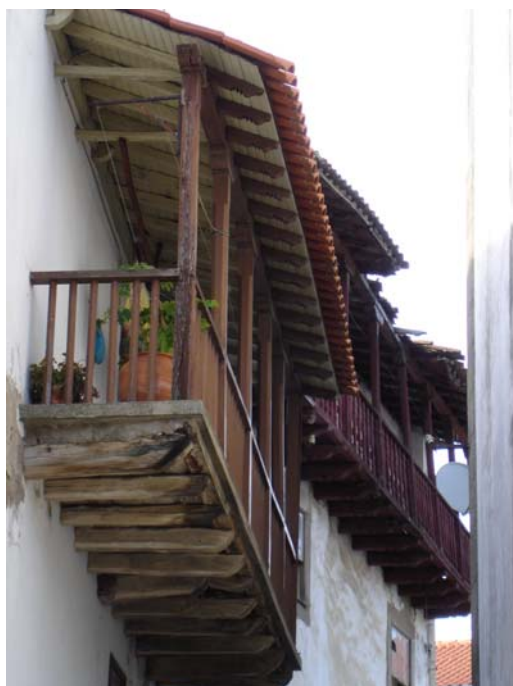
Figure 7 – Example of damage: (a) collapsed structures; (b) bulging walls; (c) stains in walls at soil level; (d) detachment of rendering and painting; (e) cracks; (f) mould, fungus and vegetation; (g) roof deterioration; (h) timber deterioration in openings frames or balconies

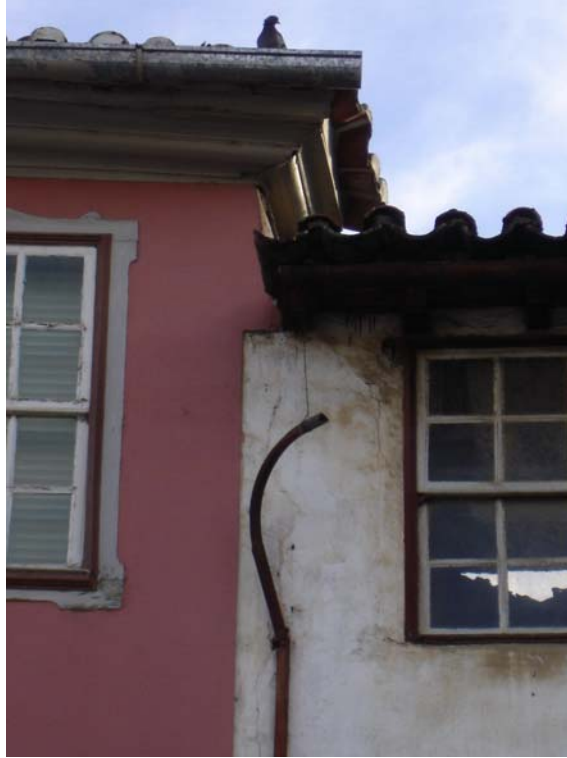
Figure 9 – Typical example of a defect in a downpipe.

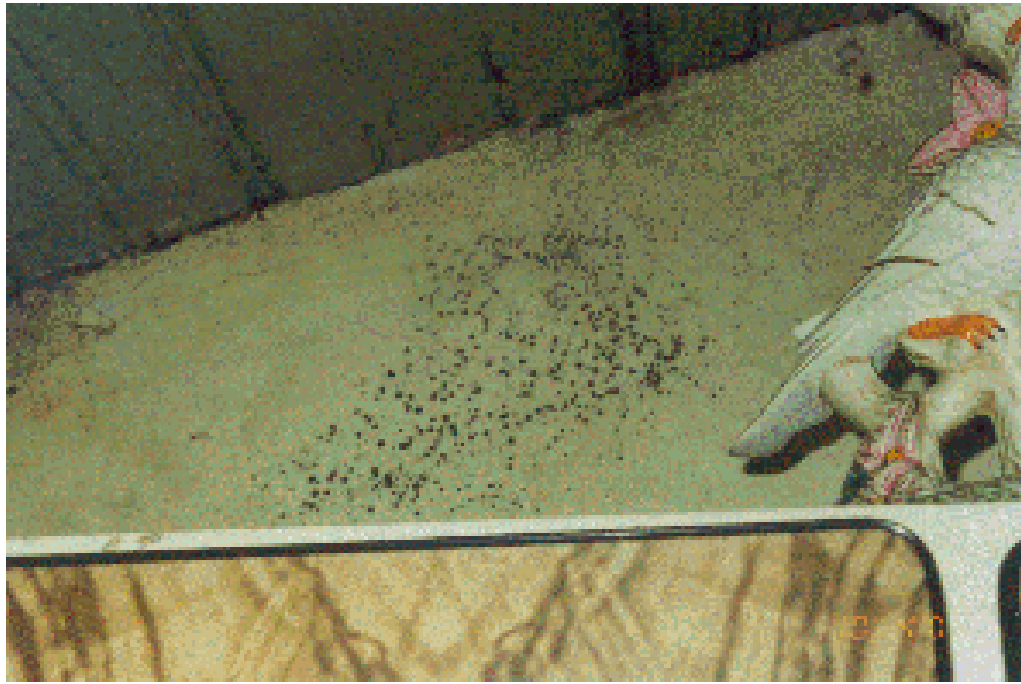
a contiguous building. These moisture manifestations include stains, sometimes accompanied by mould. This type of biological colonization appears also nearby windows and doors frames, corners or roofs, accompanied often by a strong odour.

Figure 13 – Examples of the damages observed inside the houses: (a) biologic activity; (b) stains due to humidity; (c) timber and roof deterioration; (d) detachment of rendering and painting, and efflorescence with high presence of salts.

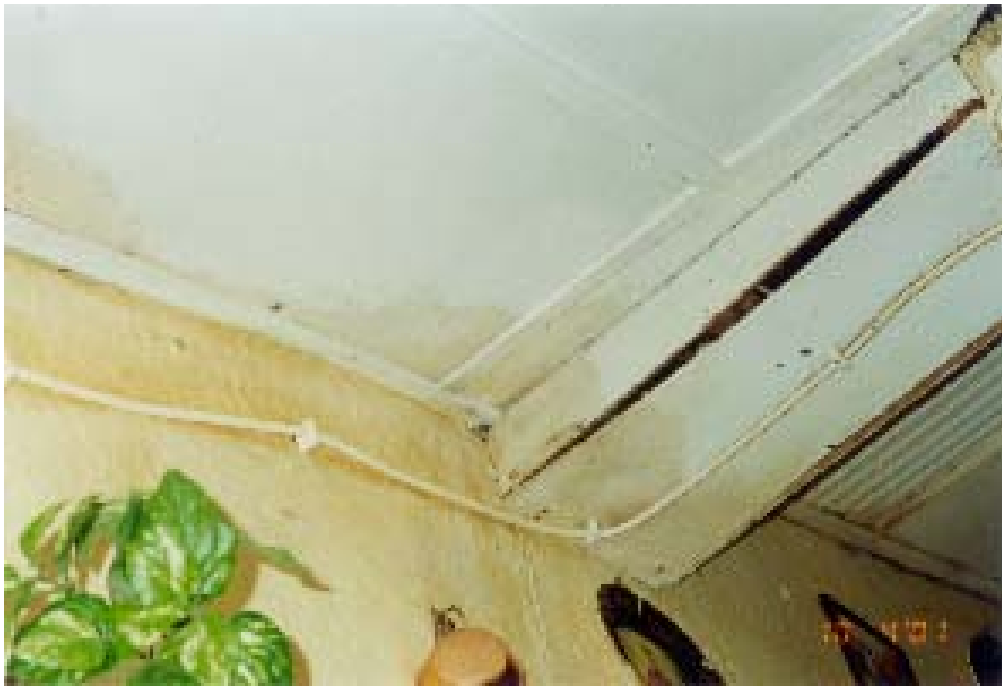
Defects and deterioration of the roof is the major cause for water leakage and building pathology. Mould is usually associated to compartments with large production of water vapour, such as kitchens and toilets, but it occurs also in bedrooms and living rooms in the present case study. Condensations are also visible in coldest zones and non-ventilated places. In underground walls, deteriorated paintings, detachment of rendering and formation of efflorescence with high presence of salts were found.

Figure 13 – Examples of the damages observed inside the houses: (a) biologic activity; (b) stains due to humidity; (c) timber and roof deterioration; (d) detachment of rendering and painting, and efflorescence with high presence of salts.

In the specific case of buildings in the Citadel of Bragança (oldest part), urgent repair is needed at many levels, with a special focus on: (a) construction of toilets, when absent; (b) repair or substitution of roofs; (c) conservation or substitution of renderings.
