# Monastery of Salzedas (Portugal): Intervention in the cloister

P.B. Lourenço, L.F. Ramos, G. Vasconcelos

## ABSTRACT

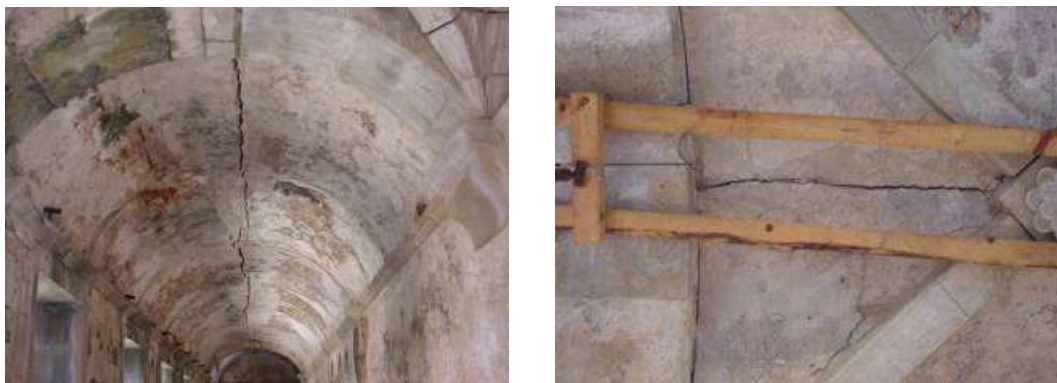
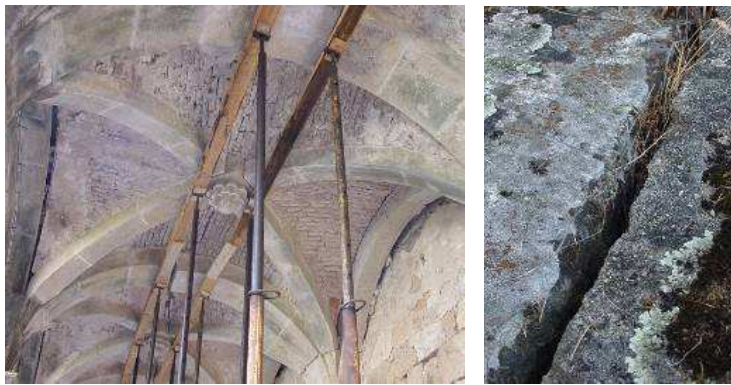
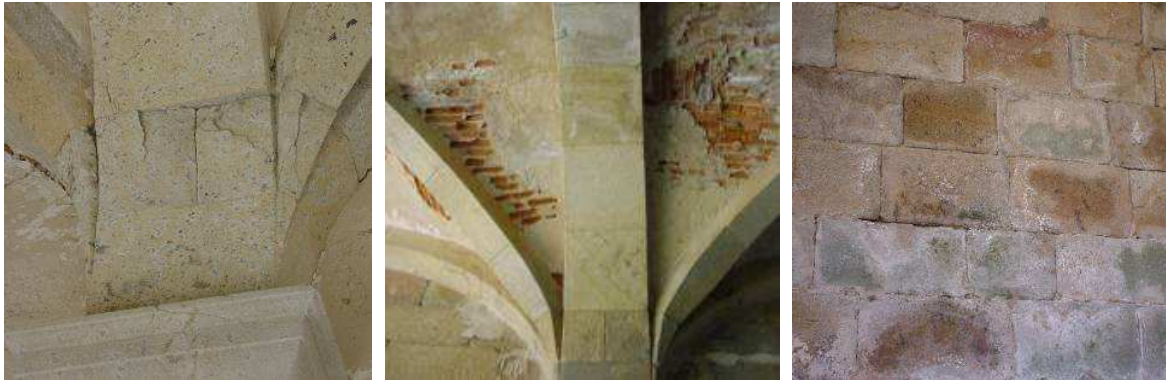
The condition of the cloister was quite poor, including biological colonization sometimes associated with moisture stains, deterioration of the bricks in the vaults, cracks with variable thickness, crushing of stones and excessive movements in walls and vaults, see Fig. 2. Vertical displacements up to 35 mm were measured at the key of the crossed vaults of the 1<sup>st</sup> level. All the walls of the cloisters exhibit large horizontal movements that lead to the separation between the vaults and the walls, in a clear lack of verticality. The out-of-plumb displacement of the internal walls reaches values of 0.18 m, 0.14 m, 0.09 m and 0.07 m in the wings West, South, East and North, respectively. The brackets supporting the crossed vaults of the first level show signs of compression/shear damage. This can be explained by the tilting movement of the walls. The absence of connection between the infill of the crossed vaults and the walls resulted in a much localized area to transfer the load, i.e. only the brackets. Also, a significant number of bricks show deterioration, particularly around the cracked areas, due to frost-thaw cycles and water infiltration. Other perturbing signs, less relevant from the structural point of view, include damage of the stone due to freeze-thaw cycles, efflorescence and biological colonization

Figure 2. Examples of observed damage: (a) cracks; (b) large movements; (c) material damage and deterioration.

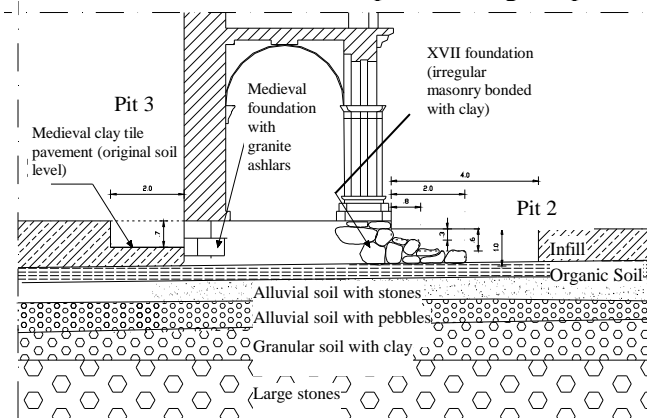
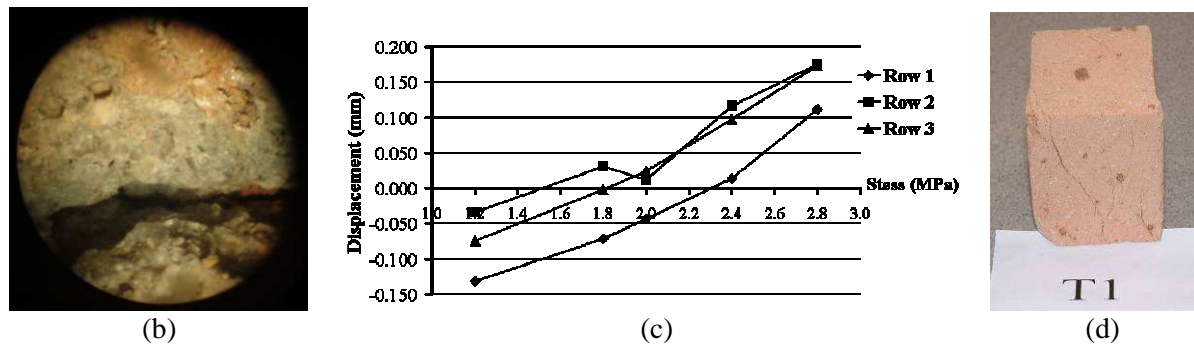
In order to better characterize the materials, to justify the observed damage and to define corrective measures, an experimental in-situ and laboratory testing program was carried out, see Fig. 3. The soil and foundation survey consisted of seven boring holes and three pits to define the mechanical and physical characteristics of the soil and foundations. It was possible to define a layered soil consisting of an infill of clayey nature (1.1 m), organic soil (0.30 m), alluvial soil with medium large stones, naturally wounded and worn by the action of water (0.60), alluvial soil with pebble (0.50 m). Between 2.5 and 2.7 m depth, the soil is granular with some clay and below 2.7 m depth large stones, with a size of 0.30 m to 0.40 m are found. The foundation soil exhibits moderated resistance and large heterogeneity for depths between 1.0 and 1.8 m, were supposedly all the cloister foundations are set. The foundations for the walls seem to be medieval and of good quality, but the foundations of the cloister columns are inadequate. These irregular masonry foundations are unable to distribute the loads over a significant soil area and the foundations depth around 1.0 m seems to indicate that the foundations were built on top of the original pavement level, directly on organic soil.

Figure 3. Some results of in situ survey and laboratory testing: (a) soil survey; (b) rigid boroscope observation; (c) flat jack testing; (d) sample for testing the brick compressive strength.

In order to characterize the inner constitution of vaults and walls, a few bore holes and several cracks were inspected with a rigid endoscope. The inspection allowed several conclusions, among which: (i) vaults are made with clay brick masonry with 0.22 m thickness. Infill material in the 1<sup>st</sup> level is soil and infill material in the 2<sup>nd</sup> level is a sort of rubble masonry. Separation between the two materials was not found; (ii) walls are made with large granite stones, with dry joints or a thin clay joint. The clay joint seems to be washed out around the cracks and in the external part of the wall due to weathering. An internal core of weaker mechanical characteristics was not found; (iii) internal longitudinal cracks that would compromise the stability of the walls under vertical loading were not found. As a result of the inspection with the rigid endoscope, it was concluded that the granite walls of the cloister are adequate and there is no danger of collapse due to desegregation under vertical loading. Coring and other techniques to estimate the strength of the walls were considered not necessary and it was decided to carry out two simple flat-jack tests. In order to confirm the internal constitution of the vaults and to characterize the mechanical behavior of the brick masonry, three  $\phi 75$  mm cores were extracted from the vault. The cores confirmed the borehole observation.

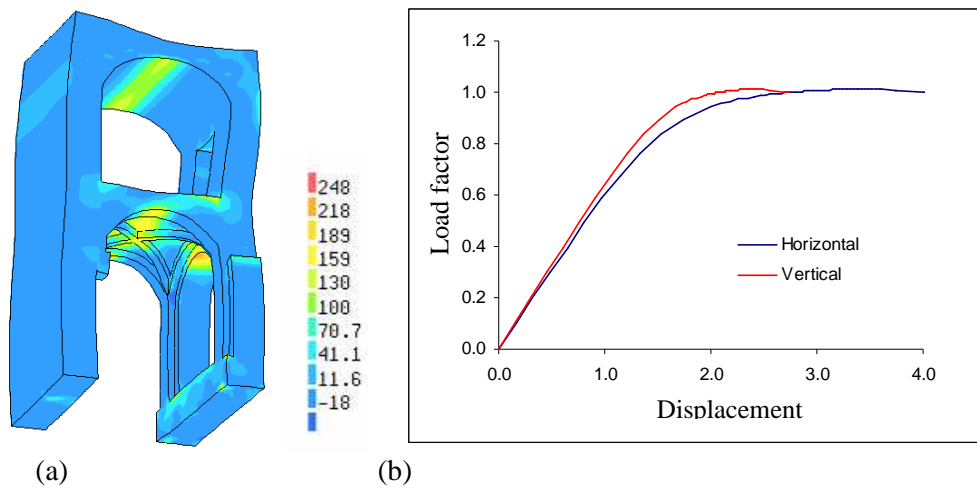
Figure 4. Examples of the results of the structural analysis: (a) maximum (tensile) principle stresses from a linear elastic analysis with a 3D model of the periodic cell of the cloister: (a) load-displacement diagram in a non-linear analysis.

The maximum tensile principal stresses are found at the key of the barrel vault of the 2<sup>nd</sup> level, at the key of the cross vault of the 1<sup>st</sup> level and at the key of the door arch in the 1<sup>st</sup> level. The maximum value of the principal stresses are +0.25 MPa and – 0.6 MPa, which are relatively moderate values. The model adopted for non-linear behavior replicates the most significant damage observed in the structure, including separation between vault and walls, and longitudinal cracking in the vault. Also the model predicts no remaining capacity of the structure in terms of additional vertical load. It is stressed that this statement holds only in the case of the weak foundation found. If the foundations are assumed as rigid, the ultimate load of the structure increases considerably.

The conclusions of the numerical analyses together with the inspection allowed to conclude that: (a) the non-symmetry between the internal and external walls of the cloister result in inwards movements in the direction of the court, as observed in the construction; (b) a linear elastic analysis of the construction results in very limited displacements and moderate stress values. The large displacements observed in the construction require a geometrical and physical non-linear analysis; (c) in order to obtain horizontal displacements of magnitude comparable to the values observed in the structure, it is necessary to consider the soil-structure interaction. It seems therefore that the foundations play a key-role in the observed damage; (d) the large movements recorded in the construction and the deterioration of the brick vaults indicate that the safety level of the structure is not compatible with any use and immediate intervention was necessary.
