Analysis of Unexpected Leaks in AISI 316L Stainless Steel Pipes Used for Water Conduction in a Port Area

Abstract: This paper clarifies the causes of a corrosion process observed in austenitic stainless-steel pipes, grade 316L, used for conducting freshwater in a port area. During the pressure test of the installation, before it was put into service, about five months after its construction, a loss of pressure was detected due to leaks of the fluid contained and the presence of corrosion damage on the wall of the tubes, in some cases even passing through the thickness of the tube. An analysis of the chemical composition of the pipe material was carried out, as well as semi-quantitative analysis of the chemical composition of the deposits in the defects, and a culture of sulfate-reducing bacteria (SRB) in Kliguer medium of the stagnant waters within the facility. All this makes it possible to conclude that the observed process fits within the so-called microbiologically induced corrosion (MIC), and, in all probability, it can be affirmed that this process is promoted by the presence and proliferation of sulfate-reducing bacteria (SRB).

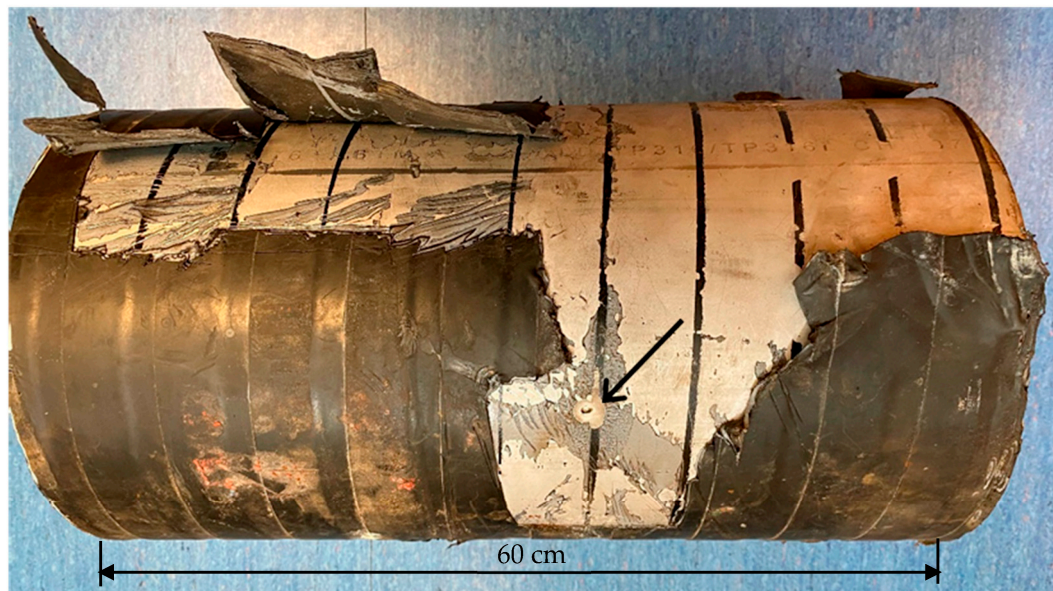
In order to clarify the causes of the aforementioned corrosion phenomenon in the AISI 316L stainless steel port piping facility, one 0.6 m long section of the pipe, shown in Figure 1, was extracted from the system. This section contains clear evidence of the commented processes, including a through-wall pitting. Additionally, as it can be observed, for better protection, the pipes were covered with a 0.3 mm thick rubber coating glued to the external surface, which had to be removed for the subsequent analysis trying not to damage the outer face in case it needed to be inspected.

Figure 1. Sample of pipe extracted from the port piping system; a through-wall pitting can be observed in the center (black arrow).

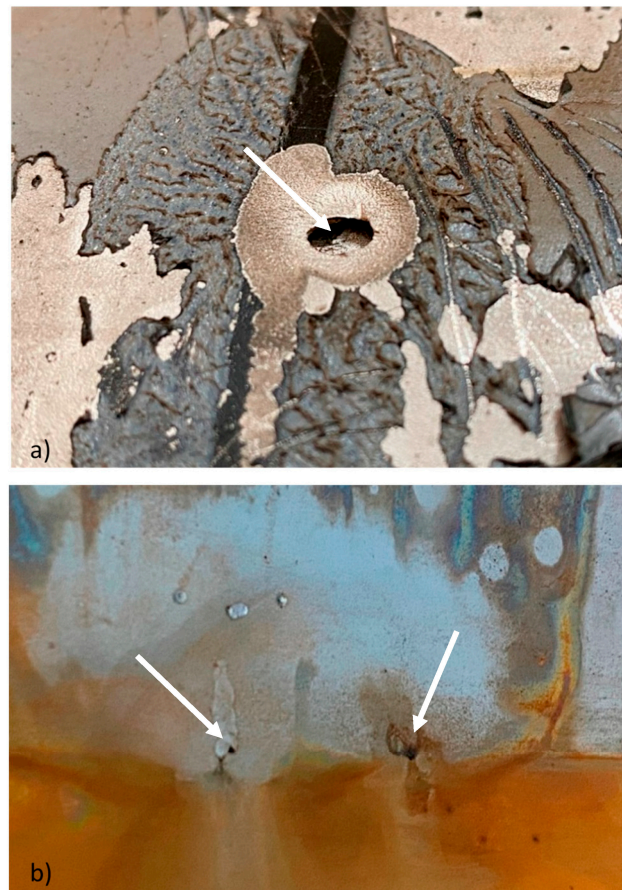
Figure 2. Through-wall pitting in the sample. (a) Through-wall pitting in the sample, outer face; (b) through-wall pitting and other pitting onsets, inner face of the sample. The arrows indicate the observed pits.

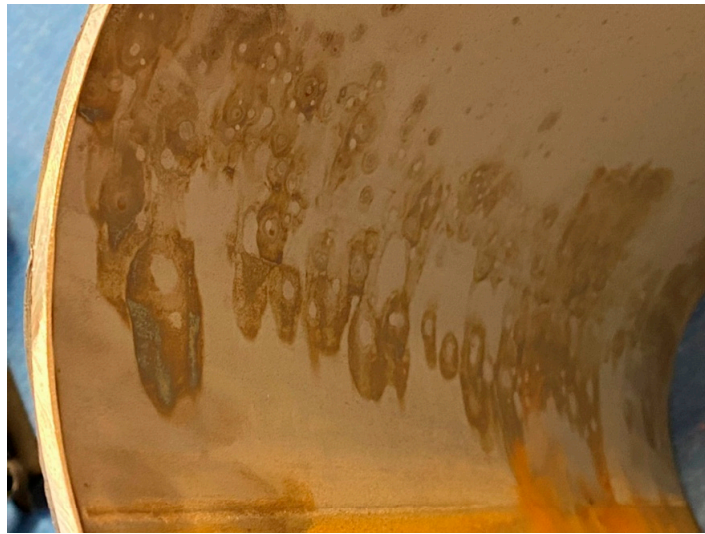
These defects, as shown in Figure 3, are present to different degrees along the whole inner wall of the sample; however, as observed in Figure 4, they were mainly located in the zone covered by the stagnant water and in a belt just above it, but only on one side. It is noteworthy that the same pattern seems to be observed in all these pitting initiations: pitting surrounded by “clean” material (i.e., non-corroded stainless-steel tone) that extends to an outermost surface crown with evidence of oxidation.

Figure 3. Multiple pitting onsets on the inside of the tube.

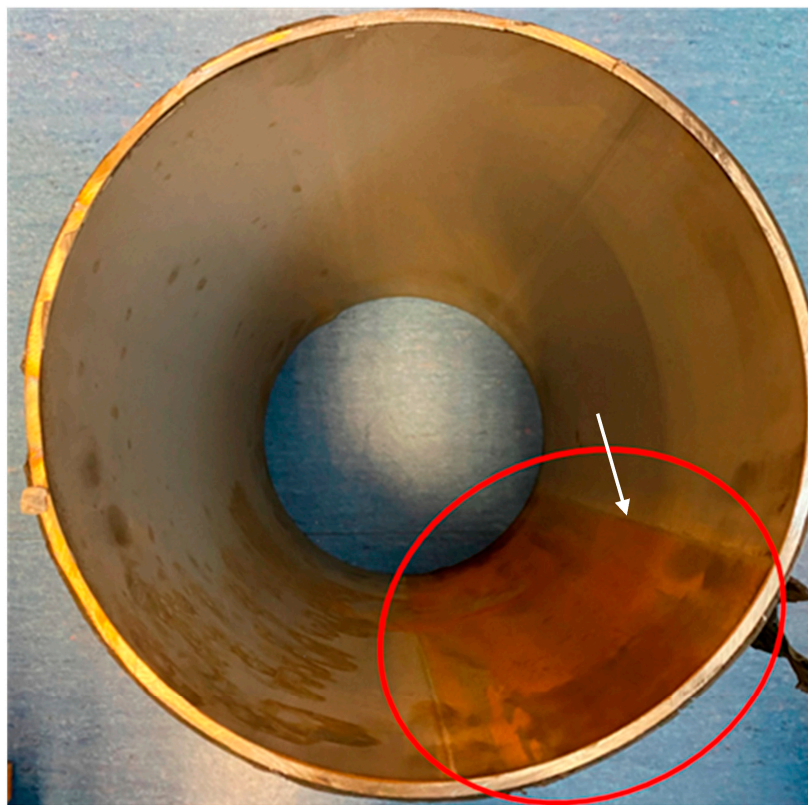
Additionally, in the inner surface of the tube, the signs of corrosion products are evident, characterized by a reddish tone. These corrosion products are deposited in a sector of the pipe (see Figure 4) which may be indicative of an existing (stagnant) water level inside the pipe during some period of the process from the installation to the pressure test.

Figure 4. Area (red ellipse) with deposits of reddish corrosion products; inner face of the tube. The arrow indicates a straight line identified as the level achieved by the stagnant water.

- There is also evidence (level marks of corrosion products) of the presence of stagnant water (corrosion products characterized by a reddish hue under the level mark). The culture of the remains on the stagnant water samples from the facility has been positive in terms of the presence of sulfate-reducing bacteria (SRB).

The analysis performed here also allows different recommendations to be provided in order to avoid similar problems. The main one consists of avoiding the presence of stagnant water in the system, given that this is the final cause of the MIC corrosion process. Additionally, other alternatives, such as the use of inhibitors, could be considered, as it has been successfully applied in other corrosive contexts (e.g., [35,36]).

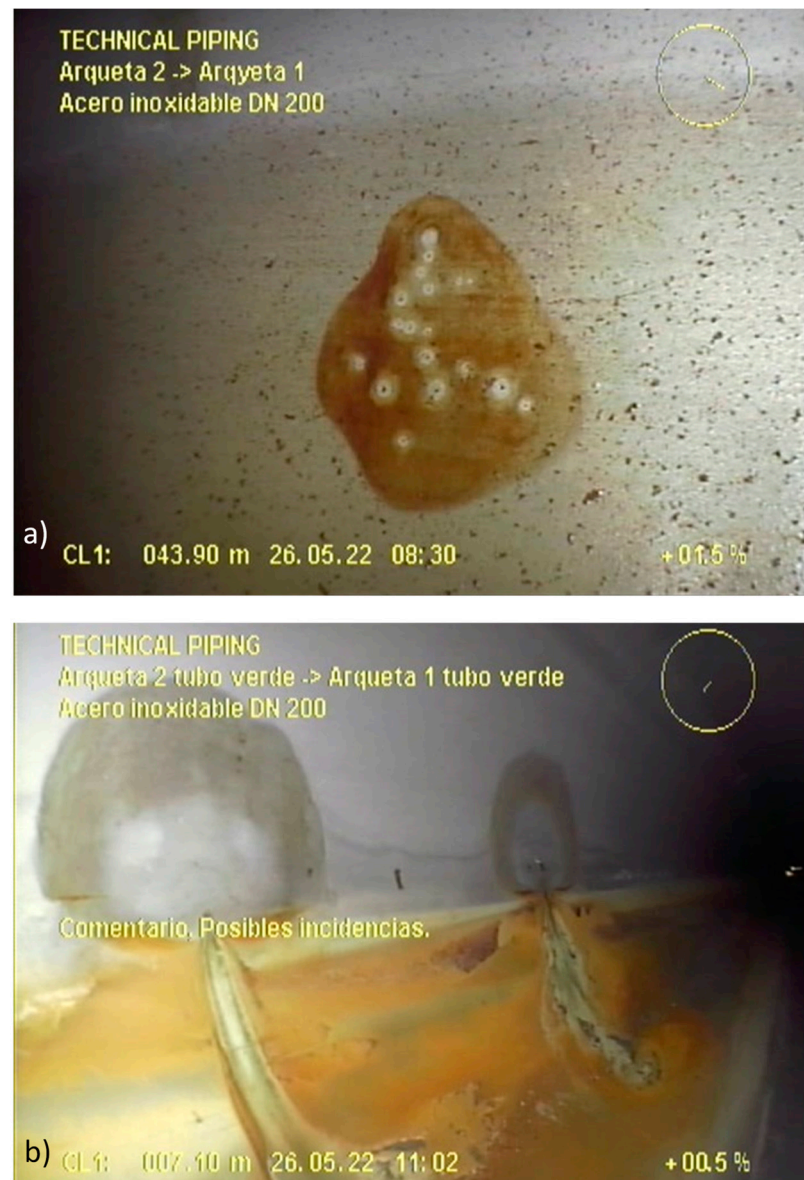
Figure 5 shows examples of the results of the inspections carried out. These records make it possible to verify that the corrosion was a very extended process, with a general

level of damage that can be classified as very advanced. Although it can be seen that the level of damage varies from one section to another, there does not seem to be any section of the piping system that is free of the corrosion process. In many of the pits observed (e.g., Figure 5b), a “mushroom-shaped” mark around the defect is evident. These marks may be due to the generation of gas during the corrosion process, which accumulates in pockets, bubbles, or tubercles around the defect and finally bursts (perhaps during the pressure test), leaving the aforementioned “mushroom-shaped” mark printed on the tube wall.

Figure 5. Video-inspection image of the interior of the piping system. (a) Detail of pitting; (b) detail of “mushroom-shaped” marks around two pits.

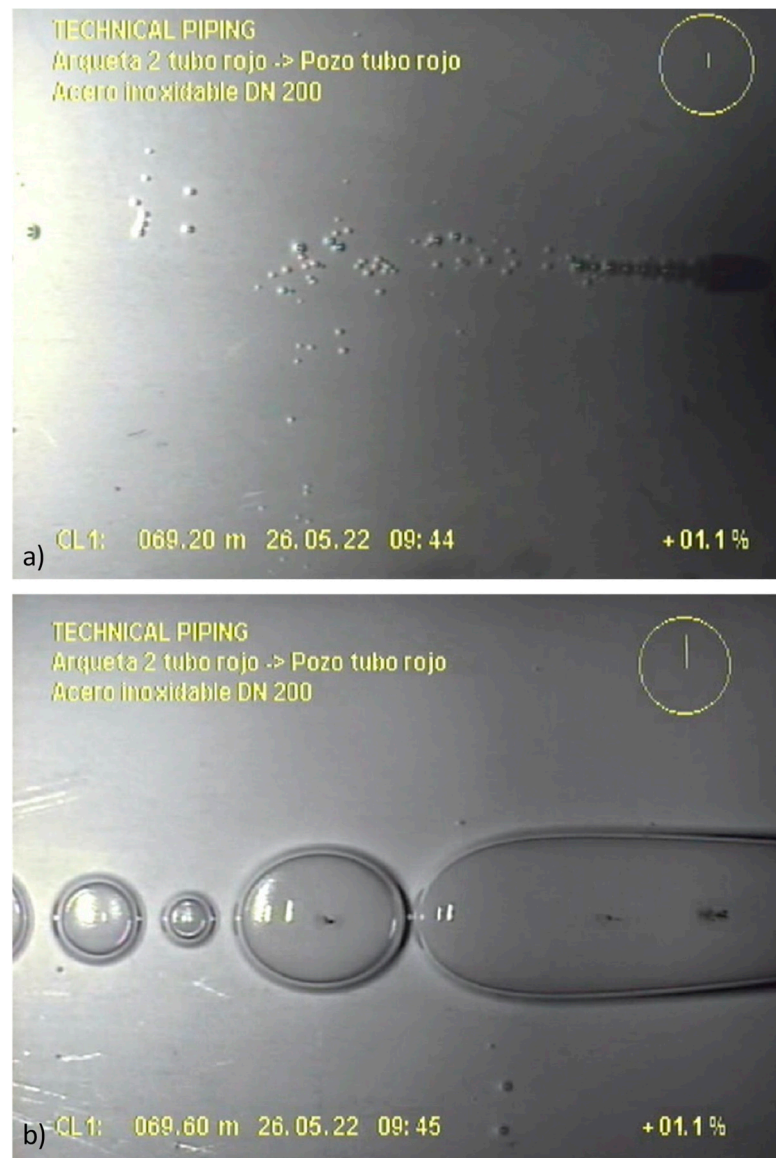
Supporting the previous observation, as presented in Figure 6, in some sequences of the inspection videos, the presence of gas bubbles attached to the inner surface of the pipe can be observed. Here, it is important to note that the figure shows images of parts of the piping system where the water level inside meant that the camera had to be submerged. A more detailed observation of these bubbles reveals the existence of a corrosion pitting in the center of each one of them, as presented in Figure 6b. At the same time, for there to be a separation between gas and water, the existence of a film or membrane that separates both media must be considered.

Figure 6. Video-inspection image of the interior of the piping system. (a) Gas bubbles; (b) detail of gas bubbles, right over some pitting defects.

H₂S, probably corresponding to the gas pockets shown in Figure 6. This hydrogen sulfide can then be used by sulfur chemolithotrophic bacteria, which cannot be detected with the culture medium used in this case, and which oxidizes it, generating the acidification of the medium.

Sulfate-reducing bacteria (SRB) comprise several groups of bacteria that use sulfate (which in this case must be present in the water) as an oxidizing agent, reducing it to hydrogen sulfide H_2S , which is a gas with a high corrosive capacity. The process generally takes place under anaerobic conditions, favored by the formation of a sheet of biological material itself (biofilm) or other elements of the system (sludge, coatings, oils). The accumulation of H_2S gives rise to the formation of pockets [23], which justify the existence of bubbles and also tubers as the ones observed in Figure 6.

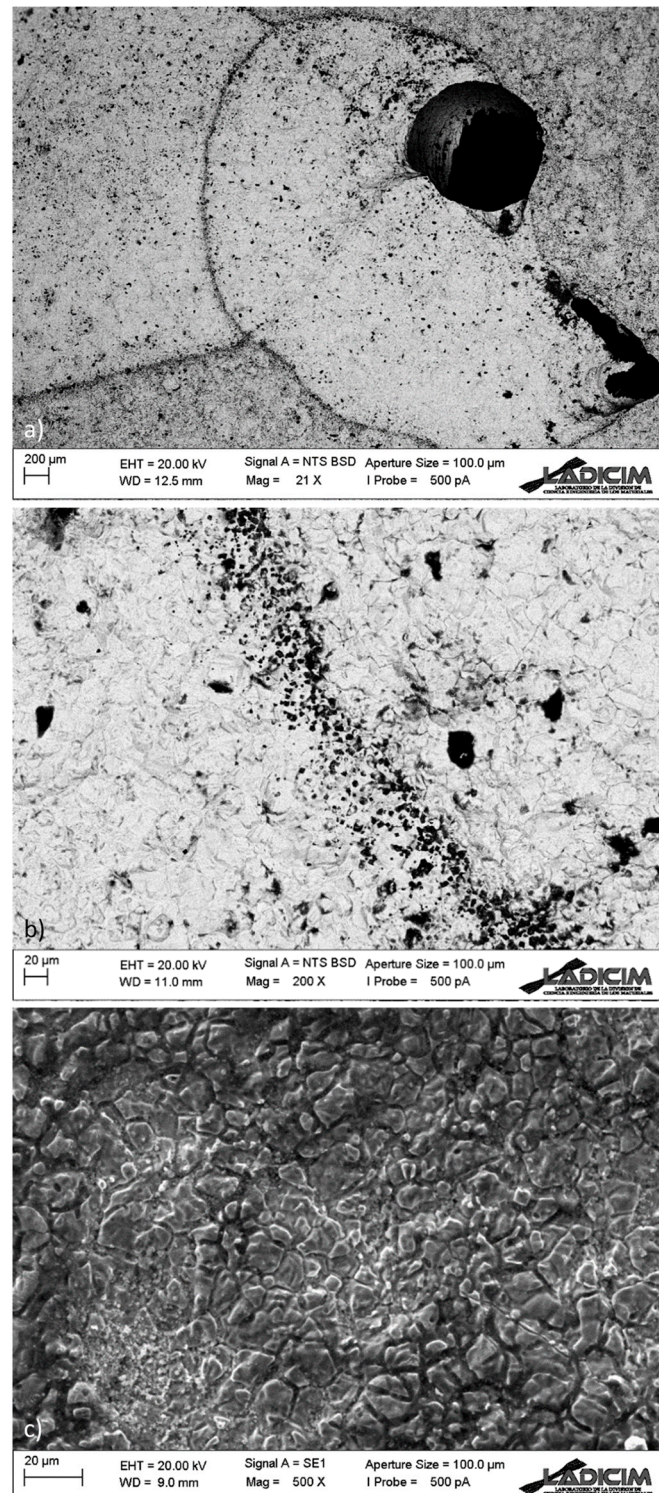
Figure 7a shows an image obtained by means of SEM of the through-wall pitting of the sample (inner face). In this image, the areas in which the process has advanced in depth, connecting with the outer surface, can be clearly distinguished. Additionally, a second region adjacent to the perforations can also be observed (see Figure 7b), where a loss of material was clear to the naked eye. In this region the tube has lost part of the surface material and grain boundaries are noticeable, pointing to a process that advances preferentially along such grain boundaries. Finally, Figure 7c shows an area attached to the through-wall pitting where no metal loss was observed by the naked eye, but where an advanced level of damage at grain boundaries can be seen through the SEM image, supporting the previous observation about the preferential attack at the grain boundaries.

Figure 7. (a) SEM image of a through-wall pitting on the inner face of the tube sample; (b) surrounding area with metal loss observed by naked eye; (c) surrounding area without metal loss to naked eye.

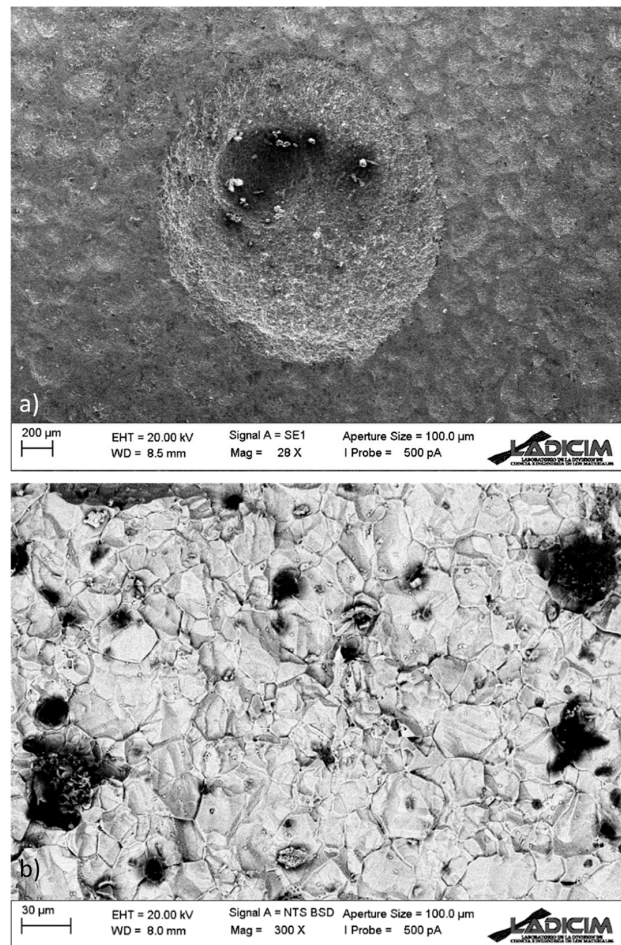
Meanwhile, Figure 8a presents another pitting from the second sub-sample, which is in an earlier stage of the process. It can be observed that it is not a through-wall pitting. In this case, the observation at higher magnification, shown in Figure 8b, makes it possible to once again confirm the existence of the same type of processes that advances preferentially through the grain boundaries.

Figure 8. (a) SEM image of a pitting in an early stage of the process on the inner face of the sample; (b) detail of the pitting in an early stage.

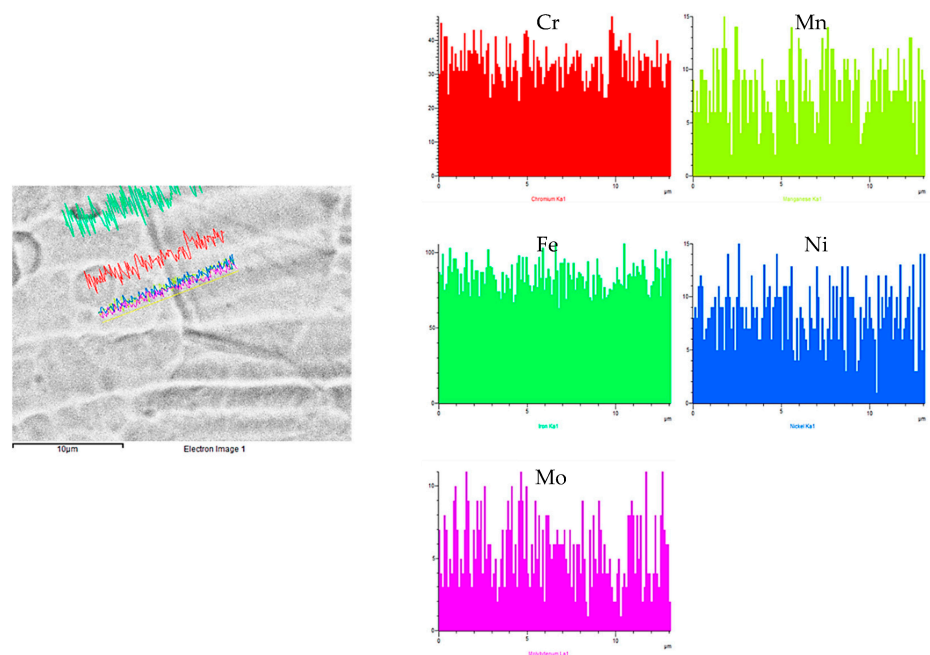
In any case, to rule this out, a semi-quantitative chemical composition scan was carried out using SEM, with an example of the results found being shown in Figure 9 (chemical composition scan in a non-damaged area) and Figure 10 (chemical composition in a particular grain boundary within a damaged area). In all cases, no peaks of Cr were observed. If these analyses had detected abnormally low Cr percentages, they would have been indirectly indicative of chromium carbide precipitation at the grain boundary (the zone close to the precipitates becomes depleted of Cr to feed the carbides). With all this, steel sensitization (precipitation of chromium carbides at the grain boundary) can be ruled out as the main cause of the corrosion phenomena being analyzed.

Figure 9. Grain boundary semi-quantitative chemical composition scan by means of SEM; Cr in red. Non-damaged area.

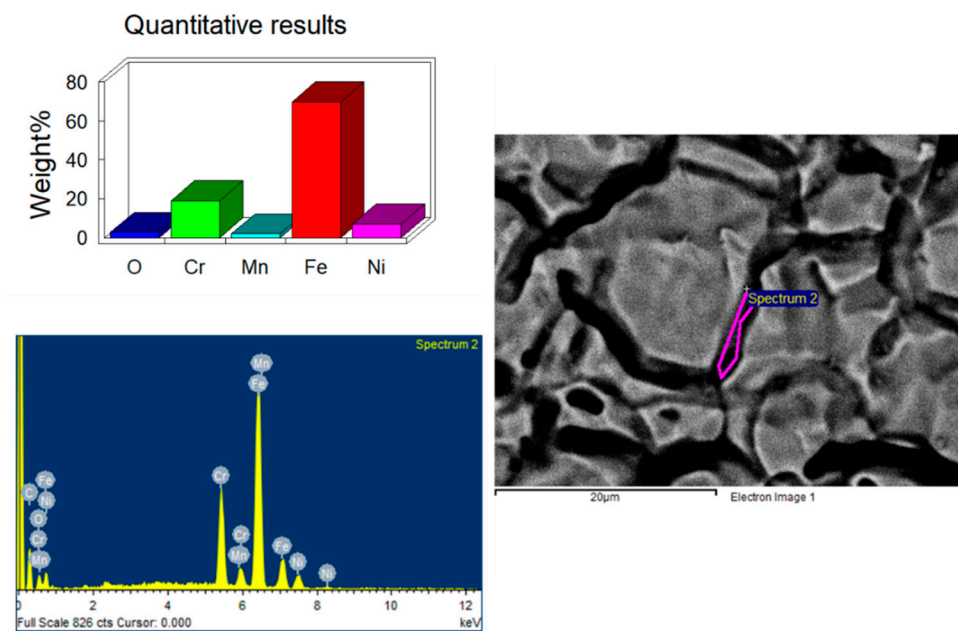
Figure 10. Spot analysis of semi-quantitative chemical composition by means of SEM in damaged grain boundary; Cr content is around 16%.

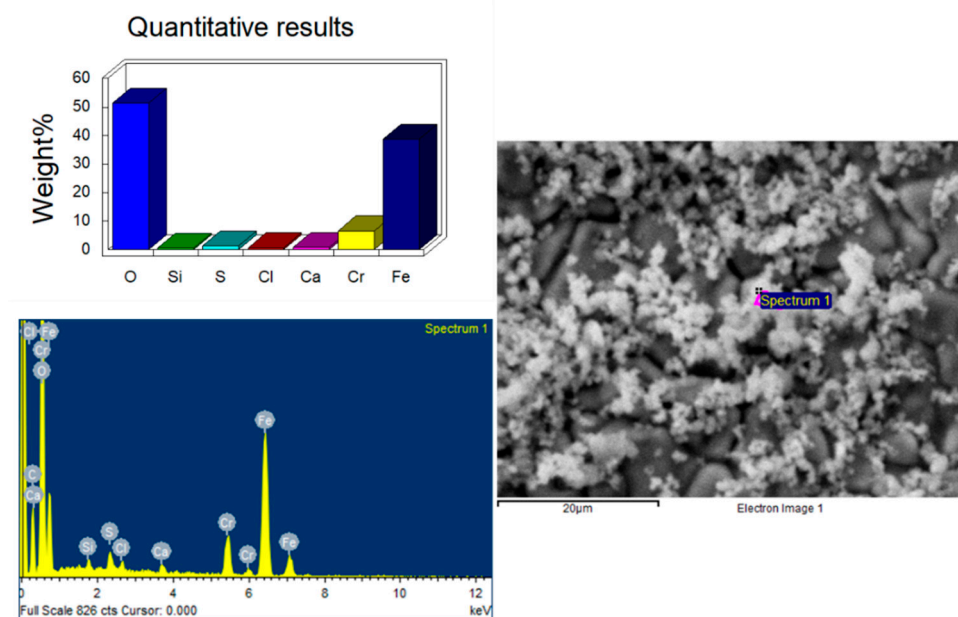
Finally, a SEM semi-quantitative analysis of the chemical composition of the corrosion products deposited in the sample was carried out in the area presented in Figure 3, where onset pitting and corrosion deposits can be observed. The results, which are presented in Figure 11, show the presence of sulfur (S) in non-negligible percentages, which cannot come

from the small amount of sulfur existing in the steel (see Table 1 with a $<0.008\%$ S content). Thus, necessarily, sulfur has been provided externally, quite likely by the corrosive agent.

Figure 11. Chemical analysis (SEM) of corrosion products in the tube.
