## Dynamic Identification and Monitoring of St. Torcato Church

RAMOS Luís F<sup>1,a</sup>, ALABOZ Murat<sup>2,b</sup> and AGUILAR Rafael<sup>3,c</sup>

<sup>1,2,3</sup>Civil Engineering Department, University of Minho, Guimarães, Portugal

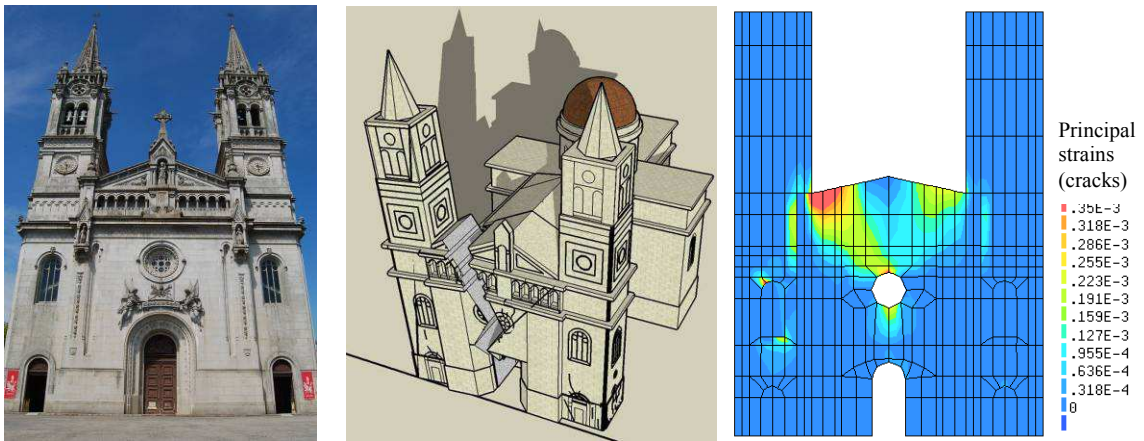
By simply looking to main façade a significant crack can be observed. Starting from the key stone of the entrance door arch, the crack goes through the rose window to the roof, splitting the façade in two macro blocks, as it is represented in Figure 1. The crack pattern seen on the façade is also observed inside.

The leaning of the towers reveals that they are moving in opposite directions due to soil settlement. The hair cracks seen at the bottom of the towers might be related with the compressive stress concentration caused by eccentric loads.

Figure 1 : Façade view, crack pattern representation, and numerical model with cracks

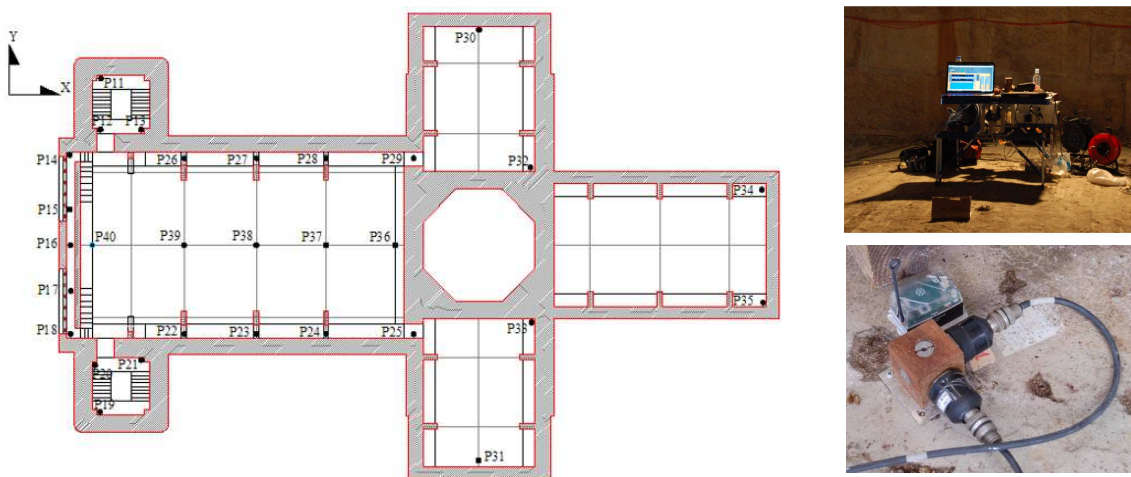
Records were taken in 35 points within 9 test setups. Schematic layout of sensors location is given in Figure 2. Reference accelerometers were decided to be placed at the top of the towers (two accelerometers in each tower in two perpendicular directions) because of their high amplitude and modal contribution in each mode. Towers and main façade had to be measured accurately as they have serious damages. Thus, the number and location of measurement points was chosen dense in this area.

Figure 2: Plan scheme of measured DOFs, acquisition system and sensors

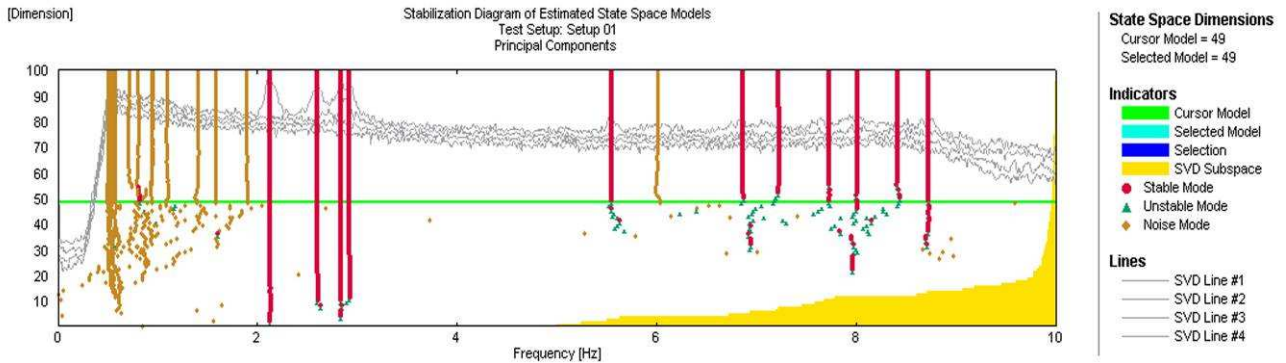
Figure 3: Estimation of frequencies with SSI method.

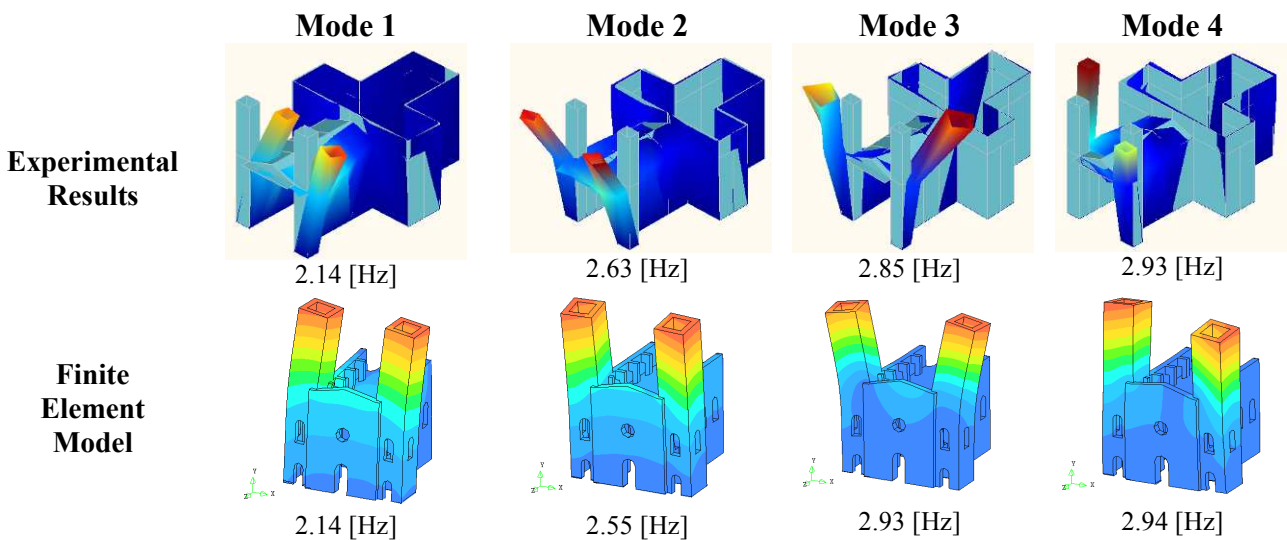
For the robust updating analysis, the Douglas-Reid method was used (Douglas et al., 1982). Lower and upper boundaries for the updating variables were defined according to engineering judgment. The updated results in terms of frequencies and MAC values are presented in Table 3. The mode shapes of the updated model exhibit high consistence with experimental mode shapes (see Fig. 4).

Figure 4: Mode shape comparison

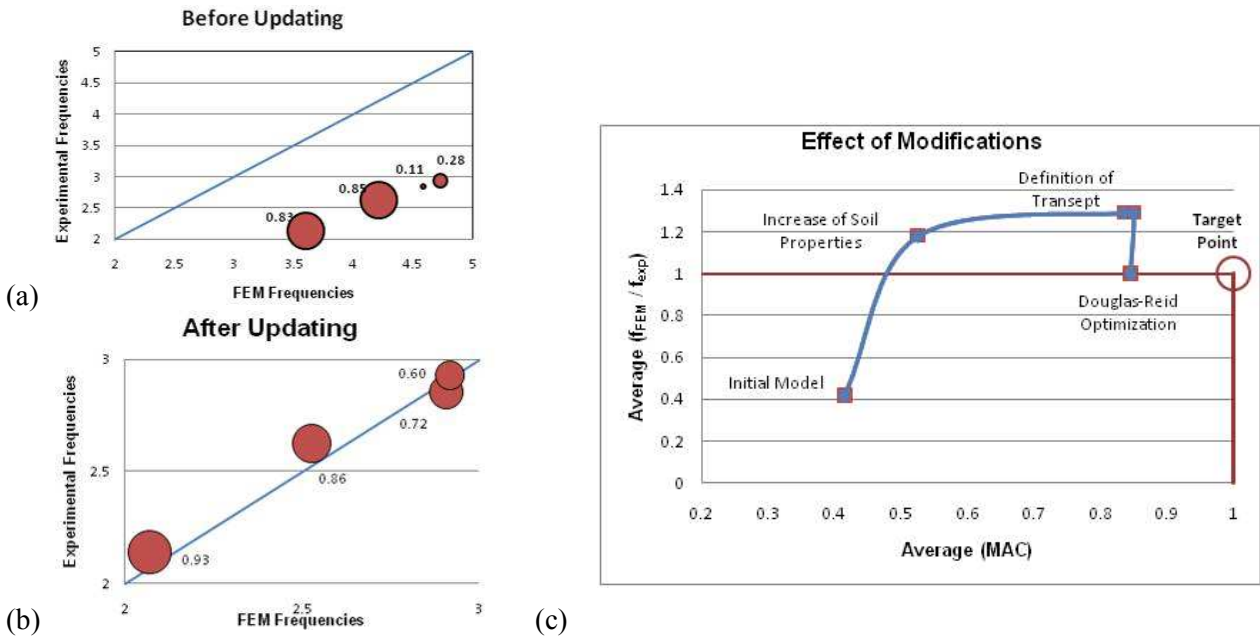
Figs. 5-a and 5-b presents the MAC and frequency comparison plot of the initial model and updated model, respectively. The updated frequencies are almost on the 45° line, which corresponds to a good correlation. Fig. 5-c shows the evolution of the results during all the updating analysis. The effect of all the modifications is plotted by means of frequency ratio and MAC values. The final point presents a high contribution of the modifications relative to the starting point. However, the evaluation of results are still far from the target point, which is desired to be one for MAC values and one for frequency ratio. This indicates that the model needs other modifications to achieve better results. Considering the crack's widths observed on the main façade, the simulation of the cracks by means of interface elements are advised for the next step.

Figure 5: a-b) Comparison of the models before and after the updating processes and c) overall effects of modifications

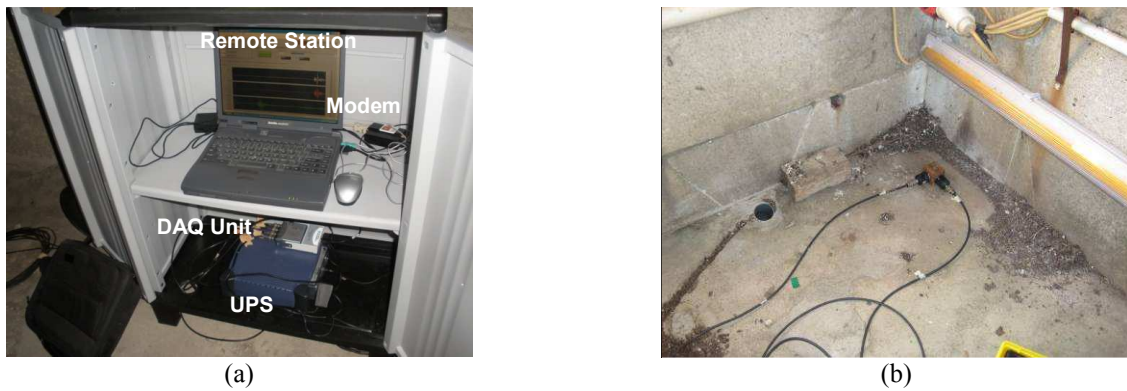
A continuous dynamic monitoring system was installed in the church starting from November 2009. This monitoring system was planned to be composed by four piezoelectric accelerometers, one portable DAQ unit, one Uninterruptible Power Supply (UPS), and one computer with embedded processor Pentium IV as remote station. A modem was included in the monitoring system to periodically send the processed data via GSM to a local FTP account. The accelerometers were located in two nodes in the towers of the church (one in each tower) for performing measurements in perpendicular directions. The central data acquisition station, as well as a scheme of the location of the measurement nodes is shown in Fig. 6.

Figure 6: Continuous Dynamic monitoring system setup. (a) Data acquisition station; and (b) measurement node

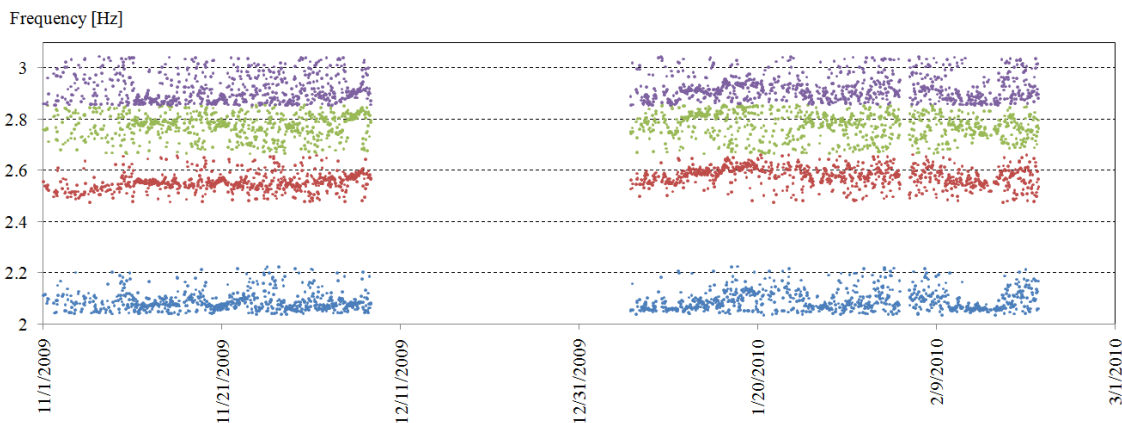
The time series recordings were remotely processed using an automatic feature extraction tool especially developed for this purpose. The results of the evolution of the first four natural frequencies of the structure are shown in Fig. 7.

Figure 7: Evolution of the natural frequencies – St. Torcato church case of study
