In situ measured cross section geometry of old timber structures and its influence on structural safety

Paulo B. Lourenço¹, Helder S. Sousa², Ricardo D. Brites³, Luís C. Neves⁴

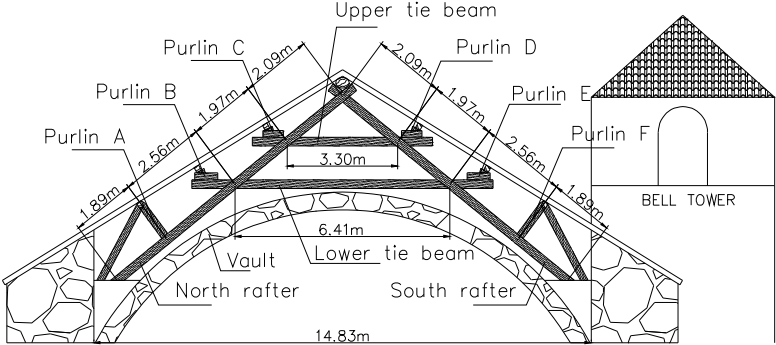
a)

The studied roof was built in the 17th century and is composed by eight timber trusses with two parallel high tie beams, without any post, see Figure 1a. The trusses and the ridge beam have round cross sections and non-straight axis, while the purlins are more recent and present rectangular cross sections and straight axis. The results of the measurements are presented in Table 2, where E is the average dimension and CoV is the coefficient of variation. It is noted that the deterioration of the rafters is often asymmetric due to localized water infiltrations or different neighbouring bodies to the roof under consideration. For this reason, the north and south rafters are considered in independent groups. The results indicate that the coefficients of variation of the dimensions of the round cross section are much larger than the coefficients of variation of the rectangular cross sections (11% on average for the purlins vs. 17% on average for the rest of the members). The lower tie beam has a larger coefficient of variation because the ends have a lower cross section than the central part of the element. The coefficient of variation of the purlins is within the expected range according to JCSS (2001).

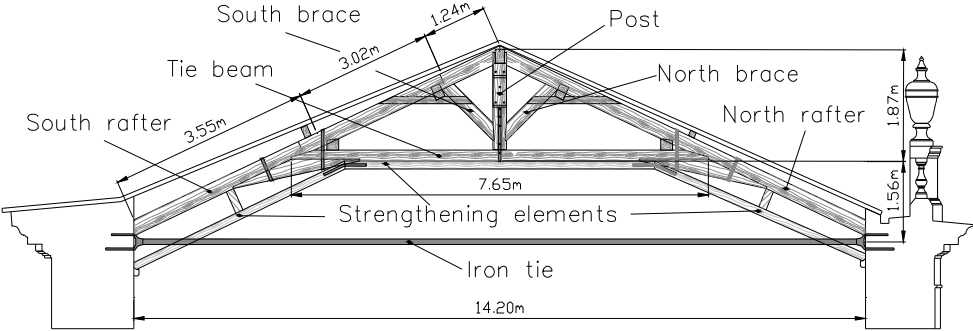
b)

This roof was built between 1773 and 1775, and the building was used as a chemical laboratory and classroom until 1998. The survey focuses on the roof of Wing 1, which was heavily deteriorated due to wood-boring beetles and fungi attack. It is assumed that the roof trusses are original, even if there are later additions and strengthening. The roof structure is composed by four trusses with an iron tie at the base and a timber tie beam at mid-height, see Figure 1b, where the post and braces are connected. The added strengthening elements (only in two of the trusses) are also shown in the figure under the rafters. The date of this intervention is not known but the wood is in better condition. The results from the geometrical survey (Table 2) indicate that the severe biological degradation provides very large coefficients of variation for the rafters and tie beam, particularly along the height of the members. The average coefficient of variation of the dimensions in these members is 18%, whereas the average coefficient of variation for the height alone is 25%. For the post and braces, the average coefficient of variation of the dimensions is 5%.

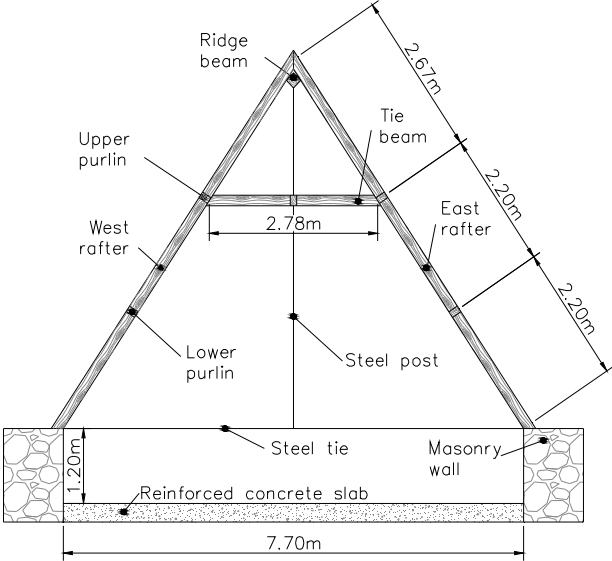
c)

The roof was reconstructed in the 1930s and consists of two rafters with a spacing of 0.55 m, on top of which timber sheeting with 0.015 m thickness and an asphalt sheet membrane for waterproofing were placed. The rafters are stabilized in the transverse direction by a ridge beam and two purlins on each slope. In addition, one high tie-beam, one steel tie at the bottom and one steel post are placed every 4.0 m, as shown in Figure 1c. The axis of the members is straight and the structure is in very good overall condition, since a regular maintenance plan is in place. Table 2 shows that the average coefficient of variation is very low (about 5%).

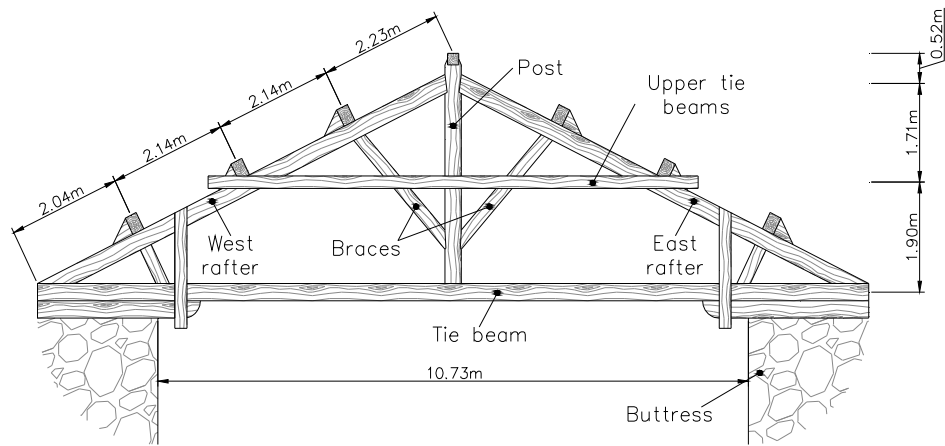
d)

This three pitched roof structure was completed only in the 1940s and is, composed by four king post trusses with the addition of a higher tie beam at approximately mid-height of the post, see Figure 1d. The distance between the trusses varies between 4.1 and 6.4 m and these are the only surveyed trusses in which the connections are made by steel plates, bolts and

nails. Table 2 shows that it is a recent structure, in good condition, and the average coefficient of variation is very low (about 3%).

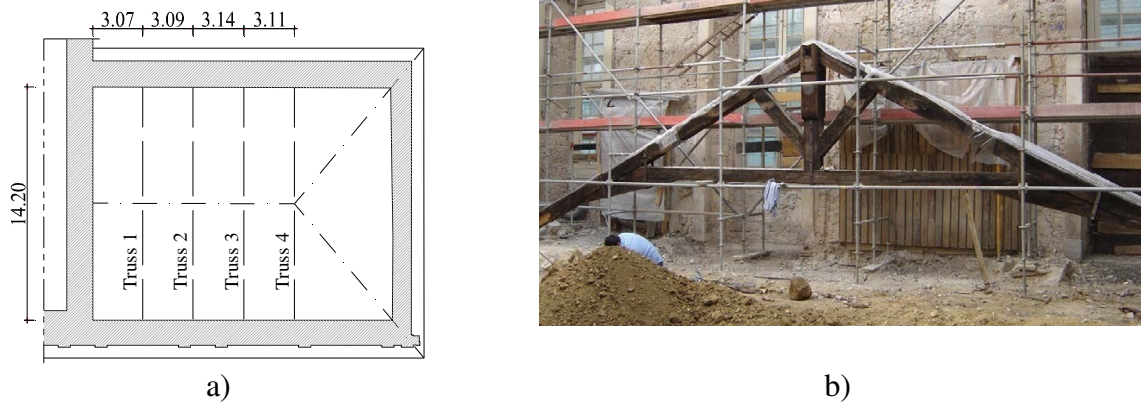
Figure 3: Wing 1 from Chimico laboratory: (a) plan with location of trusses; (b) photograph of truss #4 once it was moved down

Roof A1 from the laboratory is three pitched, including four trusses with a span of 14.2 m, see Figure 3. As a consequence of the large deterioration and damage, the trusses were brought down and a detailed survey of the condition was made. In order to identify and locate the damage during the inspection, a detailed inspection was considered for each timber member (rafters, tie-beam, braces, post and wedges) of each truss, using traditional and advanced techniques, namely controlled drilling Resistograph to obtain density profiles (Rinn and Schweingruber, 1996) and impact hammer Pilodyn for surface fungi deterioration measurement (Görlacher, 1987). To calibrate these methods, tests in areas that apparently were in good condition were carried out as reference. The combination of the above techniques allowed the definition of deterioration and damage maps, see Figure 4. The four trusses were in poor condition and, based on the inspection only, it was concluded that they were unfit for use without extensive repair and strengthening.
