THE OLD MUNICIPAL CHAMBERS BUILDING – DAMAGED BUT NOT DESTROYED – WILL IT BE THERE IN ANOTHER 125 YEARS?

ABSTRACT: *The Old Municipal Chambers is a Category I heritage building situated in Worcester Street, Christchurch. It was designed by architect Samuel Hurst Seager in the Queen Anne Arts and Crafts Style and was opened in 1887. The two storey building is constructed in solid brick and incorporates several decorative features, and it is an important part of the cultural heritage fabric of Christchurch. Some securing works were undertaken in 1989 to improve its performance under seismic loads. This paper will outline damage during the earthquake on 4 September 2010, subsequent aftershocks and the 22 February 2011 earthquake which resulted in some localised zones of collapse. The structure of the building has been stabilised externally, to secure or allow retrieval of very significant heritage features. The high cost to repair the building makes the future of the building uncertain despite its very significant heritage value. In response to the building's seismic vulnerability and possible retrofitting, finite element and simplified equivalent frame models were used for pushover

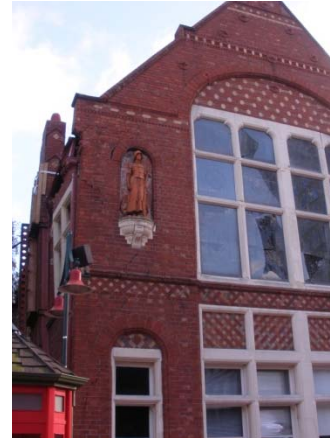
The south facade had several large cracks around the window openings to the Old Council Chamber. The wall was partly separated from the roof and presented large cracks along the returns (corners) of the east and west elevations. The first floor had maintained connection to the wall (Figure 3).

Figure 3: First floor connection to the wall

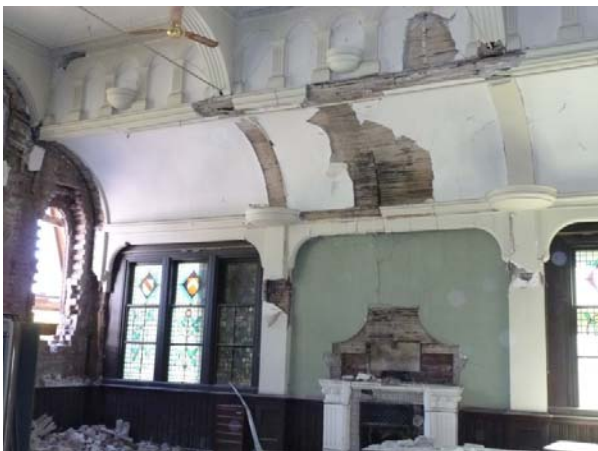
This room is located on the west side of the building and due to it being a large space open plan room, it has sustained significant damage which is also reflected on the external face. Although the roof structure appears to have remained intact, large areas of the plaster work had collapsed and the supporting brickwork on all four walls show extensive cracking, which makes the structure of this zone the most vulnerable in the building (Figure 4).

Figure 4: Damaged zone below the roof structure

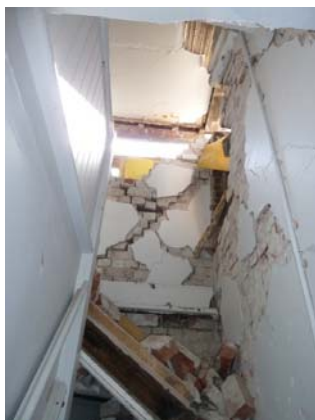
The north-west staircase which was constructed as part of the original construction suffered significant damage, where the west and north perimeter brick walls cracked and displaced. There has been localised collapse of these walls, as presented in Figure 5.

Figure 5: North-west stairwell

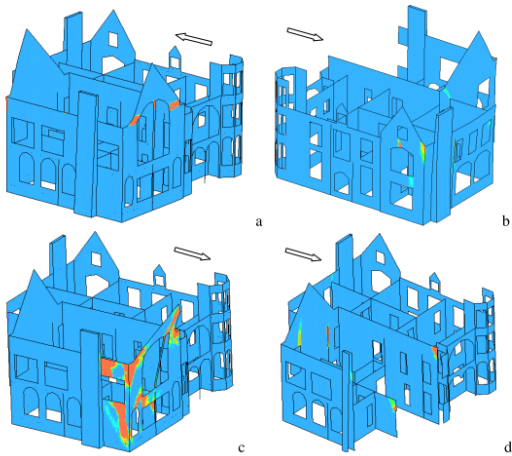
In the case of the +X direction it is possible to see in Figure 13a the collapse of the South gable, with cracks appearing on the top of the NE and NW edges and on the left side of the North gable (Figure 13b). In the -X direction the SW corner of the building collapses in Figure 13c, and cracks appear in the North façade and interior walls of the Council Chambers (Figure 13d).

Figure 13: Deformed shape and damage for +X: (a) collapse of South gable and (b) damage without South gable, and -X: (c) collapse of SW corner and (d) damage without SW corner

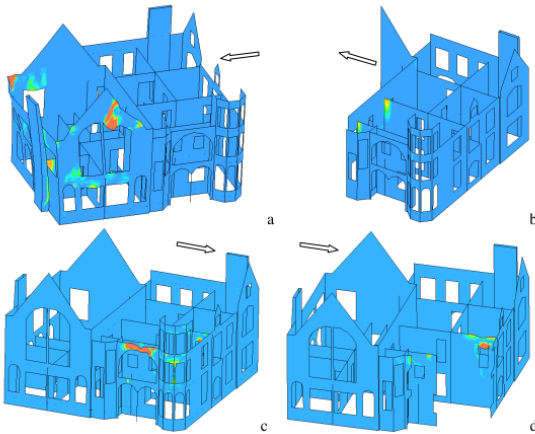
Figure 14: Deformed shape and damage for +Y: (a) wide damage of the Council Chambers and (b) damage without the Council Chambers, and -Y: (c) collapse of the top arch in South façade and (d) damage without SE corner

In the +Y direction, from Figure 14a there is deformation of the West façade to the outside and there is extensive damage on the gables of the North and South façades, with cracks in the interior walls near the Council Chambers (Figure 14b). In the -Y direction, the top arch on the right of the South façade collapses and the turret in the SE corner is damaged in Figure 14c, and there are cracks in the interior walls near the East façade (Figure 14d).

A different behaviour is identified for the +Y direction, which, from the observation of the evolution of damage and displacement in the computed response, seems to be due to the fact that the transversal walls to the East façade are working as buttresses for the building. These walls are working in elastic range (without significant damage) up to a displacement of 100 mm, allowing to considerably increase the base shear strength, after that the damage in the walls appears with corresponding decreasing of the base shear, see Figure 14a-b. This effect is not observed in the -Y direction, where the transversal walls present early damage, as shown in Figure 14c-d.

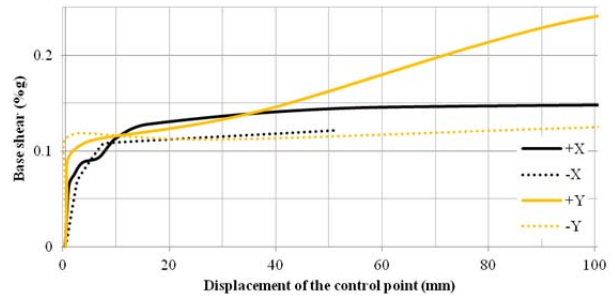
Figure 15 shows the capacity curves for all analysis corresponding to maximum load factors of 0.16, 0.13, 0.24 and 0.15 for +X, -X, +Y and -Y loadings respectively. Here, this is the percentage of the weight of the building applied horizontally, or the base shear force in proportion. Therefore, the building can withstand a static horizontal action of 0.13g, being more vulnerable in the -X direction.

Figure 15: Capacity curves from the FEM analysis
