## Conservation of cultural heritage buildings: Methodology and application to case studies

P.B. Lourenço

Modern societies understand built cultural heritage as a landmark of culture and diversity. Only during the last decades the idea that ancient buildings could be conserved and reused became appealing. Still, a large part of this heritage is affected by structural problems which menace the safety of buildings and people. The developments in the areas of inspection, non-destructive testing, monitoring and structural analysis of historical constructions, together with recent guidelines for reuse and conservation, allow for safer, economical and more adequate remedial measures. The paper addresses the issues of the methodology to adopt, of different cases studies and of present challenges. In particular, recent interventions in Portuguese cases studies (the Cathedral of Porto and a theological school in Braga) are analyzed in detail.

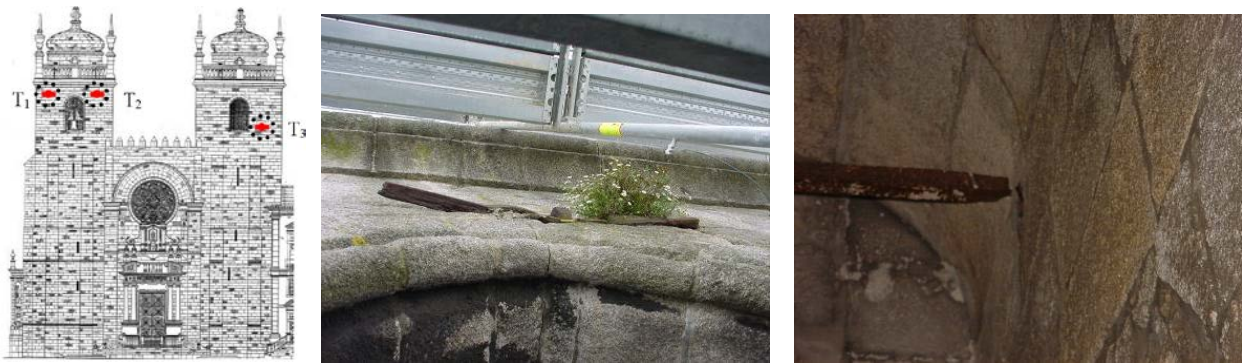
The towers exhibit distributed cracking and significant out-of-plane movements. The existing damage resulted in the past addition of three iron ties (date unknown), see Figure 5. Tie  $T_1$  presents a severely deformed anchorage and tie  $T_3$  is corroded and broken. The separation between the East and West façades of the South tower continued after tie  $T_3$  was broken. The masonry walls in the vicinity of the anchorages are also deformed, as expected due to the application of a large point load. The South tower is more damaged than the North tower, with severe cracks and out-of-plumb walls. Separation between the internal and external leaves of the walls is confirmed by the longitudinal cracking observed in most of the openings, with a maximum width of some centimeters.

Figure 5: Ancient tower ties, with deformed anchorage (T<sub>1</sub>) and broken tie (T<sub>3</sub>).

The solution adopted for strengthening consists mostly of a steel ring in both towers, aiming at confining the structure along the two orthogonal directions, in the sole location possible, see Figure 6a,b. The rings are made with welded stainless steel plates (class AISI 316L), connected to the towers using long, inclined stainless steel anchorages inside of a cloth duct to prevent generalized injection, see Figure 6c-e. The length of the steel profiles is defined so that the elements can be transported to the location through the existing doors and can be easily assembled in situ, without any further welding. In the North tower, the ring also aims at providing a support for the stone pavement for the bells, as stone columns are much deteriorated and had no structural function and the stone struts have very deficient conception. The steel ring is made of channel profiles ( $240 \times 120$  mm and  $200 \times 100$  mm height). In the South tower, a set of two ties was provided to the ring, because it was possible for aesthetic reasons and they are a testimony of the ancient broken tie. The ring must cross the staircase at a selected location because the complex internal structure of the tower does not allow otherwise. Due to the lack of internal stiffening elements, a much stiffer steel frame is needed and the steel ring is made of H profiles ( $180 \times 180$  mm). Due to the bulging outwards of the East and South façades, and the severe cracks in the corners, several short ties have been added to the structure to stitch the East and South façades, and two long ties through the core of the South façade have been added to connect the West and East façades, see Figure 6f. Figure 6g presents details of the two types of anchorage plates adopted (circular plates and specially designed crosses).

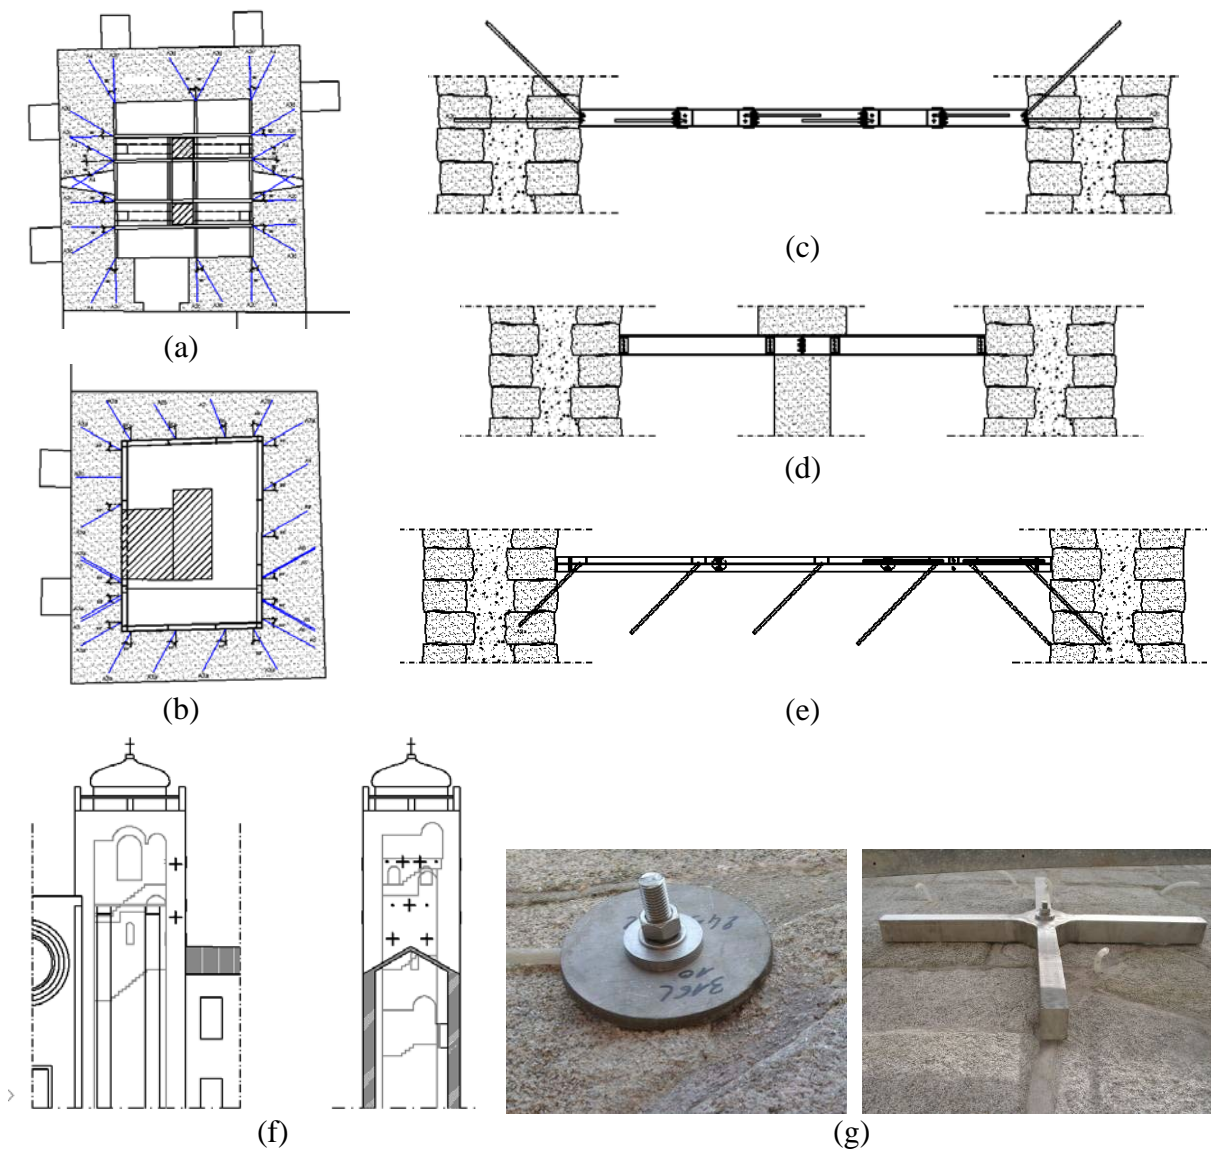
Figure 6: Aspect of the strengthening of the towers: (a) Ring for the north tower; (b) Ring for the south tower; (c) North-south section for north tower; (d) West-east section for north tower; (e) Typical section for south tower; (f) Additional ties in the west and south façades of the south tower; (g) Details of the anchorage plates.

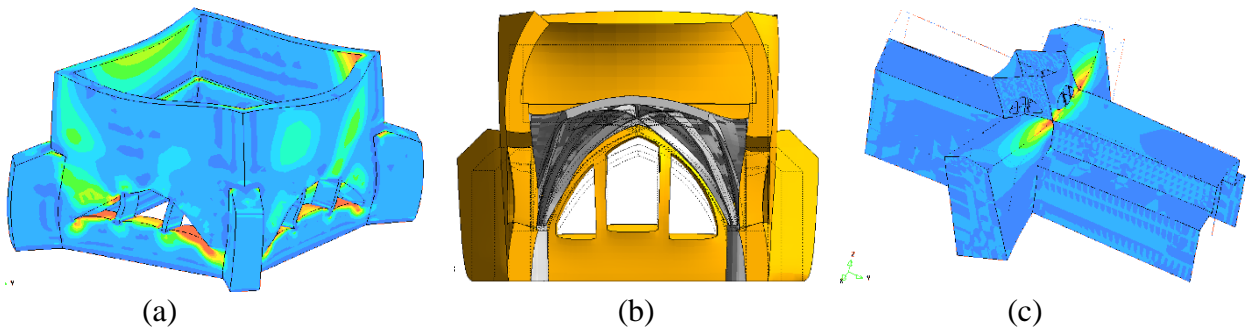
for seismic loading has some resemblance with the observed movements in the structure, the stresses found are too low to provoke any damage. The deformed mesh associated with the differential temperature indicates that the walls move to the exterior and suffer significant bending, with significant curvatures in the columns. Still moderate stresses are found and the deformation is not in agreement with the observed movements, meaning that the temperature effect is relevant but should not be the main cause of the damage. A full model of the church was then prepared to analyze the influence between the skylight, the adjacent structure and the soil, see Figure 8c. Very high tensile stresses are found in the skylight and the deformation is similar to the one observed in the structure, confirming that this is the major cause of damage. The remedial measures are given in Lourenço et al. (2004).

Figure 8: FEM analysis: (a) Live loads; (b) Temperature variation; (c) Dead load for full model.

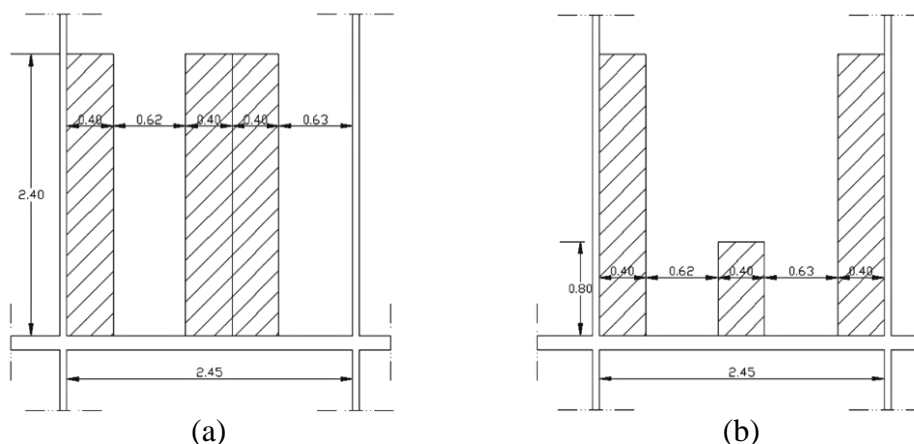
The reinforcement that is present in the slabs is adequate for the previous loads but it is clearly insufficient for the new loads. The proposal of the architect responsible for the works was to adopt three archive shelves with a height of 2.40 m and a base of 0.40 m, see Figure 10, which implies a reinforcement amount twice the existing. The original proposal is possible with a new supporting structure of steel profiles HEB 100, placed transversally in the rooms, and supported by steel angles placed close to the walls. On top of this structure, an OSB new floor would be placed, with a total cost for the solution of about  $100 \text{ USD/m}^2$ . The proposed alternative was to use two taller shelves close to the walls and a shorter shelf in the center, in order to reduce the bending moment, allowing even to provide more room for stocking.

Figure 10: Proposal for book archive: (a) Original; (b) New.

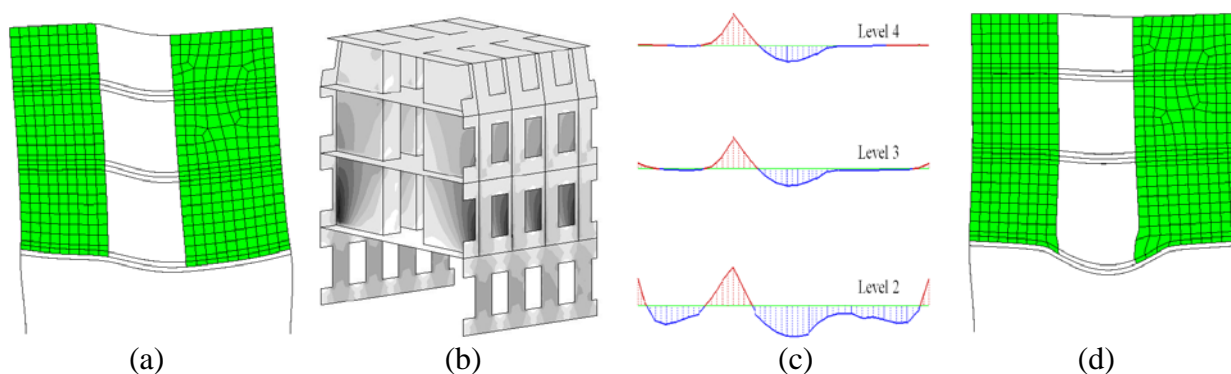
A finite element model was used for the global stability of the structure. The results allow confirming the large stiffness of the internal walls and the asymmetry of the response, see Figure 11a. The analysis of the principal compressive stresses shows that the load is transferred to the external walls, with a behavior similar to a deep beam and using the main beam of level 2 as a “tie” subjected to large flexure, see Figure 11b. The bending moment of the main beams obtained using a linear elastic approach and the failure of the structure using non-linear analysis is shown in Figures 11c,d. The asymmetric deformation and the large stiffness of the walls led to large bending moments producing tensile stress in the upper fibers (60 kN.m in the beam of level 2, in the connection with the left transverse wall). Therefore, the global stability is ensured by the flexural capacity of the nodes in the connection between beams and walls, in a zone where the amount of upper reinforcement is rather low. Figure 11d shows the attempt of the structure to follow a strong redistribution, with a fast progression of a horizontal crack between the walls and the beam in level 2. As the lower reinforcement in the beams is insufficient to carry out the load corresponding to the new use, the structure must be strengthened.

Figure 11: Results for the structural analysis: (a) Deformed mesh; (b) Compressive principal stresses; (c) Bending moments in main beams; (d) Failure from non-linear analysis.
