## Dynamic identification and modelling of Clérigos Tower: initial studies

Álvaro Cunha<sup>1</sup>, Luís F. Ramos<sup>2</sup>, Filipe Magalhães<sup>1</sup>, Paulo B. Lourenço<sup>2</sup>

**ABSTRACT:** This paper describes the work carried out to assess the dynamic properties of the historical construction of the Clérigos Tower in Porto, Portugal. A brief description of the Church, Infirmary and Tower is presented followed by a quick survey of the construction in terms of geometry and damages. Later it is discussed the dynamic test plan, and the first results from the modal identification tests are presented and discussed. Finally, a preliminary numerical analysis to tune the mechanical properties is presented as a first attempt to evaluate the structural behaviour and safety of this historical construction.

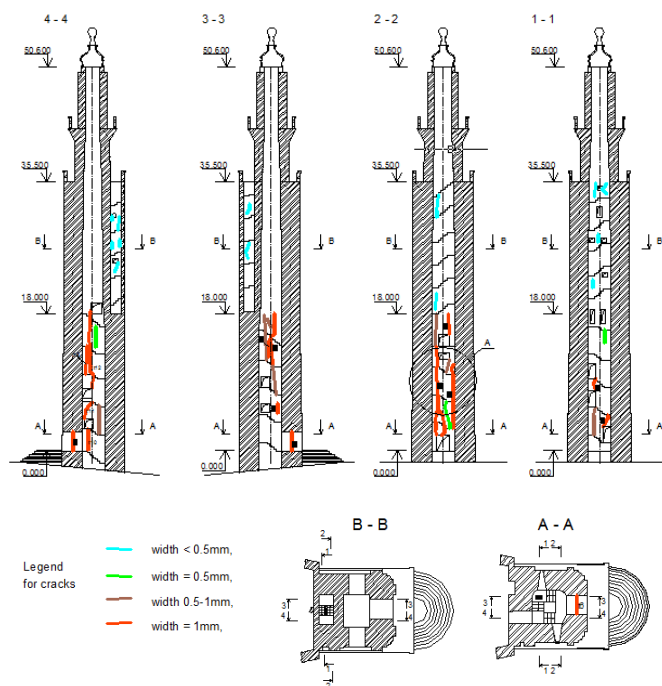
This first check was followed by a damage survey, including the material deterioration and other structural damages, such as cracks. Damage maps were drawn as can be seen in Figure 4. Damage map from the Bell Tower [5].

Figure 4. Damage map from the Bell Tower [5].

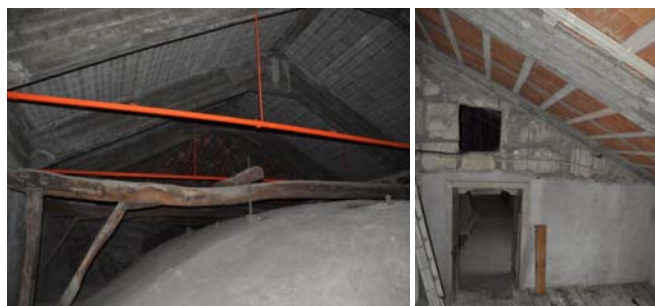
The roof of the church and, partially, of the *Casa dos Clérigos*, was substituted (probably in 1984) by a (heavy) reinforced concrete roof. Some original elements (tie beams of timber trusses) were left, adding some steel ties, as can be seen in Figure 5.

Figure 5. Configuration of the roof structure.
