## NOVEL PREFABRICATED PANELS FOR THE REPAIR OF DAMAGED INTERIOR RC BEAM-COLUMN JOINTS

**ABSTRACT:** A novel prefabricated panel is introduced for the repair and strengthening of damaged interior RC beam-column joints. This prefabricated hybrid composite plate (HCP) is made of a Strain Hardening Cementitious Composite (SHCC) reinforced with CFRP materials. Besides the higher durability of this system when compared to EB-FRP, thanks to the high ductility of the SHCC, anchors can be used in combination with adhesive to attach the HCP to the concrete substrate. The first section of this paper reports the methodologies to apply HCP for the repair of two severely damaged interior RC beam-column systems. To evaluate the performance of this rehabilitation technique, the repaired specimens were subjected to the same loading pattern as it was imposed to their virgin states. Since both repaired specimens showed a higher lateral load and energy dissipation capacities than the corresponding values in their undamaged state, the effectiveness of the HCP for the repair of damaged interior beam-column joints is proved.

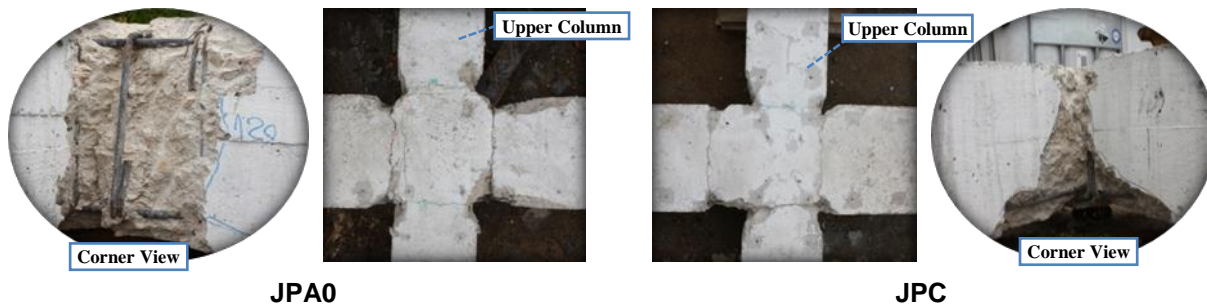
At the end of the test, the relevant damages were localized at the beams at vicinity of connecting zones to the columns (Fig. 2). Also cracks along the interfaces of the columns with the joint region, with minor importance, were observed. The premature loss in beams bending resistance, as a consequence of deficient bond between smooth longitudinal bars and surrounding concrete was reported as the failure mode for both specimens.

Fig. 2 - Damage Extent and Distribution before Repairing

All the repairing procedures were applied to the horizontally placed specimens. For both specimens, the damaged concrete at the corners was removed, and then air pressure was used to clean the surfaces. The visible cracks were sealed by injecting a low viscosity high strength epoxy resin (Sikadur®-52N). To reconstruct the corners at the joint regions a premixed cementitious grout was used (SikaGrout-213).

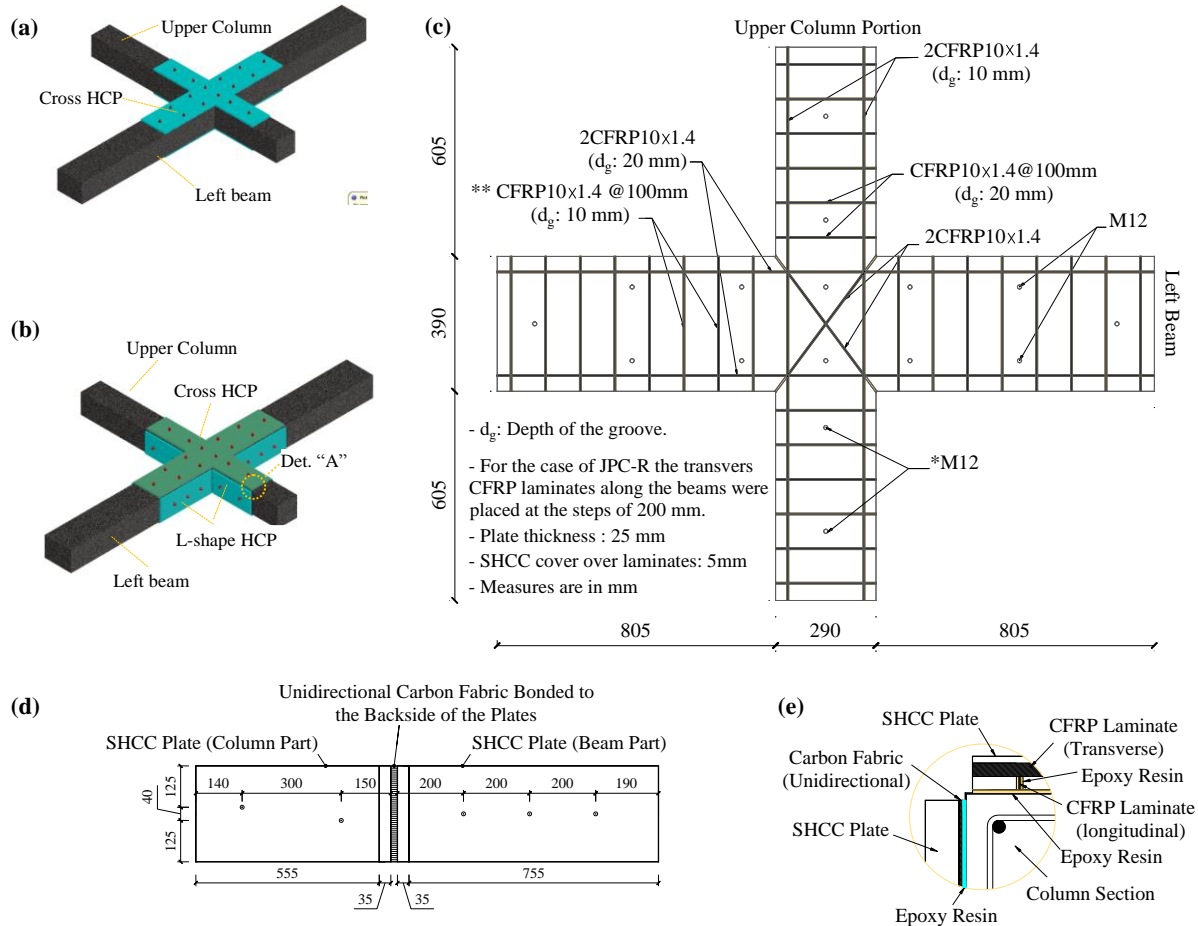
**Fig. 3 - Repair Configurations and Details of HCP a) Schematic 3D View of JPA0-R b) Schematic 3D View of JPC-R c) Plan View of the Contact Face of Cross-Shape HCP<sup>(L)</sup> d) Details of L-shape HCP<sup>(s)</sup> Shown in Plan Expanded View e) Det. "A" According to 3D View Shown in (b)**

The schematic 3D views of both specimens after repair are shown in Fig. 3a and Fig. 3b. For both specimens, a cross-shape HCP<sup>(L)</sup> was attached to their front and back faces by means of epoxy resin and mechanical anchors. For the case of JPC, also L-shape HCP<sup>(S)</sup> was attached to the lateral faces of the beams and the columns in the joint region. For the repaired JPA0 and JPC specimens the designation of JPA0-R and JPC-R was assumed, respectively.

According to the details of L-HCP<sup>(S)</sup>, illustrated in Fig. 3d, unidirectional carbon fabric was externally bonded along the length of the plates to offer additional flexural strengthening for the beams and the columns of JPC-R. In addition, SHCC plates have high potential for the shear strengthening of RC elements (Esmaeeli et al., 2013a). The bonding procedure of carbon fabric to the SHCC plates followed the common EB-FRP technique. However, only the contact face of carbon sheet and the top face of SHCC plate were impregnated with low viscose resin epoxy (S&P 50/55). The relevant properties of carbon fabric and resin epoxy are reported in (Esmaeeli et al., 2013a).

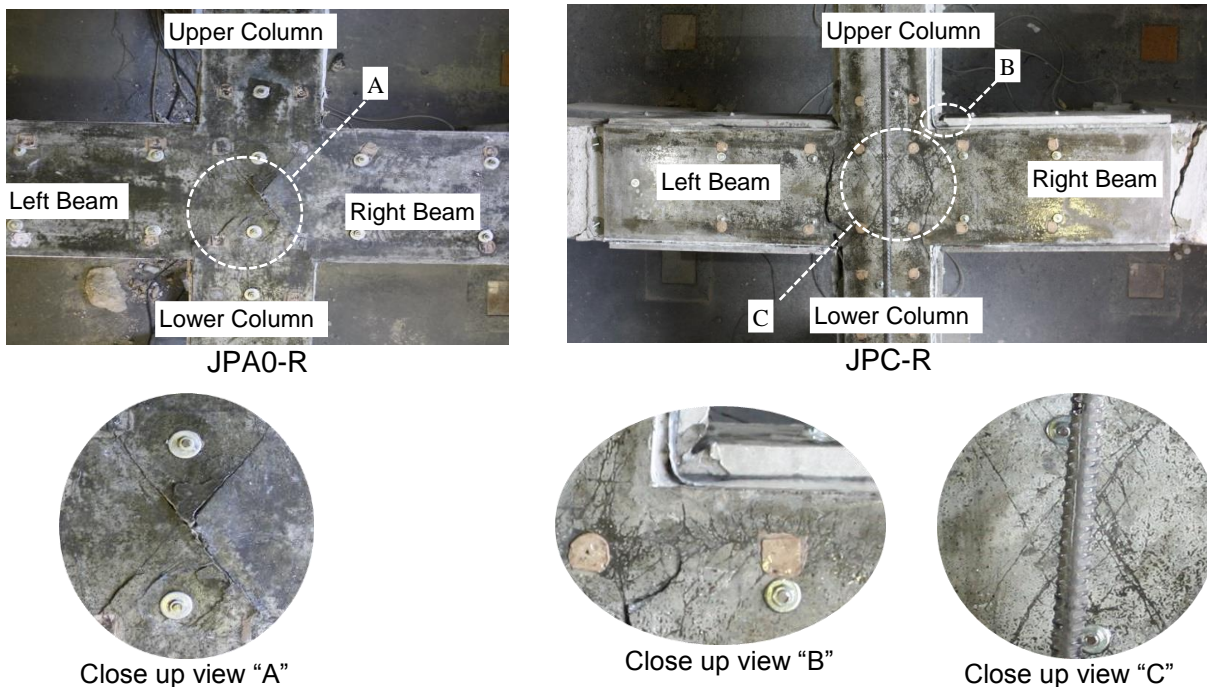
The governing failure mode of JPA0-R was based on the reduction of the shear capacity of the joint panel due to the formation of diagonal, horizontal and vertical cracks, and crushing the core concrete in this zone (Figure 5). For the case of JPC-R, the damages were mainly restricted to flexural cracks, formed initially out of the repaired regions of both beams, followed by further cracks at the vicinity of the framing section of left and right beams into the column. Therefore, JPC-R has reached its maximum lateral load carrying capacity after the formation of plastic hinges at the ends of the beams (Figure 5).

**Fig. 5 - Damage Distribution and Close-Up Views at the End of Testing the Specimens**
