Damage Inspection in Churches – The Canterbury Earthquake (New Zealand) Experience

João Leite¹, Jason M. Ingham², Paulo B. Lourenco³

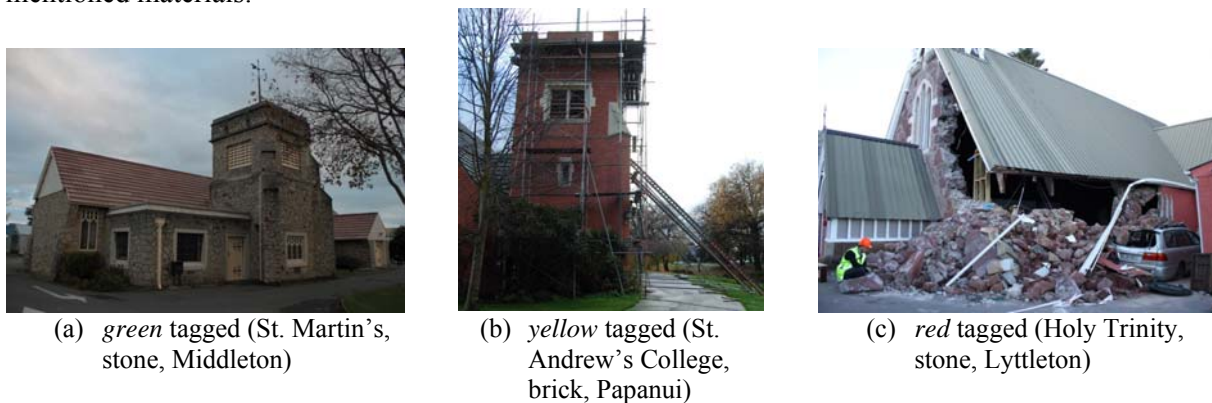
Figure 3. Examples of damaged churches.

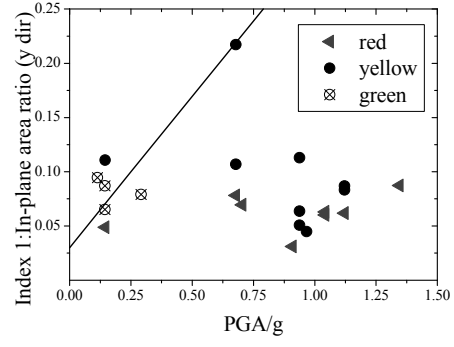
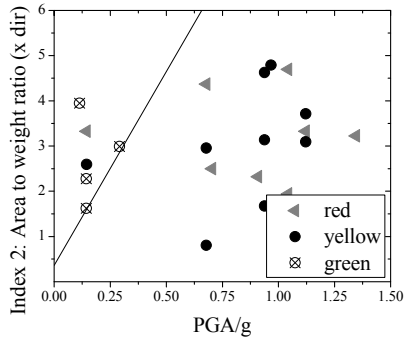
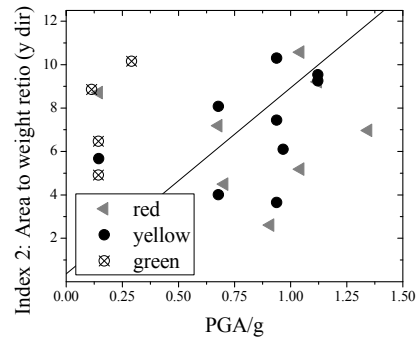
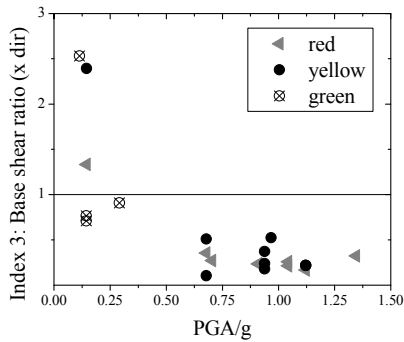
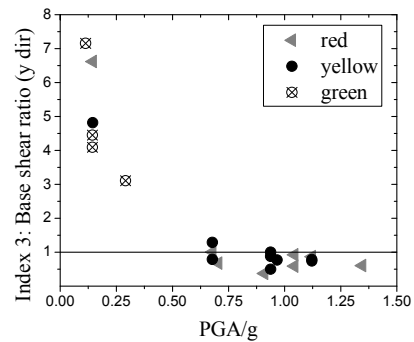
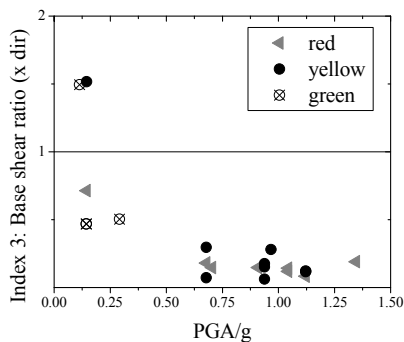
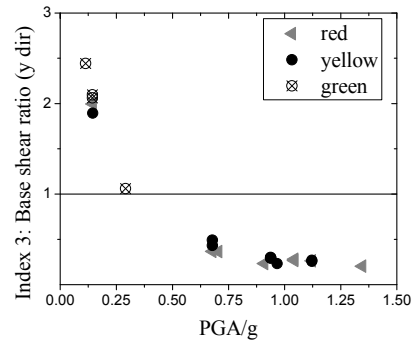
Figure 7. Clay brick churches: (a) index 1: In-plane area ratio in the x (transversal) direction; (b) index 1: In-plane area ratio in the y (longitudinal) direction; (c) index 2: Area to weight ratio in the x (transversal) direction; (d) index 2: Area to weight ratio in the y (longitudinal) direction; (e) index 3: Base to shear ratio, taking cohesion into consideration, in the x (transversal) direction; (f) index 3: Base to shear ratio, taking cohesion into consideration, in the y (longitudinal) direction; (g) index 3: Base to shear ratio, considering zero cohesion, in the x (transversal) direction; (h) index 3: Base to shear ratio, considering zero cohesion, in the y (longitudinal) direction.

Figure 7 presents the scatter plots of each index and the recorded horizontal PGA of the 22 February 2011 event for clay brick churches, as well as the proposed thresholds from Figure 6. Direction X and Y correspond, respectively, to the transversal and longitudinal directions regarding the main nave. The threshold for the first index is excellent, with all the green tagged churches above or near the line and only one yellow and one red church incorrectly identified. The yellow tagged church had only minor cracking with the exception of a large shear crack on one longitudinal wall of the main nave. There were also unstable nonstructural elements inside that could collapse during a stronger aftershock, which led the structural inspector to classify the church as yellow. The red tagged church was also a particular case, as it had pinnacles overhanging from the transversal walls and therefore was unstable even for a low PGA. These elements were severely damaged or partially collapsed compromising the connection between the transversal and longitudinal walls. The thresholds for index 2 and 3 also have acceptable results. The X (or transverse) direction provides better results in all three indexes, and this is the critical direction. The indexes are consistent even if they are not directly correlated. Index 3 exhibits the worse performance if cohesion is taken into consideration, with better results obtained for a zero cohesion, see Figure 7 (e) (f) (g) (h).
