Conservation of cultural heritage buildings: Methodology, research and applications

P.B. Lourenço

3. CATHEDRAL OF PORTO

4. THEOLOGICAL SCHOOL IN BRAGA

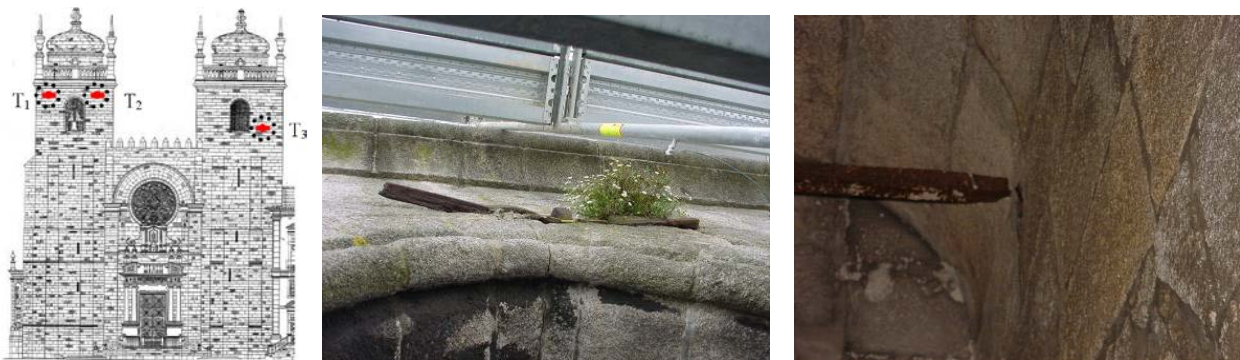
The towers exhibit distributed cracking and significant out-of-plane movements. The existing damage resulted in the past addition of three iron ties (date unknown), see Figure 5. Tie T_1 presents a severely deformed anchorage and tie T_3 is corroded and broken. The separation between the East and West façades of the South tower continued after tie T_3 was broken. The masonry walls in the vicinity of the anchorages are also deformed, as expected due to the application of a large point load. The South tower is more damaged than the North tower, with severe cracks and out-of-plumb walls. Separation between the internal and external leaves of the walls is confirmed by the longitudinal cracking observed in most of the openings, with a maximum width of some centimeters.

Figure 5: Ancient tower ties, with deformed anchorage (T_1) and broken tie (T_3).

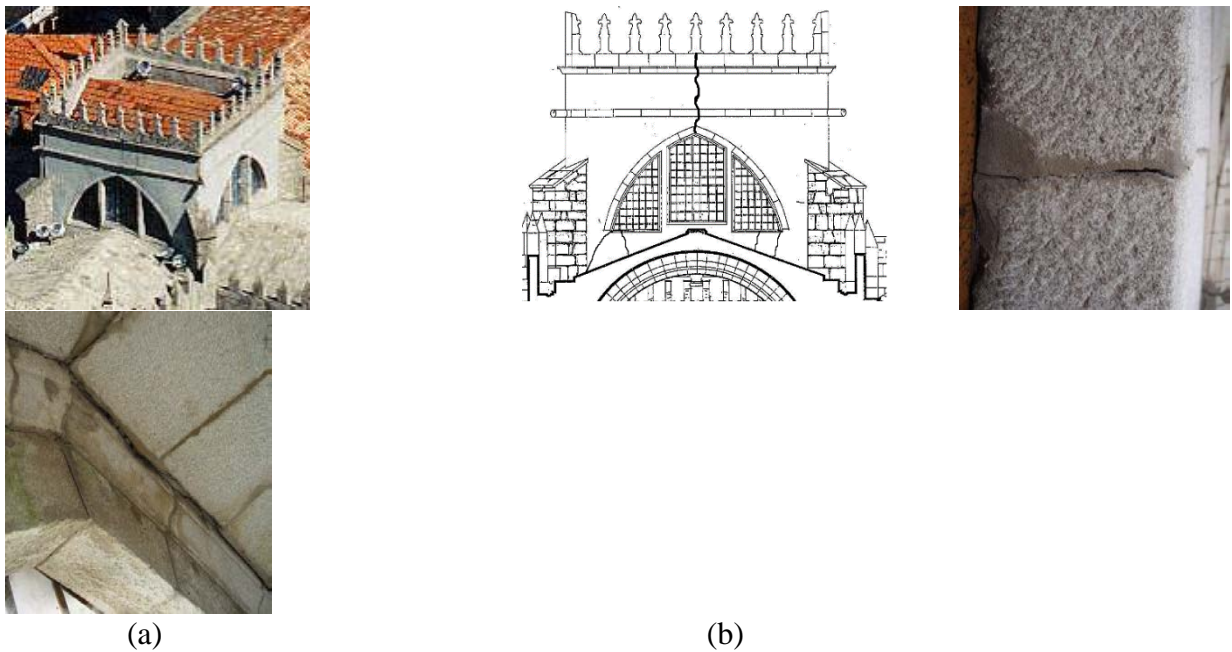
The three walls with windows are cracked at the arch key, with maximum crack widths of 10, 1 and <0.5 mm, in the façades West, North and South, respectively. These walls are also bulging outwards. Figure 7b shows the main crack in the West façade, which crosses the entire section of the wall. Smaller cracks can be also observed closer to the buttresses, under the opening, together with horizontal cracks in the window columns due to bending. The most severe crack in the interior has a width of 25 mm and shows that the vault is separated from the wall in the West façade. Due to this crack, the stone slabs of the vault are no longer supported in the side rib and a settlement of about 20 mm can be observed at the key of the vault.

The observation of the damage in the skylight, together with the local relief, the severe separation between the East façade and the chancel, the old documents indicating consolidation and enlargement of foundations and the bulging of the walls of the nave indicate that soil settlements and weak foundations can be the main cause of damage. A finite element model of the skylight was used to understand and justify the existing damage. The actions considered include the self-weight of the structure, the weight of the infill, the seismic action and differential temperature. The results for the combination of self-weight plus rubble infill provided a maximum tensile stress found lower than 0.1 N/mm^2 and located in the window-sills and ribs. The skylight should have minor or no damage under self-weight and infill. Seismic loading and temperature were then added to the structure, aiming at explaining the damage, see Figure 8a,b. Even if the deformation for seismic loading has some resemblance with the observed movements in the structure, the stresses found are too low to provoke any damage. The deformed mesh associated with the differential temperature indicates that the walls move to the exterior and suffer significant bending, with significant curvatures in the columns. Still moderate stresses are found and the deformation is not in agreement with the observed movements, meaning that the temperature effect is relevant but should not be the main cause of the damage. A full model of the church was then prepared to analyze the influence between the skylight, the adjacent structure and the soil, see Figure 8c. Very high tensile stresses are found in the skylight and the deformation is similar to the one observed in the structure, confirming that this is the major cause of damage. The remedial measures are given in Lourenço et al. (2004).

Figure 7: Skylight: (a) Aerial view; (b) Cracks in façades, windows columns and vaults.

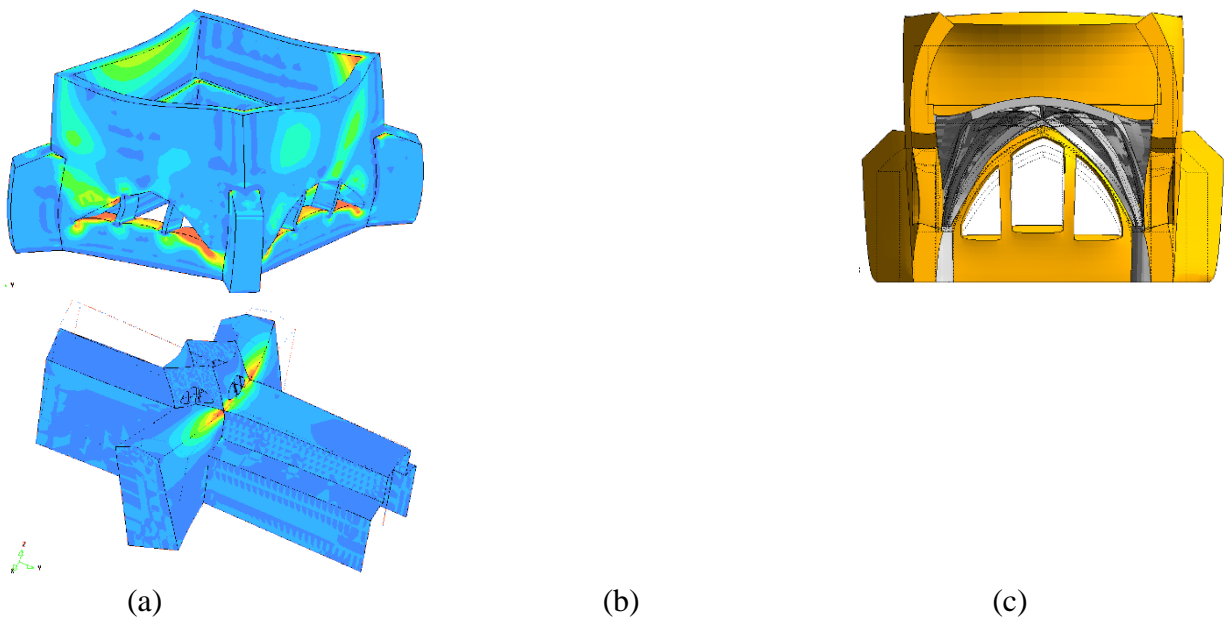
Figure 8: FEM analysis: (a) Live loads; (b) Temperature variation; (c) Dead load for full model.

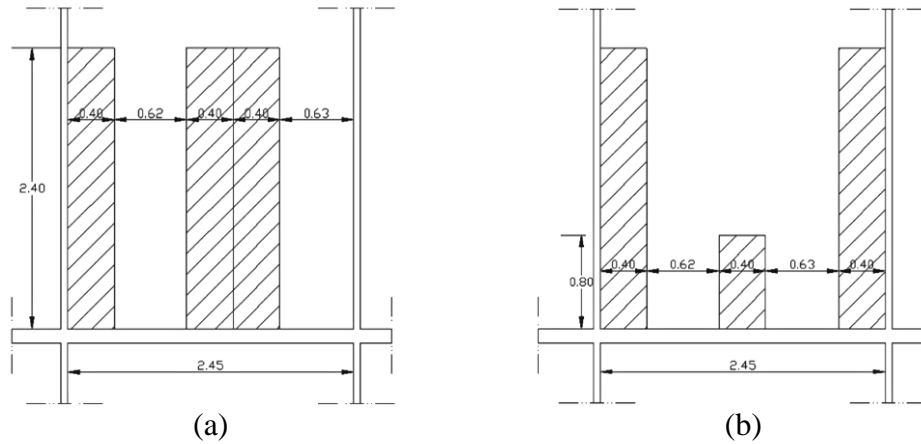
The reinforcement that is present in the slabs is adequate for the previous loads but it is clearly insufficient for the new loads. The proposal of the architect responsible for the works was to adopt three archive shelves with a height of 2.40 m and a base of 0.40 m, see Figure 10, which implies a reinforcement amount twice the existing. The original proposal is possible with a new supporting structure of steel profiles HEB 100, placed transversally in the rooms, and supported by steel angles placed close to the walls. On top of this structure, an OSB new floor would be placed, with a total cost for the solution of about 100 USD/m^2 . The proposed alternative was to use two taller shelves close to the walls and a shorter shelf in the center, in order to reduce the bending moment, allowing even to provide more room for stocking.

Figure 10: Proposal for book archive: (a) Original; (b) New.

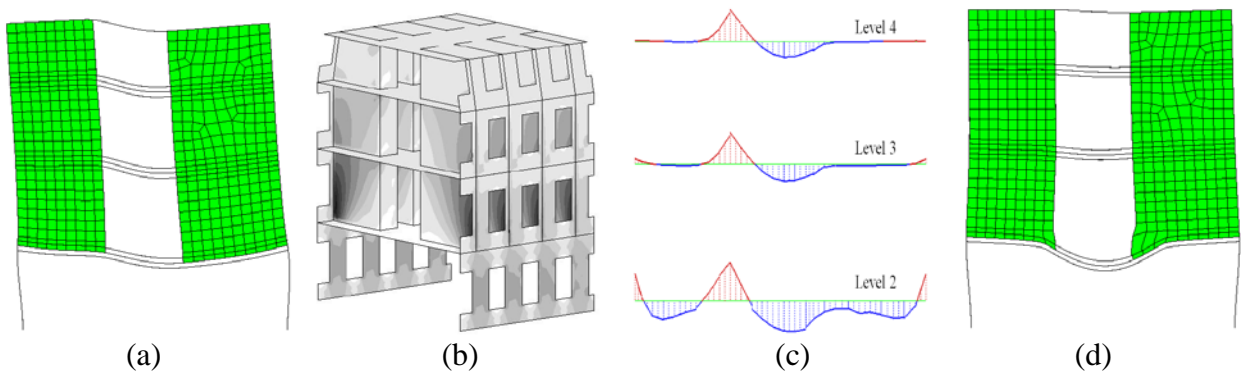
A finite element model was used for the global stability of the structure. The results allow confirming the large stiffness of the internal walls and the asymmetry of the response, see Figure 11a. The analysis of the principal compressive stresses shows that the load is transferred to the external walls, with a behavior similar to a deep beam and using the main beam of level 2 as a “tie” subjected to large flexure, see Figure 11b. The bending moment of the main beams obtained using a linear elastic approach and the failure of the structure using non-linear analysis is shown in Figures 11c,d. The asymmetric deformation and the large stiffness of the walls led to large bending moments producing tensile stress in the upper fibers (60 kN.m in the beam of level 2, in the connection with the left transverse wall). Therefore, the global stability is ensured by the flexural capacity of the nodes in the connection between beams and walls, in a zone where the amount of upper reinforcement is rather low. Figure 11d shows the attempt of the structure to follow a strong redistribution, with a fast progression of a horizontal crack between the walls and the beam in level 2. As the lower reinforcement in the beams is insufficient to carry out the load corresponding to the new use, the structure must be strengthened.

Figure 11: Results for the structural analysis: (a) Deformed mesh; (b) Compressive principal stresses; (c) Bending moments in main beams; (d) Failure from non-linear analysis.
