Survey and dynamic behaviour of the Our Lady of Conception Church, Portugal

ABSTRACT

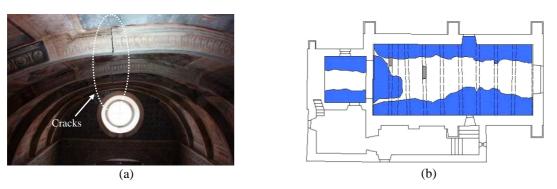
The church presents a crack pattern with significant damage (Fig. 2), namely in the intrados of the barrel vault and in the transversal masonry walls of the central nave (façade and chancel arch). The arches of the vault presents severe cracks along the central nave, mainly near to the central alignment and South masonry wall (Fig. 3a). Furthermore, the vault presents many damp patches that were caused by infiltrations of rainwater from the roof (Fig. 3b). Over time, the infiltrations have increased the degradation of the masonry vault and paintings inside.

Figure 3. Damage: (a) cracks at the arches of the vault; (b) damp patches.
