1st International Symposium on Building Pathology

Rain infiltration mechanisms in ventilated façades: literature review, case studies, understanding common practice flaws

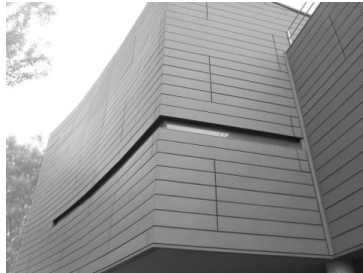
Figure 1. General view.

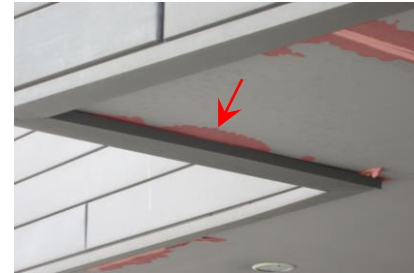
Figure 3. Moisture stains.

there is a risk of wetting the bolt (see E in Fig. 6). Infiltrated rainwater (level IV) that reaches the inside bottom of the cassette remains stagnant until it is drained away through the openings on the corners of the cassette returning to level III again (see Fig. 6). Note that the shape of the overlap prevents water from reaching level VI in this pathway (see G in Fig. 4). On the other hand, the rainwater that collides with vertical joints (see Fig. 6) drains away along the exterior surface of the omega profiles (level VI; B in Fig. 5). Nevertheless, rainwater near the panel edges might infiltrate through the contact interface between the cassette and the vertical profile (level VII; C in Fig. 5), which is not sealed, by capillary forces or by wind pressure or by hydrostatic pressure. Infiltrated rainwater may be collected at the top of a panel, run down at the back and fall on the next panel, causing a splash, projecting water droplets onto the insulation. The visual inspection has corroborated the expected wetting pattern. The dark stains around the upper and lower borders of the cassettes (see Fig. 2) show the places where rain droplets combined with dirt particles have remained by surface tension. Moreover, the moisture stains at the bottom border of the façade demonstrate that rainwater has infiltrated until level IV and has flown down in the cavity (see Fig. 3).

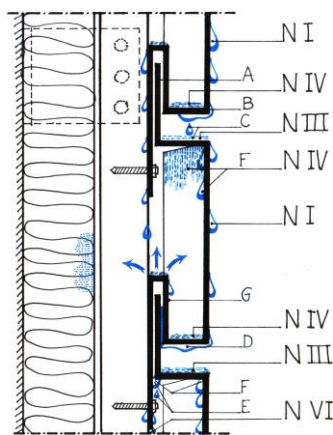
In this type of metallic coverings, the direct entry of wind-driven raindrops in the cavity is rather unlikely because the horizontal joints between panels are overlapped (see A in Fig. 4) and in the vertical ones, the vertical profile prevents it (see A in Fig. 5). So, when rain droplets collide with the zinc cassettes water will run down along its exterior surface (level I) by gravity until it reaches the lower edge (see B in Fig. 4). Then, water might drip in the horizontal joint, where it can remain stagnant or can flow along the horizontal plane (level III) by wind forces (see C in Fig. 4). Note that surface tension allows water to flow sideways along the lower face of the cassette. If this water reaches the overlap, there might be some capillary uptake. However it might not be enough to reach the top of the overlap and drip in the backside of the overlap (see D in Fig. 4). When water flowing along level III reaches the corner of the cassette, it might infiltrate inside through its border opening and trickle down adhered to its inner surface by gravity (level IV; Fig. 6 and F in Fig. 4) unless it overflows the border opening of the cassette and continues its downward flow (level II). Note that

Figure 4. Vertical section.

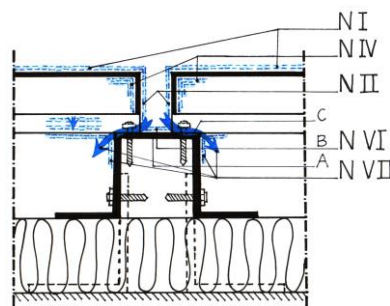
Figure 5. Horizontal section.

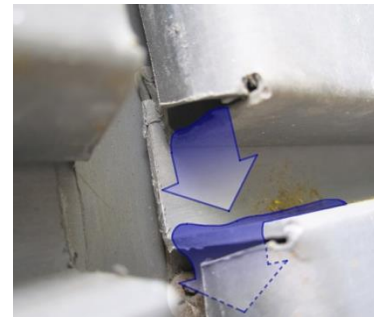
Figure 6. Detail of the cassette.

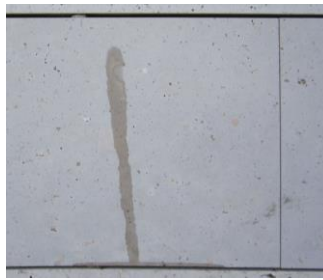
order to draw the constructive details. Then, an analysis of the rain flow paths has been carried out based on the state of the art and on site tests of micro-runoff (see Fig. 9). These own designed tests have allowed us to differentiate the surface runoff over the panels and the rainwater flow in the horizontal joints. Subsequently, the rainwater flow pathways in each system have been classified by means of levels from I to VII (see Table 1), which are depicted in the draws of each study-case. Finally, the obtained models have been compared to the observed damages in field inspections. The results are summarised in the Table 6.

Figure 9. Micro runoff test.

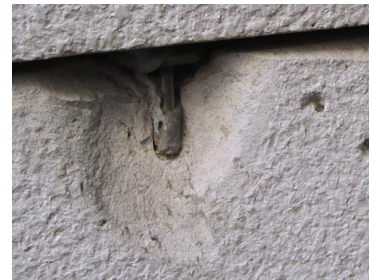
the gap by gravity creating some kind of tank (see C in Fig. 12). Thereby, as the infiltrated rainwater is not drained and has difficulties in being evaporated, it might cause the spalling of the plaque in that area if it freezes. This type of damage has been observed during the inspection of the building (see Fig. 10). Wind pressure might force the occluded water to drip down the threaded rod of the anchor (level VII) or the inner surface of the plaque (level IV; D in Fig. 12). On the other hand, rainwater infiltrates in vertical joints by means of capillary suction (level II) since the stone plaques are placed side by side in horizontal rows. Then, vertical joints are capillary pathways, in which water can be driven to the backside of the plaques by wind forces and by pressure differences (level IV; B in Fig. 13). Note that both horizontal and vertical joints can get easily occluded, leading to an airtight exterior leaf, corresponding poor pressure equalisation, and in turn high pressure differences over the cladding causing water to infiltrate more quickly into the cavity. The moisture stains at the bottom border of the façade demonstrate that water flows down along level VII.

Figure 10. Stone-panel spalling

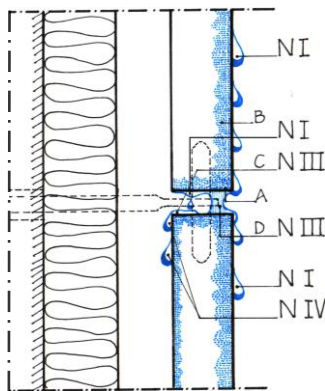
Unlike vertical joints, the width and shape of horizontal joints enables the direct entry of wind-driven raindrops to level VII (see A in Fig. 11 and 13). Rainwater impinging on the stone plaques will run down on its exterior surface by gravity (level I) until it reaches the lower edge. Note that whereas the zinc is an impermeable material, the limestone is a porous material that will absorb some of the water contained in the rivulet (see B in Fig. 11). Then, water might flow sideways along the border and the lower face of the plaque by surface tension (see A in Fig. 12 and Fig. 1). When the water bubble formed is big enough to enable the superiority of gravity action over surface tension, rainwater might drip in the top face of the adjacent panel (level III), where it can remain stagnant or flow sideways or leak down the inner surface of the plaque by gravity (level IV; C in Fig. 11). The rainwater running down in level I can also bridge the gap of the horizontal joint and continue its downward flow along the adjacent plaque (level I; D in Fig. 11). If the rivulet is located near the anchorages, rainwater coming from level I and flowing sideways along the lower face of the plaque might infiltrate into the gap by capillary forces (level I; B in Fig. 12). In contrast, the water retained in level III might drip into

Figure 11. Vertical section (middle of the stone plaque).

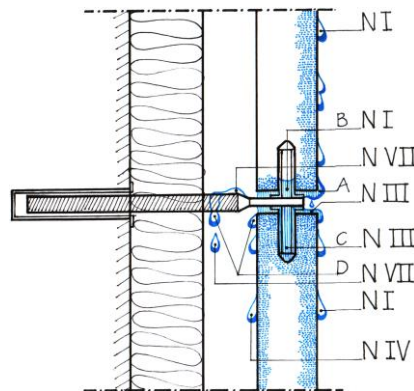
Figure 12. Vertical section (anchorage system).

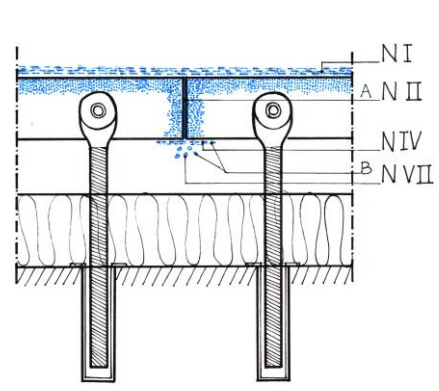
Figure 13. Horizontal section.

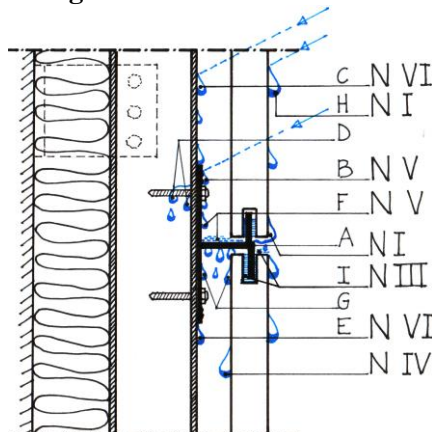
In this case, the entry of WDR in the cavity through the horizontal joints between panels is rather unlikely since the horizontal aluminium profile blocks its pathway (see A in Fig. 17). Contrarily, the kinetic energy of wind-driven raindrops will allow water entrance through the vertical ones easily

(level II; Fig. 18). However, whether water will reach the thermal insulation layer (level VII; B in Fig. 18) or only come into contact with the horizontal profile (level V; B in Fig. 17 and A in Fig. 18) and the vertical profile (level VI; C in Fig. 17) is uncertain. The rainwater that collides with the horizontal profile (see B in Fig. 18) will run down and accumulate at the bottom part (level V; A in Fig. 18) by gravity. Albeit, if it comes into contact with the screws it might be forced through the gap to the rod of the screw and / or the backside of the vertical profile by means of wind pressure and capillary suction (see D in Fig. 17). The rainwater impinging on the exterior surface of the vertical profile (level VI; C in Fig. 17) will trickle down by gravity until it reaches the top border of the horizontal profile. Then, it can flow down through the contact interface between the profiles (level VI; E in Fig. 17) or it can be held in the horizontal profile (level V; F in Fig. 17). If the stagnant rainwater reaches the connection between two horizontal profiles by local air currents and / or wind pressure, it might leak and run down either the inner surface of the panel (level IV) or the vertical surface of the horizontal profile (level V; G in Fig. 17). Finally, the rainwater that collides with the panel (level I; H in Fig. 17) will run down by gravity until it reaches the lower border, where it might flow sideways by surface tension and drip down in level III by gravity. Note that whereas the water flowing along the lower face of the panel (level I) might infiltrate in the anchor gap by capillary suction, the water flowing in level III might drip in the gap by gravity (see I in Fig. 17). Like in the before mentioned case, the freezing of this infiltrated rainwater might cause the spalling of the panel (see Fig. 15). In addition, red and black stains over the fibre cement panels and moisture stains over the bottom border of the façade have been identified during the inspection (see Fig. 16).

Figure 17. Vertical section.

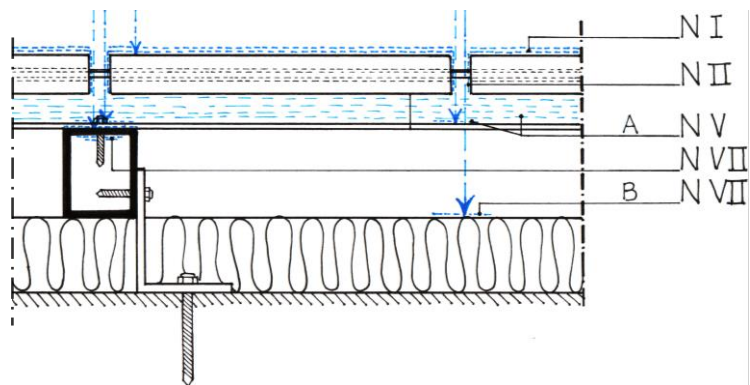
Figure 18. Horizontal section.

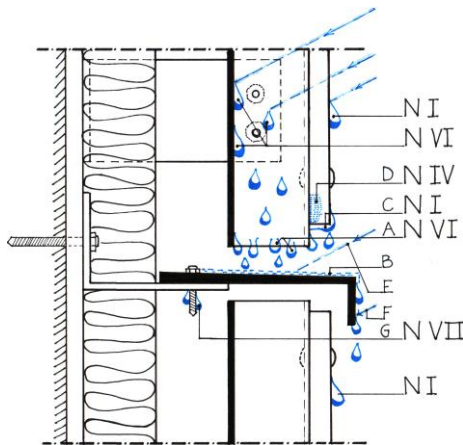
Figure 22. Vertical section.

The design of the horizontal and vertical joints in the ventilated façade of this building is quite original. So, the vertical joints are designed as pipes and, an aluminium cross-cavity flashing is installed in the horizontal ones, collecting and shedding the water drained from the omega profiles (see B in Fig. 22). When the kinetic energy of wind carries the raindrops into the vertical open joints (level II), the water can only collide with the omega profile (level VI; A in Fig. 23). The infiltrated water flows down in the omega profile by gravity dripping down over the horizontal profile, whose slope drives it to the exterior (see A and B in Fig. 22). However, if the water adhered to the surface of the omega profile reaches the interface between the profile and the panel by means of wind forces, capillary suction might cause the penetration of moisture in that area (see B in Fig. 23). This phenomenon might also occur when rainwater coming from level II reaches this contact interface by wind forces (see C in Fig. 23) or if water running down level I reaches this interface by surface tension (see D in Fig. 22). Note that this material is hygroscopic and retained water may give rise to premature deterioration. On the other hand, when rainwater impinges on the surface of the panel (level I), it will run down until it reaches the bottom border, where it might drip down over the horizontal profile and be shed (see B in Fig. 22). Nevertheless, if rainwater reaches the rivets (level I), there might be capillary uptake through the gap between the panel and the rivet (see D in Fig. 23) and the resulting soaking of the rivets and the panel in that area. Wind pressure forces might force the water in that gap to the inner surface of the omega profile (level VII). Regarding the horizontal joints, the aluminium profile divides the joint in two areas: the top and the bottom area. So, when rainwater infiltrates through the upper part of the joint (see E in Fig. 22), it might collide with the aluminium

profile, which will drain it directly outside the façade. Note that if the splash caused by the rainwater colliding with the horizontal profile might project water droplets onto the insulation is uncertain. In contrast, the entry of rainwater through the lower area of the joint (see F in Fig. 22) is rather unlikely as the shape of the profile prevents it. Note that the rainwater channelled outwards by the horizontal profile might leak down through the connection between profiles by gravity. There might be a critical point in the connection of the horizontal profile with the bracket if the slope of the profile is not sufficient. If rainwater reaches that point it might leak down through the gap of the screw by gravity (see G in Fig. 22). No damages have been identified during the inspection of the building.

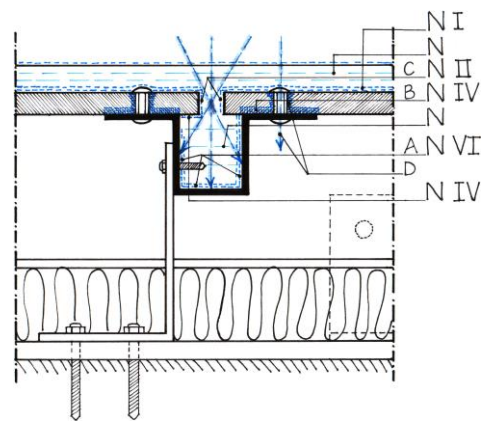
Figure 23. Horizontal section.
