Fatigue failure mechanism analysis of 1Cr17Ni2 stainless steel blades ground by an abrasive belt

Fatigue failure, as the main failure form of aero-engine blades, has a direct impact on the reliability and service life of aviation equipment. In order to improve the service performance of machined blades, it is necessary to understand the failure process and failure mechanism of blades and then optimize the grinding process. This paper takes abrasive belt grinding of an 1Cr17Ni2 stainless steel blade as the research object and analyzes the fatigue failure mechanism by characterizing the surface morphology, cross-sectional microstructure, and cross-sectional characteristics of the fatigue failure blade. The results show that cracks are prone to propagate in carbon-rich areas with poor mechanical properties inside the material, and the accumulation of large-size carbon-rich areas leads to continuous cracks easily and accelerates crack growth. The grinding process promotes the migration and consumption of surface carbon elements and forms a carbon consumption layer on the surface of the material, which can inhibit the initiation of fatigue cracks. The point-like pits on the ground surf

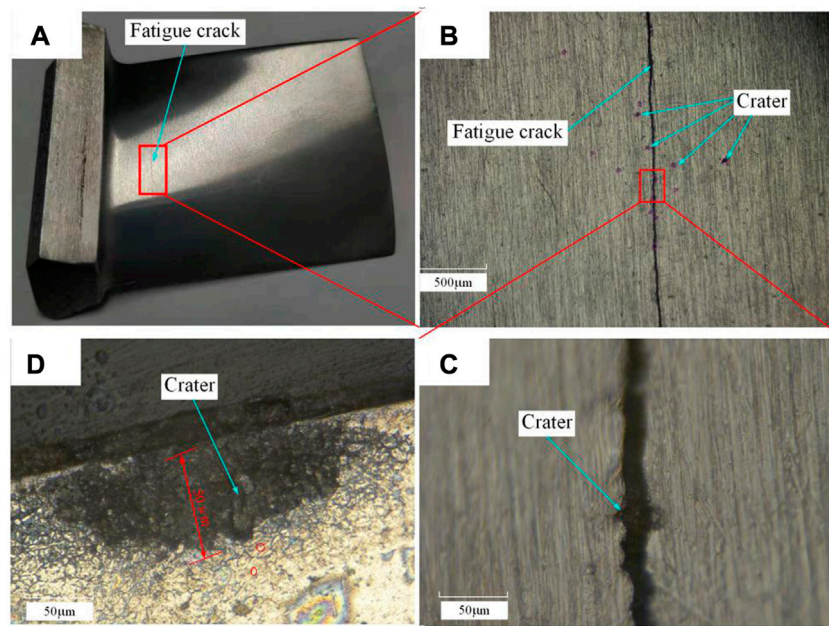
The surface morphology of the fatigue blade is shown in Figure 3. It can be seen from Figure 3A that blade fatigue cracks appear at the back of the blade near the root of the blade and extend along the direction perpendicular to the body of the blade. This is consistent with the direction of load on the blade surface, indicating that the direction of the load is the main factor affecting the direction of crack propagation. It can be seen from Figure 3B that approximately circular micro-pits are also found at the blade fatigue source in addition to grinding marks. It can be seen from Figure 3C that there are a large number of micro-pits near the crack, and some of them cross during the process of crack growth. This

Surface morphology of the fatigue blade. (A) Macro-cracks on the surface of the blade, (B) surface morphology near the crack source, (C) dimples on the crack, and (D) cross-sectional view of the dimples.

phenomenon indicates that the micro-pit has an important effect on the initiation and propagation of cracks. In order to obtain the basic information of surface micro-pits, the cross-sectional information of micro-pits is obtained by wire cutting and polishing. The cross-

sectional microstructure diagram of the micro-pit is shown in Figure 3D, and it can be seen that the size of the micro-pit is about 50 µm. In addition, the grain size at the bottom of the micro-pit is larger than that at the surface of the micro-pit.

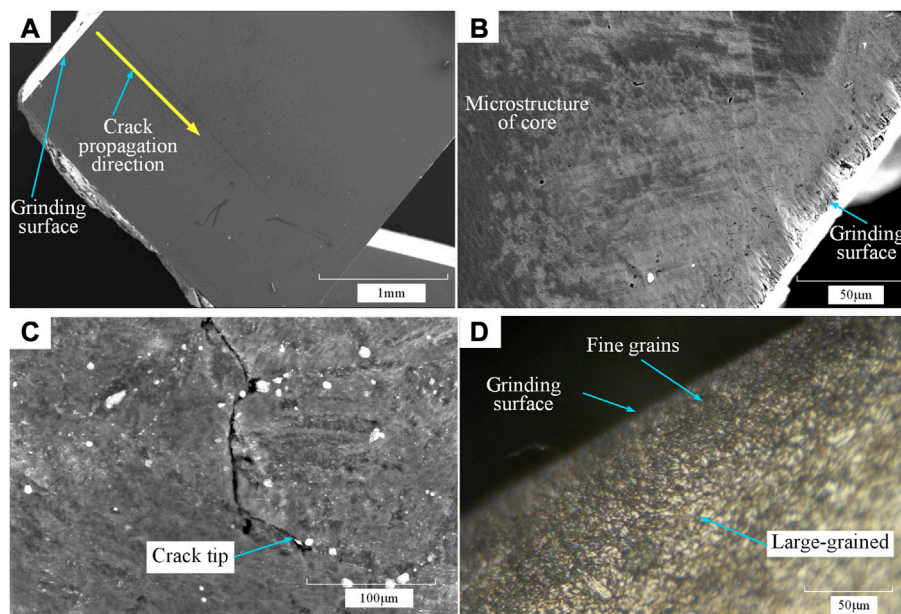
Blade cross-sectional microstructure. (A) Crack section, (B) grinding surface microstructure, (C) crack tip, and (D) grinding surface metallography.

The blade cross-sectional microstructure is shown in Figure 4. Figure 4A is a picture of the crack section. It can be seen that the crack growth is characterized by extreme depth propagation. In other words, the crack depth is much larger than the crack width, and the crack growth direction is approximately perpendicular to the grinding surface, so this type of fatigue failure has an extremely adverse effect on the service reliability of the aero-engine blade. The grinding surface microstructure is shown in Figure 4B. The grinding surface is white, which is more uniform and diffuses along the depth direction, and the area decreases gradually, while the microstructure of the core is dark. At the same time, the color change of the blade surface material has a gradual gradient. This phenomenon indicates that the composition and properties of the surface materials of the blade are changed due to grinding, and this change is extended from the surface to the inside. The crack tip is shown in Figure 4C. It can be seen that the crack growth shows an intergranular propagation. This indicates that cracks are more likely to propagate at grain boundaries. The metallographic structure of the grinding surface is shown in Figure 4D. It can be seen that the grain size is small on the grinding surface, while the grain size is larger near the core. Due to the refinement of surface grains, the number of grain boundaries increases, and the number of grain boundary barriers encountered in the process of crack propagation increases, so the crack propagation resistance increases, which is not conducive to crack propagation and the formation of large fatigue cracks. In addition, it can also be seen from Figure 4D that the gradient color characteristics of the blade surface are consistent with the observation results of the microstructure in Figure 4B. This indicates that microstructure refinement is a possible factor for the color variation of surface materials. That is, the surface grain refinement leads to the change of material properties.

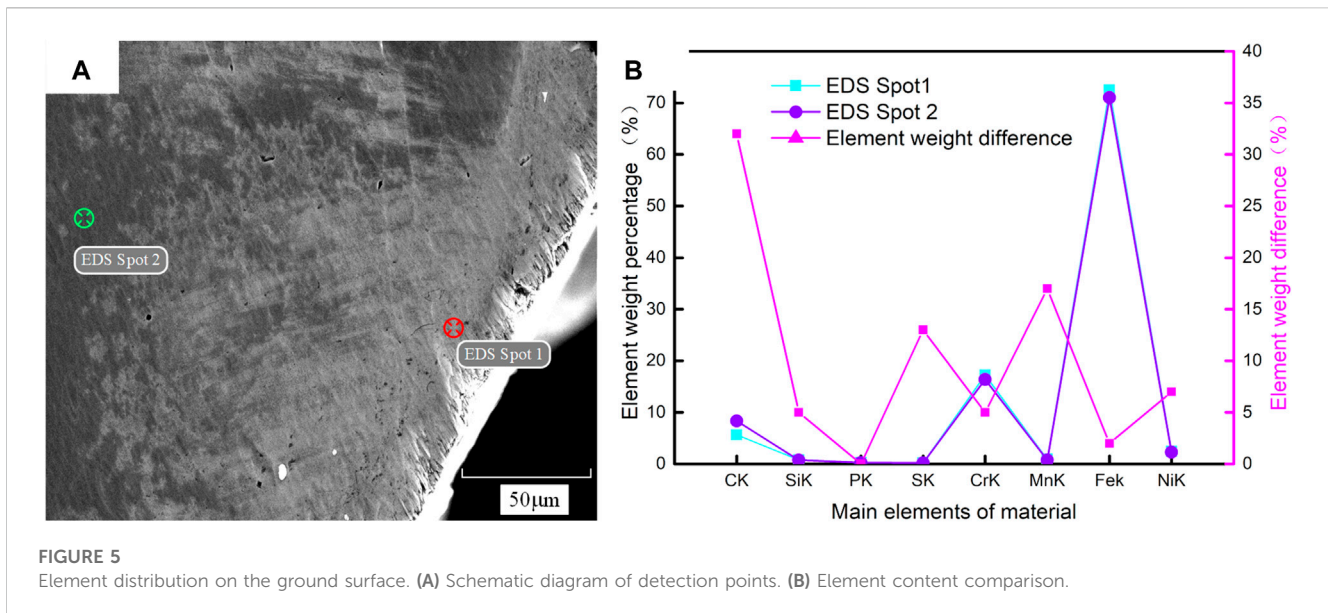
FIGURE 5 Element distribution on the ground surface. (A) Schematic diagram of detection points. (B) Element content comparison.

obtain the reasons for the changes in the surface microstructure, the element distribution of the grinding surface and core structure are analyzed by EDS. The element distribution on the ground surface is shown in Figure 5. It can be seen that the carbon elements, potassium elements, and sulfur elements have great changes on the grinding surface, among which the carbon content changes the most, the carbon content of the surface tissue is 64% lower than that of the core tissue, and it indicates that the carbon content of the surface material is consumed during grinding. However, there was a 30% increase in sulfur element. As we all know, the increase of potassium and sulfur content in steel makes the grinding surface brittle, which has an adverse effect on the initiation of fatigue cracks (Maciejewski, 2015).

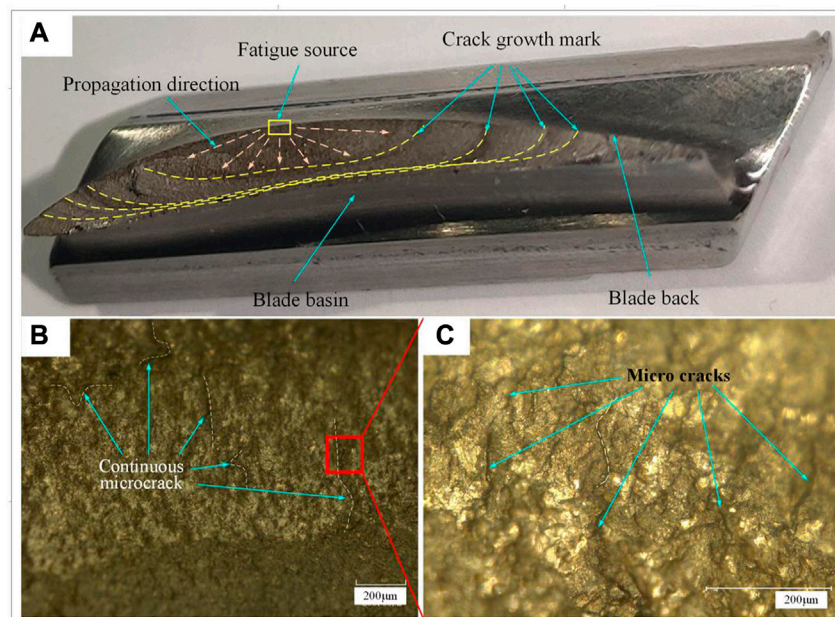
The processes of fatigue crack initiation and propagation are recorded by the fatigue section, and the section morphology of the fatigue fracture blade is shown in Figure 6. It can be confirmed from Figure 6A that the fatigue cracks start from the middle of the blade back near the blade root and then radiate to the inside of the blade. At the initial stage of crack growth, the crack propagates in both the depth direction and the vertical blade body, and the propagation speed in the depth direction is slightly slower than that in the vertical blade body direction. As the crack propagates along the depth direction near the blade basin, the crack growth slows down along the depth direction, and the crack growth rate along the width direction is greater than that along the depth direction. When the crack depth direction extended to the side of the blade, the crack depth direction is stagnant, and only the crack growth speed is found in the vertical blade body direction. The morphological characteristics of the blade fracture surface are shown in Figure 6B, and a bright area with metallic tint and a dark area are discovered on the fracture surface. There are micro-cracks in the dark area, and the micro-cracks are connected with each other and

FIGURE 6 Section morphology of the fatigue fracture blade. (A) Overall characteristics of the section, (B) partial morphology of the section, and (C) micro-cracks on the section.

even form continuous cracks in the continuous area. This also indirectly confirms that the grinding process has an effect on the properties of the surface materials, which corresponds to the microstructure results in Section 3.1. Figure 6C is an enlarged figure; it can be seen that the size of micro-cracks is large and the number of micro-cracks is high in the dark area, while the number is low and the size is small in the surrounding matrix; it indicates that the strength is poor and cracks easily initiate in the dark area. It is known from Section 3.1 that the grinding surface has dark areas, which also indicates that the grinding process leads to partial degradation of the material properties, which, in turn, makes it more prone to crack initiation.

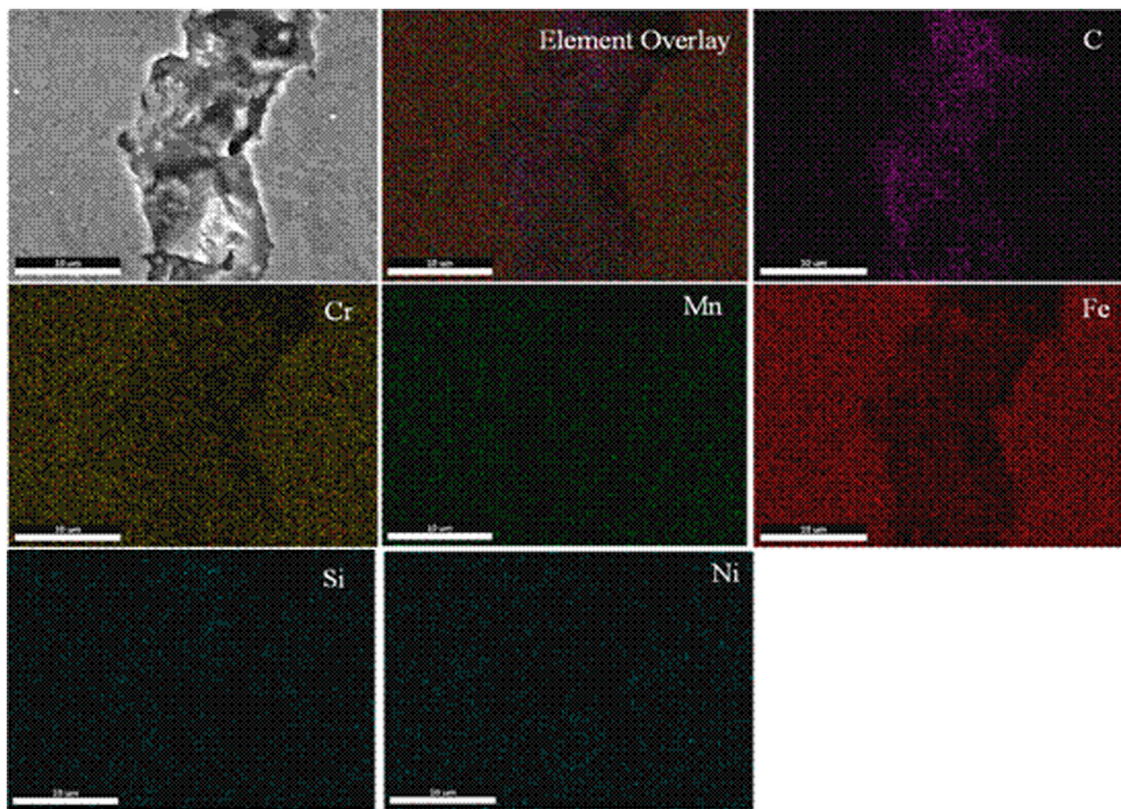
The elements and composition of the material directly affect the mechanical properties of the material and, thus, the bearing capacity of the surfaces (Gholami-Kermanshahi et al., 2023). In order to deeply understand the formation mechanism of the crack, the microstructure of the crack section is analyzed by EDS, and the distribution of elements is obtained near the crack, as is shown in Figure 7. It can be seen that the content of C element is high near the crack, the content of Fe element is low, and the distribution of other elements has little difference; it is indicated that the crack growth is related to the uneven distribution of the C element. This conclusion is consistent with the aforementioned analysis results and also proves that the difference of element distribution is the main reason for the difference of material properties on the grinding surface.

FIGURE 7
Element distribution near the fatigue crack.

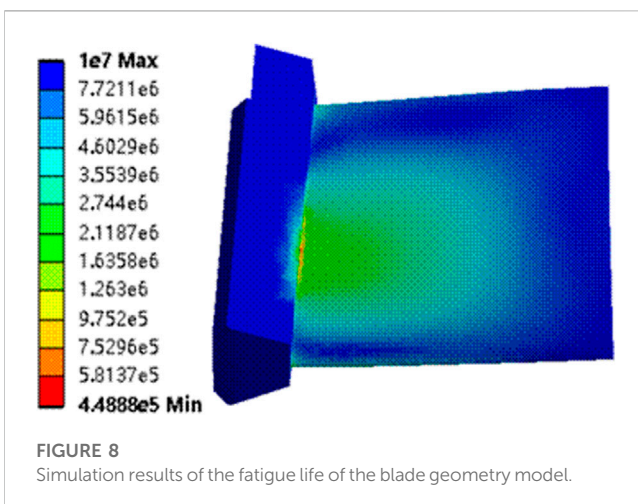
to the direction of the blade, and it is parallel to the direction of the grinding marks, which is consistent with the direction of the load. In order to explore the impact of blade geometry on fatigue failure, a blade model was established and combined with the test parameters, and the fatigue life of the blade under the first-order vibration frequency was simulated in ANSYS. The simulation results of the fatigue life of the blade geometry model are shown in Figure 8; it can be seen that there is stress concentration at the root, and it has the shortest theoretical fatigue life. Also, the actual fracture part of the blade is located at a certain distance from the root. At the same time, the actual fatigue cycle number of the blade is 323,479, which is lower than the theoretical minimum fatigue cycle number of dangerous parts (448,880). Based on the analysis of the microstructure and fatigue failure process of the blade surface, it is considered that this is caused by the change of the texture characteristics and microstructure properties of the grinding surface. The actual fatigue position of the blade is observed under the microscope, and it is found that there are punctuate micro-pits on the surface and there are more micro-pits near the fatigue cracks, which indicated that the micro-pits play a role in promoting the initiation of fatigue cracks on the surface. It can also be seen from the case that the initiation of fatigue cracks is highly localized, so there are some limitations in using macroscopic roughness evaluation standard. That is, the evaluation parameter within the range of roughness cannot evaluate the influence of local pitting defects on fatigue life, and the evaluation method cannot take into account the influence of material microstructure and other influences on material properties.

FIGURE 8
Simulation results of the fatigue life of the blade geometry model.

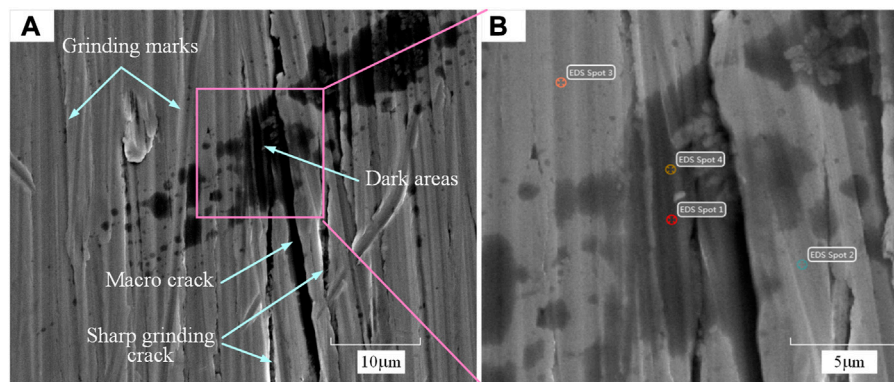
crack source. The surface characteristics and element distribution of the blade are shown in Figure 9 and Table 3, respectively. An interesting phenomenon is found in the surface morphology of the blade. In other words, there are many micro-cracks in the black area of the section, and continuous micro-cracks also appear in the continuous part of the black area, which has an extremely adverse effect on the anti-fatigue resistance. However, the aforementioned cracks are not found in the surrounding matrix; it is indicated that

the strength of the black area is weak, which is conducive to the initiation of fatigue cracks, and then, the large-diameter black particles play a role in promoting the propagation of fatigue cracks. The element content test results also showed that the carbon content in the black particle area is higher than that in the surrounding matrix. From the distribution of the elements in different regions (Figure 9; Table 3), it can be seen that the content of carbon increases from 5%–6% to 9%–10% of the matrix. The corresponding iron content dropped by about 2%, while the other elements remained roughly the same. It is indicated that the change of material properties was caused by the non-uniform distribution of carbon elements. Micro-cracks are easily generated in the area with large carbon content due to its hard and brittle characteristics, which promotes the initiation and propagation of cracks. Therefore, the uniformity and consistency of the material composition should be improved in the development stage of materials, so as to avoid the adverse effects of large particle size carbon-rich on the initiation and propagation of fatigue cracks. At the same time, the influence of surface thermodynamic coupling factors on material properties should be avoided in the process of blade molding.

FIGURE 9
(A) Surface characteristics of the blade and (B) Schematic diagram of detection points.
