Guidelines for Conservation and Restoration of Historic Polychrome Plasterwork: the Church of St María la Blanca in Seville, Spain

Case study: the Church of Santa María la Blanca

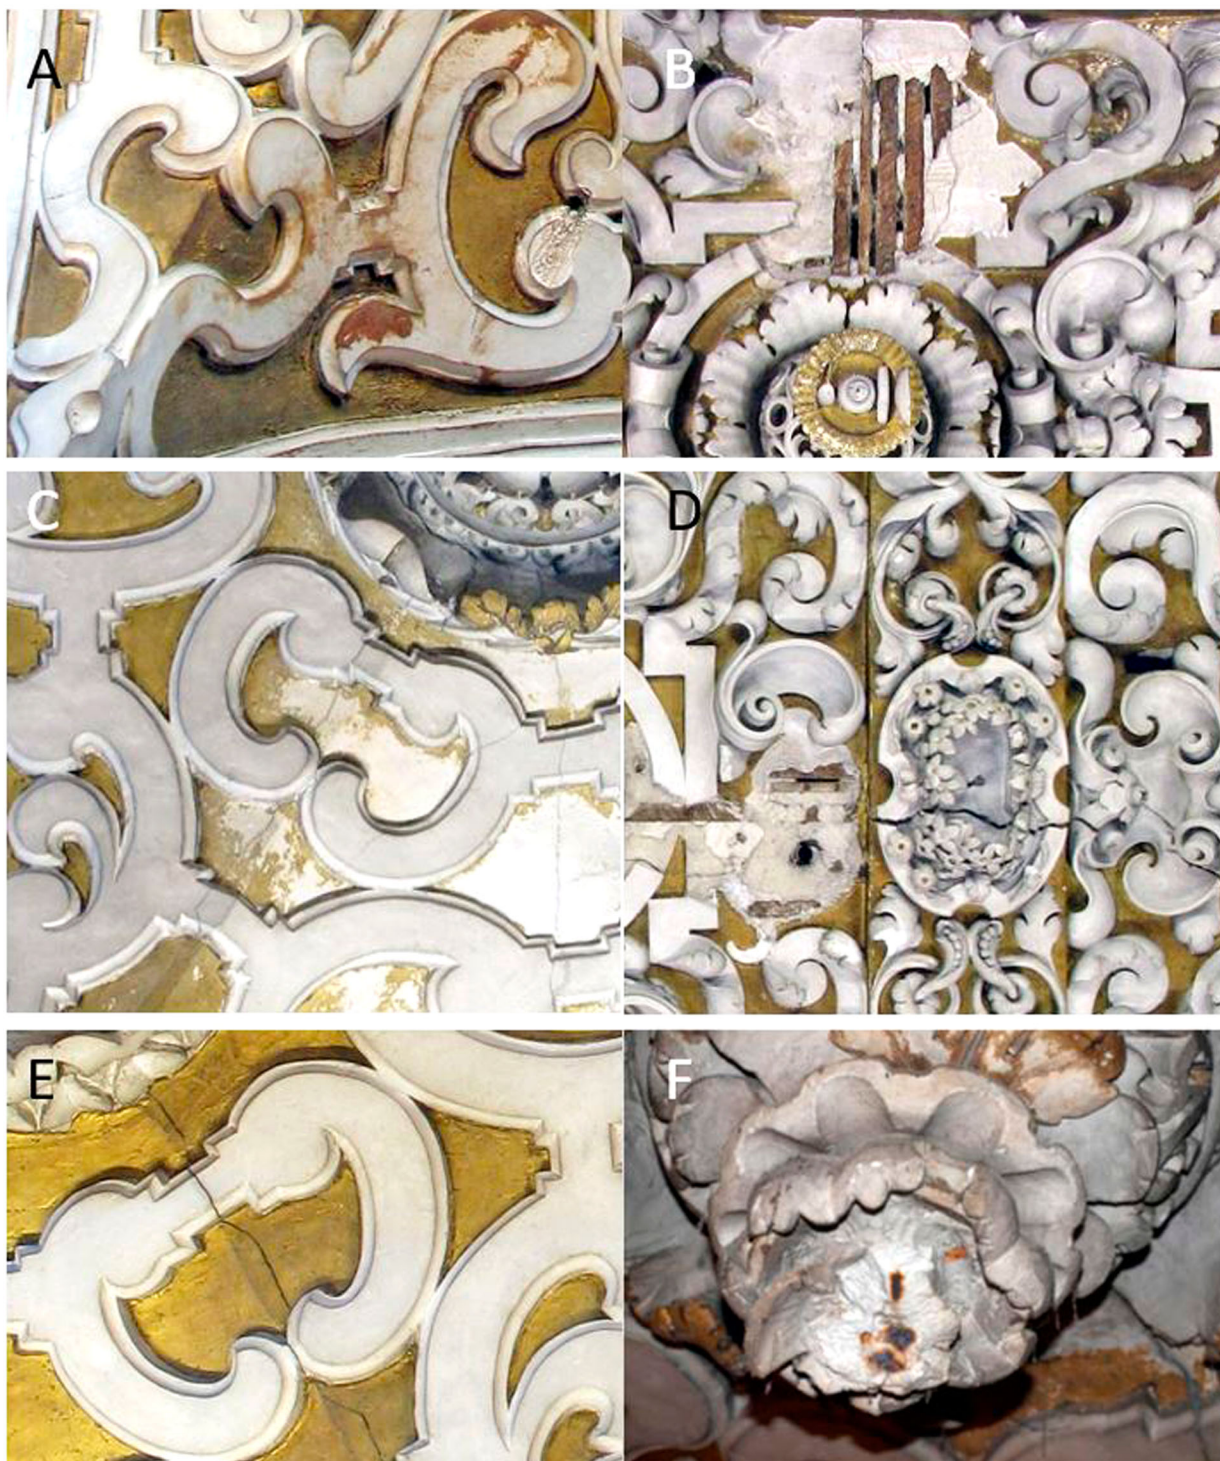
However, the presence of water in any of its states is the cause of generalized degradation of the decorations since the main component of plaster renders and plasterwork is gypsum. Gypsum has low hygroscopicity (Mesquita 2012; Goossens 2003) and medium-low solubility (Rubio Domene 2010) that does not represent a direct risk to the preservation of plasterwork (Torres-González et al. 2021a). Nevertheless, gypsum plaster has high capillary absorption – in this case, liquid water comes from roof leaks and some singular points – which is the main cause of degradation of these decorative elements. Additionally, the water that penetrates solubilizes any existing salts and also some gypsum, causing the formation of efflorescence at the surface when evaporation occurs. This favors the separation of the gilding layers and the degradation and deformation of the volumes in plaster, or even fracture when strength is lost (Rubio Domene 2010). Additionally, plaster is the binder in paints so its contact with water from leaks causes a washing effect of the paints.

The main damage found in the plasterwork and polychromies of SMLB are flaking, small detachments, and lifting of the layers of gilding; stains due to migration of dirt from the back of the elements – which is drawn in by the water from leaks, when it evaporates – remain on many decorative elements. Other damage includes swelling and weakening of the plaster volumes, causing breakage, a problem worsened when the pieces have metallic materials (Rubio Domene 2002) that, in contact with water, oxidize, causing an increase in volume and internal tensions that originated the fracture; and finally, the damage caused by washing of the pictorial layers, a consequence of larger leaks (Figure 6).

Figure 6. Alterations present in the plasterwork: damp stains (A), loss of support (B), detachment of gold leaf in the choir area (C), detachment and loss of material (D), fissures and cracks (E), and oxidation of metallic element used to fix the plasterwork (F).

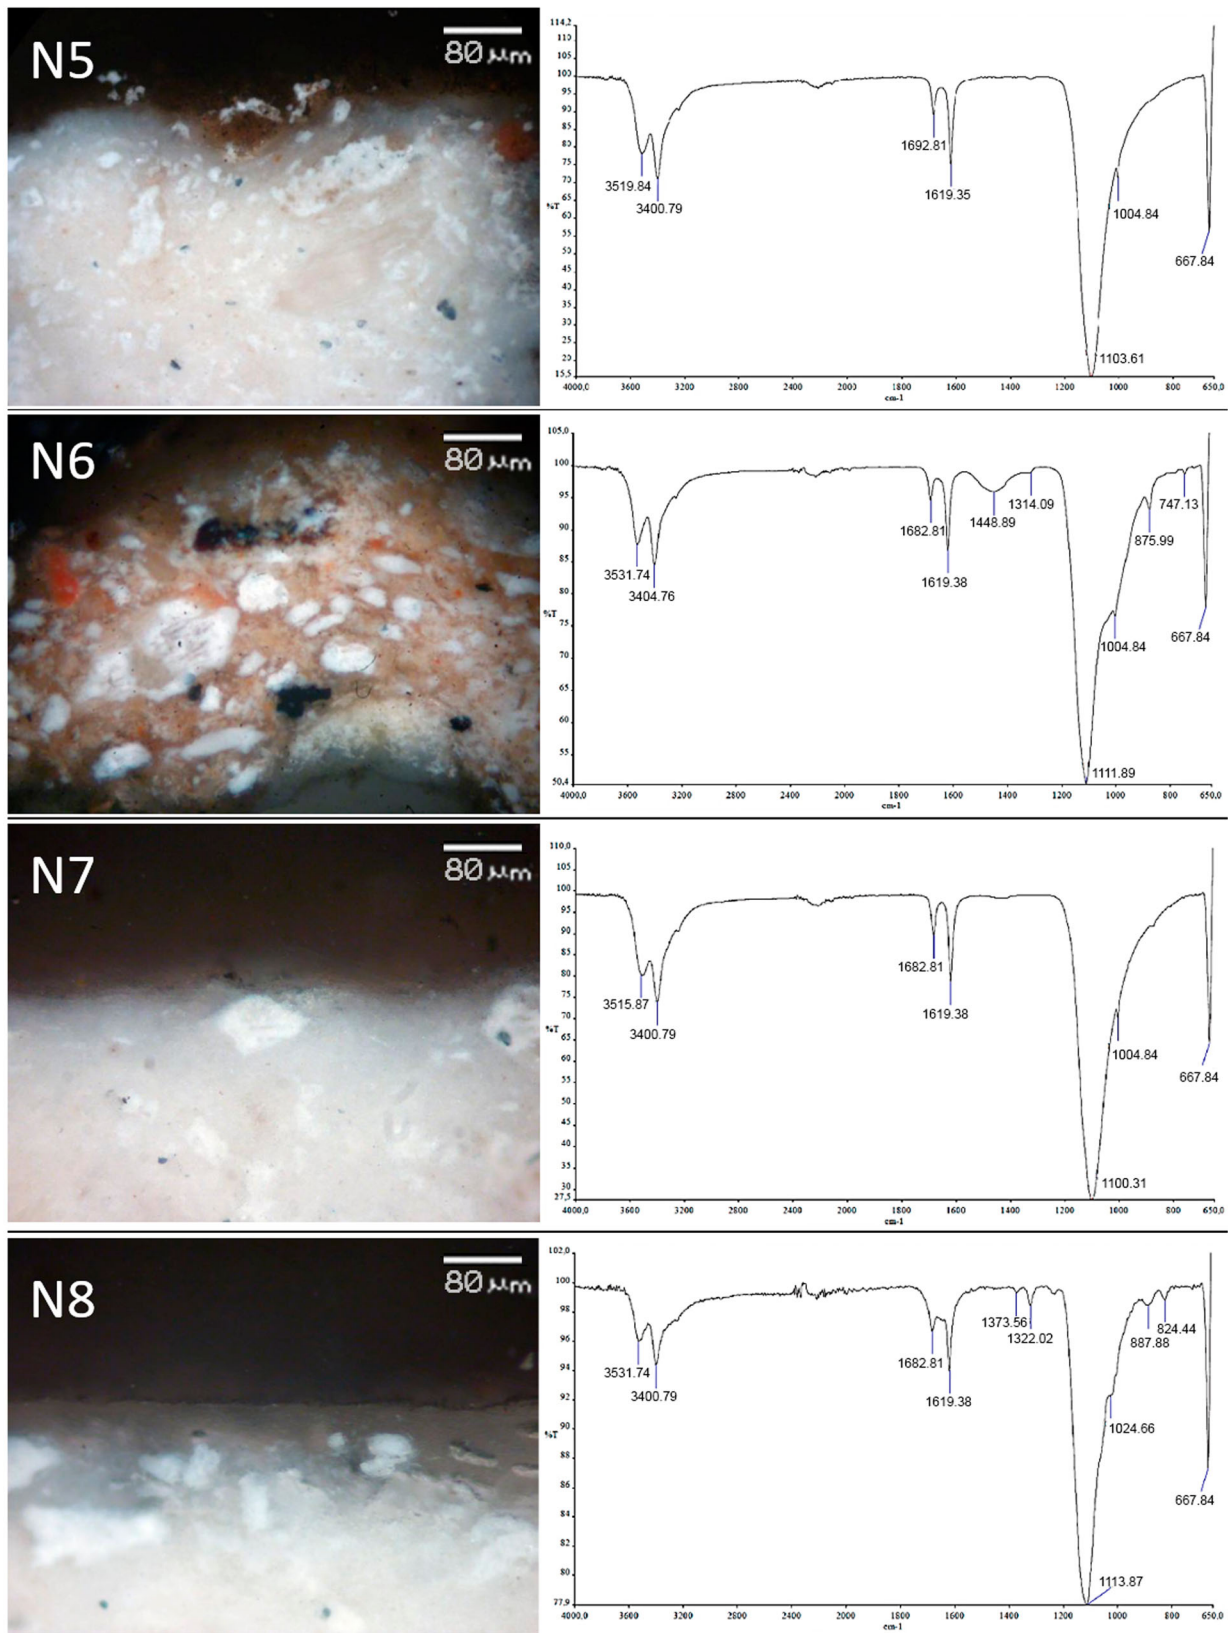
Figure 14. Optical microscopy of the cross-sections of N5-N8 (MPlan 20 X / 0.40 objective) and the respective FTIR spectra.

With respect to sample N8 (Figure 14), it can be observed that, along with the typical gypsum bands, as described in samples N5 and N7, other absorption bands appear at 1373 and 1322 cm^{-1} and at 887

and 824 cm^{-1} , characteristics of nitrate and oxalate salts. The characteristic positions of the nitrate bands are $1380\text{--}1350\text{ cm}^{-1}$ and $840\text{--}815\text{ cm}^{-1}$ (Conely 1979).

The presence of oxalate must be considered as a bio-signature of some microorganisms that have colonized the walls and their metabolic activity (excretion of oxalic acid), due to the continuous presence of water leaks. This final cause can also explain the existence of nitrates from environmental pollution (Magurégui et al. 2008; Madariaga et al. 2014).

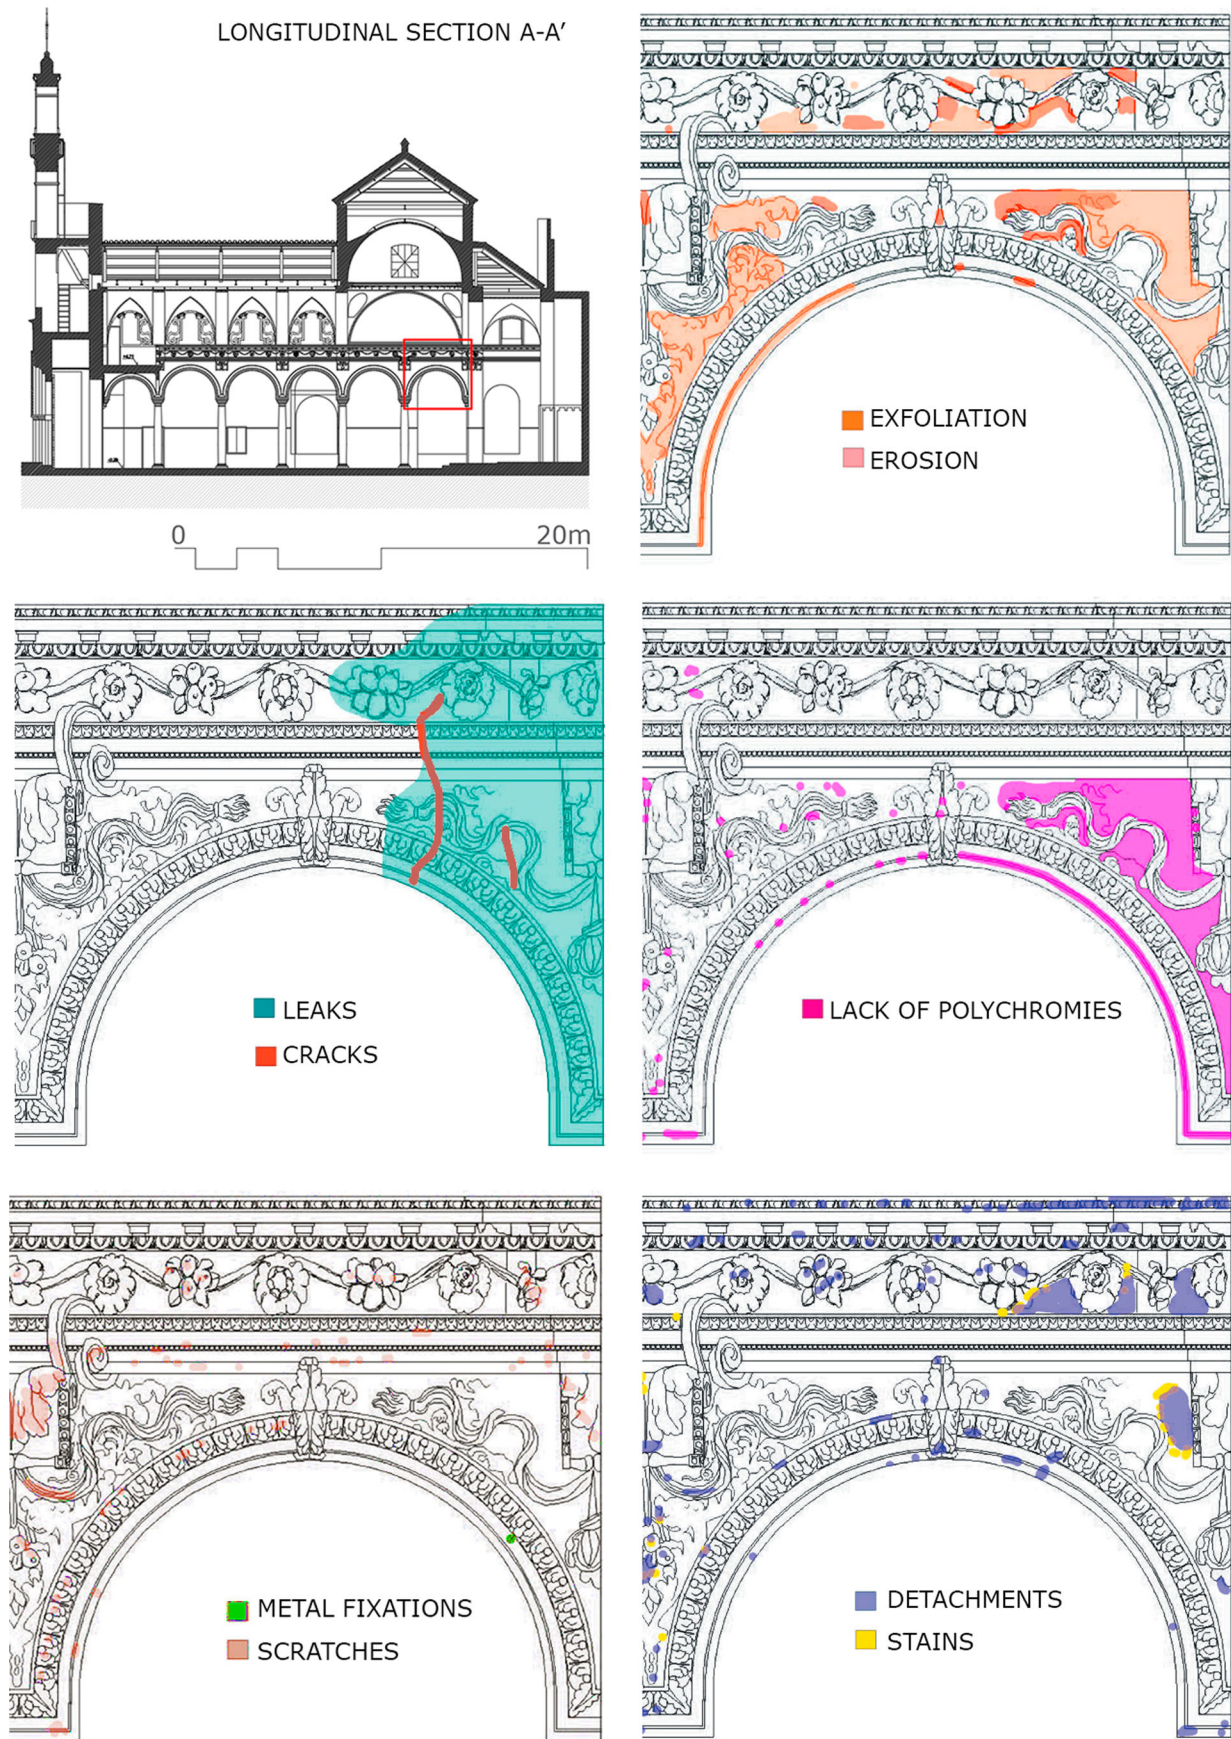
Figure 16. Planimetric survey showing the state of preservation of the plasterworks of the lateral arches of the central nave.
