86 MARYLAND AVENUE HISTORIC STRUCTURE REPORT
Annapolis, Maryland

AMANDA E. MOORE
University of Maryland
Graduate Program in Historic Preservation
Final Project
May 2014

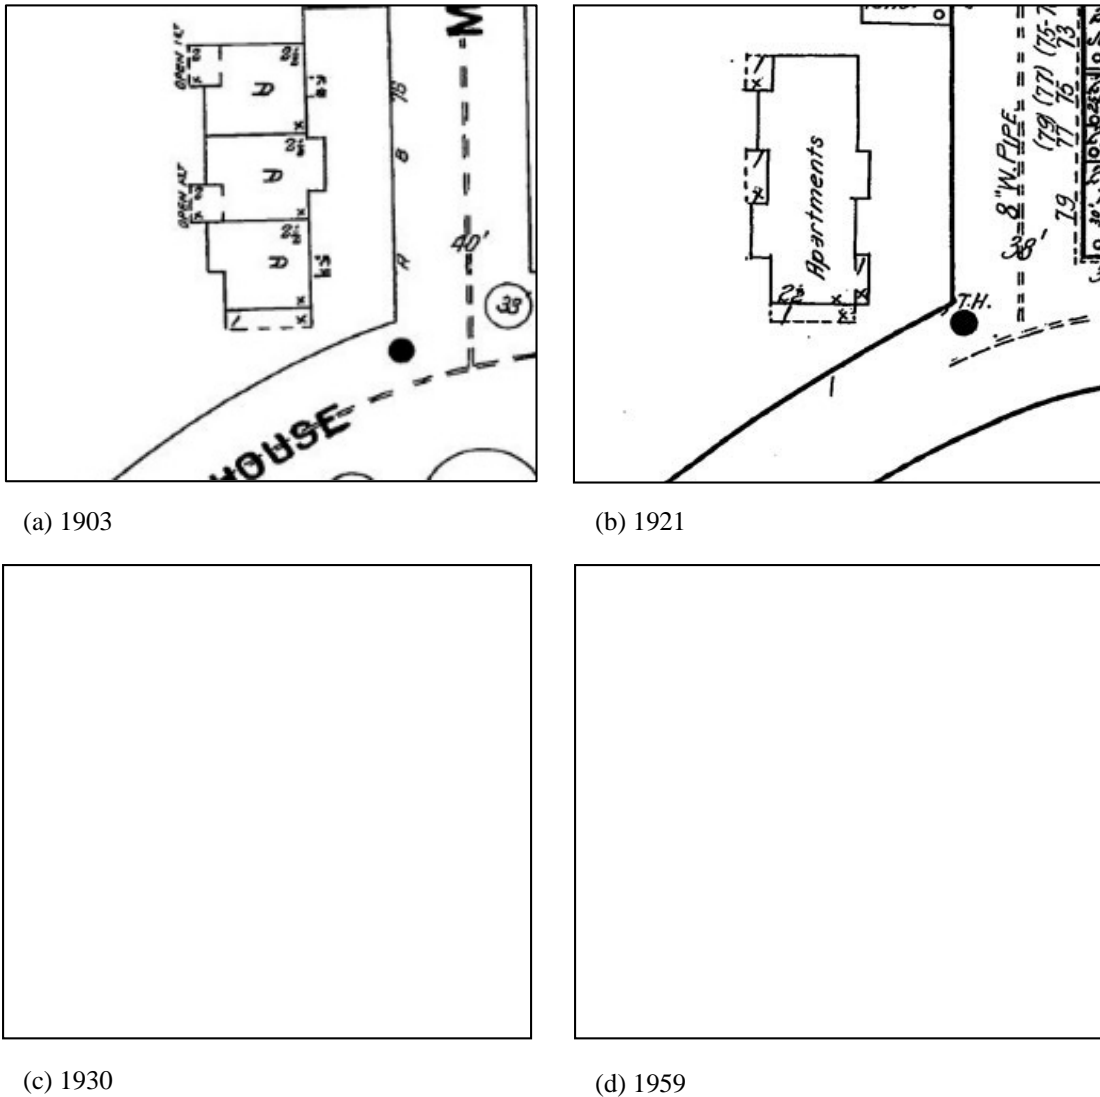
Figure 6: Maps of 86 Maryland Avenue / 3 Randall Court (Sanborn Fire Insurance Maps).

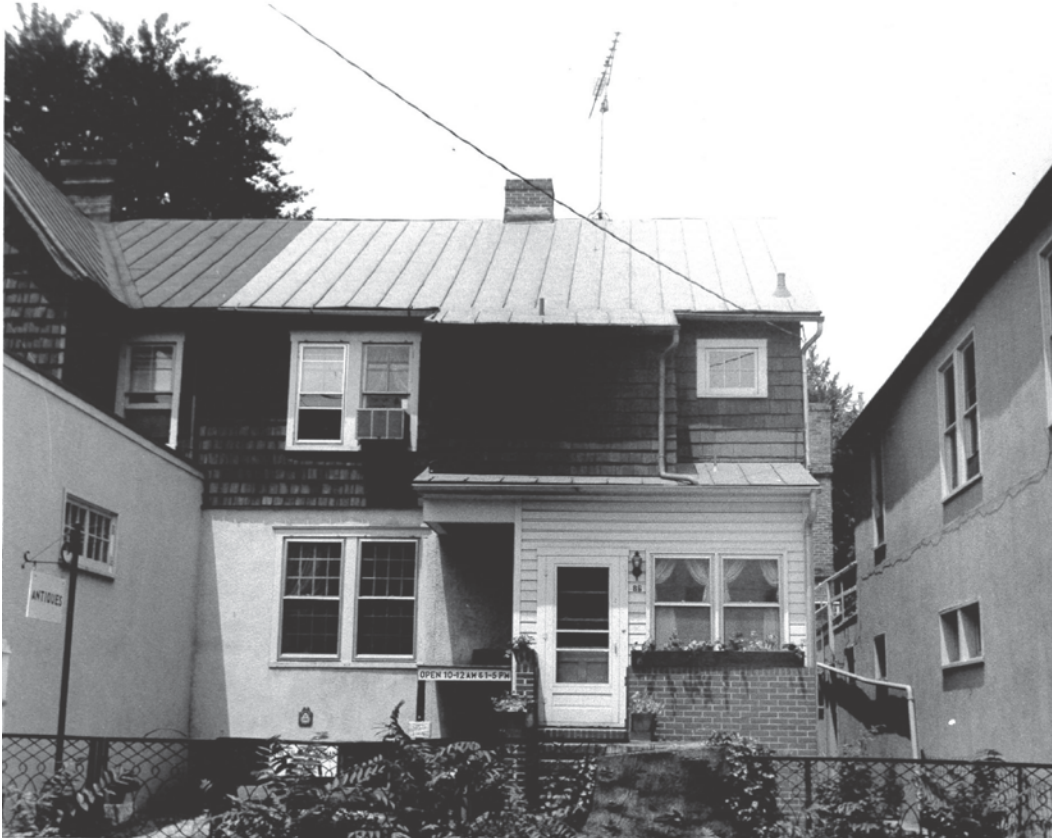
Figure 7: 1973 photograph of 86 Maryland Avenue (Historic Annapolis Foundation Archives).

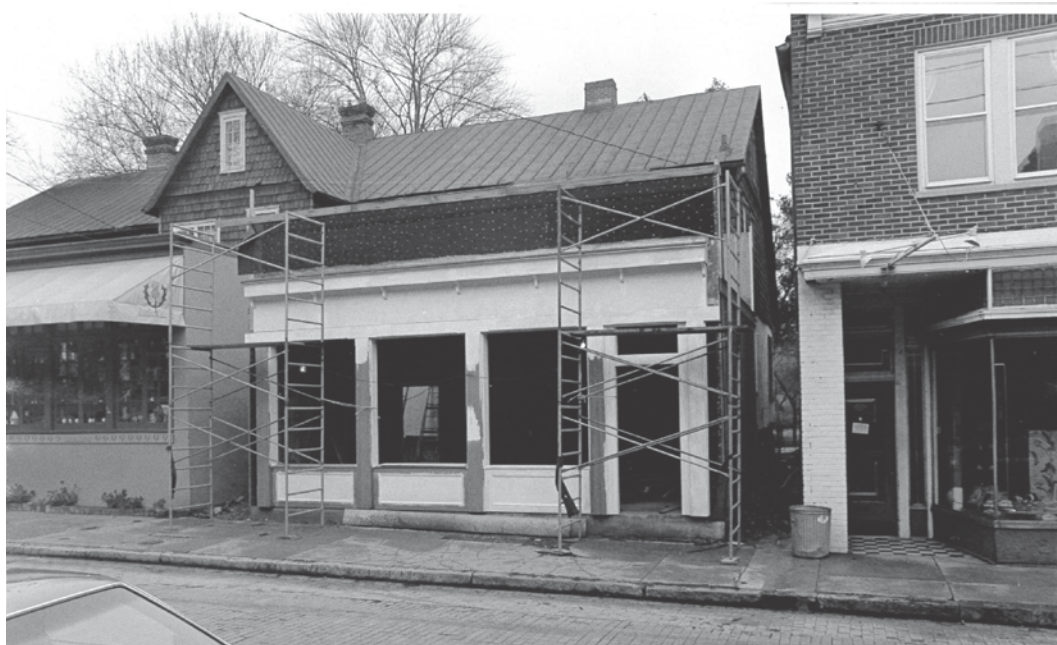
Figure 8: 1980 photograph of 86 Maryland Avenue's commercial addition under construction (Historic Annapolis Foundation Archives).

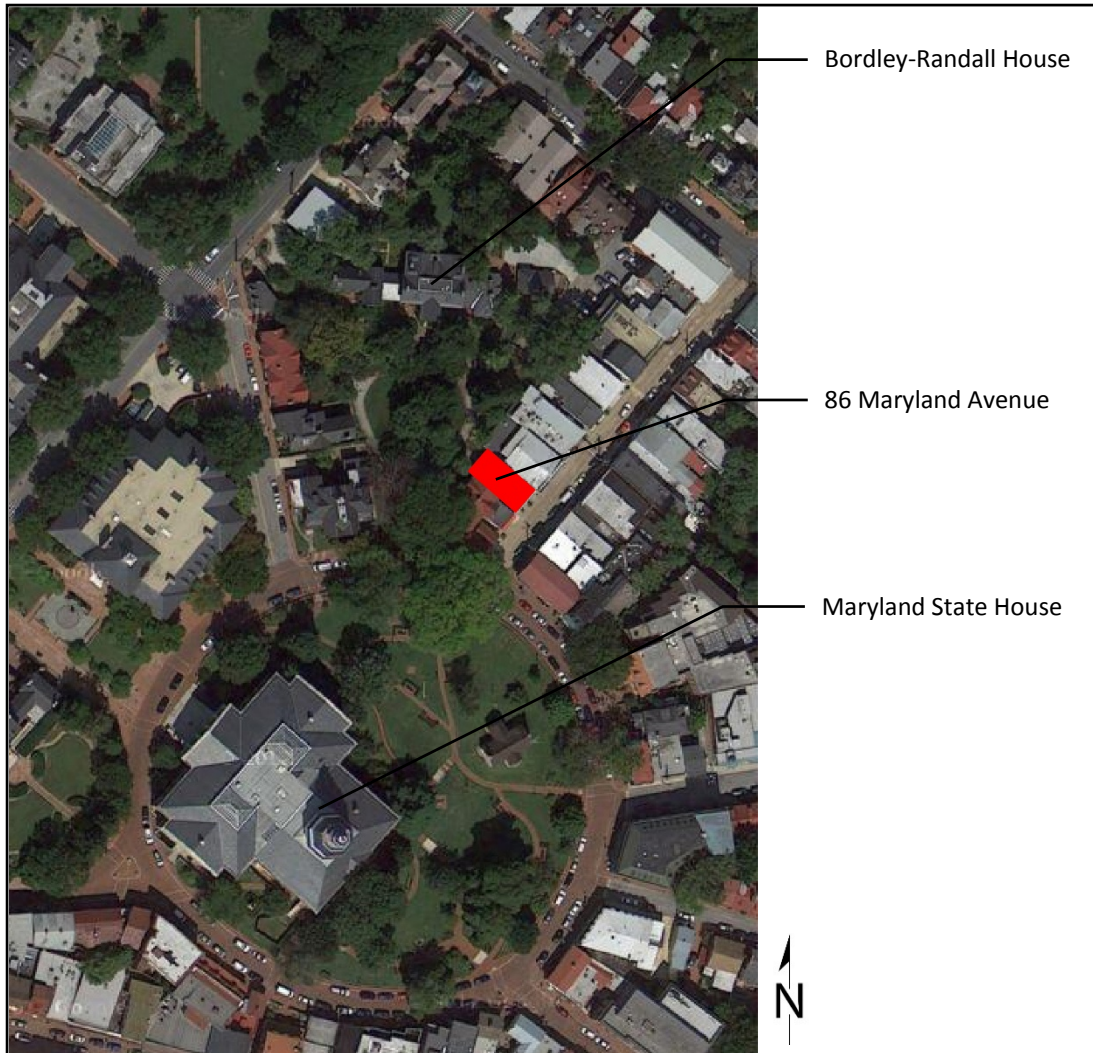
Figure 14: Aerial view of 86 Maryland Avenue. Satellite imagery from <https://maps.google.com/>.

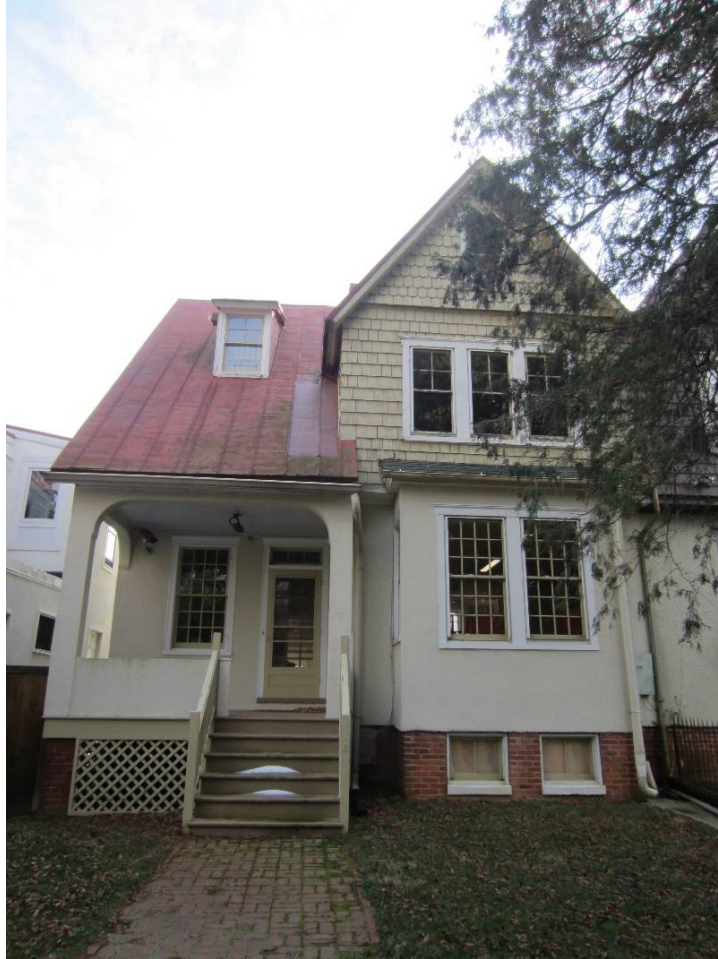
Figure 16: Northwest elevation of 86 Maryland Avenue /
3 Randall Court.

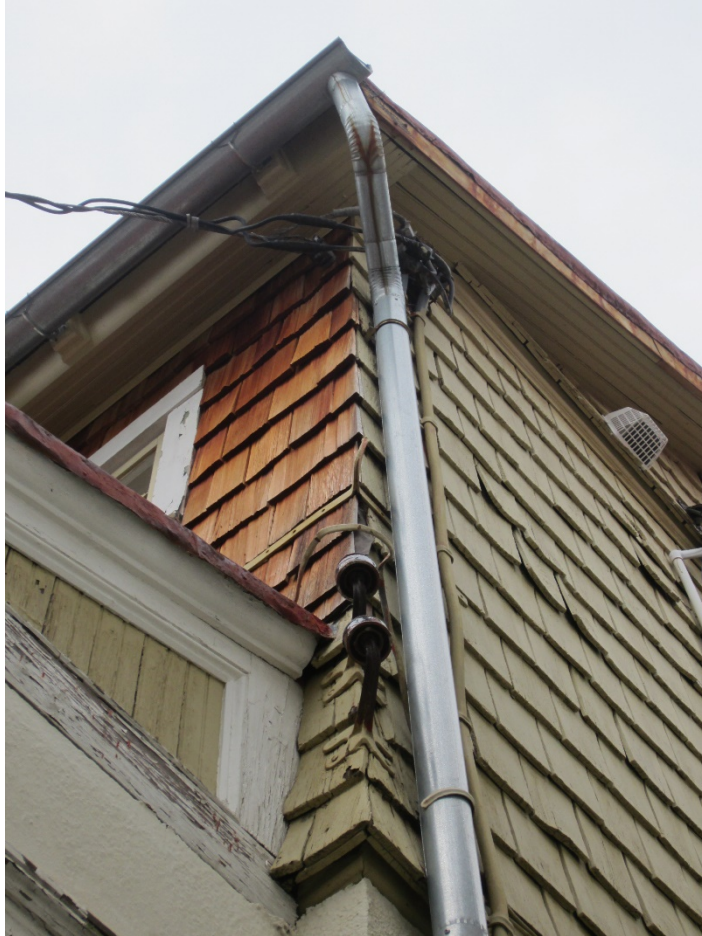
Figure 17: Eastern corner of 86 Maryland Avenue showing the painted and unpainted shingles.

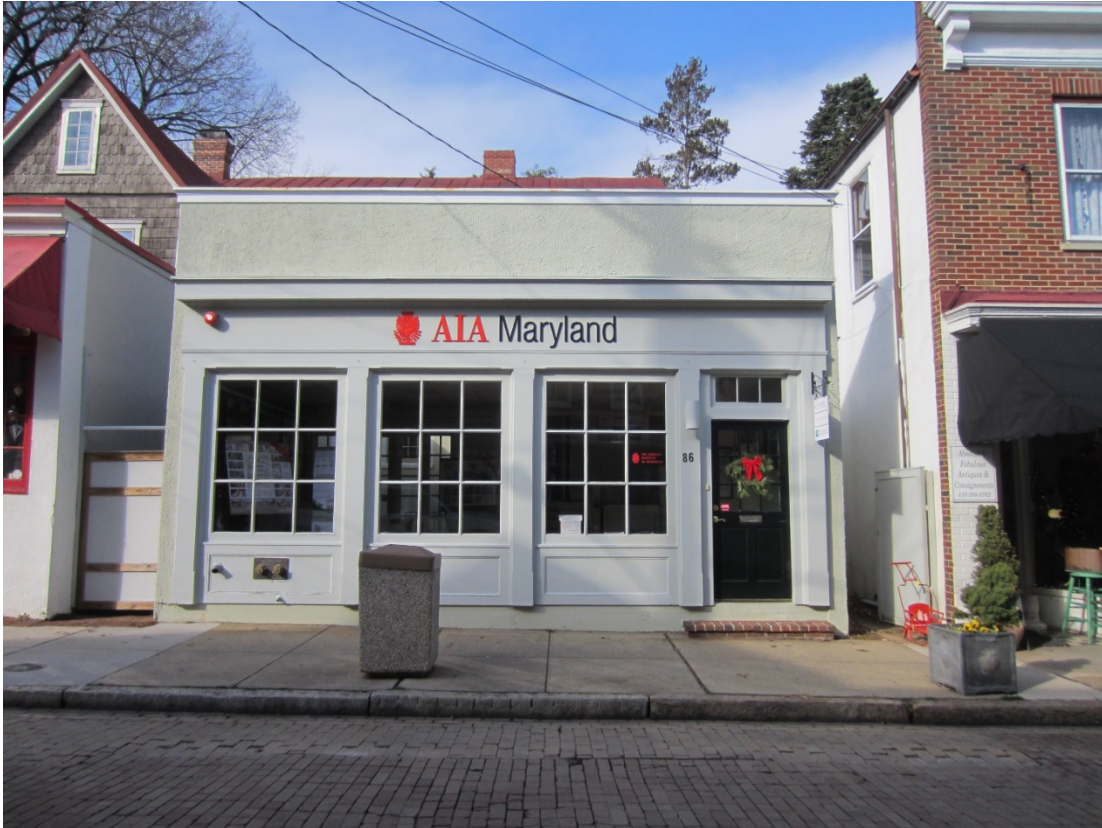
Figure 18: Southeast elevation of 86 Maryland Avenue's commercial addition.

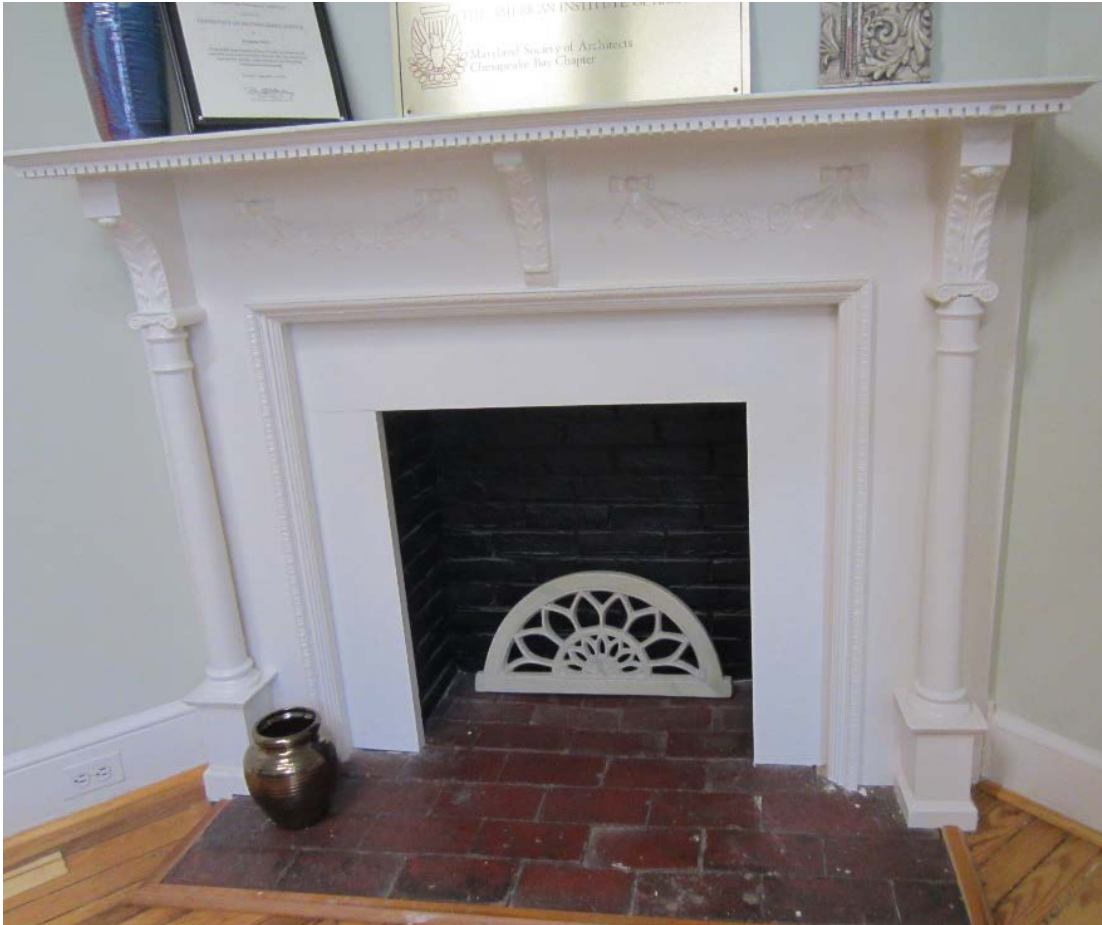
Figure 20: Corner fireplace in the AIA Maryland Executive Director's.

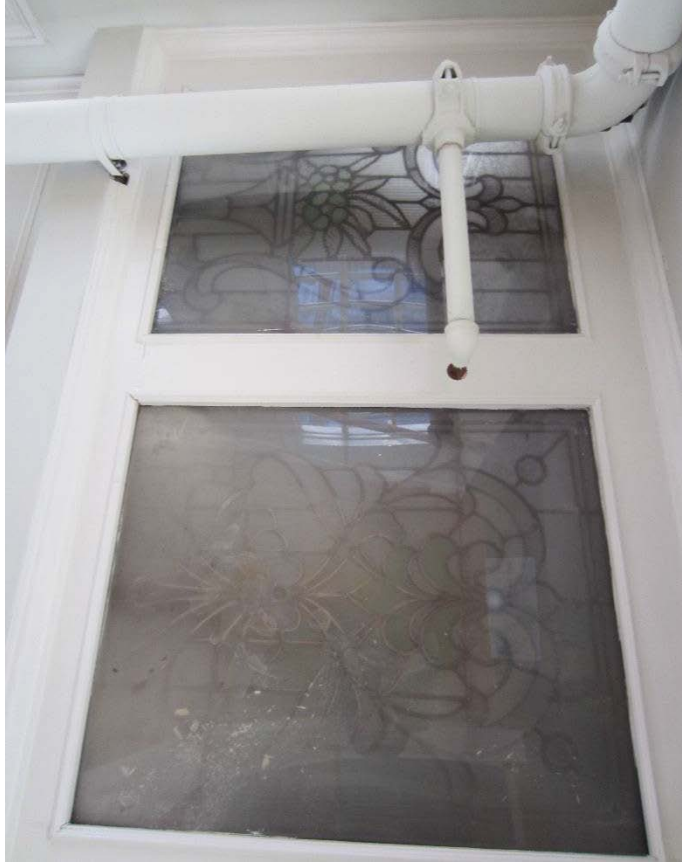
Figure 21: Stained-glass skylight in the ceiling on the stair connector.

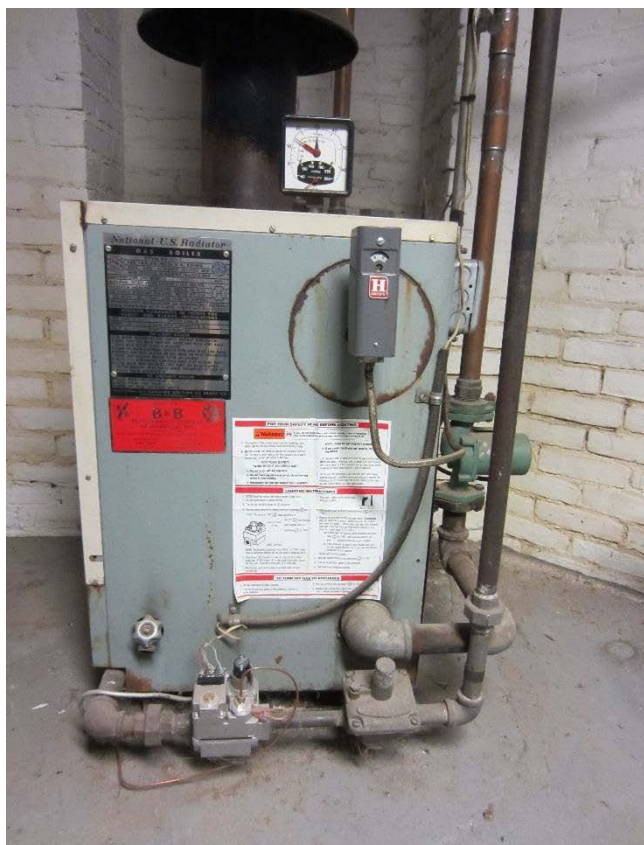
Figure 23: Old gas boiler by the National-US Radiator Division of Crane Company still installed in the basement.

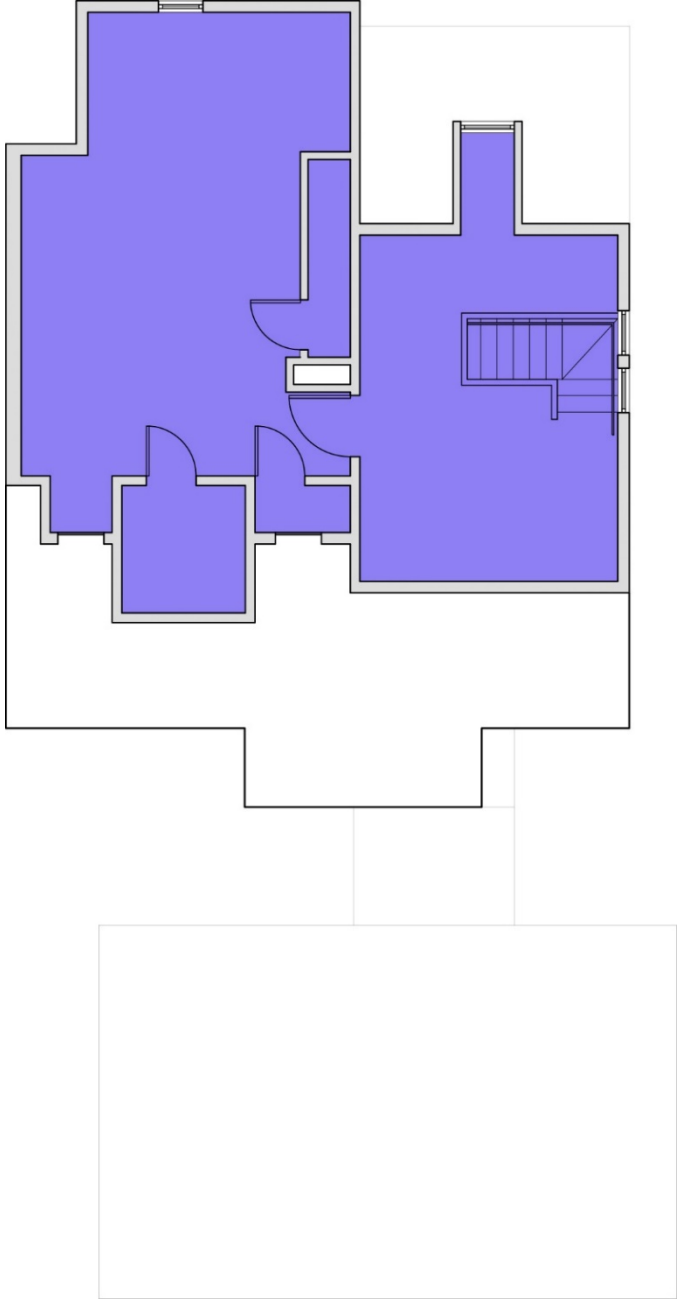
Character-Defining Elements

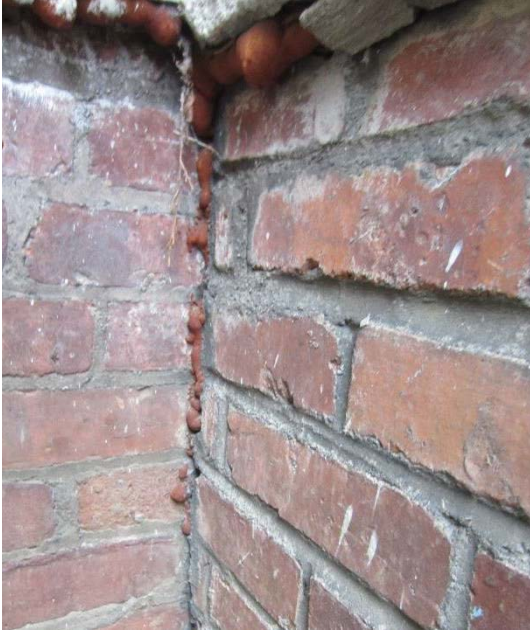
Figure 32: Northern corner where the square bay foundation connects with the main foundation. Spray foam insulation fills the openings caused by the settling.

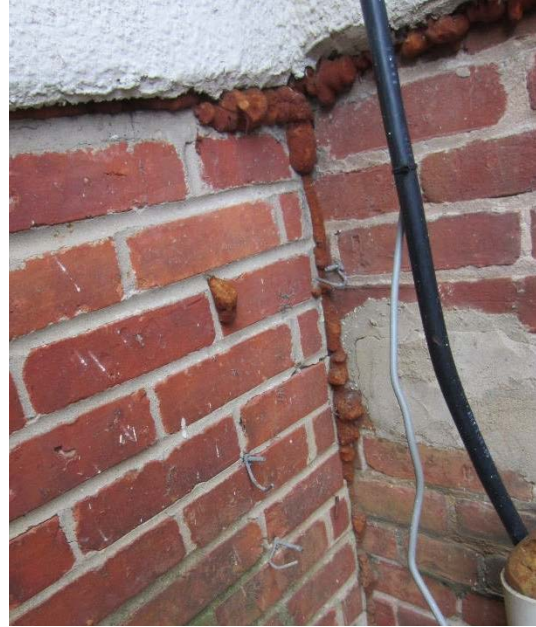
Figure 33: Western corner where the square bay foundation attaches to the main foundation. Spray foam insulation was used to fill the gaps between the two foundations, and between the sill and the foundation.

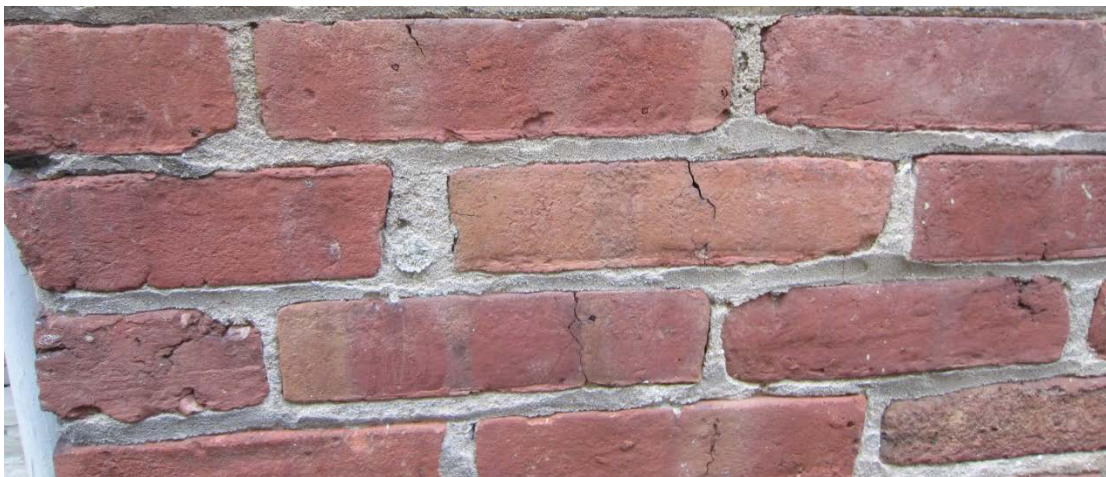
Figure 34: Bricks cracking north of the basement window on northwest elevation.

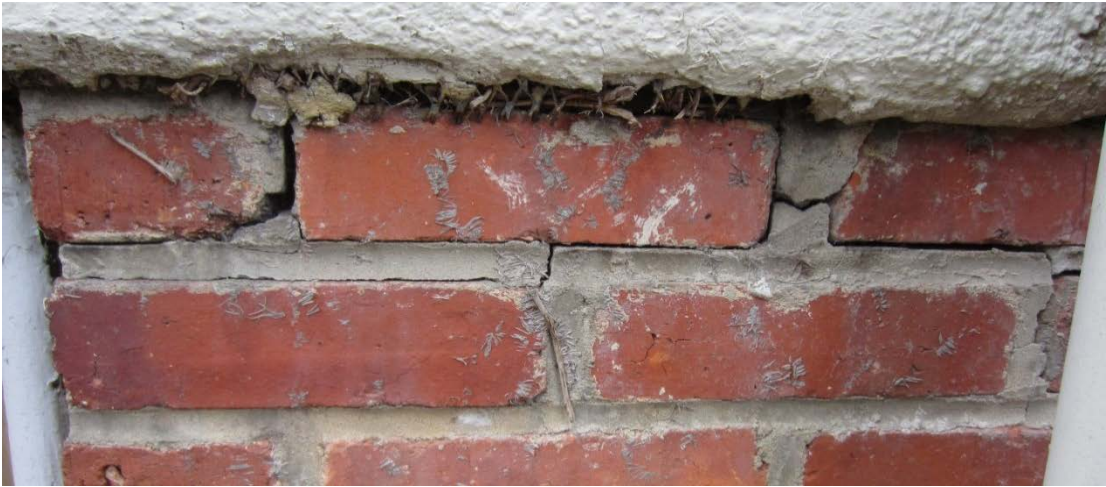
Figure 35: Cracking mortar west of the basement windows on the square bay; episodes of improper repointing are also evident.

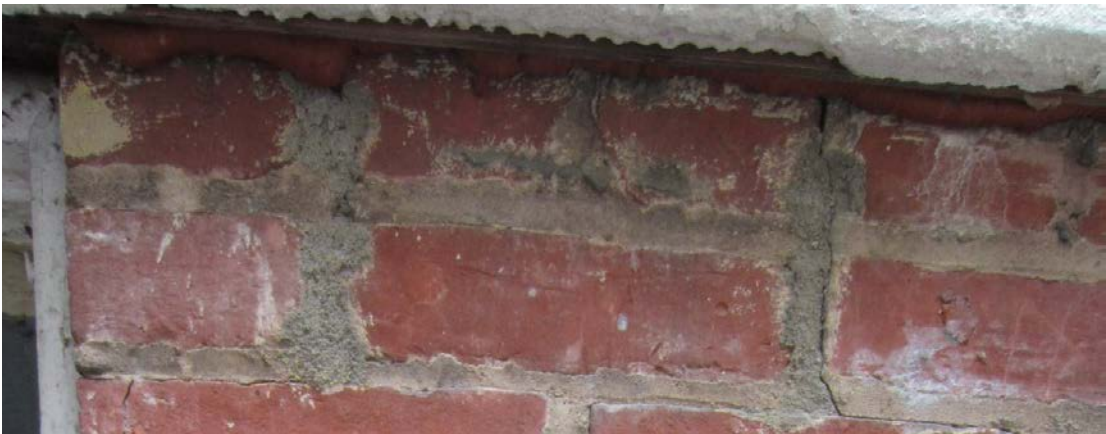
Figure 36: Repointing that tried to repair some cracks, but did not fix them on the northwest elevation, north of the basement window.

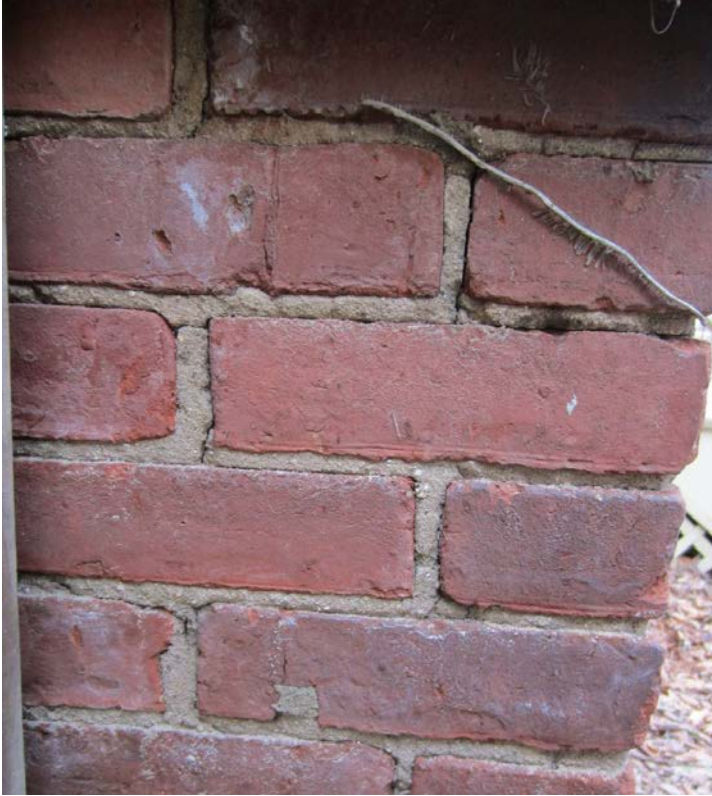
Figure 37: Cracking and deteriorated mortar on the northern brick porch pier, northeast elevation. In addition, dead organic matter is still attached to the brick.

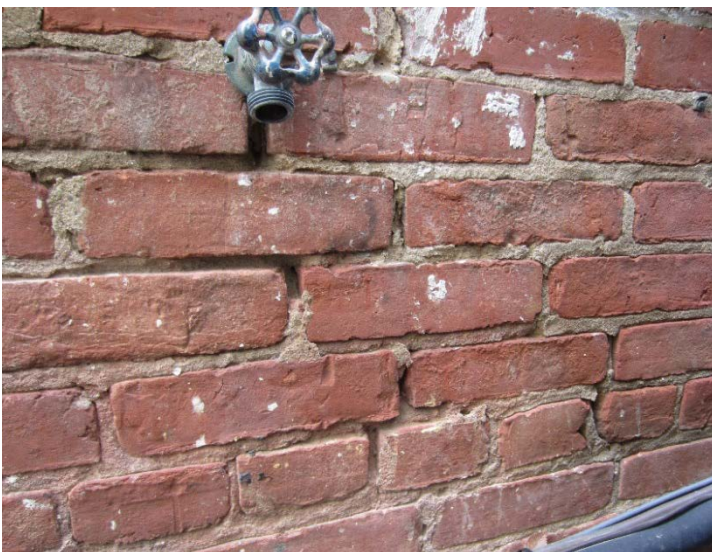
Figure 38: Cracking and deteriorated mortar surrounding the hose faucet on the northeast elevation. The deterioration has caused the loss of a substantial amount of mortar in this location.

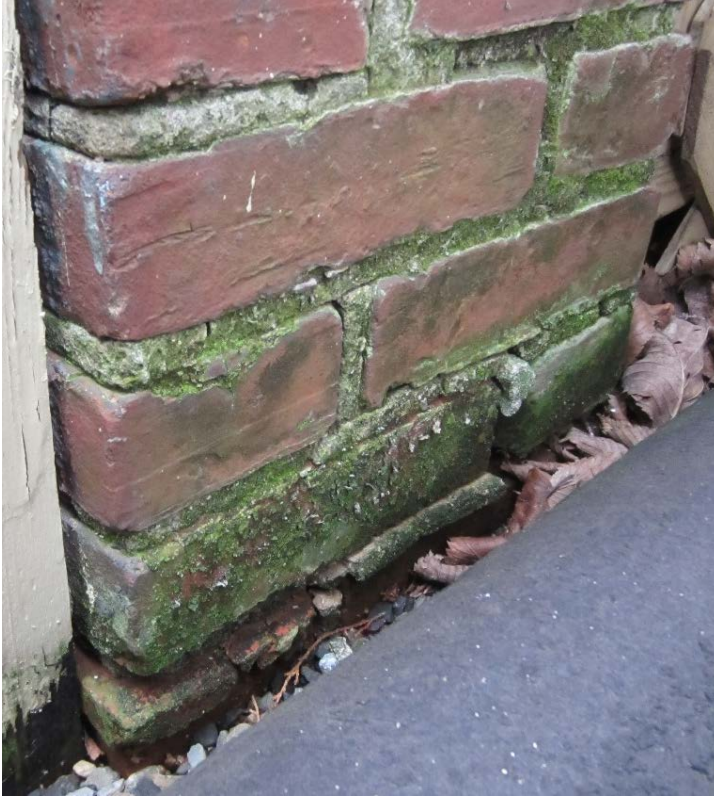
Figure 39: Cracking and deteriorated mortar on the bottom portion of the western brick porch pier on its southwest elevation.

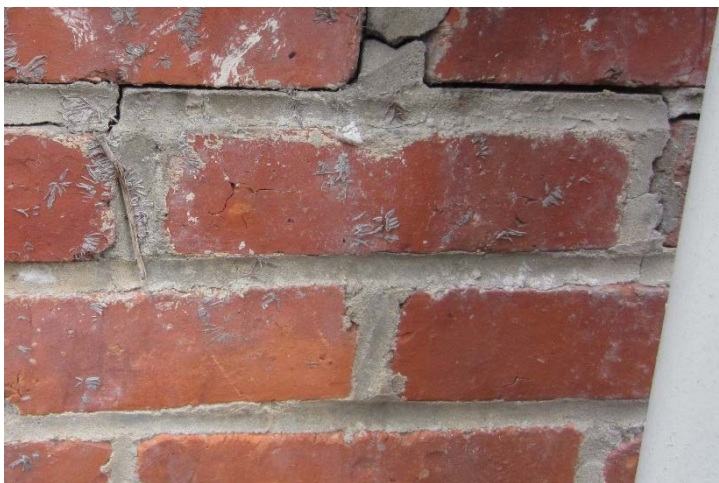
Figure 40: Evidence of poor repointing on the square bay west of the basement windows. The mortar is covering the bricks.

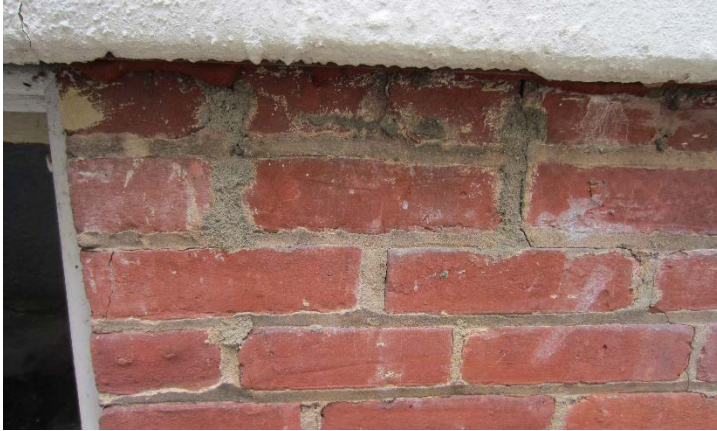
Figure 41: Improper repointing on the northeast foundation to the north of the basement window. The mortar is a different color and the joint is too wide.

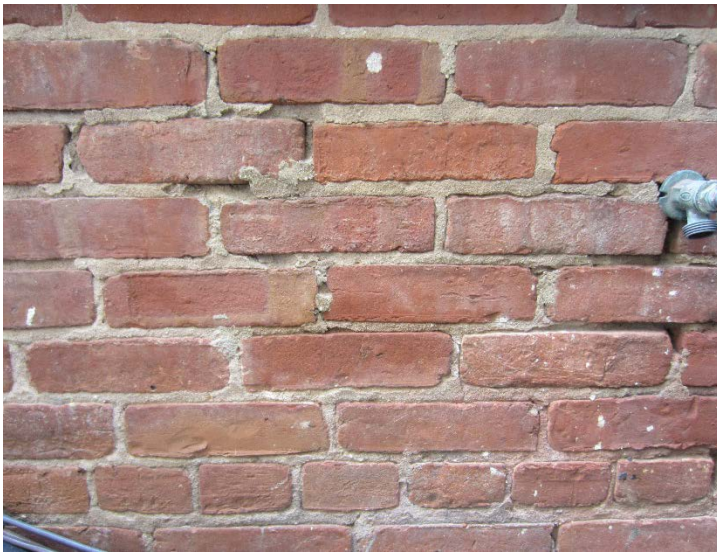
Figure 42: Incorrect repointing east of the hose faucet on the northeast elevation, and more cracking and deteriorating of the mortar joints.

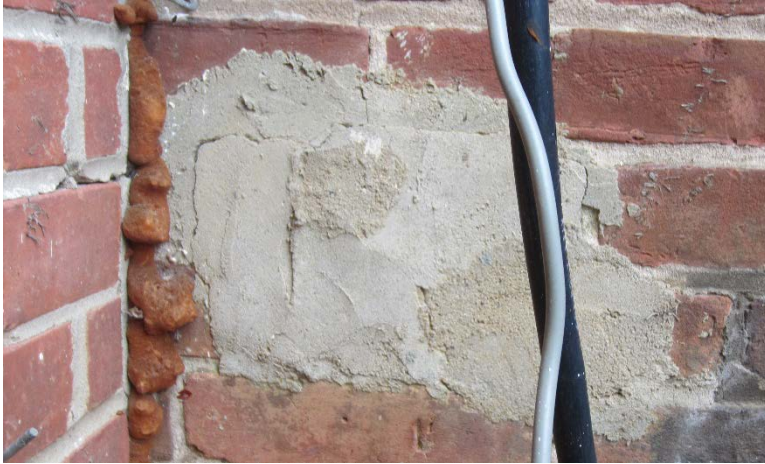
Figure 43: Mortar filling foundation hole and covering the surrounding bricks west of the square bay.

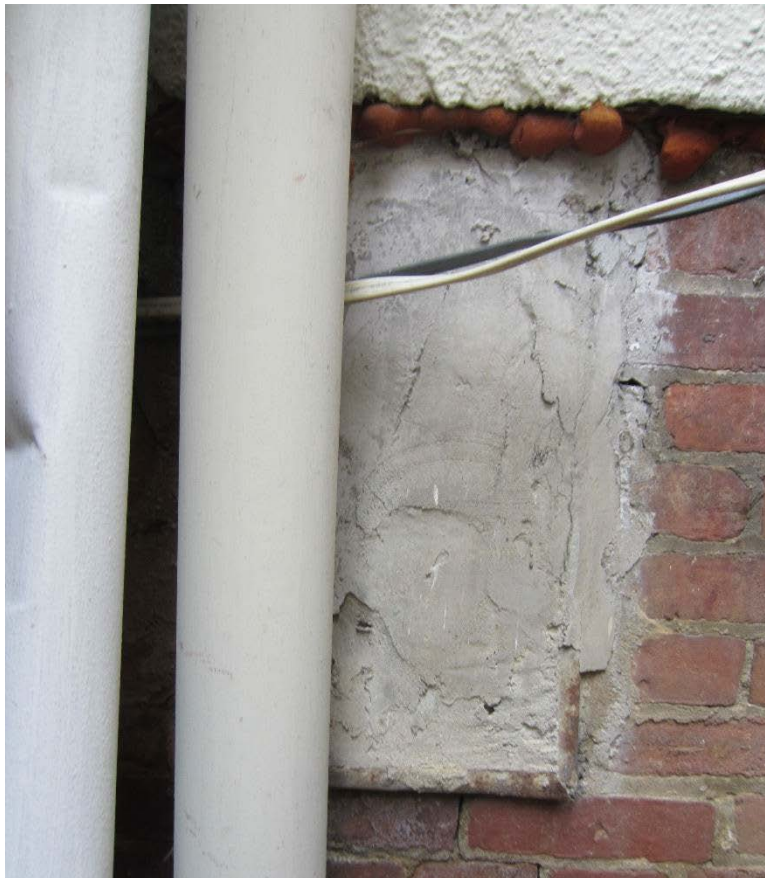
Figure 44: Improper mortar fill in a hole in the foundation north of the square bay.

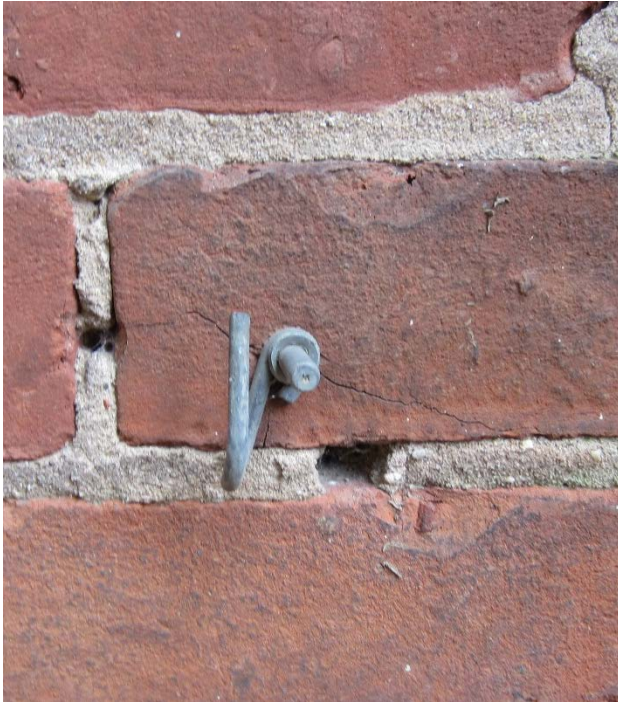
Figure 45: Metal anchor secured in brick with hairline crack radiating out from it.

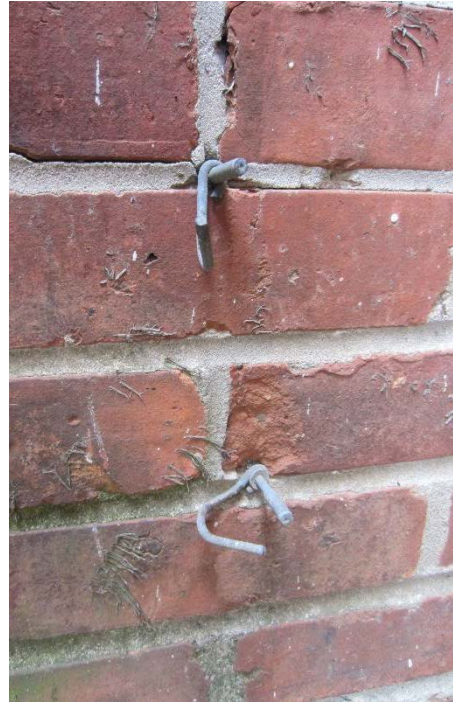
Figure 46: Metal anchors fastened in the mortar and the mortar cracking around it.

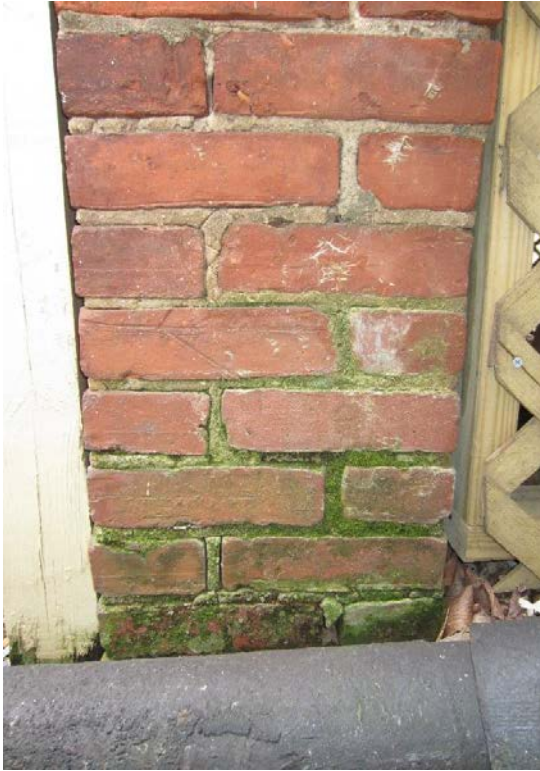
Figure 47: Biological growth on the bottom portion of the southwest elevation of the western brick porch pier.

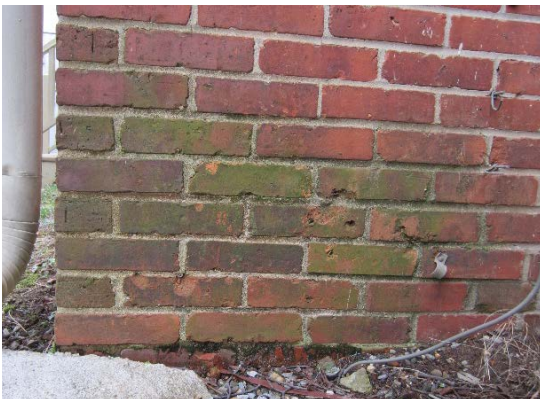
Figure 49: Biological growth on a portion of the southwest elevation of the square bay.

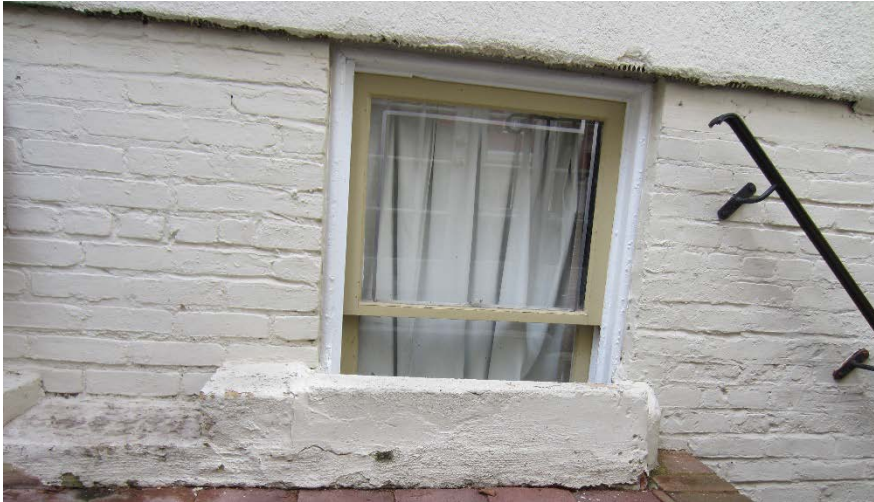
Figure 50: The only painted portion of the foundation.

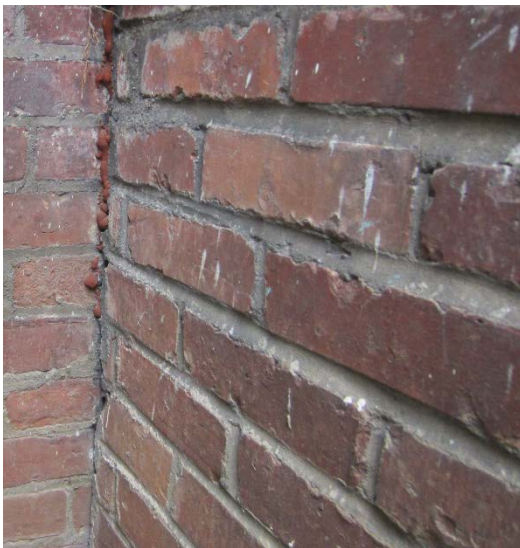
Figure 51: Paint splatter on the northeast face of the square bay.

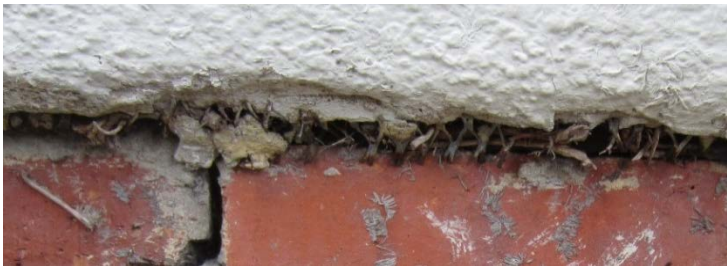
Figure 53: Exposed metal lath and deteriorating stucco west of the basement windows on the square bay.

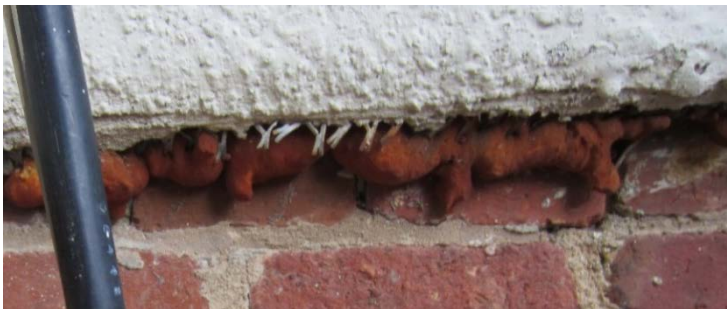
Figure 54: Exposed metal lath west of the square bay.

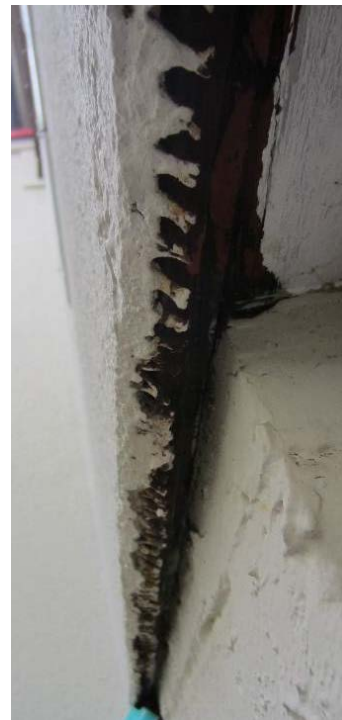
Figure 55: Exposed metal lath along the bottom of the stucco on the southeast façade.

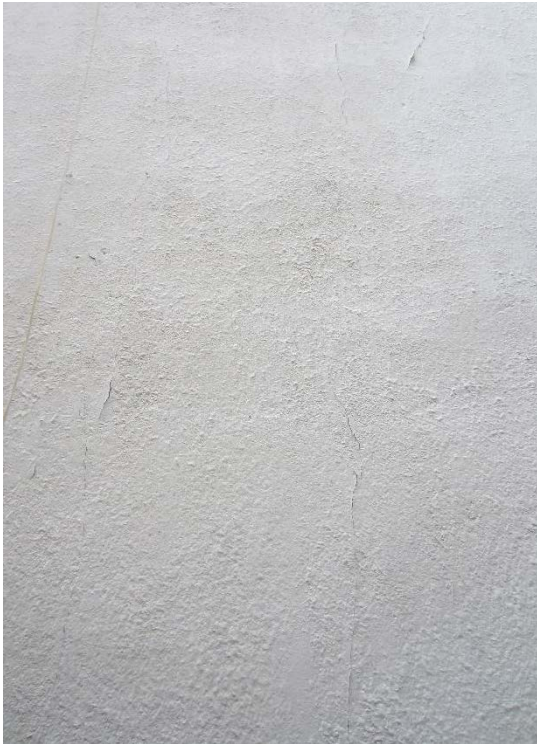
Figure 56: Vertical cracks north of the northeast elevation first floor windows. The cracks run from the foundation to the second floor.

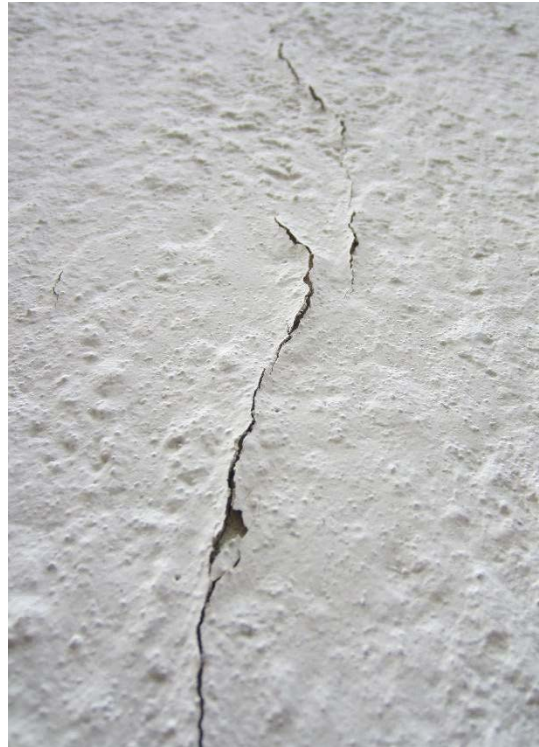
Figure 57: Close-up of the vertical cracks on the northeast elevation.

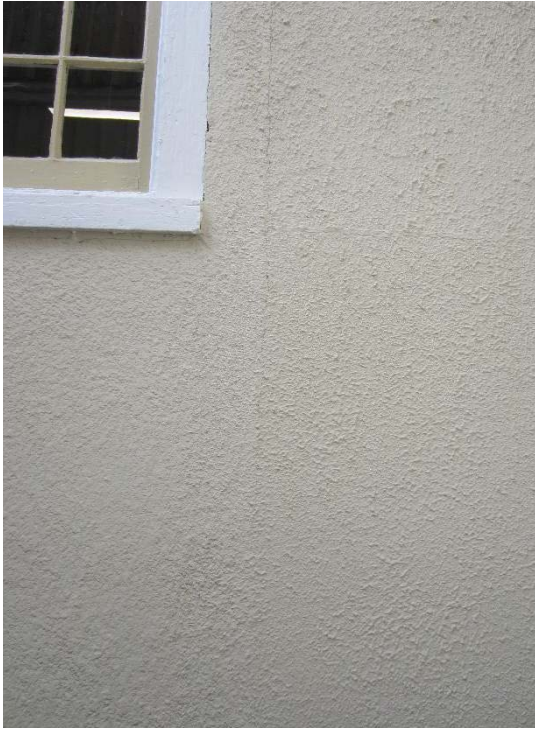
Figure 58: Vertical crack running from the second floor to the foundation on the southeast elevation.

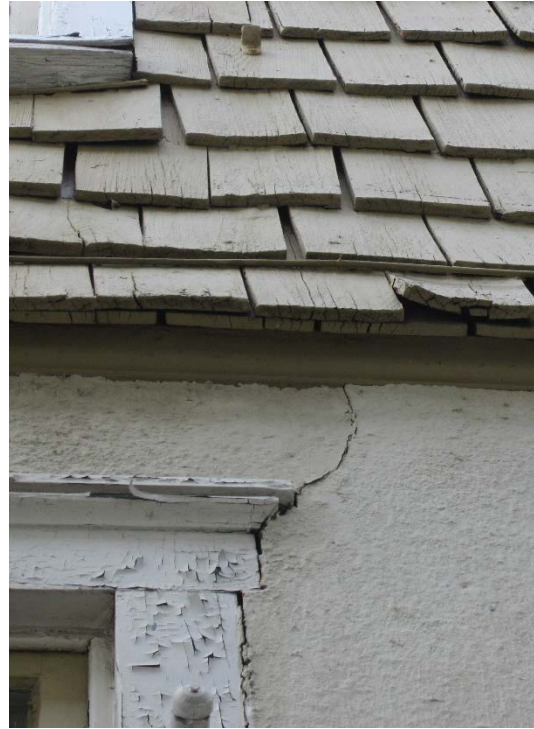
Figure 59: Example of the stress cracks at the two first floor windows on the northeast elevation.

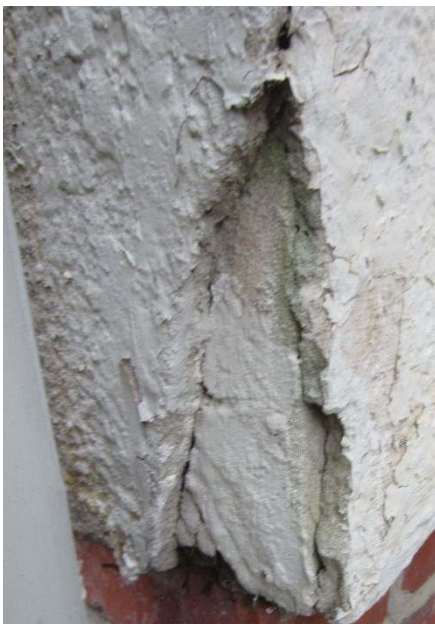
Figure 60: Missing outer coats of stucco exposing the scratch coat.

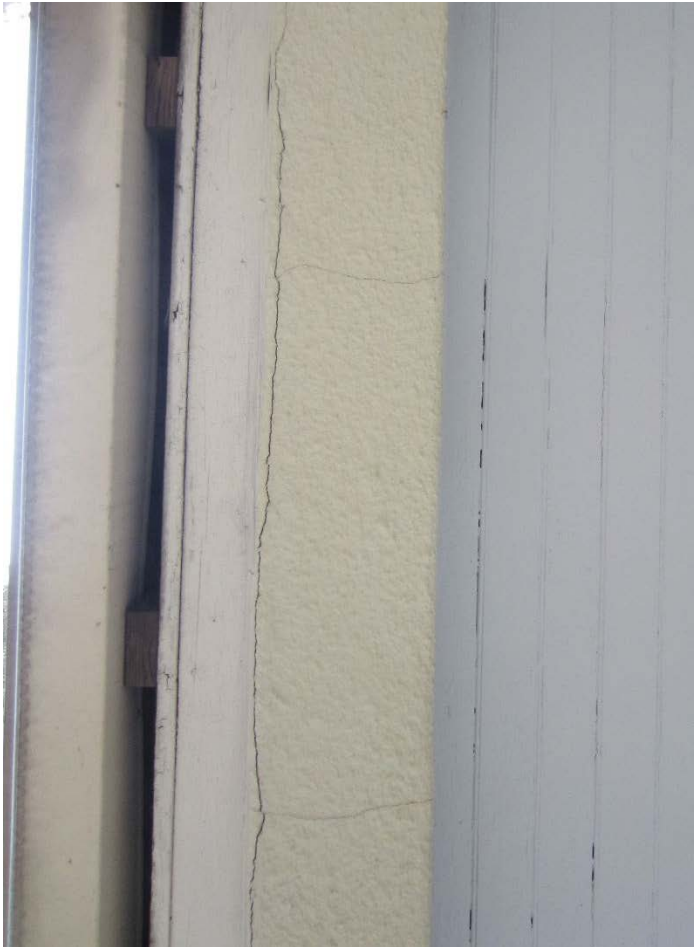
Figure 61: Crack along the edge of the flat portion of the porch opening.

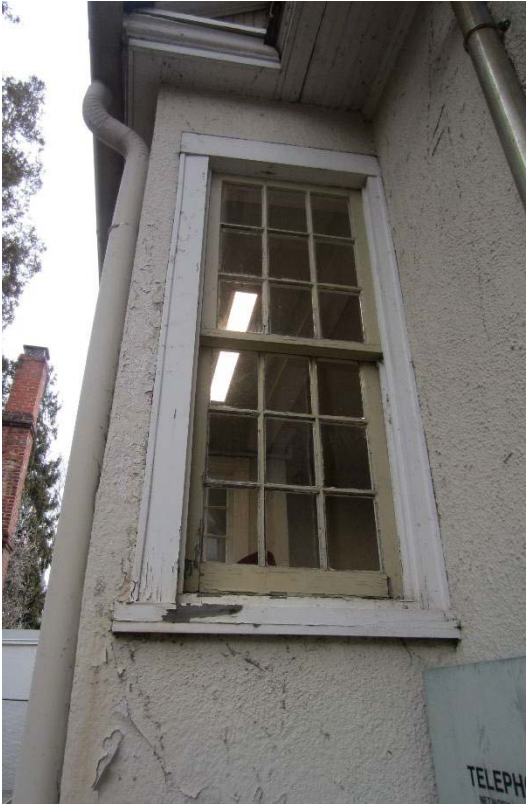
Figure 62: Peeling paint below the window on the southwest elevation of the square bay.

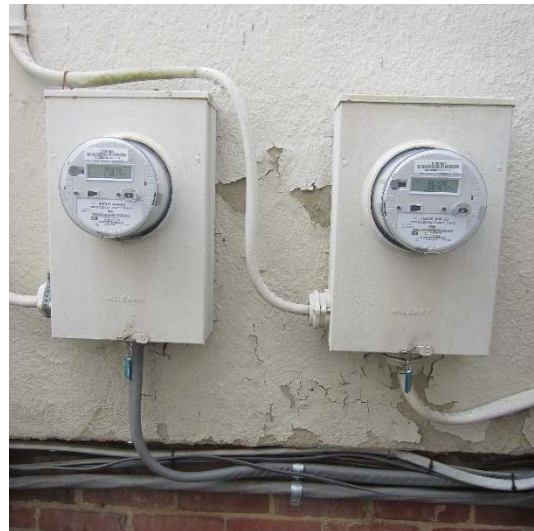
Figure 65: The peeling paint under the electrical meters on the northeast elevation. In addition, the northern meter has pulled away from the wall.

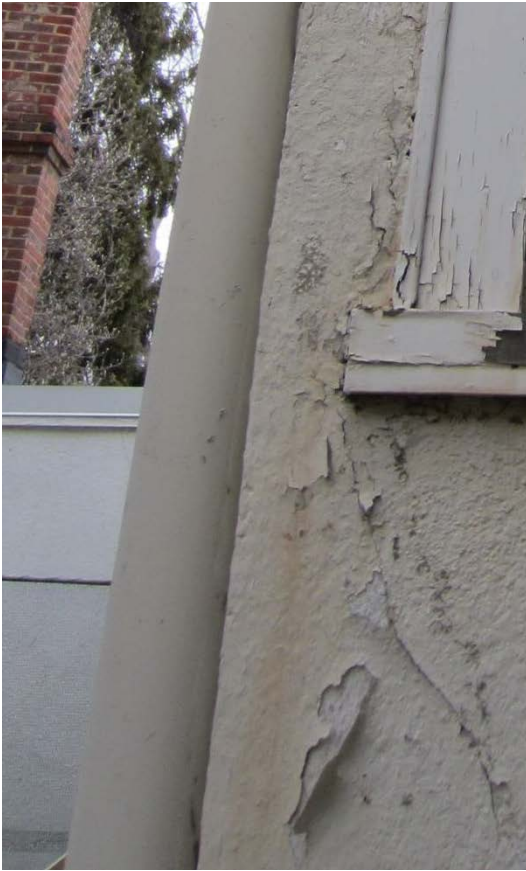
Figure 66: The water staining along the corner of the southwest elevation of the square bay and a close-up of the peeling paint.

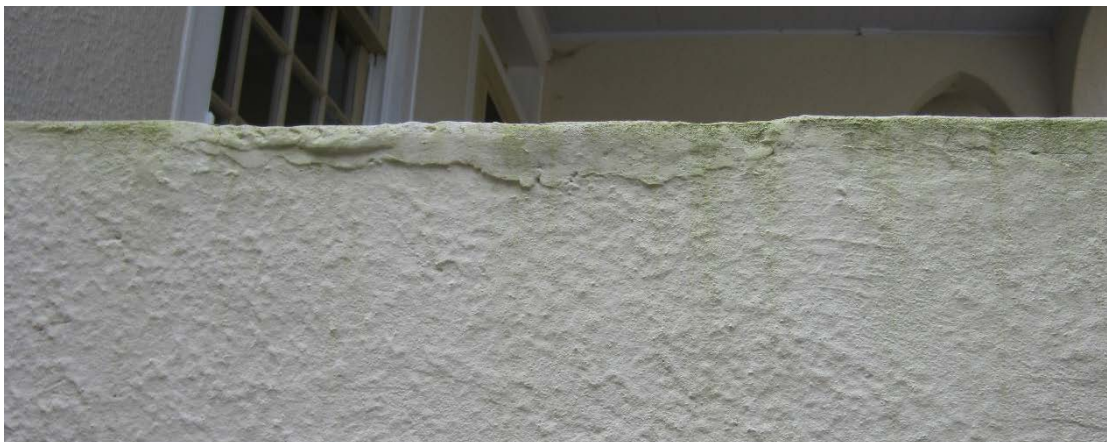
Figure 67: Biological growth along the porch railing.
