86 MARYLAND AVENUE HISTORIC STRUCTURE REPORT
Annapolis, Maryland

AMANDA E. MOORE
University of Maryland
Graduate Program in Historic Preservation
Final Project
May 2014

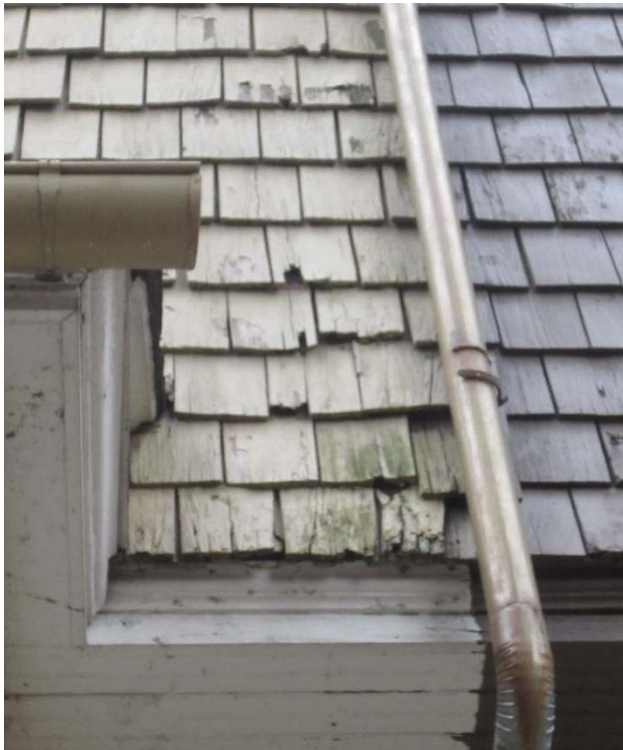
Figure 68: Extensive damage and deterioration in the second floor shingles where the building connects to the next unit.

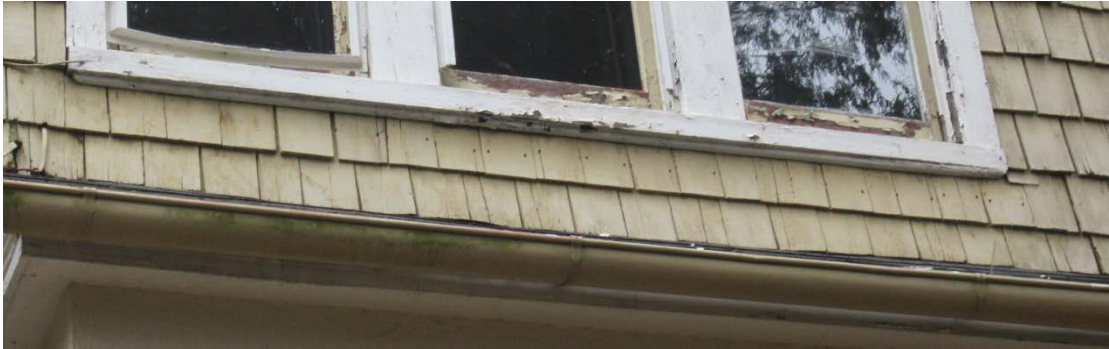
Figure 69: Minor deterioration in the shingles below the triple window on the northwest elevation.

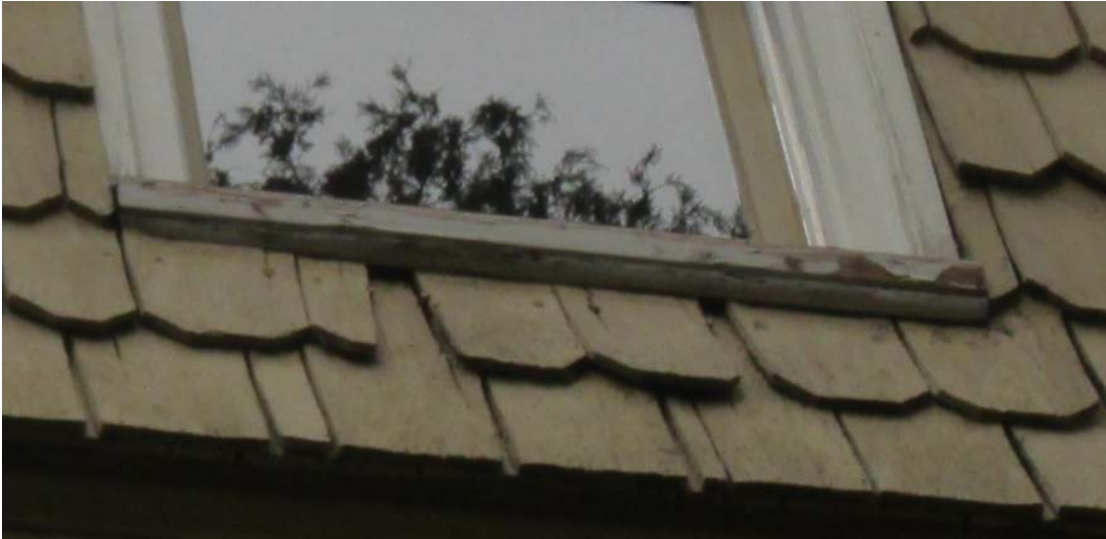
Figure 70: Partially missing shingles under the third floor / attic window in cross gable on the northwest elevation.

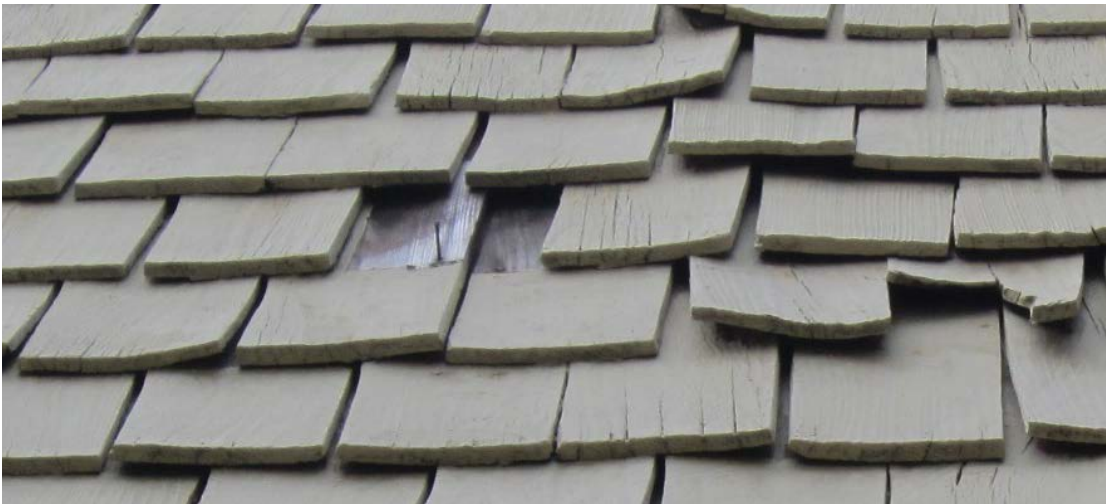
Figure 71: Missing shingles on the second floor on the northeast elevation.

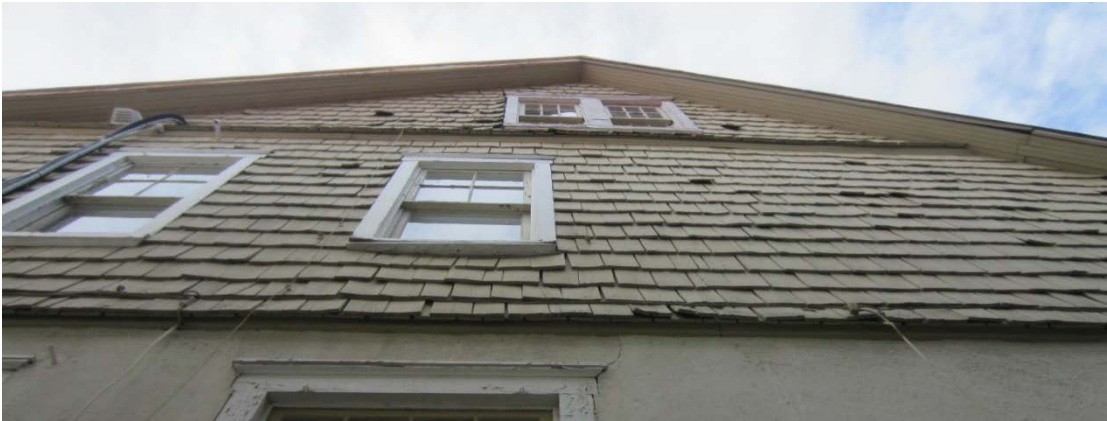
Figure 72: The warped and raised shingles on the northeast elevation.

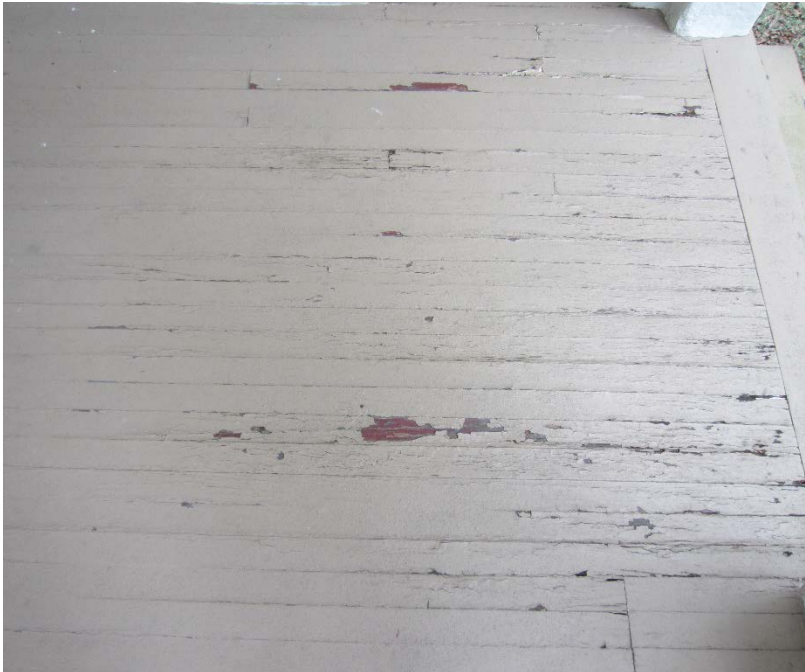
Figure 76:
Deteriorated boards
and peeling paint on
the porch floor.

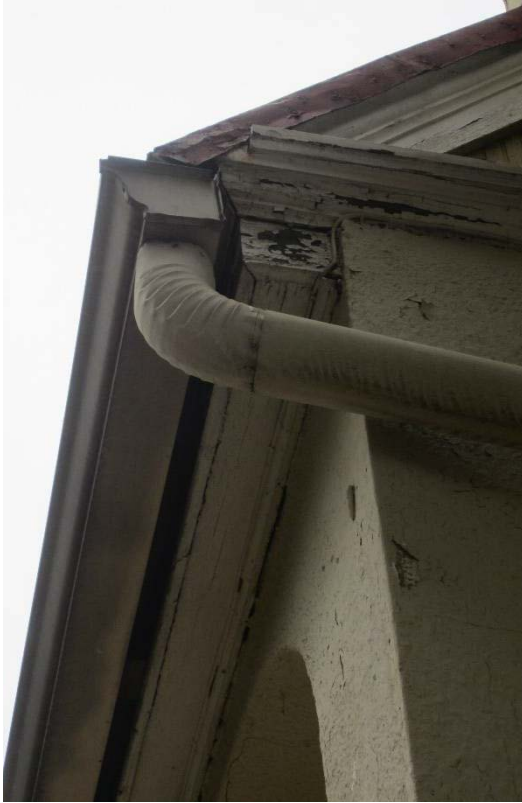
Figure 77: The deteriorating wood and peeling paint on the porch soffit on the northwest elevation and the trim on the southwest.

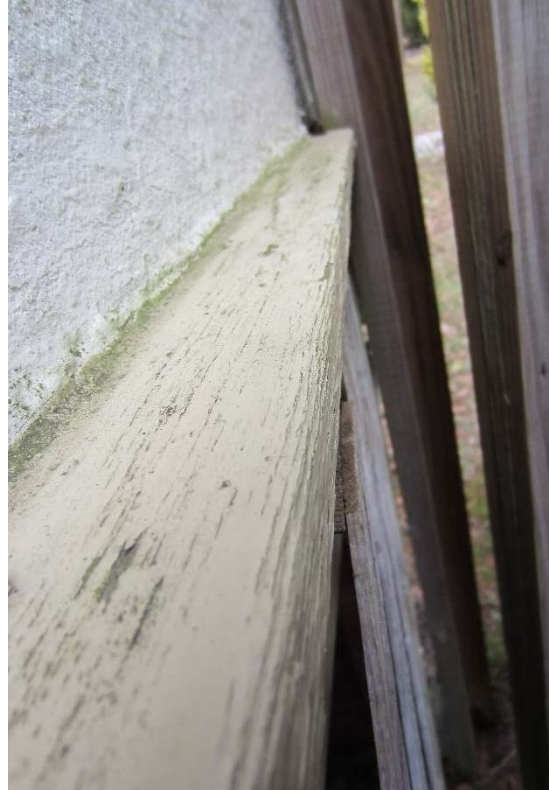
Figure 78: Deteriorating wood and peeling paint on the trim where the stucco is terminated on the northeast elevation of the porch.

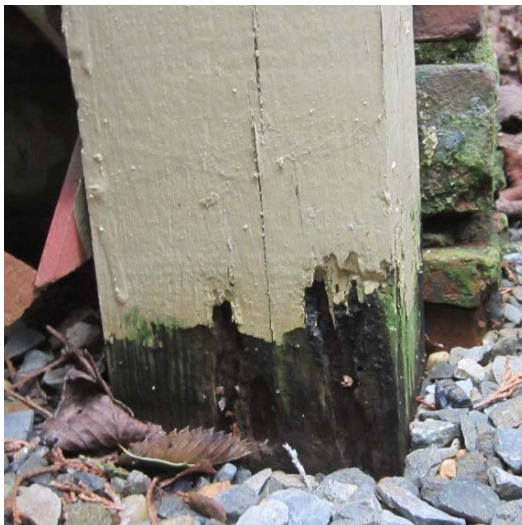
Figure 79: Deteriorating wood, peeling paint and biological growth on the western stair column.

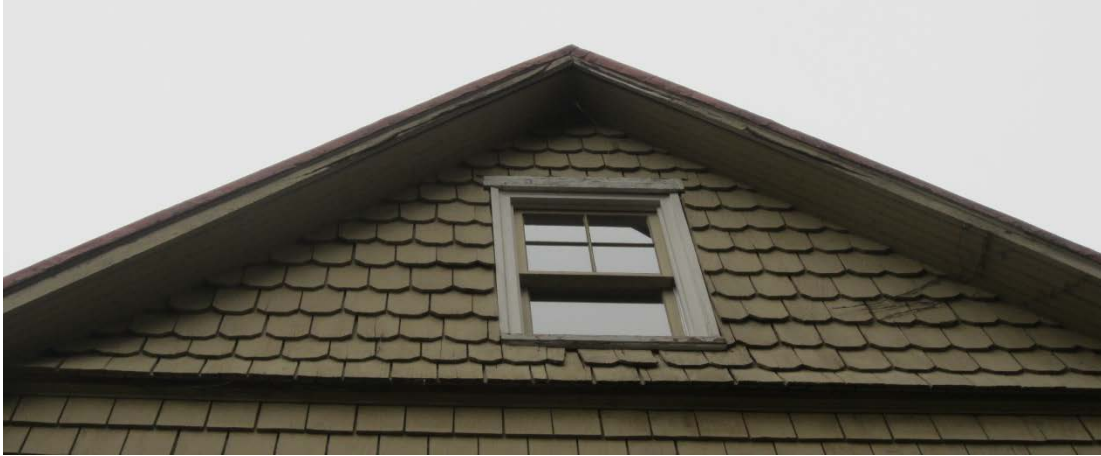
Figure 80: The wood for the fascia is deteriorating on both sides at the cross gable.

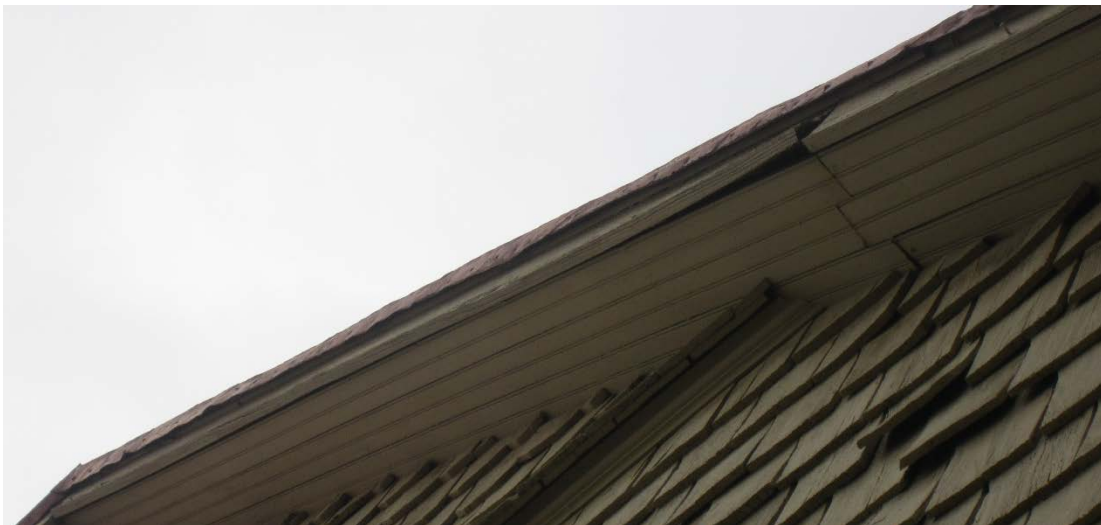
Figure 81: The portion of the fascia that is warped and loose on the northeast elevation.

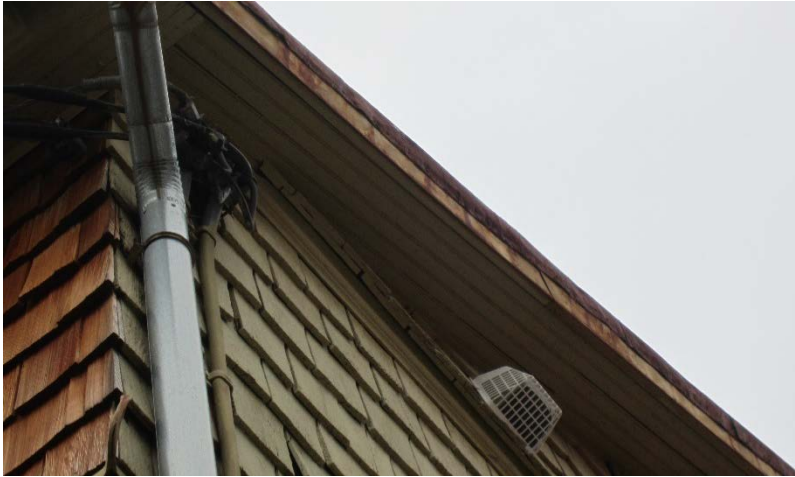
Figure 82: A detail of the rust staining on the fascia on the northeast elevation.

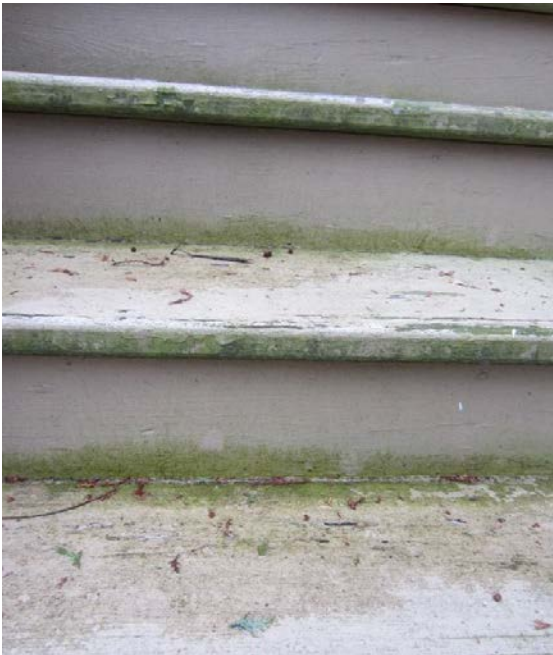
Figure 83: There is biological growth on the majority of the porch stairs.

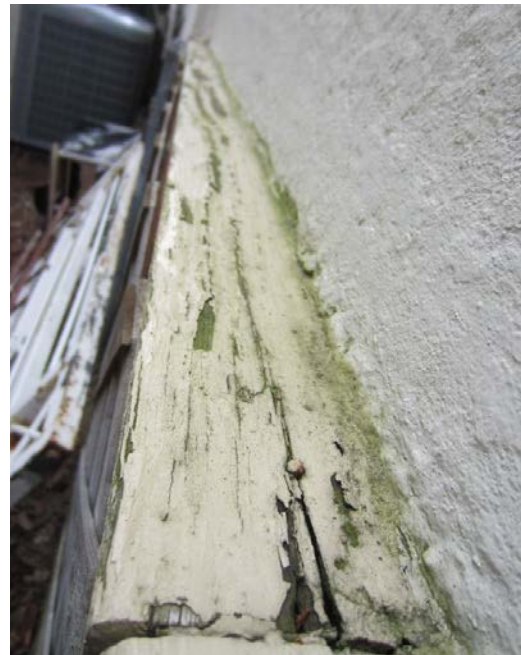
Figure 84: Biological growth is evident on the wood along the edge of the stucco on the northeast elevation of the porch. This image also shows the extent of the deterioration and peeling paint on this element.

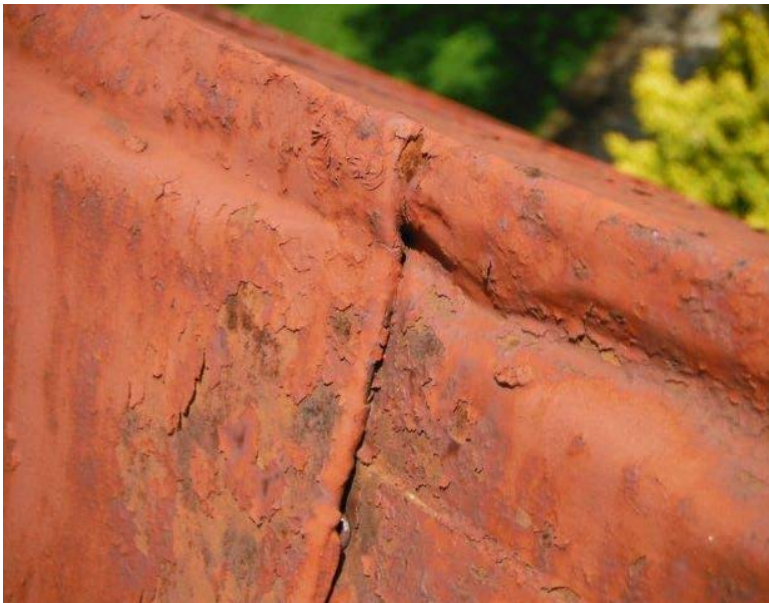
Figure 85: A close-up example of the peeling paint throughout the entire roof. Photograph taken on June 8, 2013 and provided to the author by AIA Maryland.

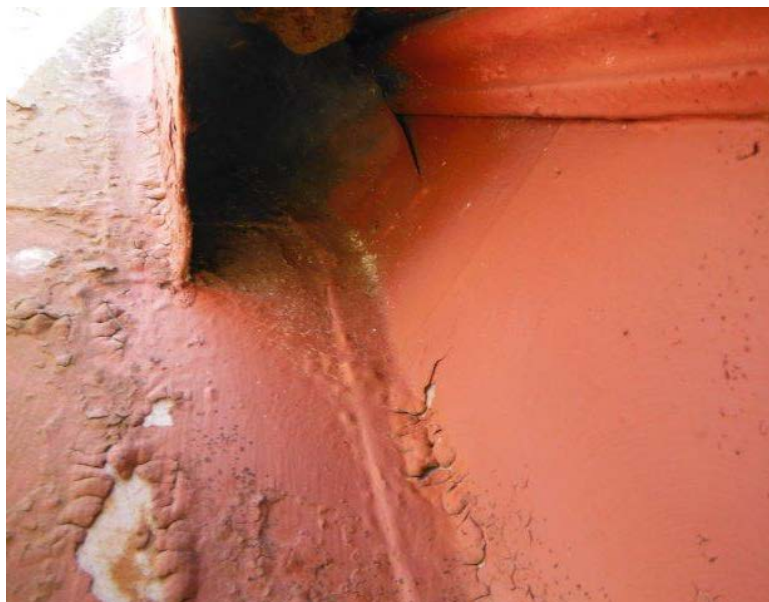
Figure 86: Example of the blistered and peeling paint on the roof. Photograph taken on June 8, 2013 and provided to the author by AIA Maryland.

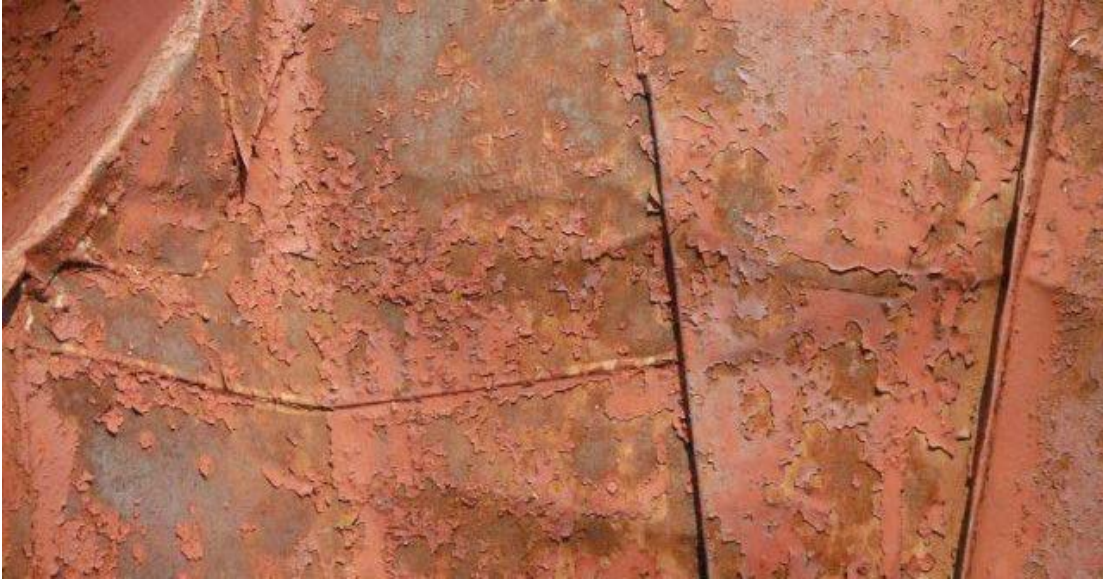
Figure 87: An example of the typical condition of the standing seam metal roof, showing the peeling paint and corrosion of the metal. Photograph taken on June 8, 2013 and provided to the author by AIA Maryland.

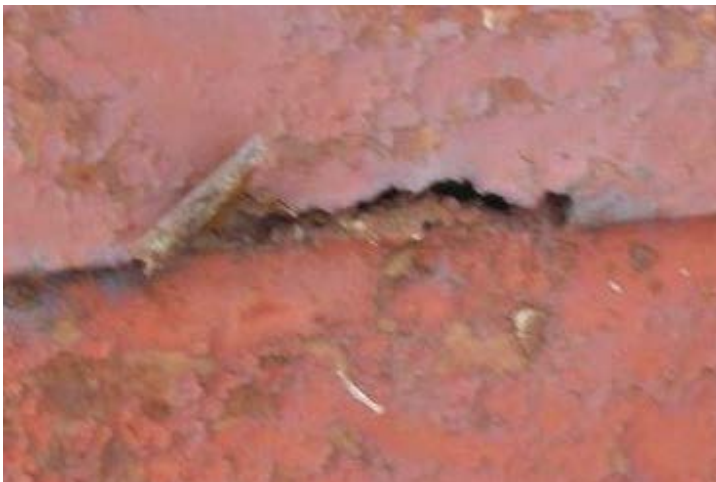
Figure 88: Example of a broken seam. Photograph taken on June 8, 2013 and provided to the author by AIA Maryland.

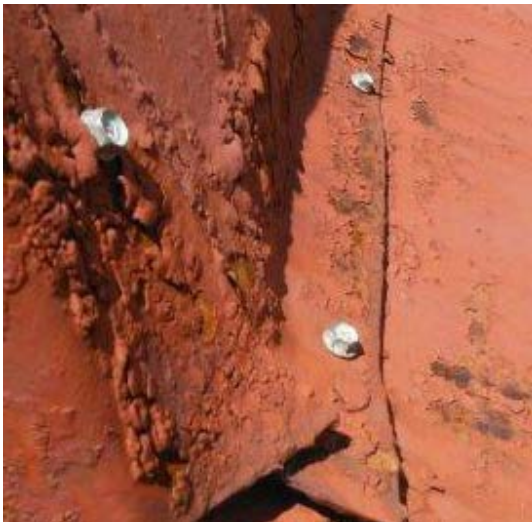
Figure 90: Roof repair in the flashing at the chimney. Example of improper repair with stainless steel screws. Photograph taken on June 8, 2013 and provided to the author by AIA Maryland.

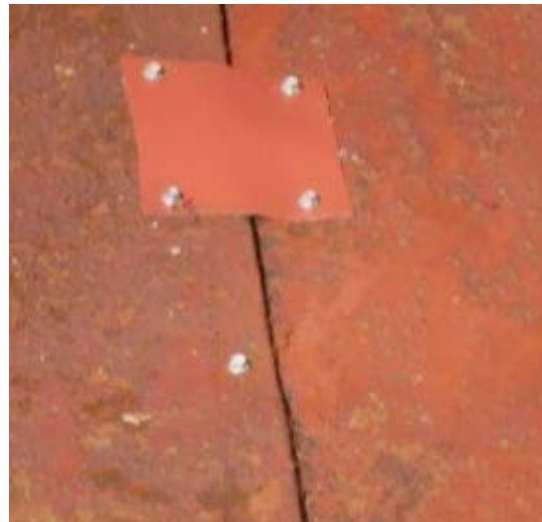
Figure 91: Examples of an improper roof repair at a seam. Photograph taken on June 8, 2013 and provided to the author by AIA Maryland.

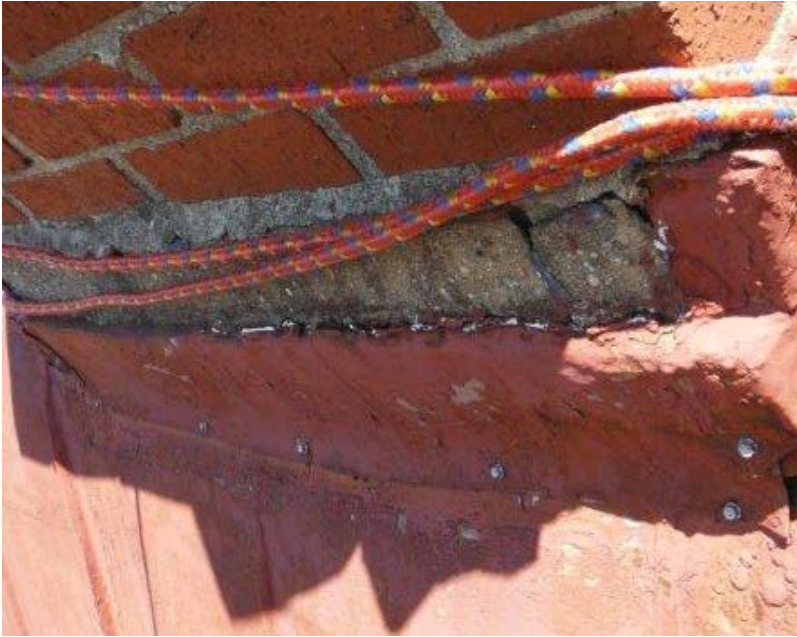
Figure 92: Missing metal flashing at the chimney. Photograph taken on June 8, 2013 and provided to the author by AIA Maryland.

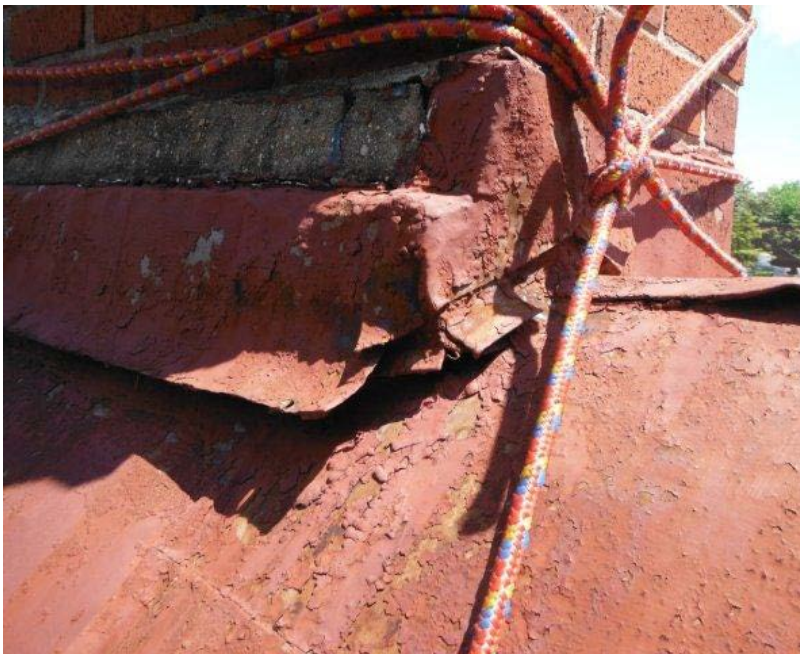
Figure 93: Raised metal flashing at the chimney. Photograph taken on June 8, 2013 and provided to the author by AIA Maryland.

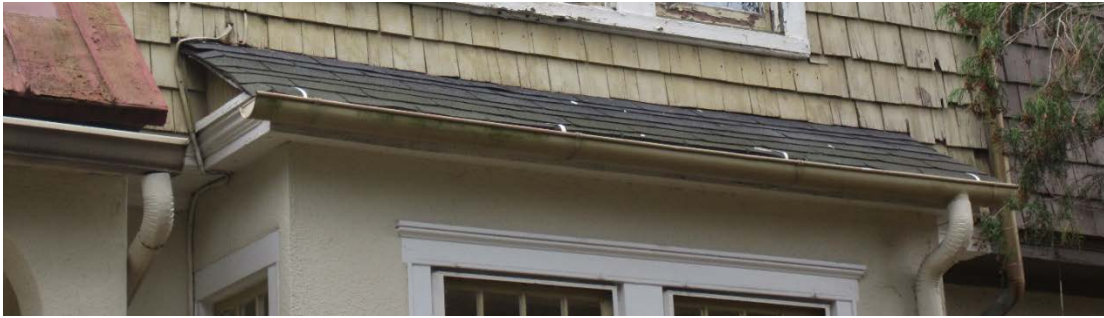
Figure 95: Biological growth on the low portion of the asphalt shingle roof on the square bay.

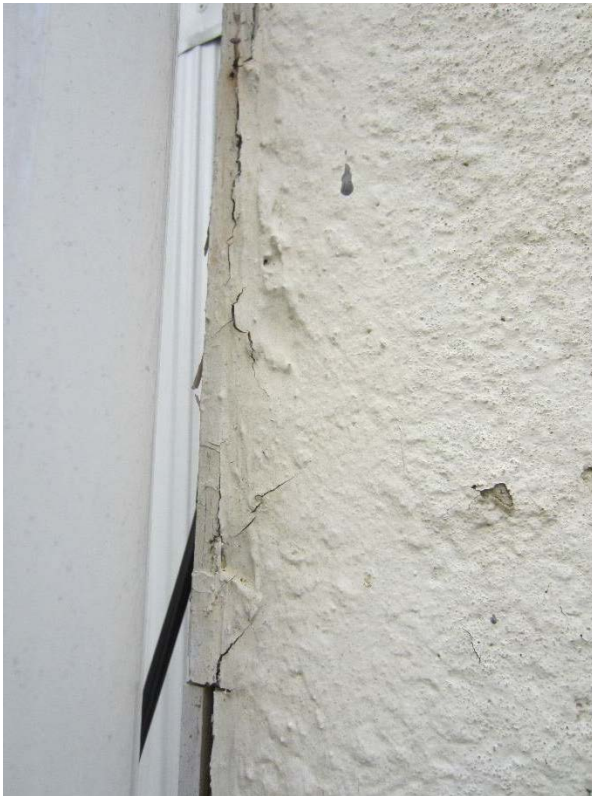
Figure 96: A close-up of the crack that is along the full length of the corner between the small and commercial additions.

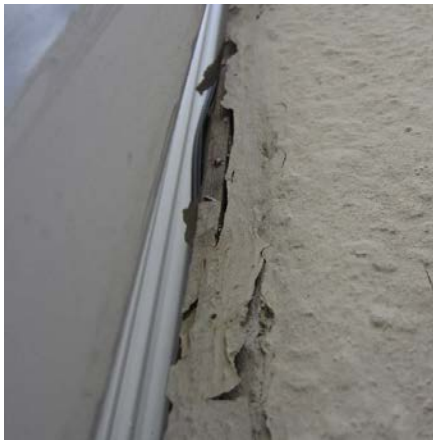
Figure 97: The typical condition of the peeling paint along the corner between the small and commercial additions.

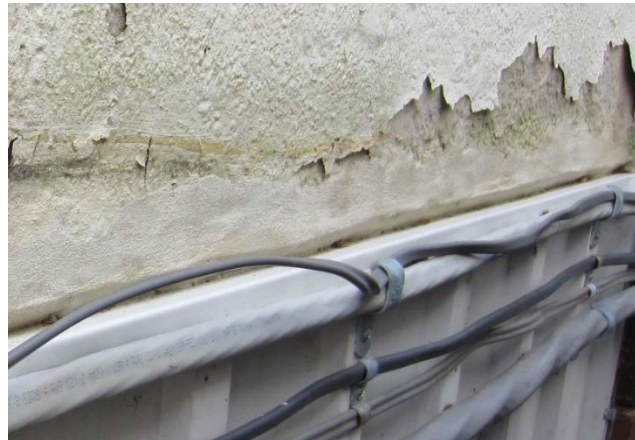
Figure 98: An example of the peeling paint, exposed brown coat, and biological growth on the bottom of the northeast elevation.

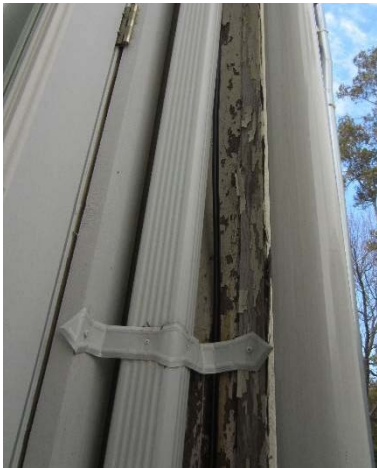
Figure 100: A portion of the peeling paint and deteriorated wood at the corner between the small and commercial additions.

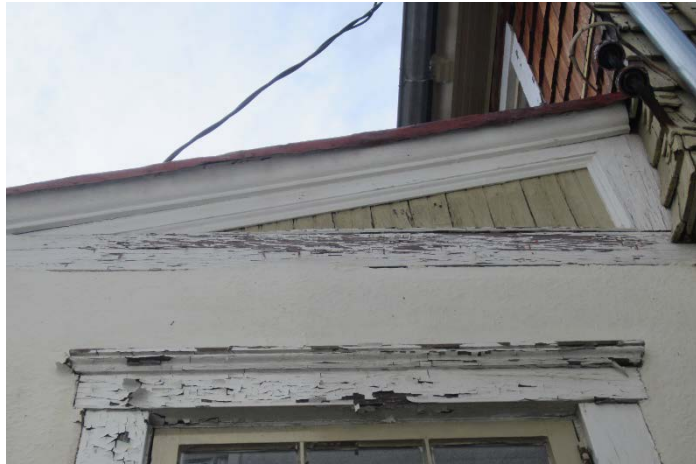
Figure 101: The peeling paint and deteriorated wood above the stucco on the northeast elevation.

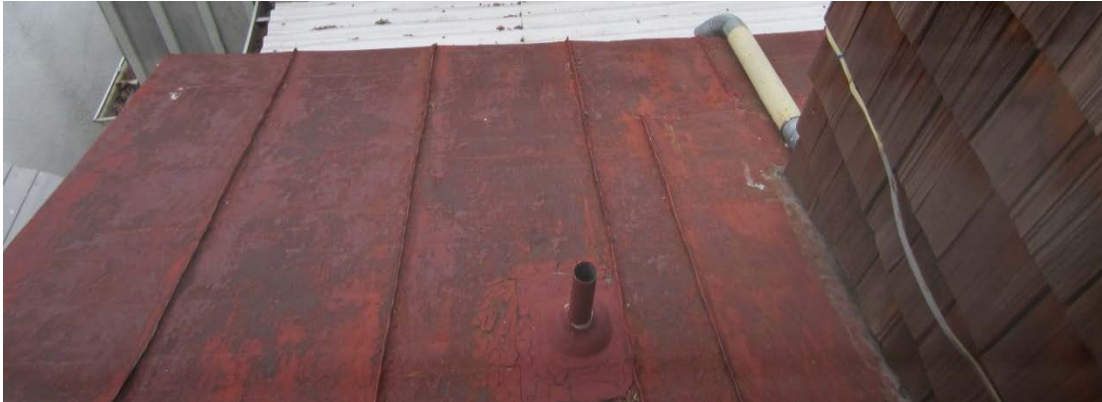
Figure 102: Part of the metal roof, showing the typical conditions of peeling paint and rust.

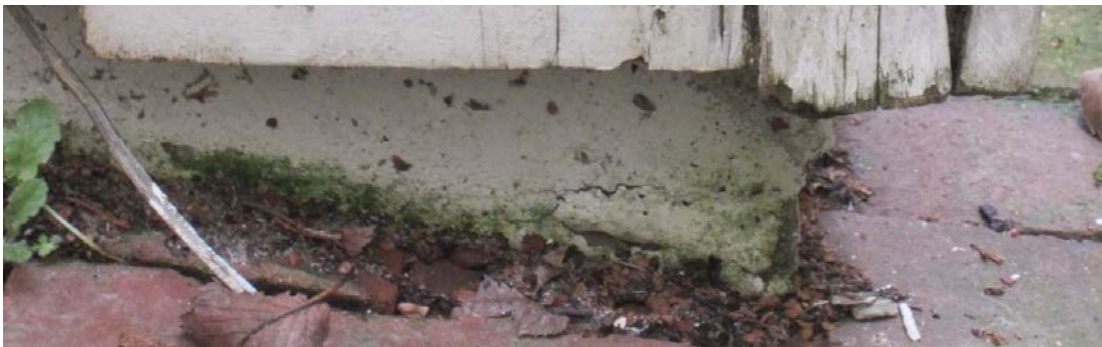
Figure 103: Biological growth on the concrete slab-on-grade.

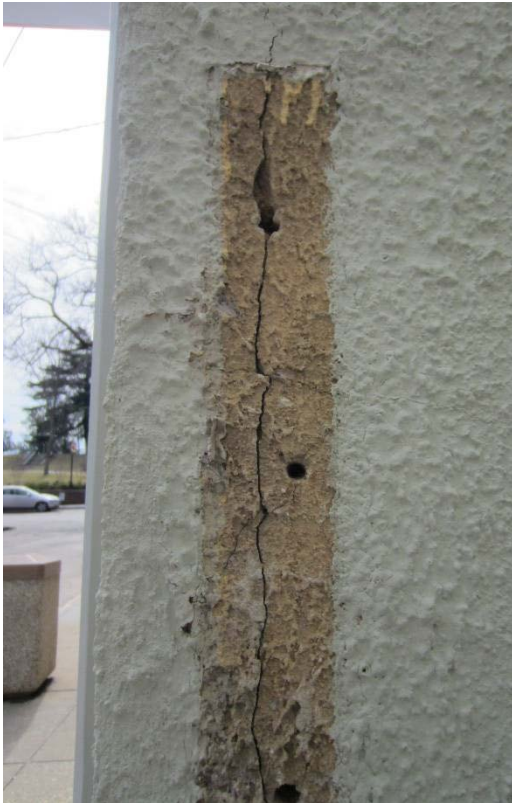
Figure 104: A portion of the damage to the stucco caused by a piece of wood that was formerly attached to the northeast elevation.

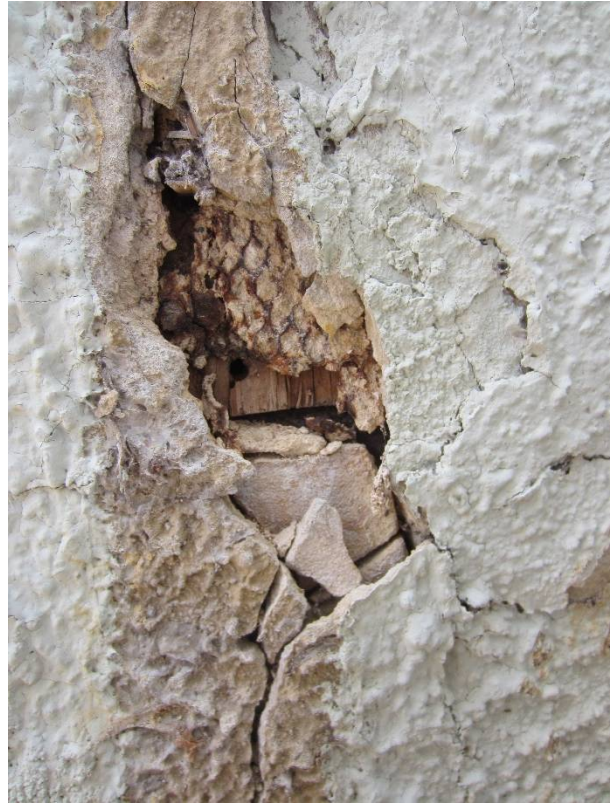
Figure 105: A close-up of one of the holes where the wood was anchored to the wall.

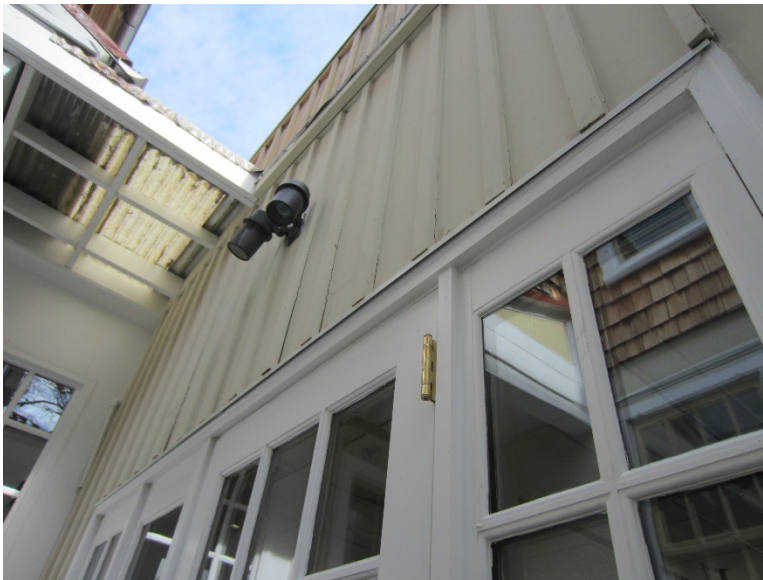
Figure 106: The seven detached battens on the northwest elevation.

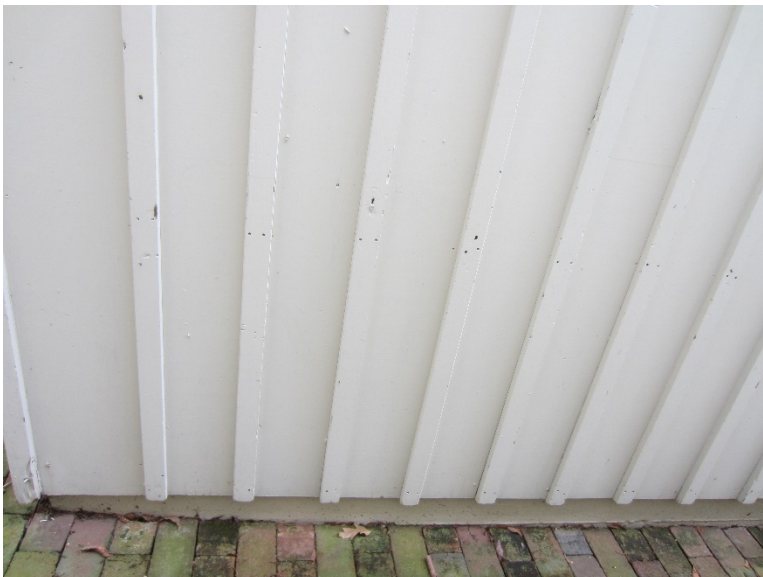
Figure 107: The detached battens on the southwest elevation.

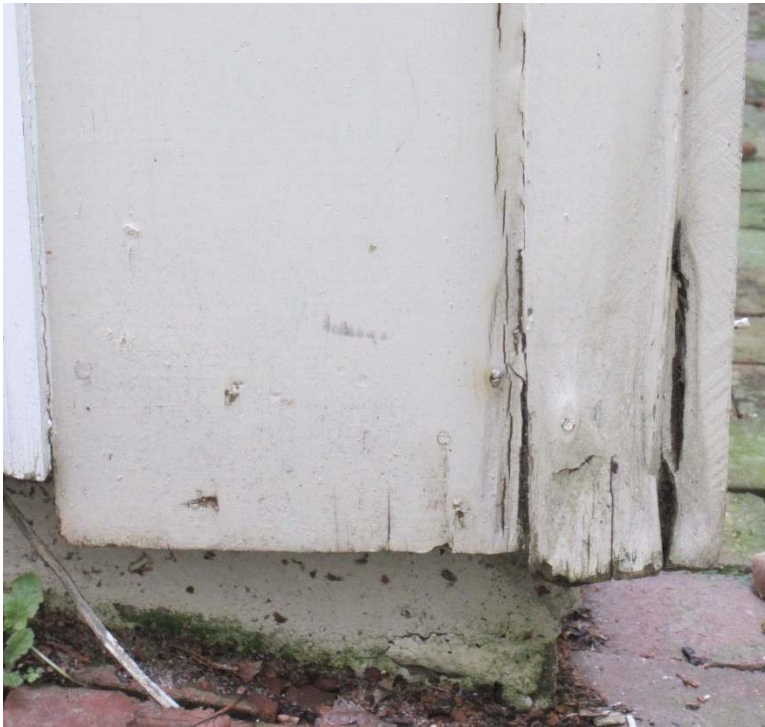
Figure 108: Deteriorated wood and peeling paint on the eastern corner.

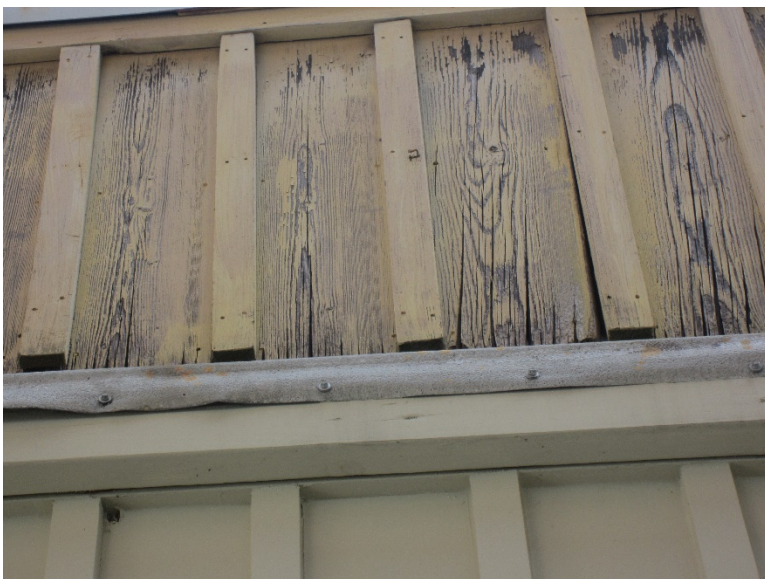
Figure 109: Deteriorated boards above the courtyard door on the northwest elevation.

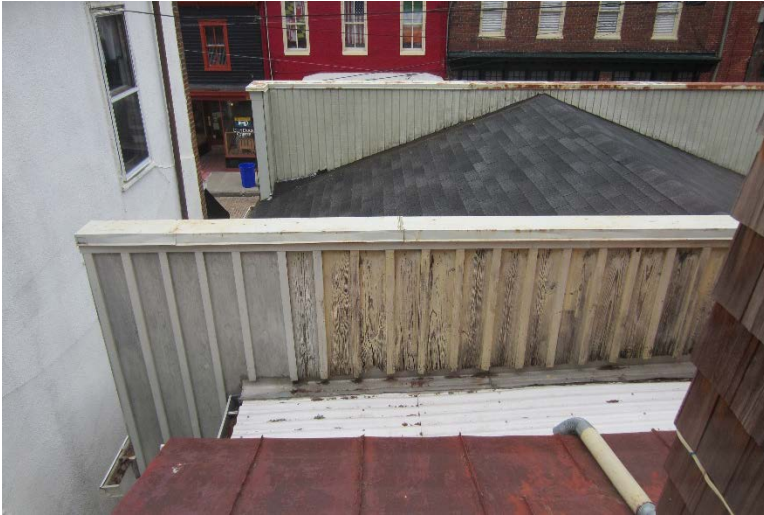
Figure 110 Primed but unpainted parapet on the northwest elevation.

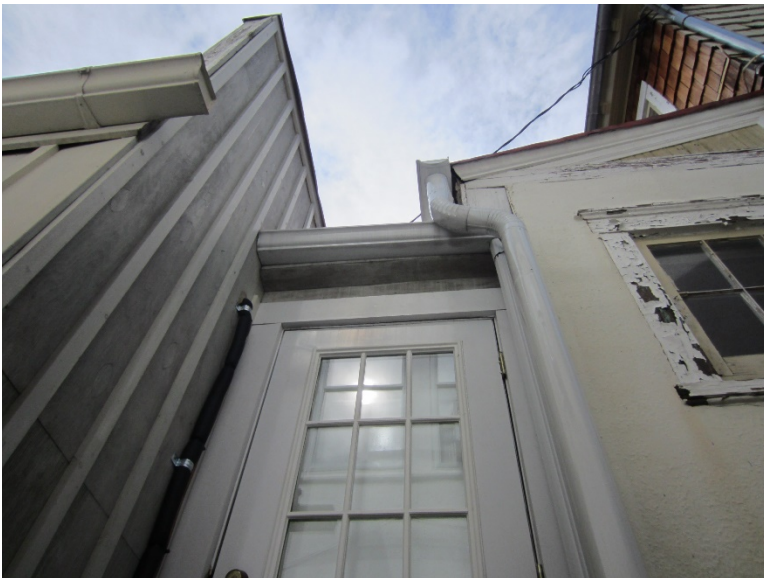
Figure 111: The portion of the northwest elevation that has been primed but left unpainted.

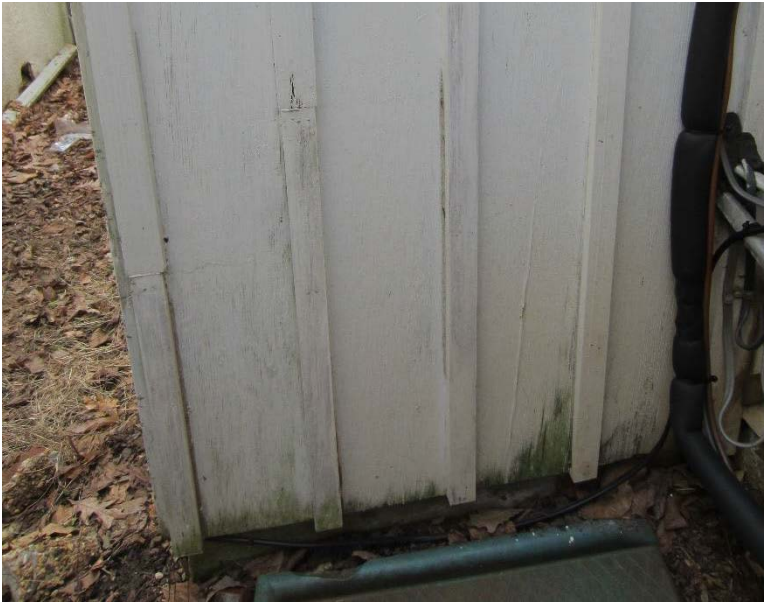
Figure 112: Worn paint with biological growth on the northwest elevation.

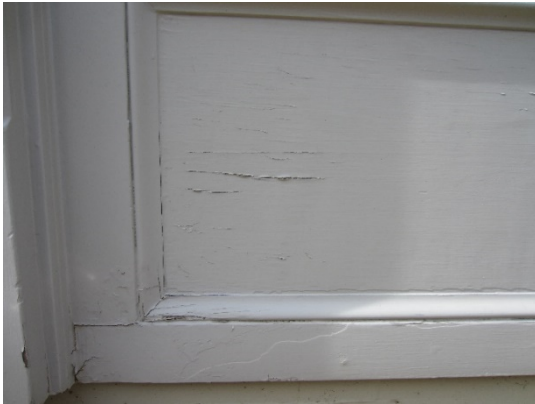
Figure 113: Typical condition of the peeling paint in the recessed panels.

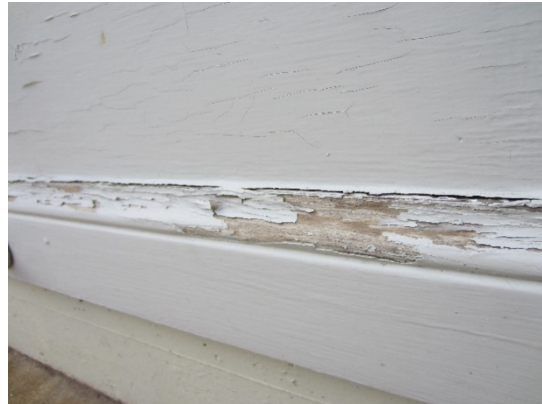
Figure 114: The peeling paint on the lower trim of the southern panel.

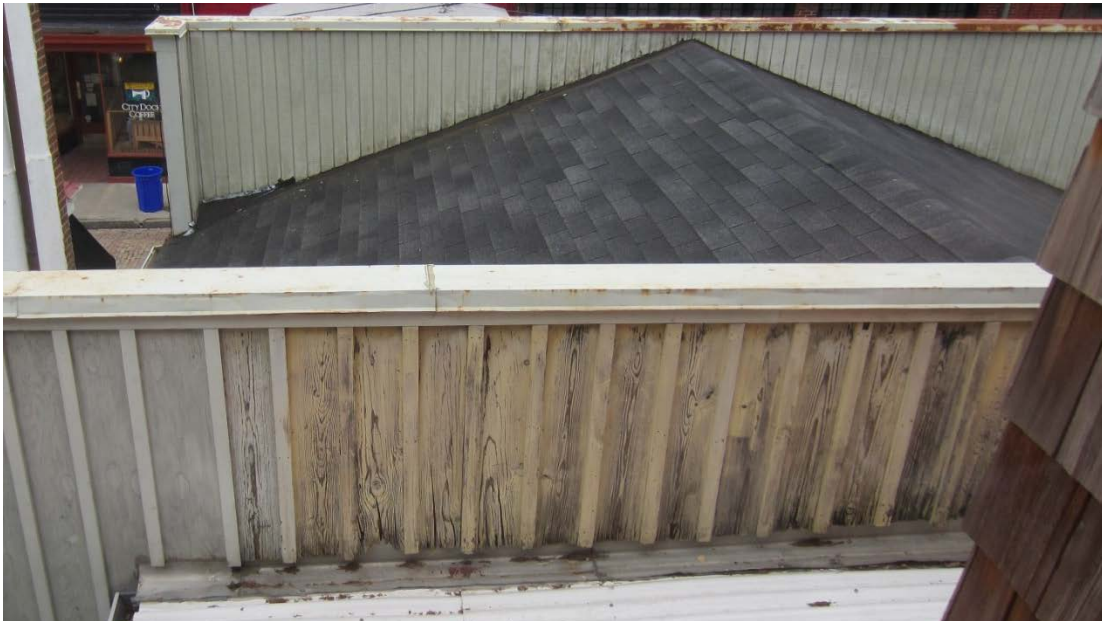
Figure 117: The current condition of the corrugated fiberglass and asphalt roofs with the rusted parapet caps.

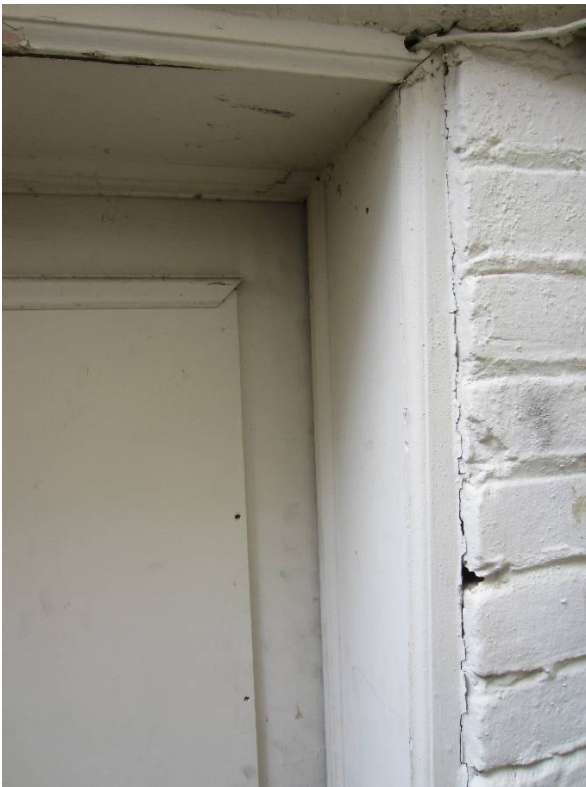
Figure 118: Close-up of the crack between the door and the foundation, and the opening in the header.

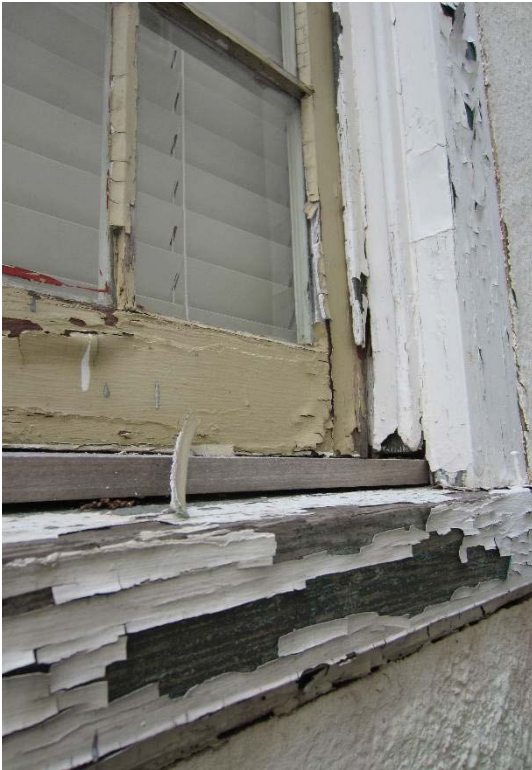
Figure 119: The eastern window on the first floor of the northeast elevation serves as an example of the extent of the peeling paint found on the window sashes and trim.

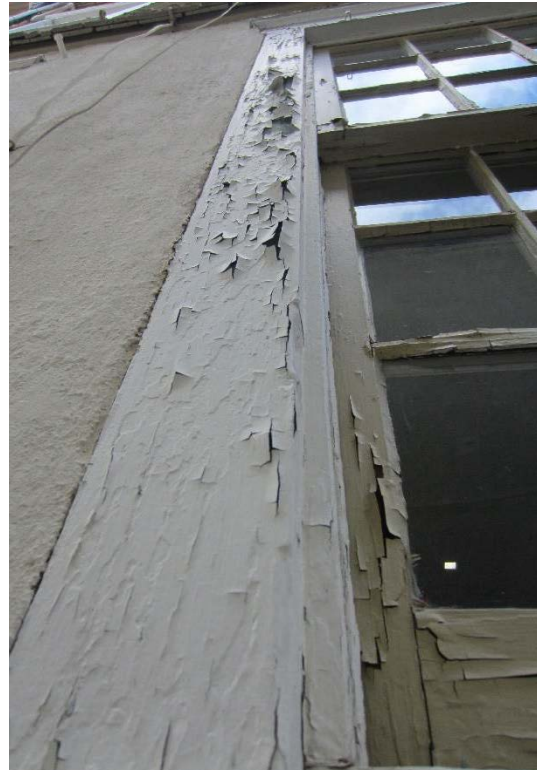
Figure 120: Northern window on the first floor of the northwest elevation, showing the typical condition of peeling paint on the windows.

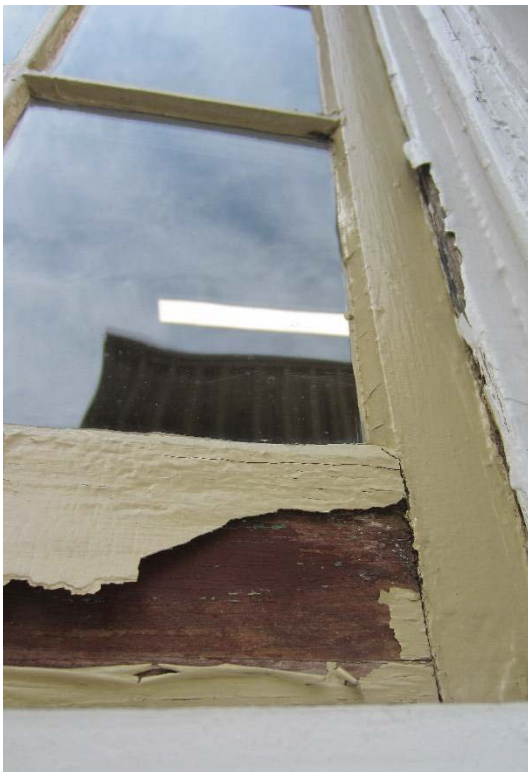
Figure 121: The southern window on the first floor of the southeast is an example of the typical peeling paint found on the window sashes.

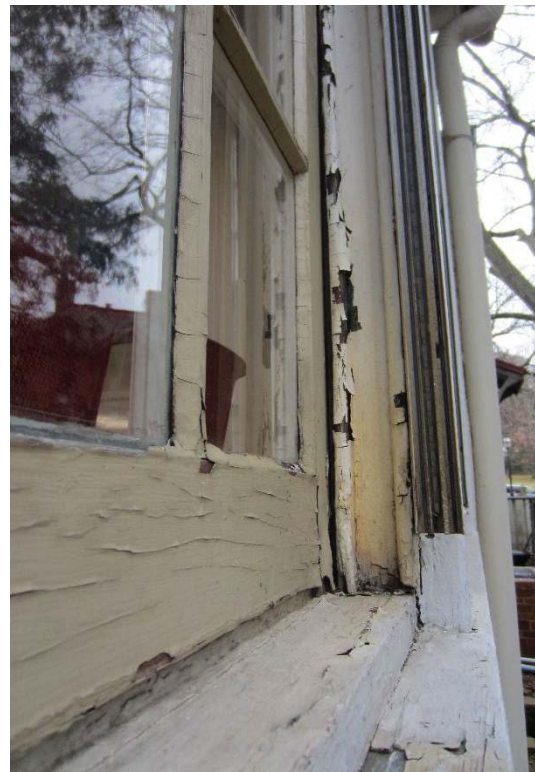
Figure 122: The western window on the first floor of the square bay which serves as an example of the peeling paint on the window sashes and trim. In addition, remnants of the old storms are still attached to the window.

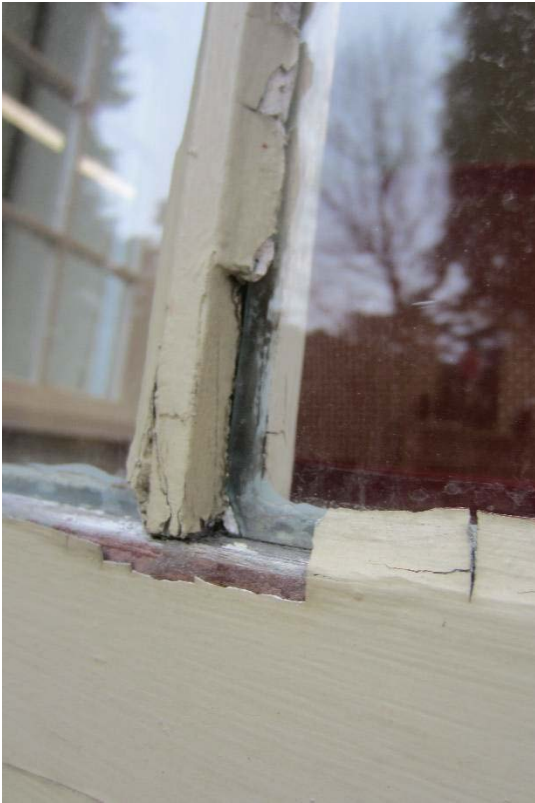
Figure 123: Northern first floor window on the square bay which is an examples of the deterioration of the glazing putty.

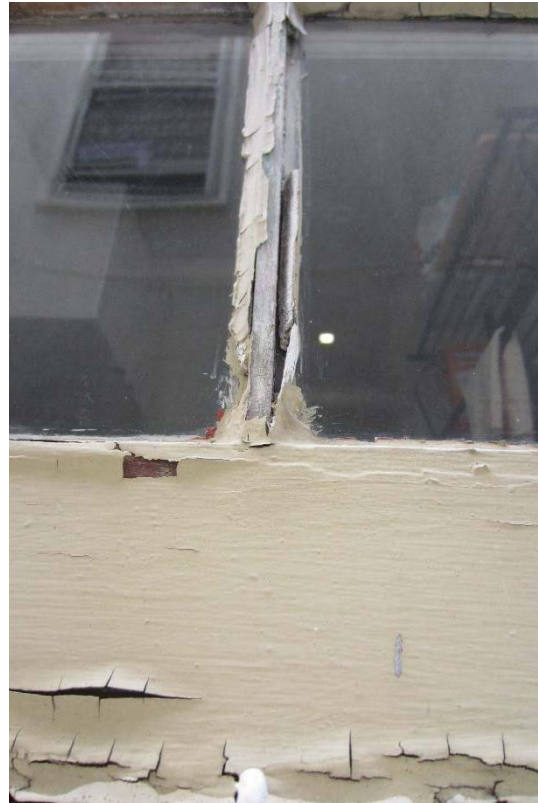
Figure 124: The eastern window on the first floor of the northeast elevation, which shows the typical condition of the glazing putty.

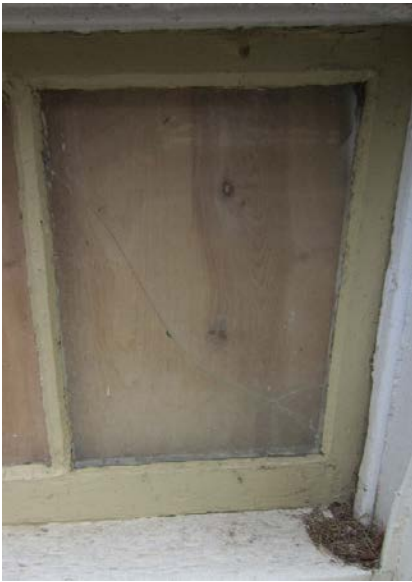
Figure 125: Broken glass pane in the basement window.

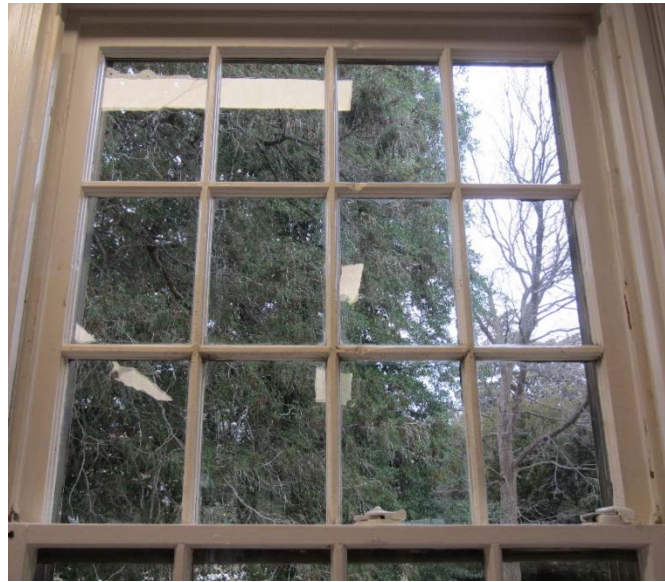
Figure 126: The three broken panes of glass are in the corners of the top sashes excluding one on the upper right.

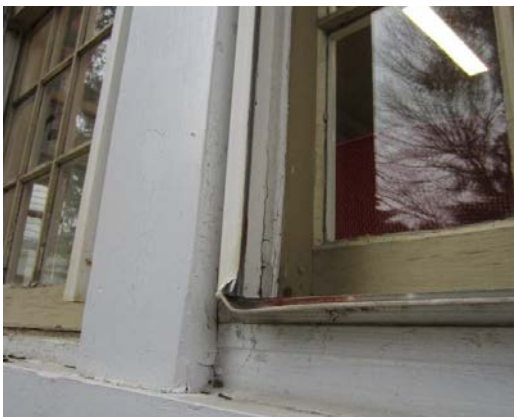
Figure 127: The first floor windows on the northwest elevation of the square bay serve as an example of the remnants of the storm windows.
