86 MARYLAND AVENUE HISTORIC STRUCTURE REPORT
Annapolis, Maryland

AMANDA E. MOORE
University of Maryland
Graduate Program in Historic Preservation
Final Project
May 2014

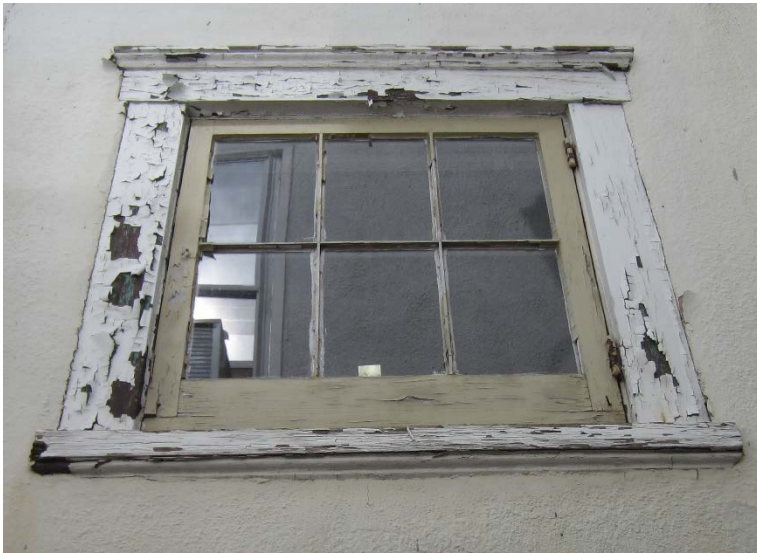
Figure 128: Northeast window on the small addition: with peeling paint and deteriorated glazing putty.

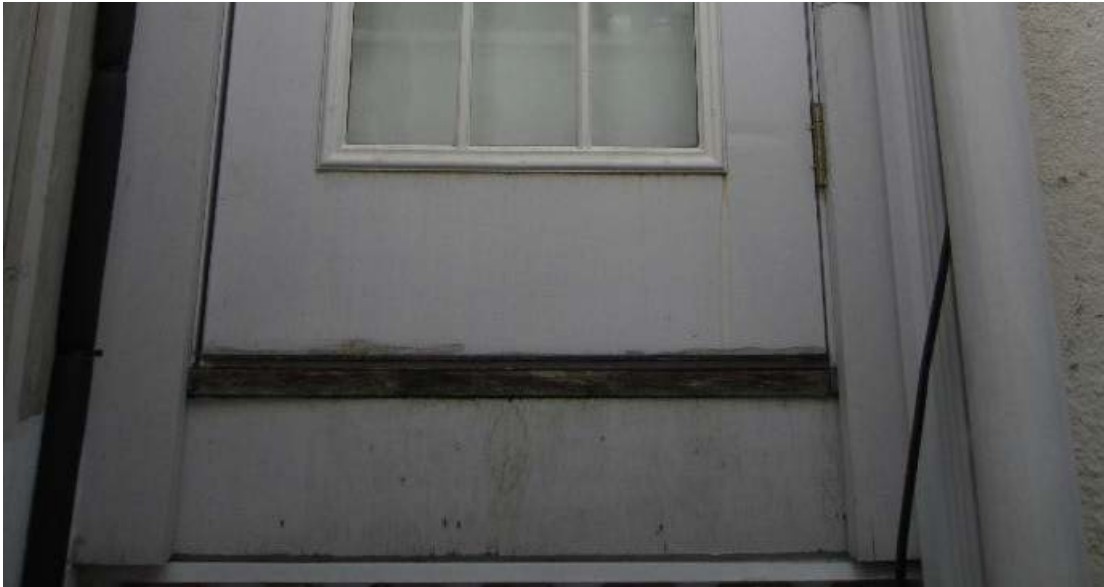
Figure 129: Deteriorated sill and rust staining on the fixed door.

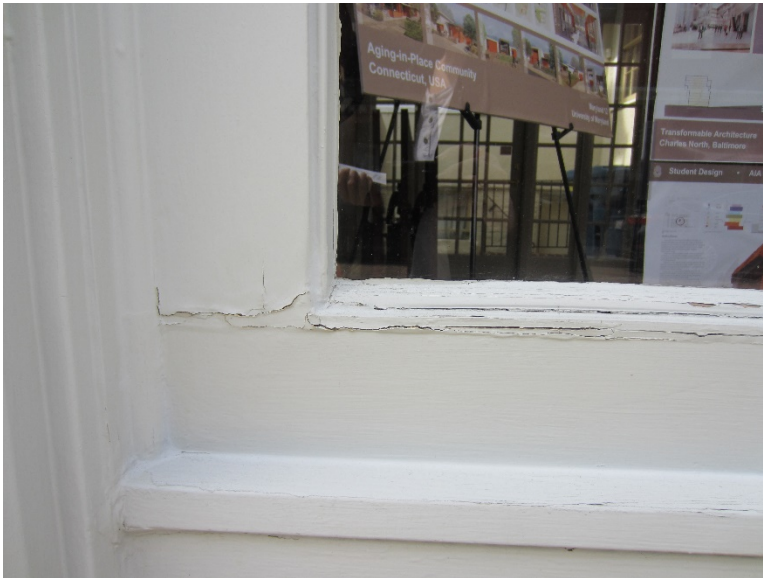
Figure 130: Hairline crack and peeling paint at the southern window.

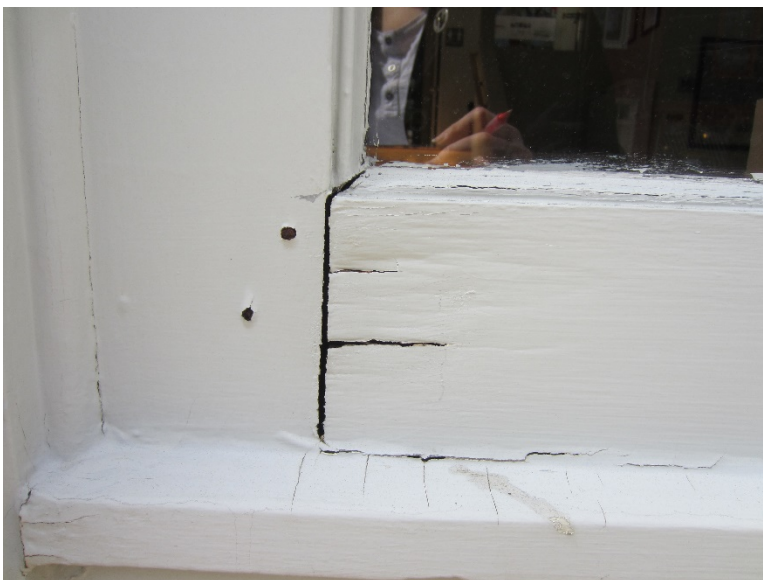
Figure 131: Separation at the sash joint at the center window.

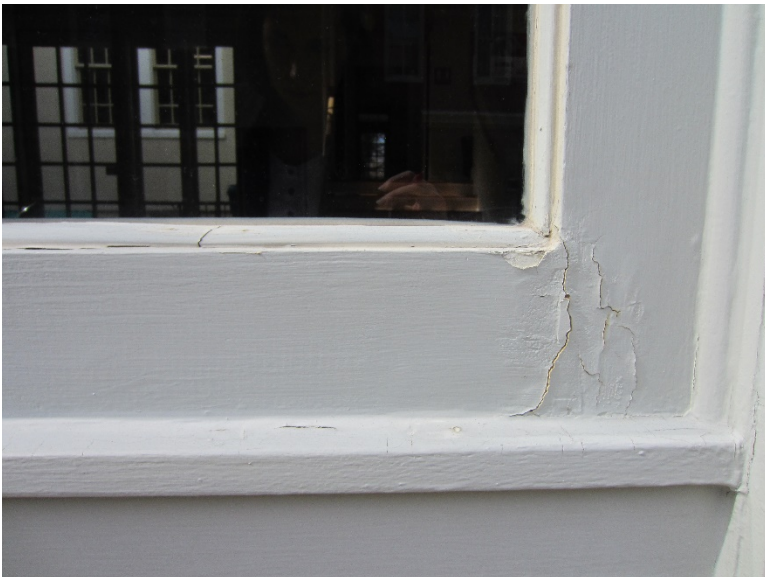
Figure 133: Peeling paint on the southern window sash.

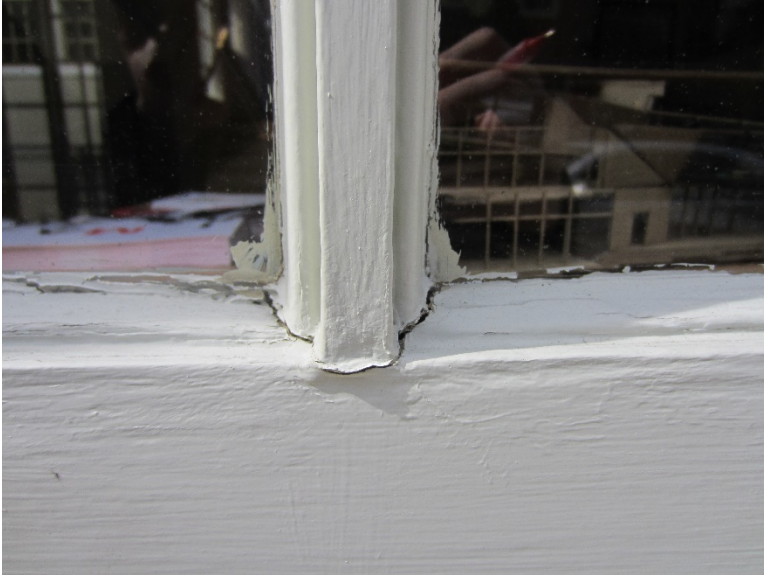
Figure 134: Crack in the glazing putty and around the muntin.

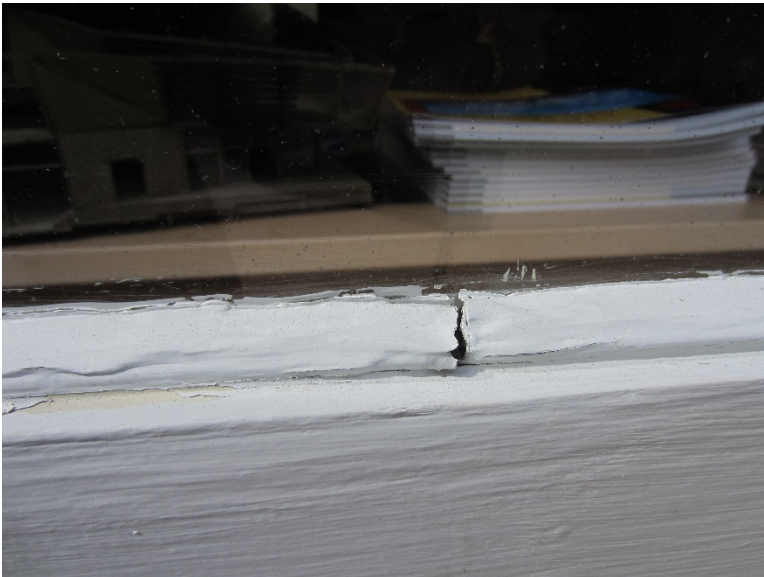
Figure 135: Crack in glazing putty.

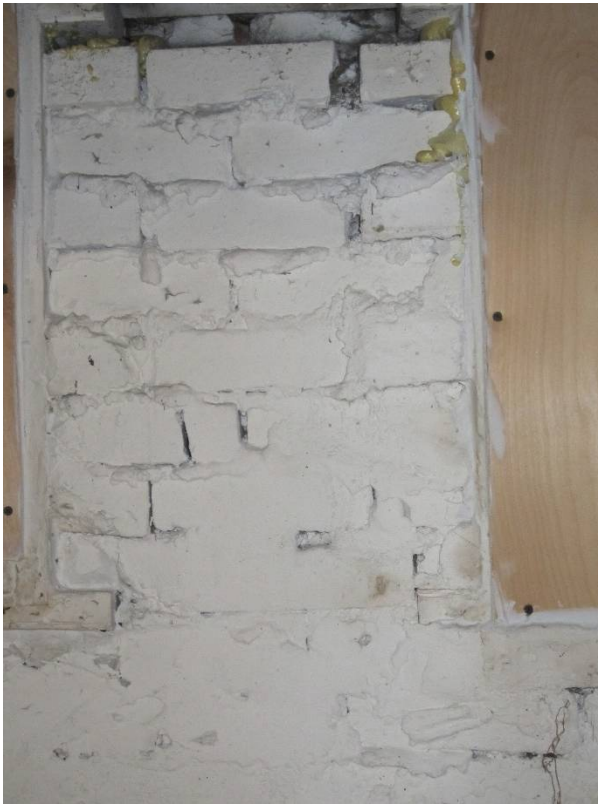
Figure 136: Deteriorated mortar in the basement.

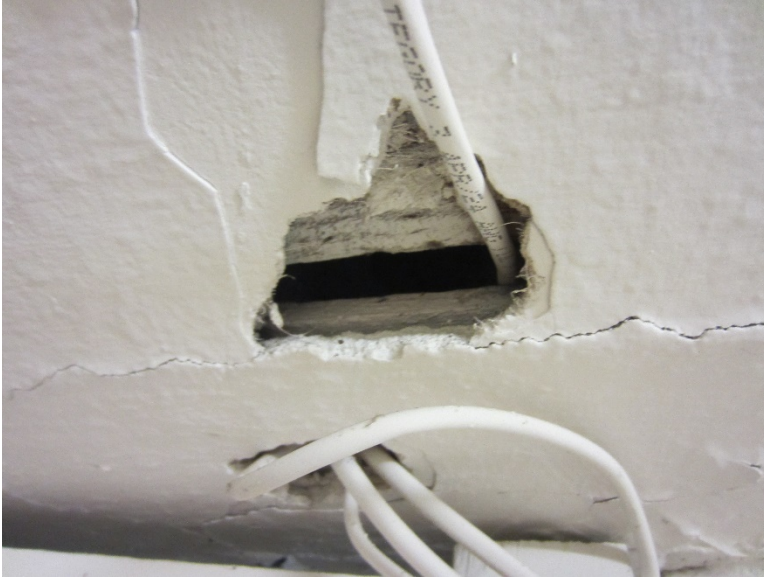
Figure 137: Two of the holes and radiating cracks in the basements plaster ceiling; both made to run wiring.

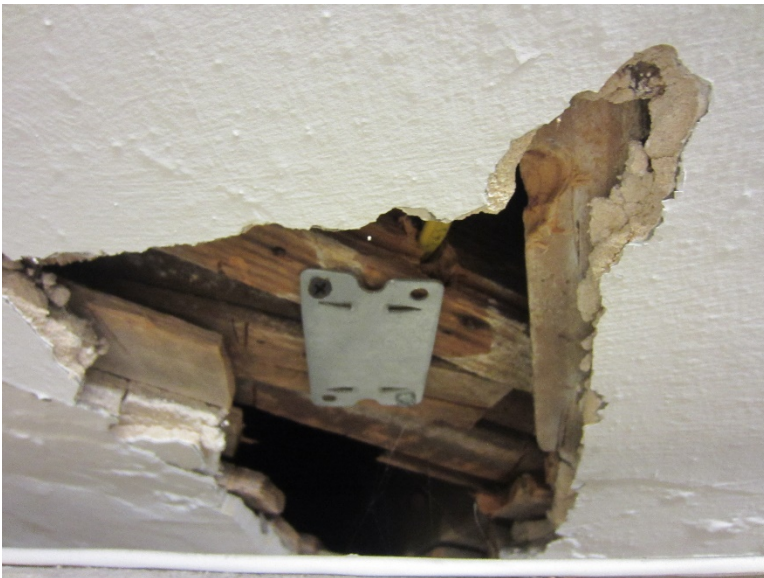
Figure 138: The worst of the holes in the basement plaster ceiling.

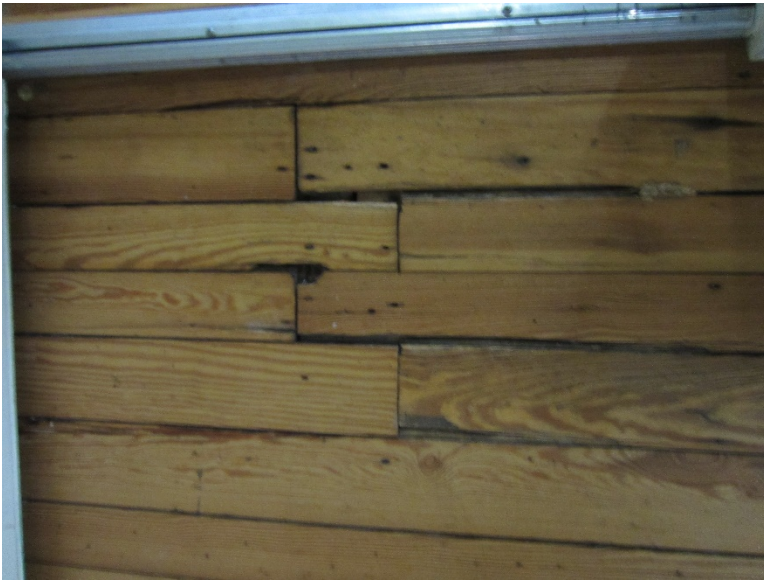
Figure 139: Deteriorated floorboards in the stair hall.

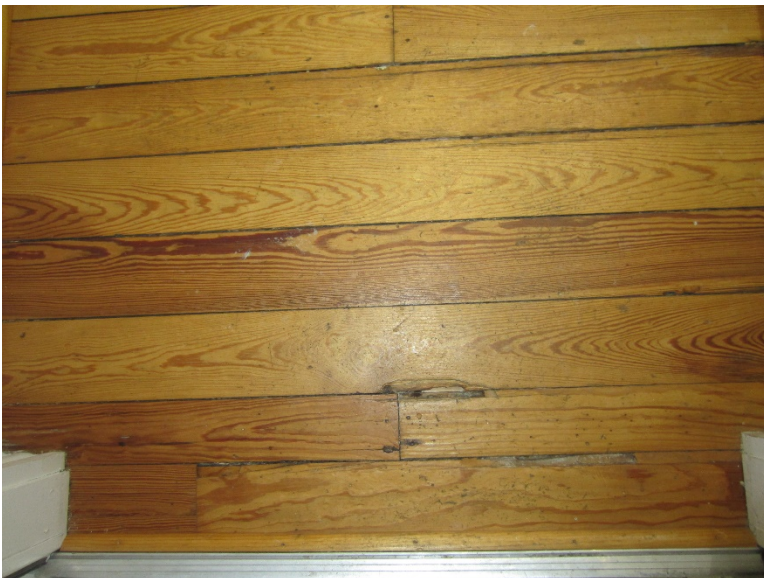
Figure 140: Deteriorated floorboards near the door separating the hall in the eastern set of the rooms.

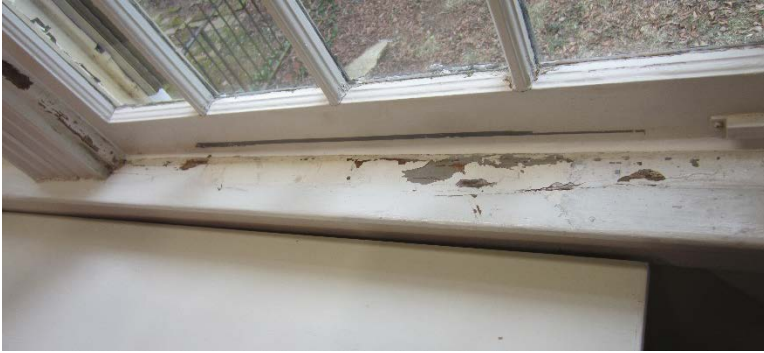
Figure 141: The peeling paint on the window sill on the northern window.

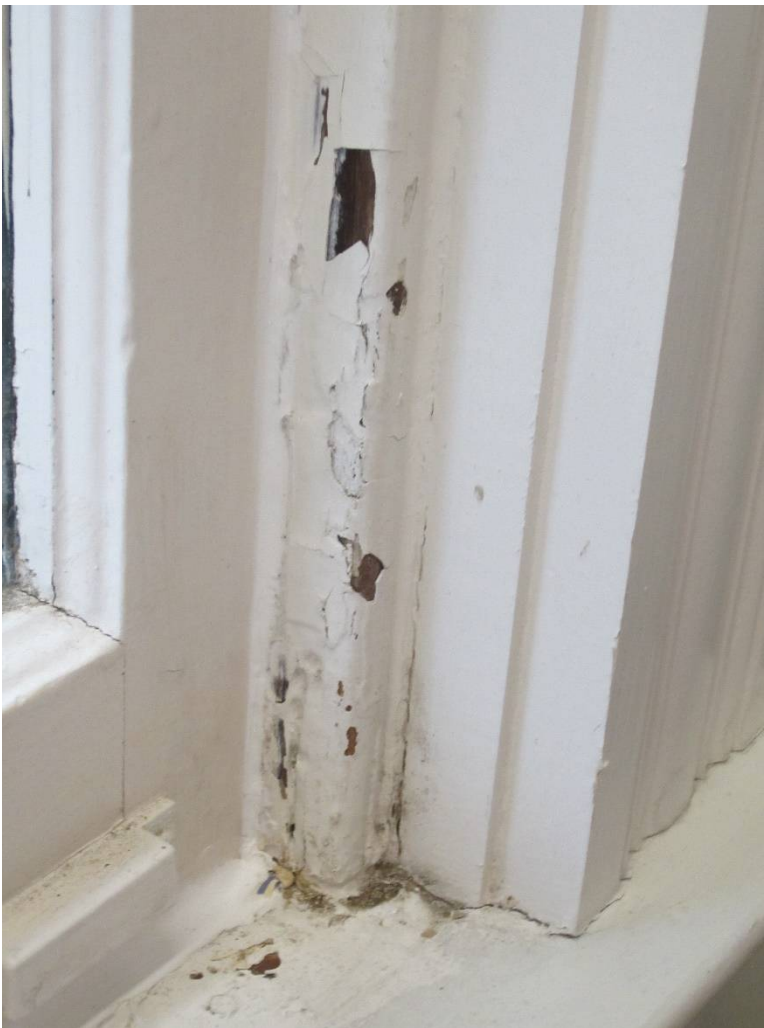
Figure 142: A close-up of the peeling paint on the window trim.

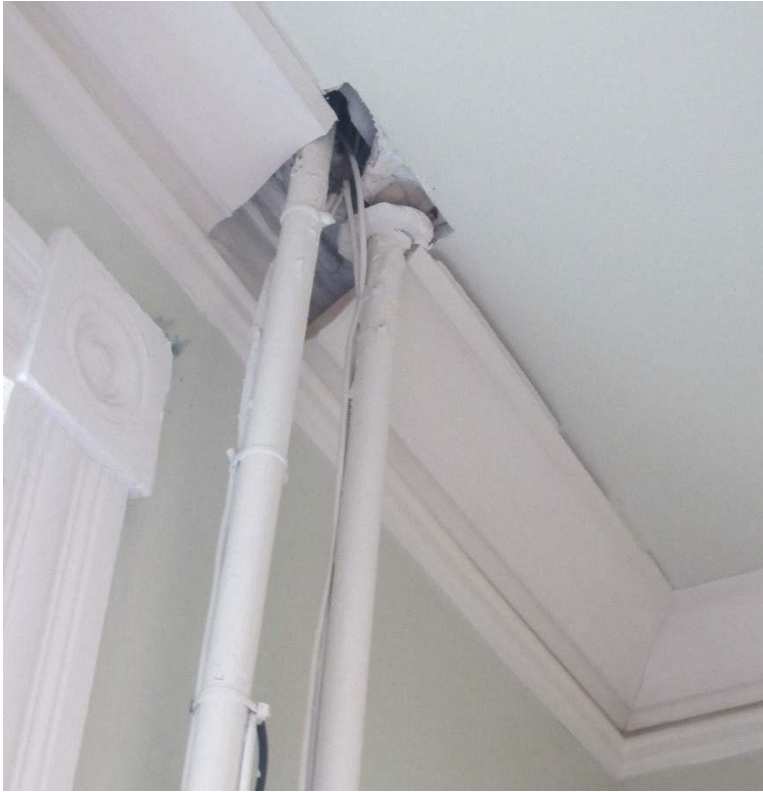
Figure 143: Detached crown molding in the southern corner.

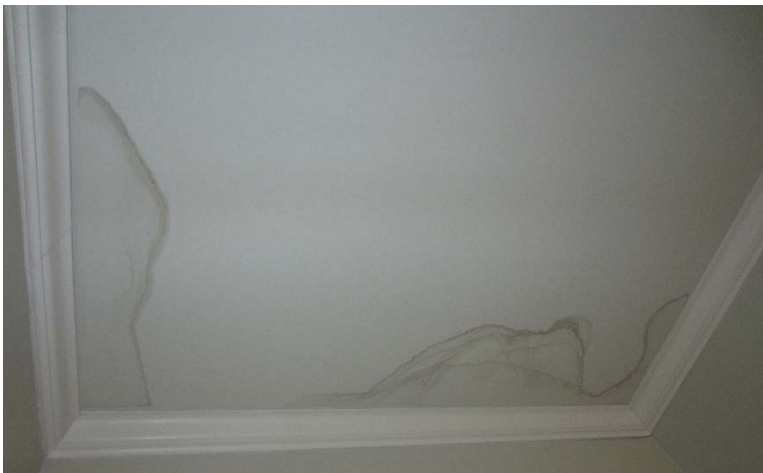
Figure 144: Water stains in the ceiling along the exterior wall.

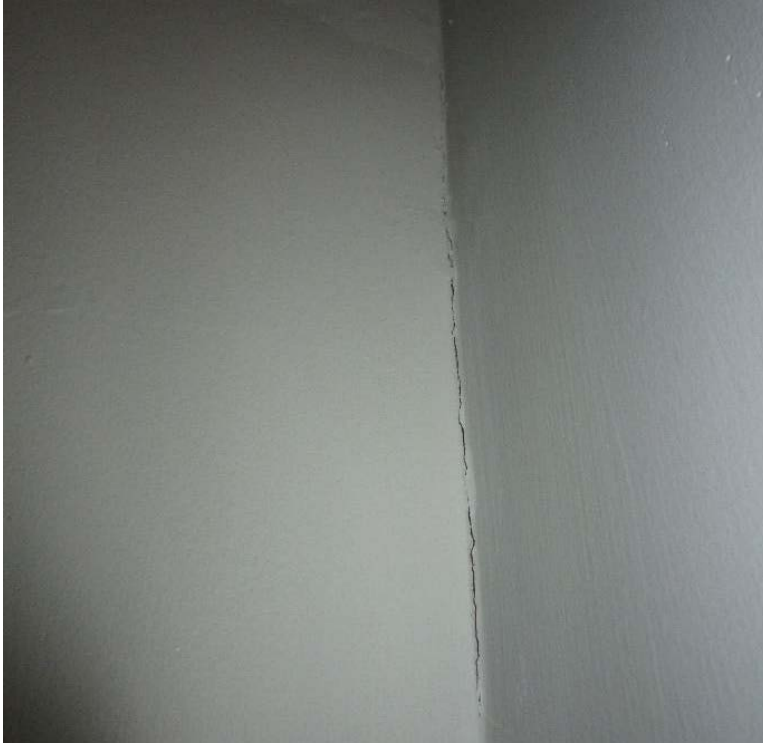
Figure 145: A portion of the staining and cracking in the eastern corner.

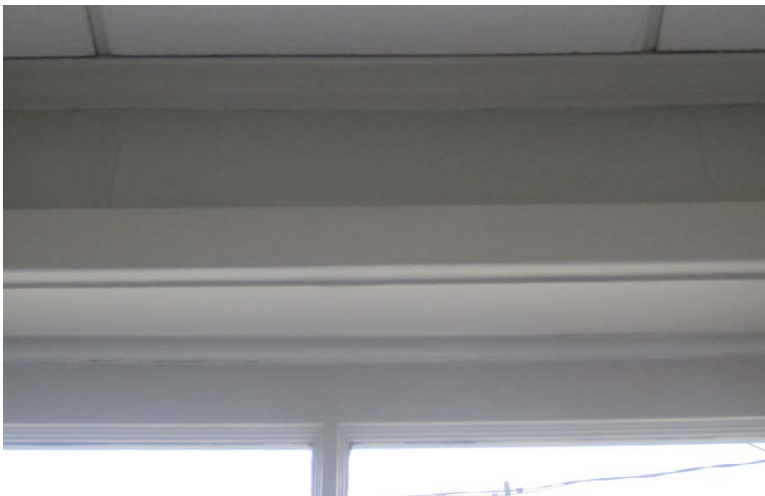
Figure 146: Two cracks above the northern window.

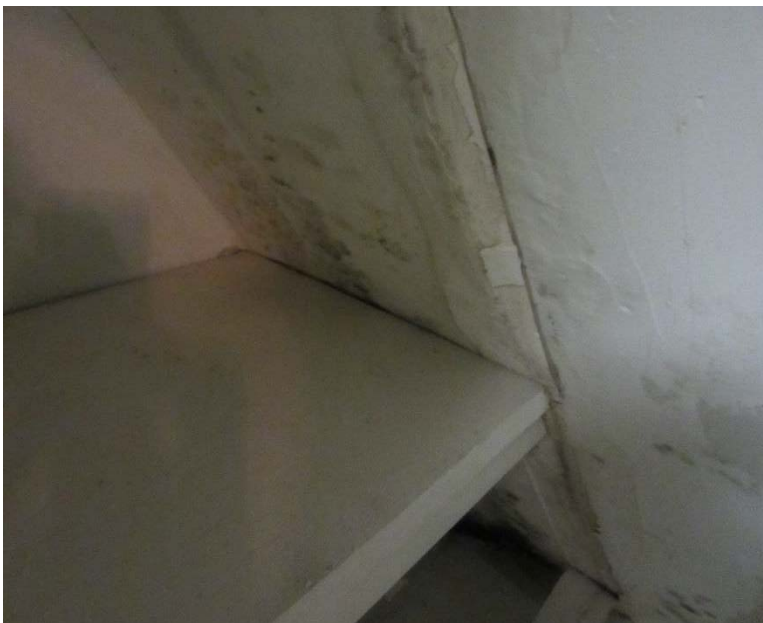
Figure 147: A portion of the mold on the exterior wall.

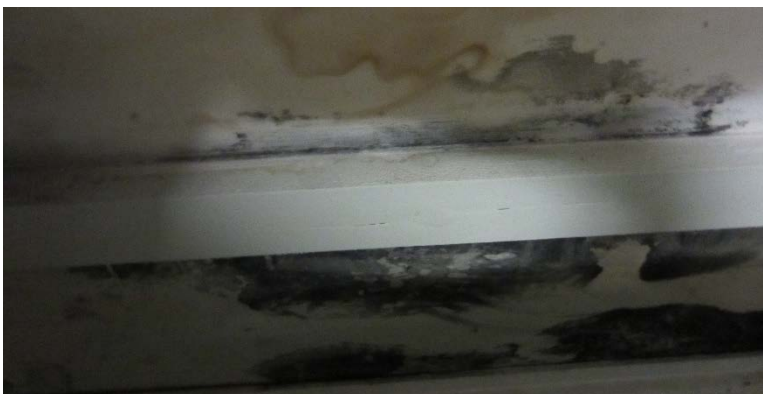
Figure 148: Mold and staining on the exterior wall of the closet.

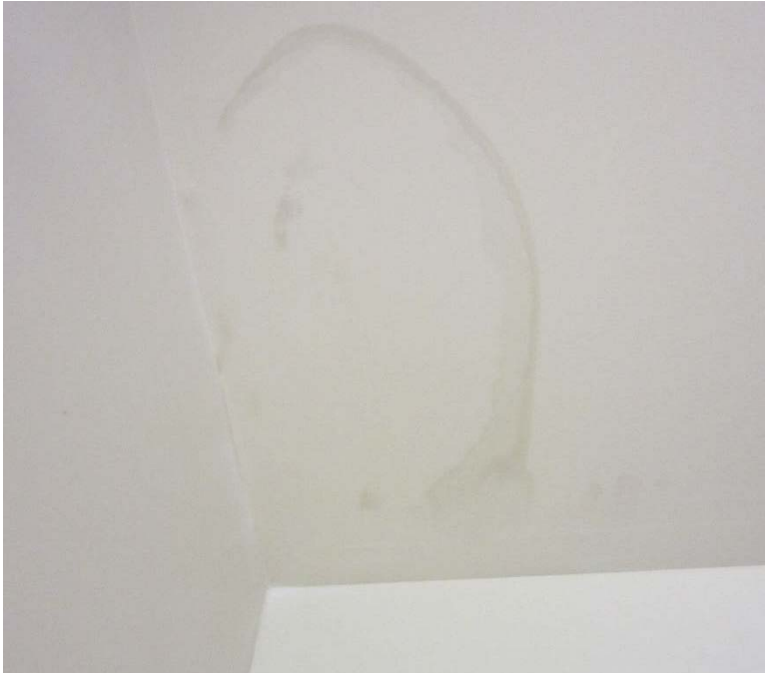
Figure 149: Water staining on the wall above closet door.

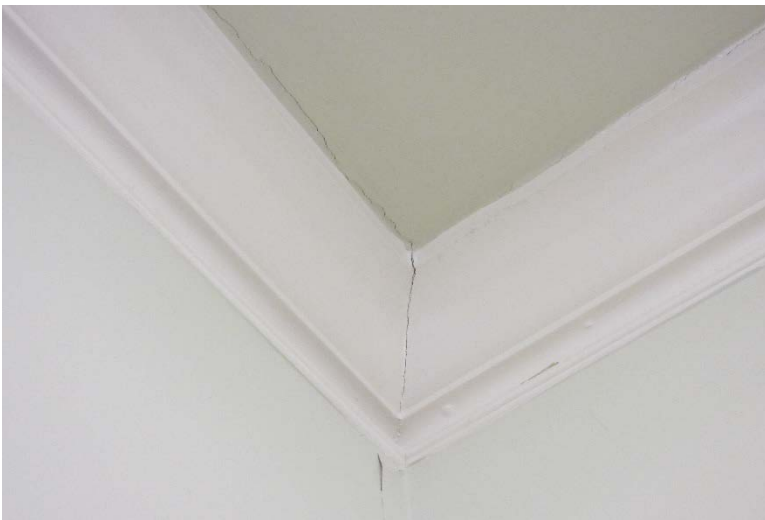
Figure 150: Crack running along the ceiling and through the crown molding in the eastern corner.

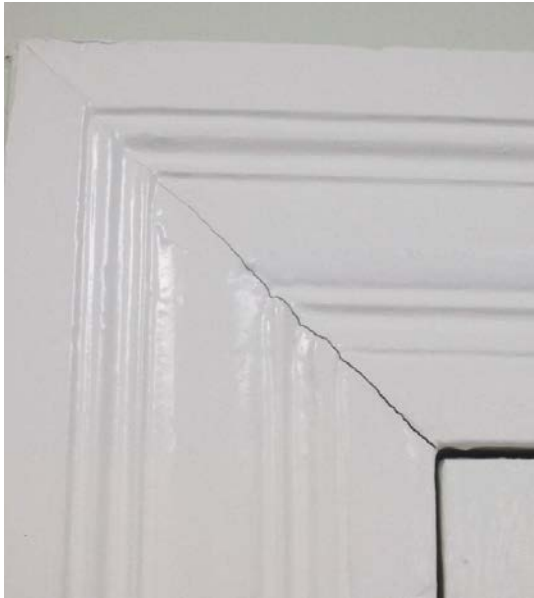
Figure 151: The historic door trim in the conference rooms serves as an example of a crack in a mitered joint.

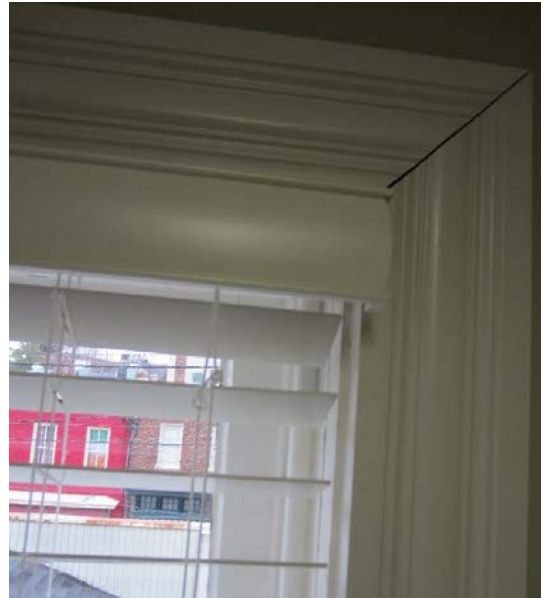
Figure 152: The new window trim in the southern office is an example of separation in a mitered joint.

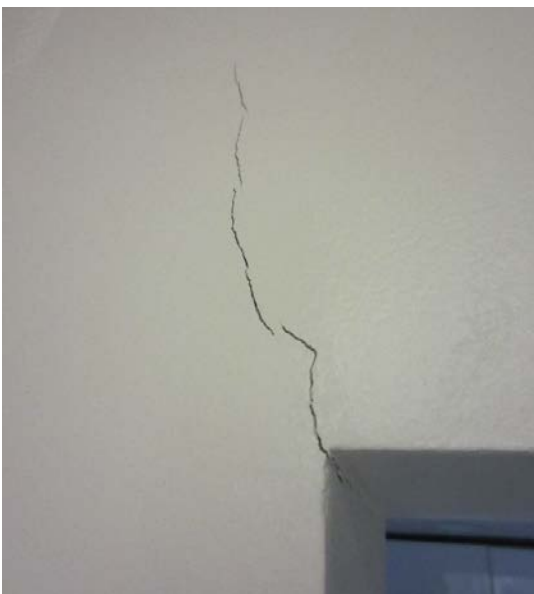
Figure 153: Stress crack at the opening between the transverse hall and kitchenette.

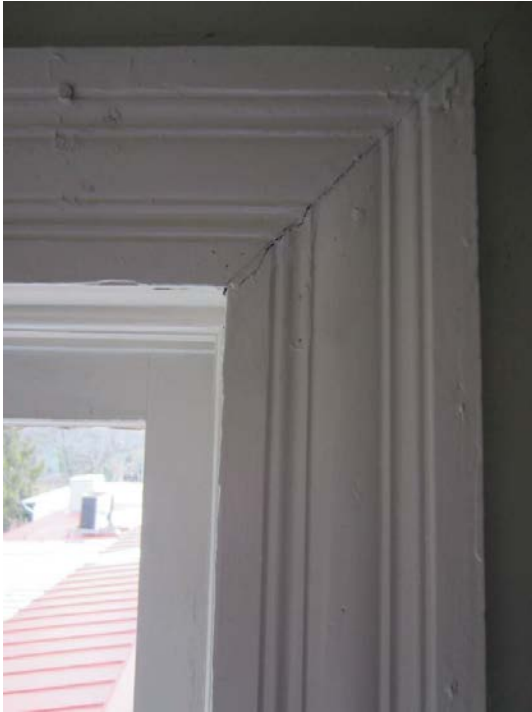
Figure 154: Historic window trim in the northeastern room is an example of a crack in mitered joint.

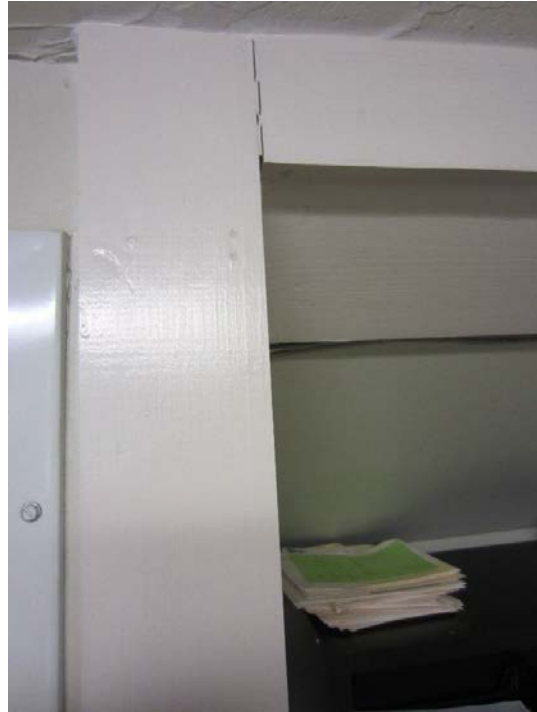
Figure 155: The new door trim serves as an example of the separation of a mitered joint.

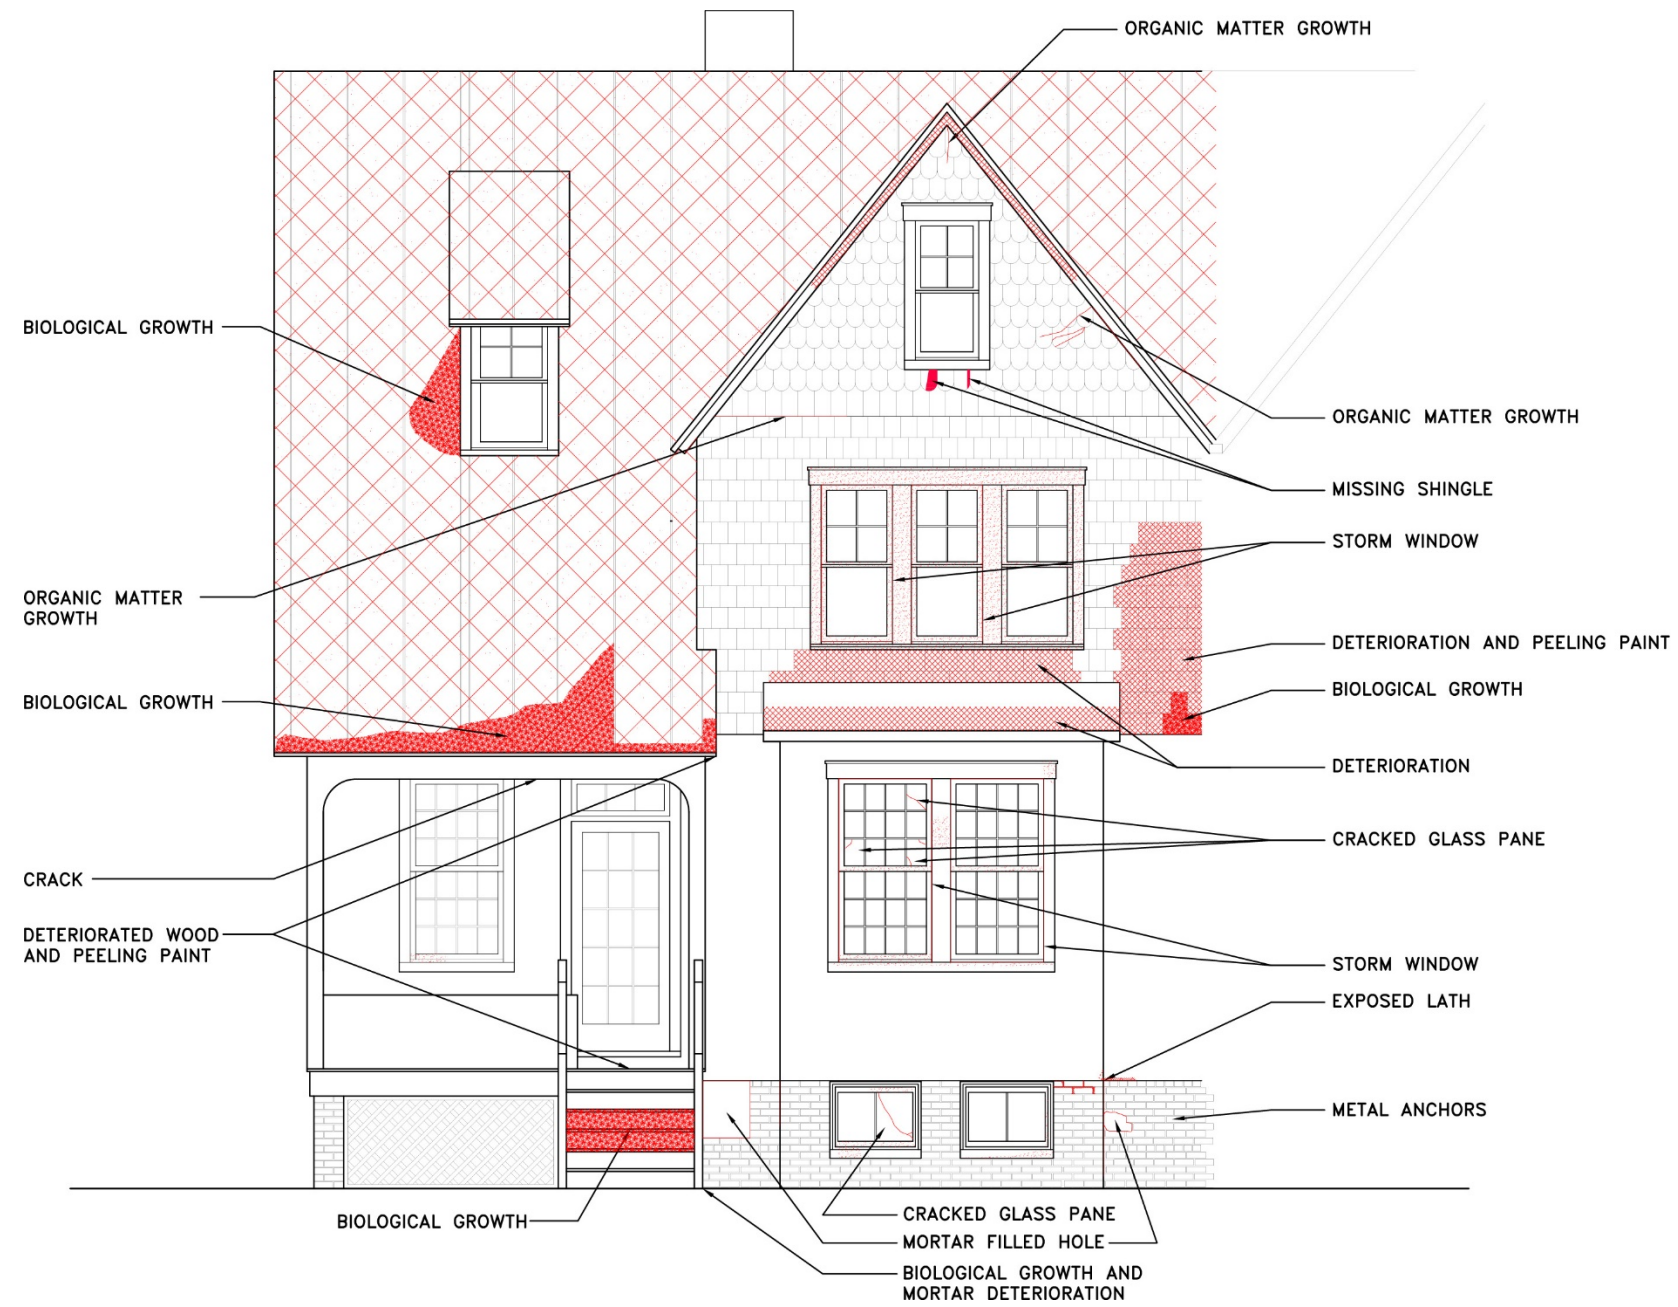
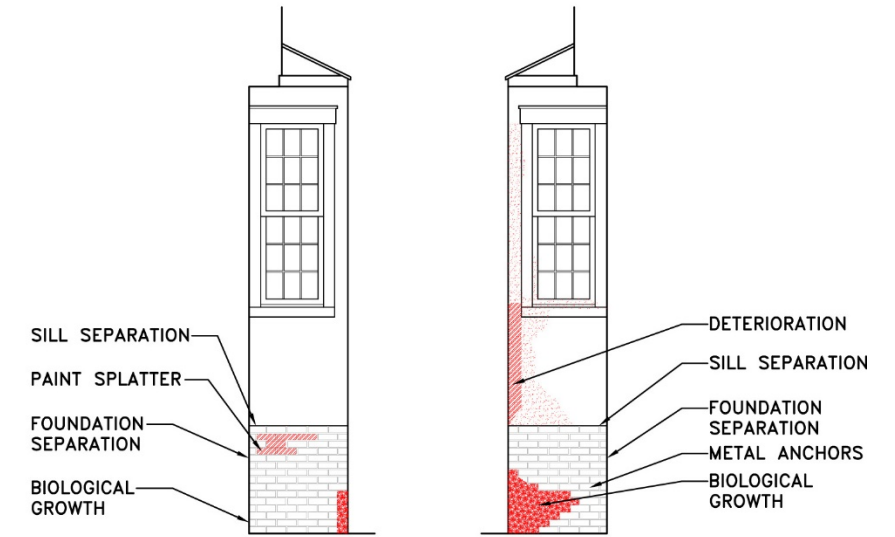
Northeast and Southwest Elevations of Square Bay

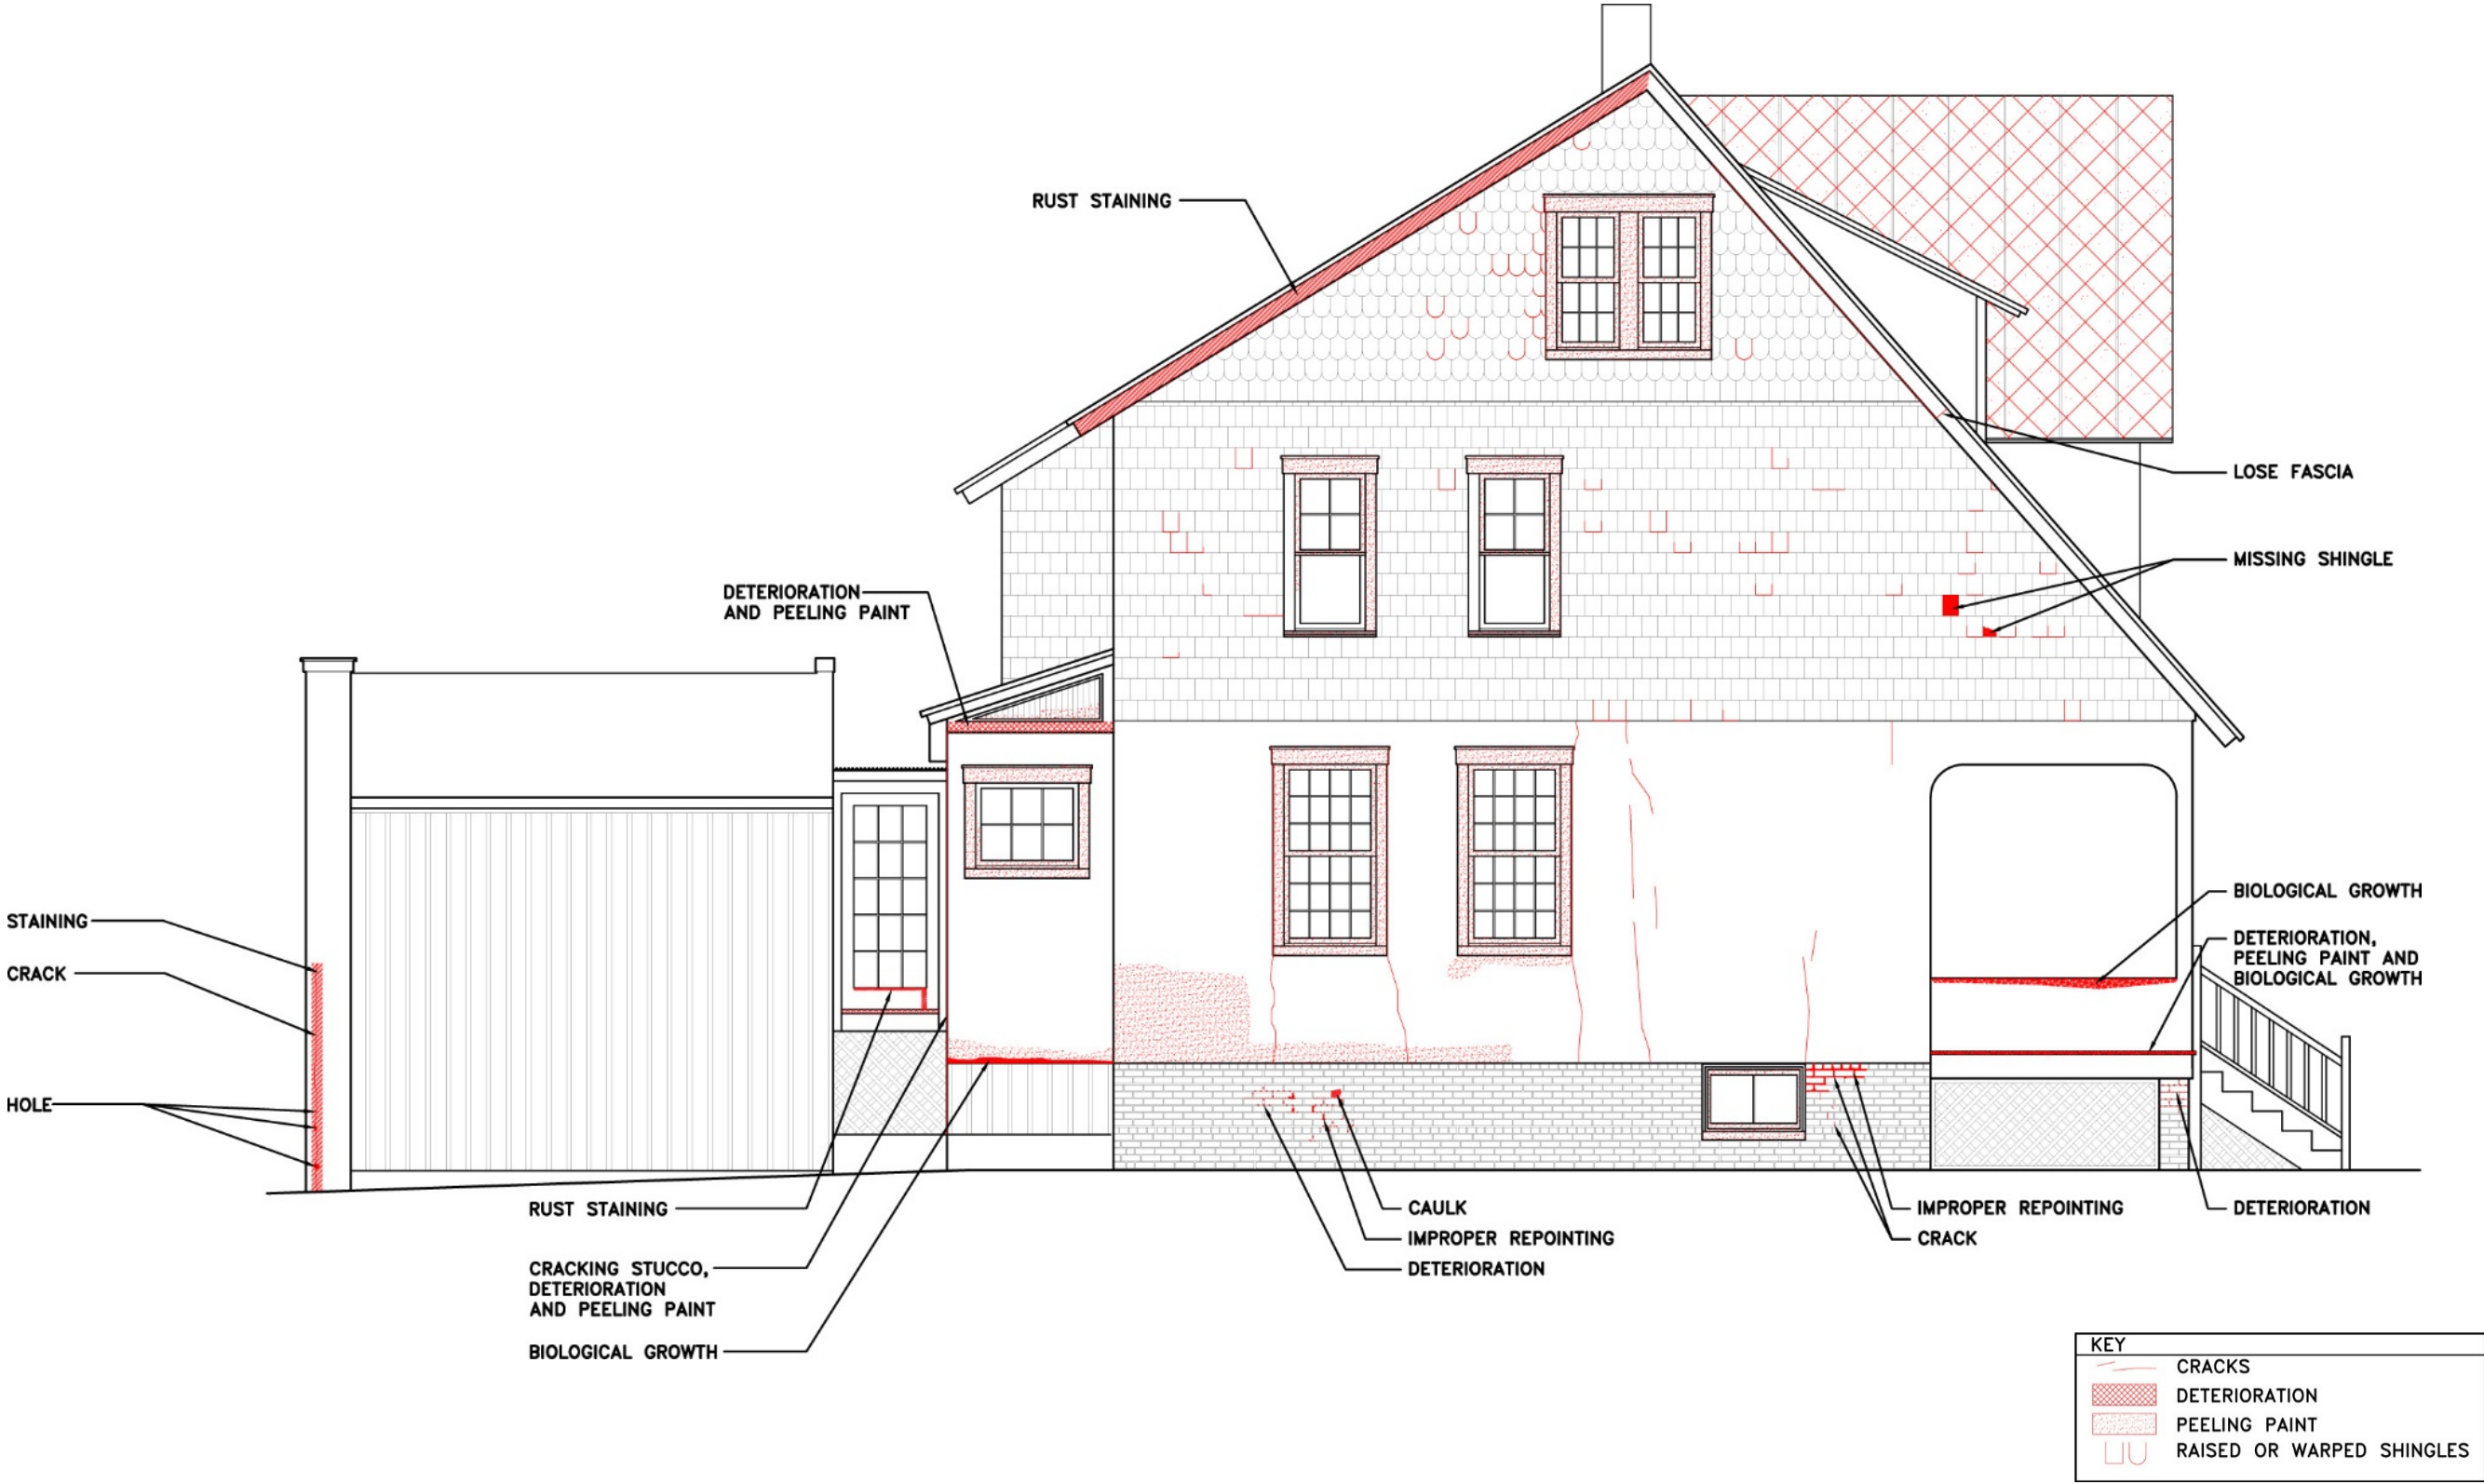
Existing Conditions | Southeast Elevation of Original Structure (Figure 158).

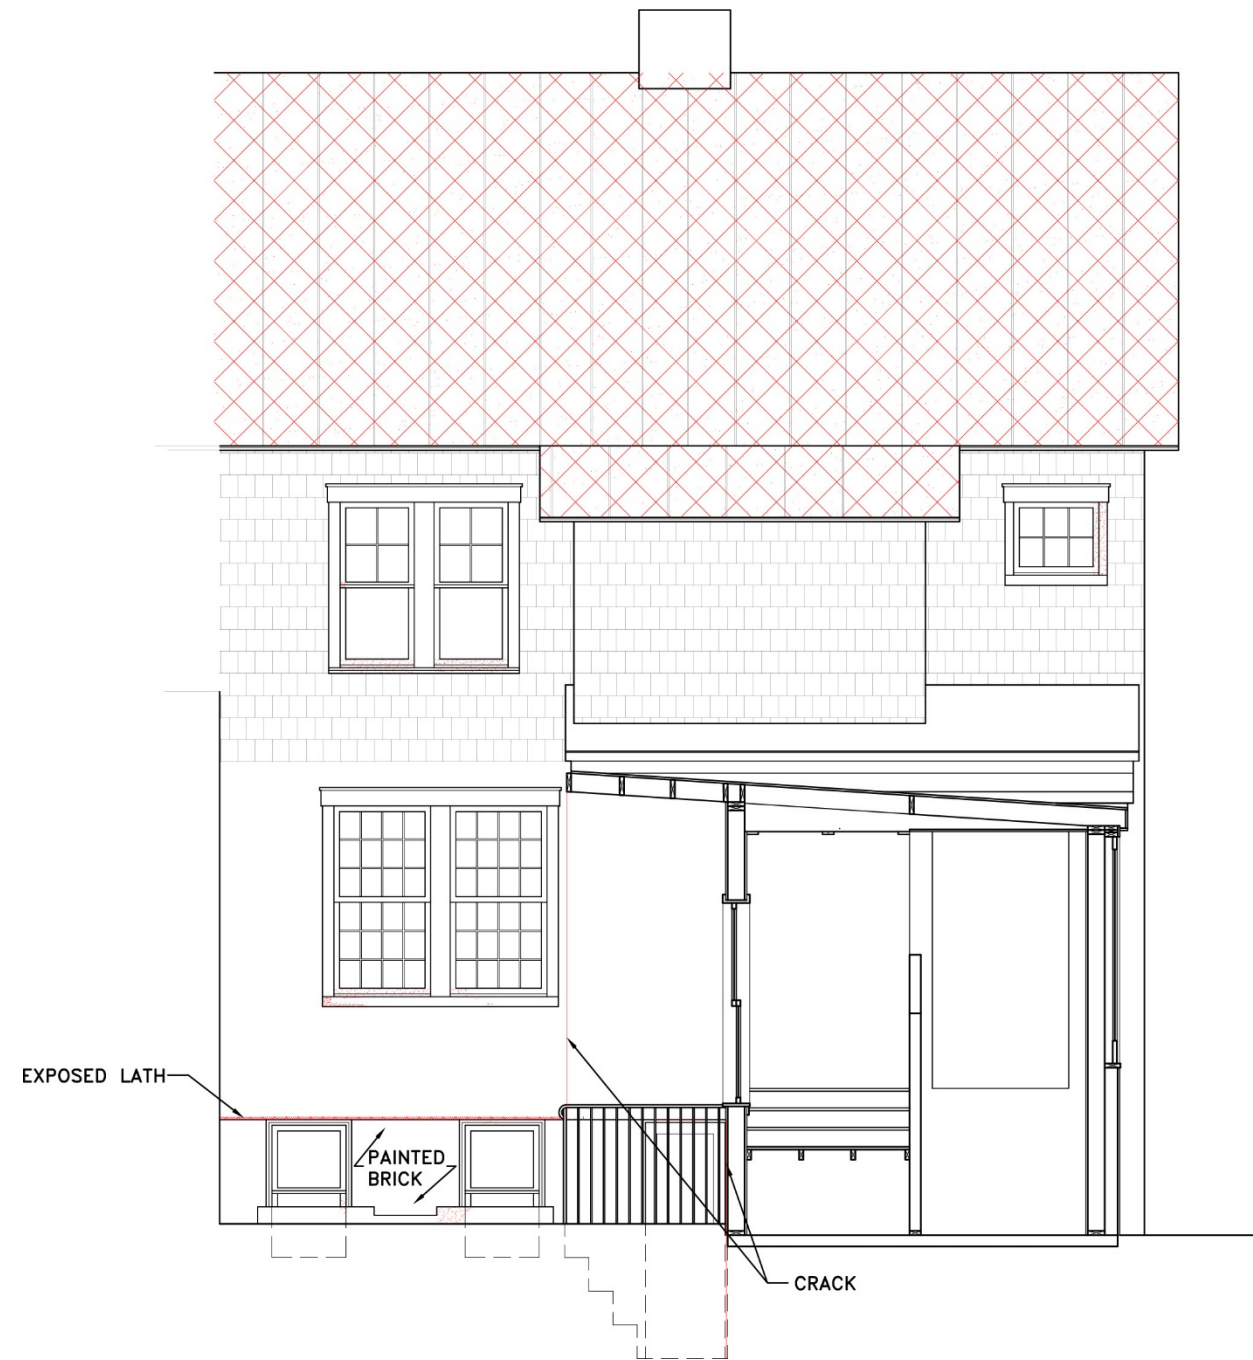
Existing Conditions | Southeast Elevation of Commercial Addition (Figure 159).

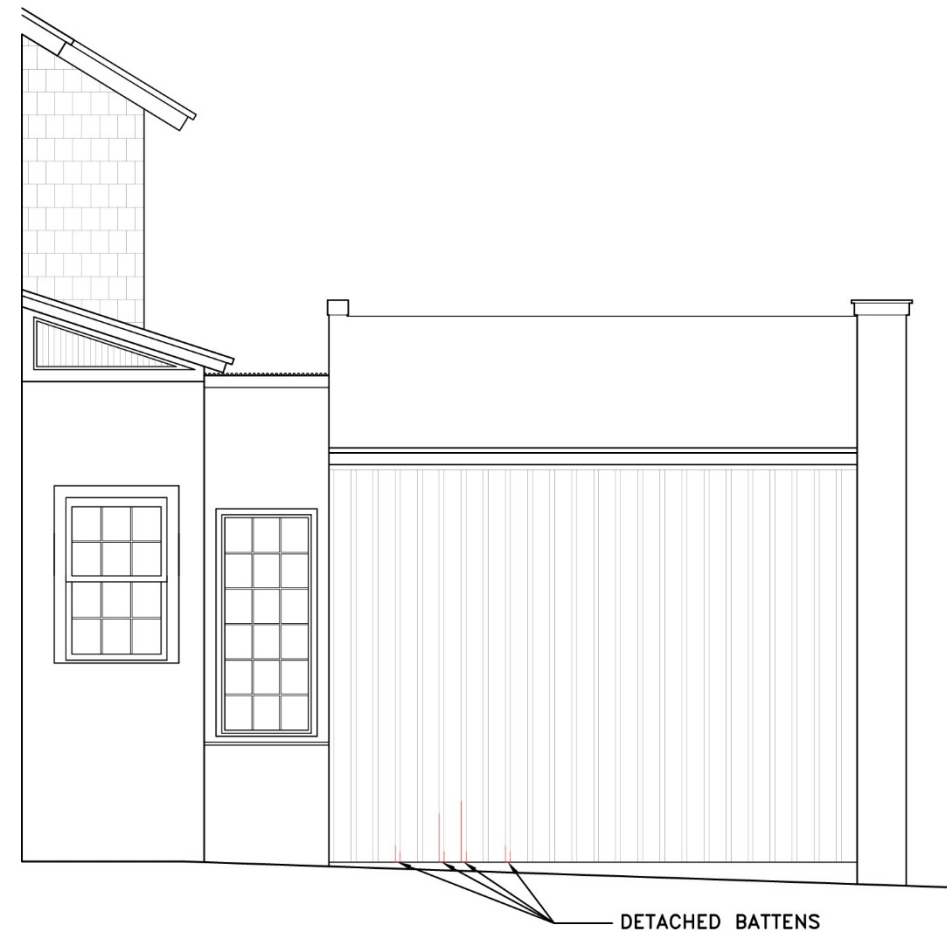
Existing Conditions | Northwest Elevation of Commercial Addition (Figure 161).

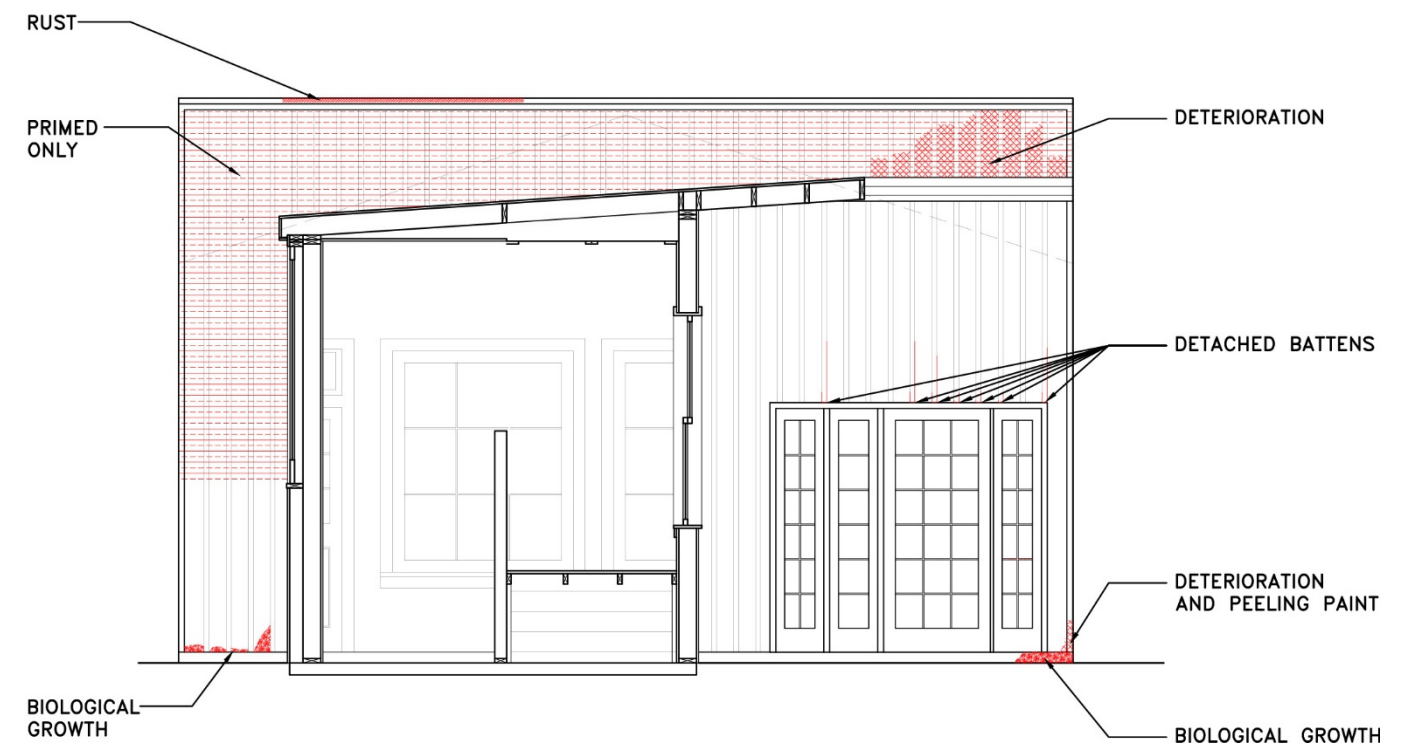
KEY	
	CRACKS
	DETERIORATION
	PEELING PAINT
	RAISED OR WARPED SHINGLES
